### Preliminary Geotechnical Assessment

# **Geotechnologies, Inc.**

Subject: Preliminary Geotechnical Assessment  
Proposed Mixed-Use Development  
1330 West Pico Boulevard, Los Angeles, California

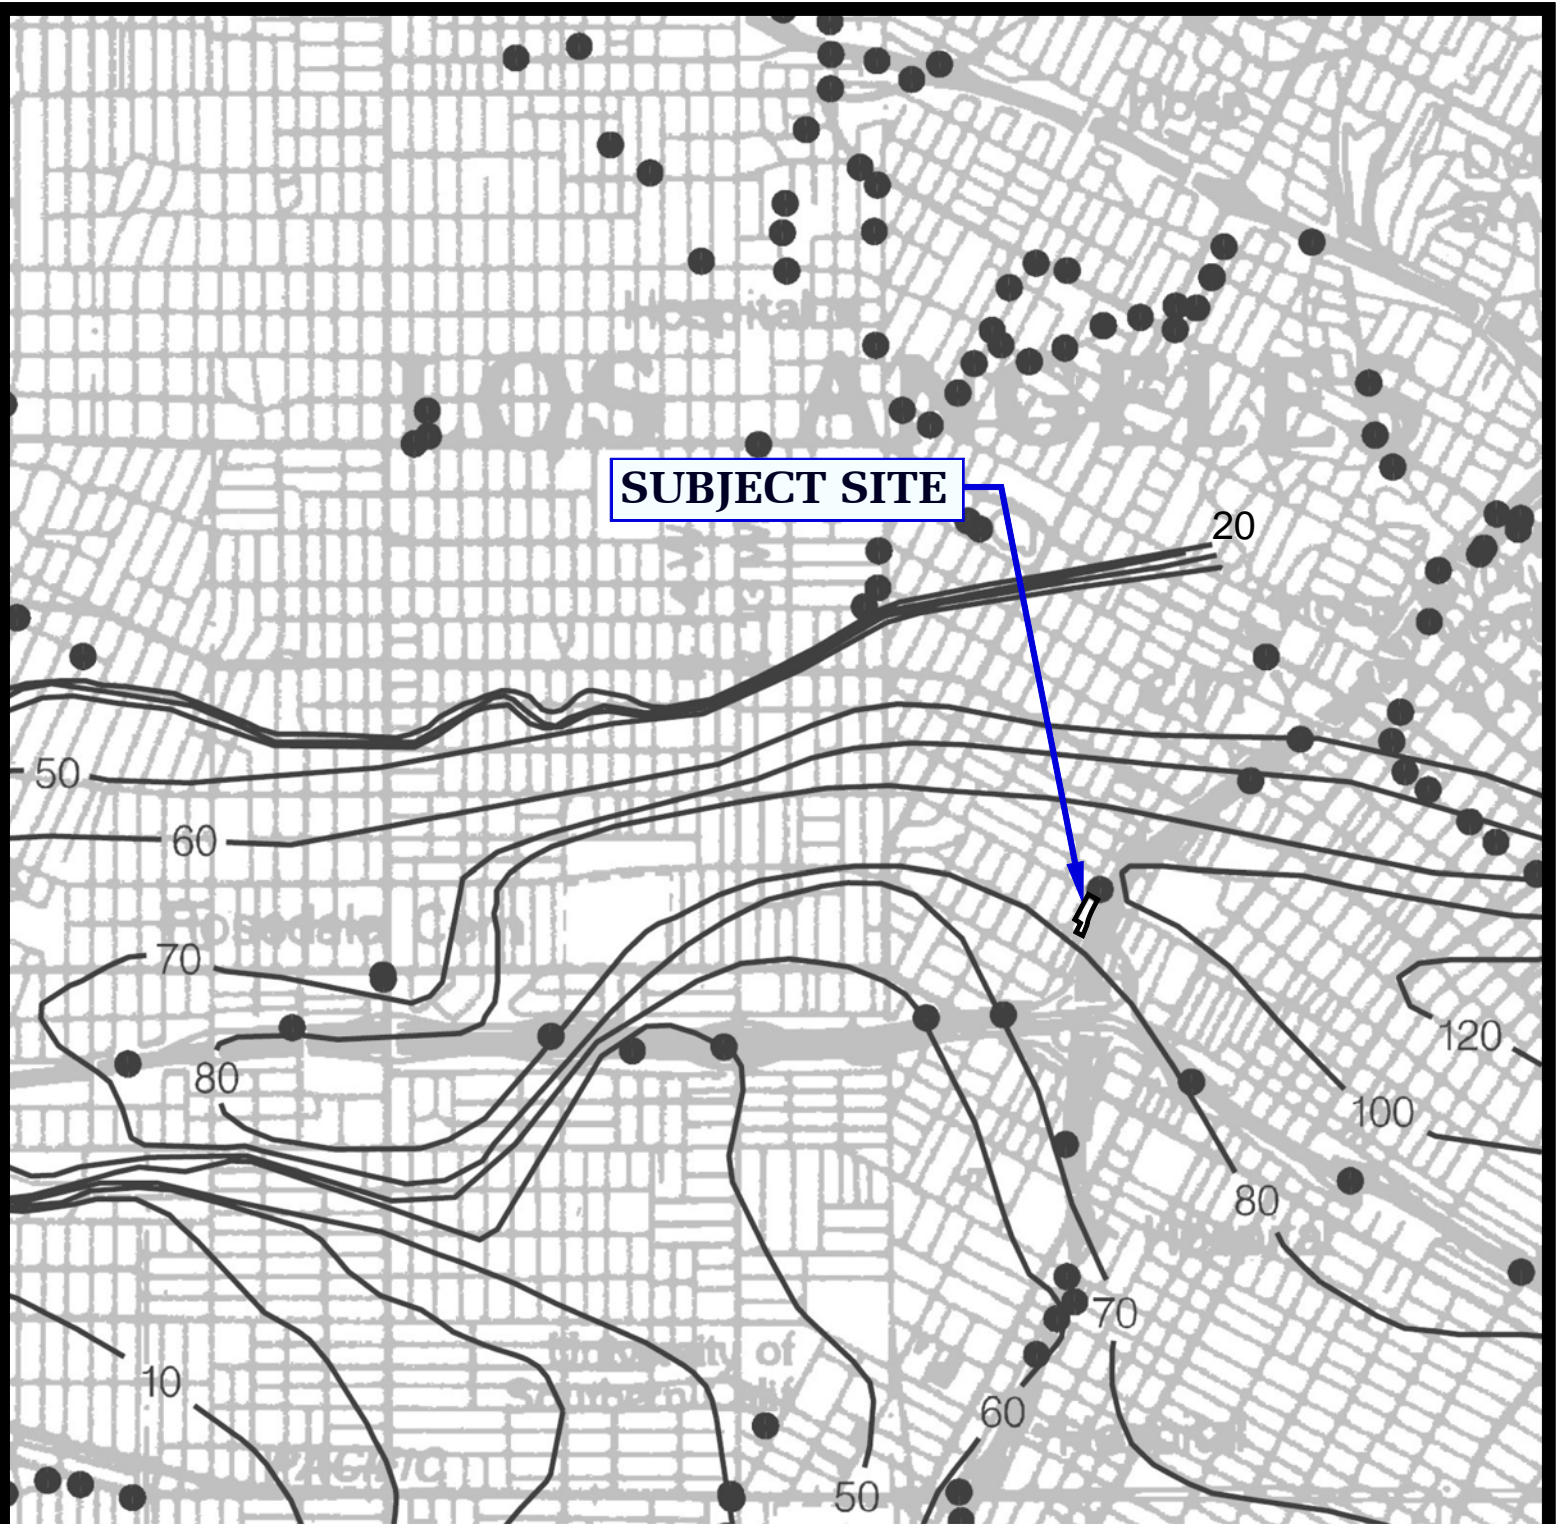
20 Depth to groundwater in feet

The historically highest groundwater level was established by review of the Hollywood 7½ Minute Quadrangle Seismic Hazard Evaluation Report, Plate 1.2, Historically Highest Ground Water Contours (CDMG, 2006). Review of this plate indicates that the historically highest groundwater level at the site is estimated at 85 feet below ground surface. A copy of this plate is included in the Appendix as Historically Highest Groundwater Levels Map.
