## **APPENDIX H**

### **Geology and Soils Data**

# **EXISTING SETTING**

## *Geologic Hazards*

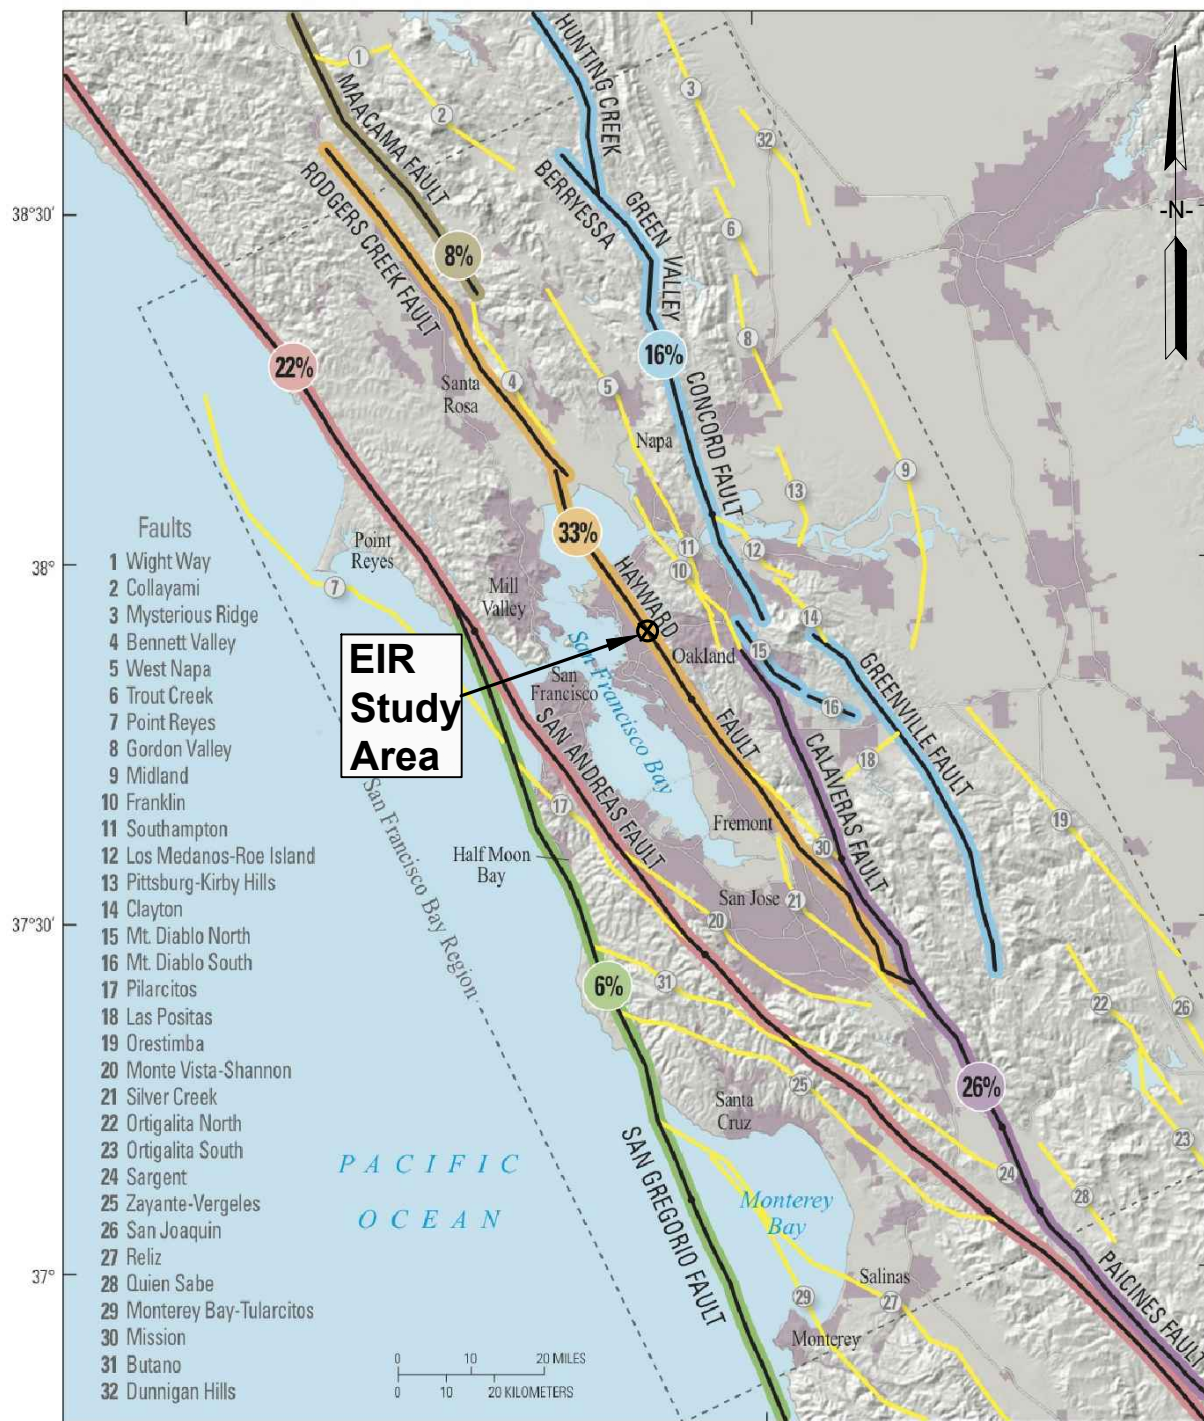
FIGURE **1**

Base: "Map of Known Active Geologic Faults in the San Francisco Bay Region," USGS, Fact Sheet 2016-3020, 2016.

Seismic activity within the Coast Ranges is generally associated with active faults of the San Andreas system, which includes major active faults both east and west of the EIR Study Site. Over the width of the San Francisco Bay Region, approximately 1.5 inches/year of relative horizontal movement occurs between the North American and Pacific Plates (WGCEP, 2003, 2008, 2015). This movement is partially accommodated by earthquakes and creep occurring along several active faults. Locations of these active

faults relative to the study site are shown on the San Francisco Bay Area Fault Map, Figure 1.

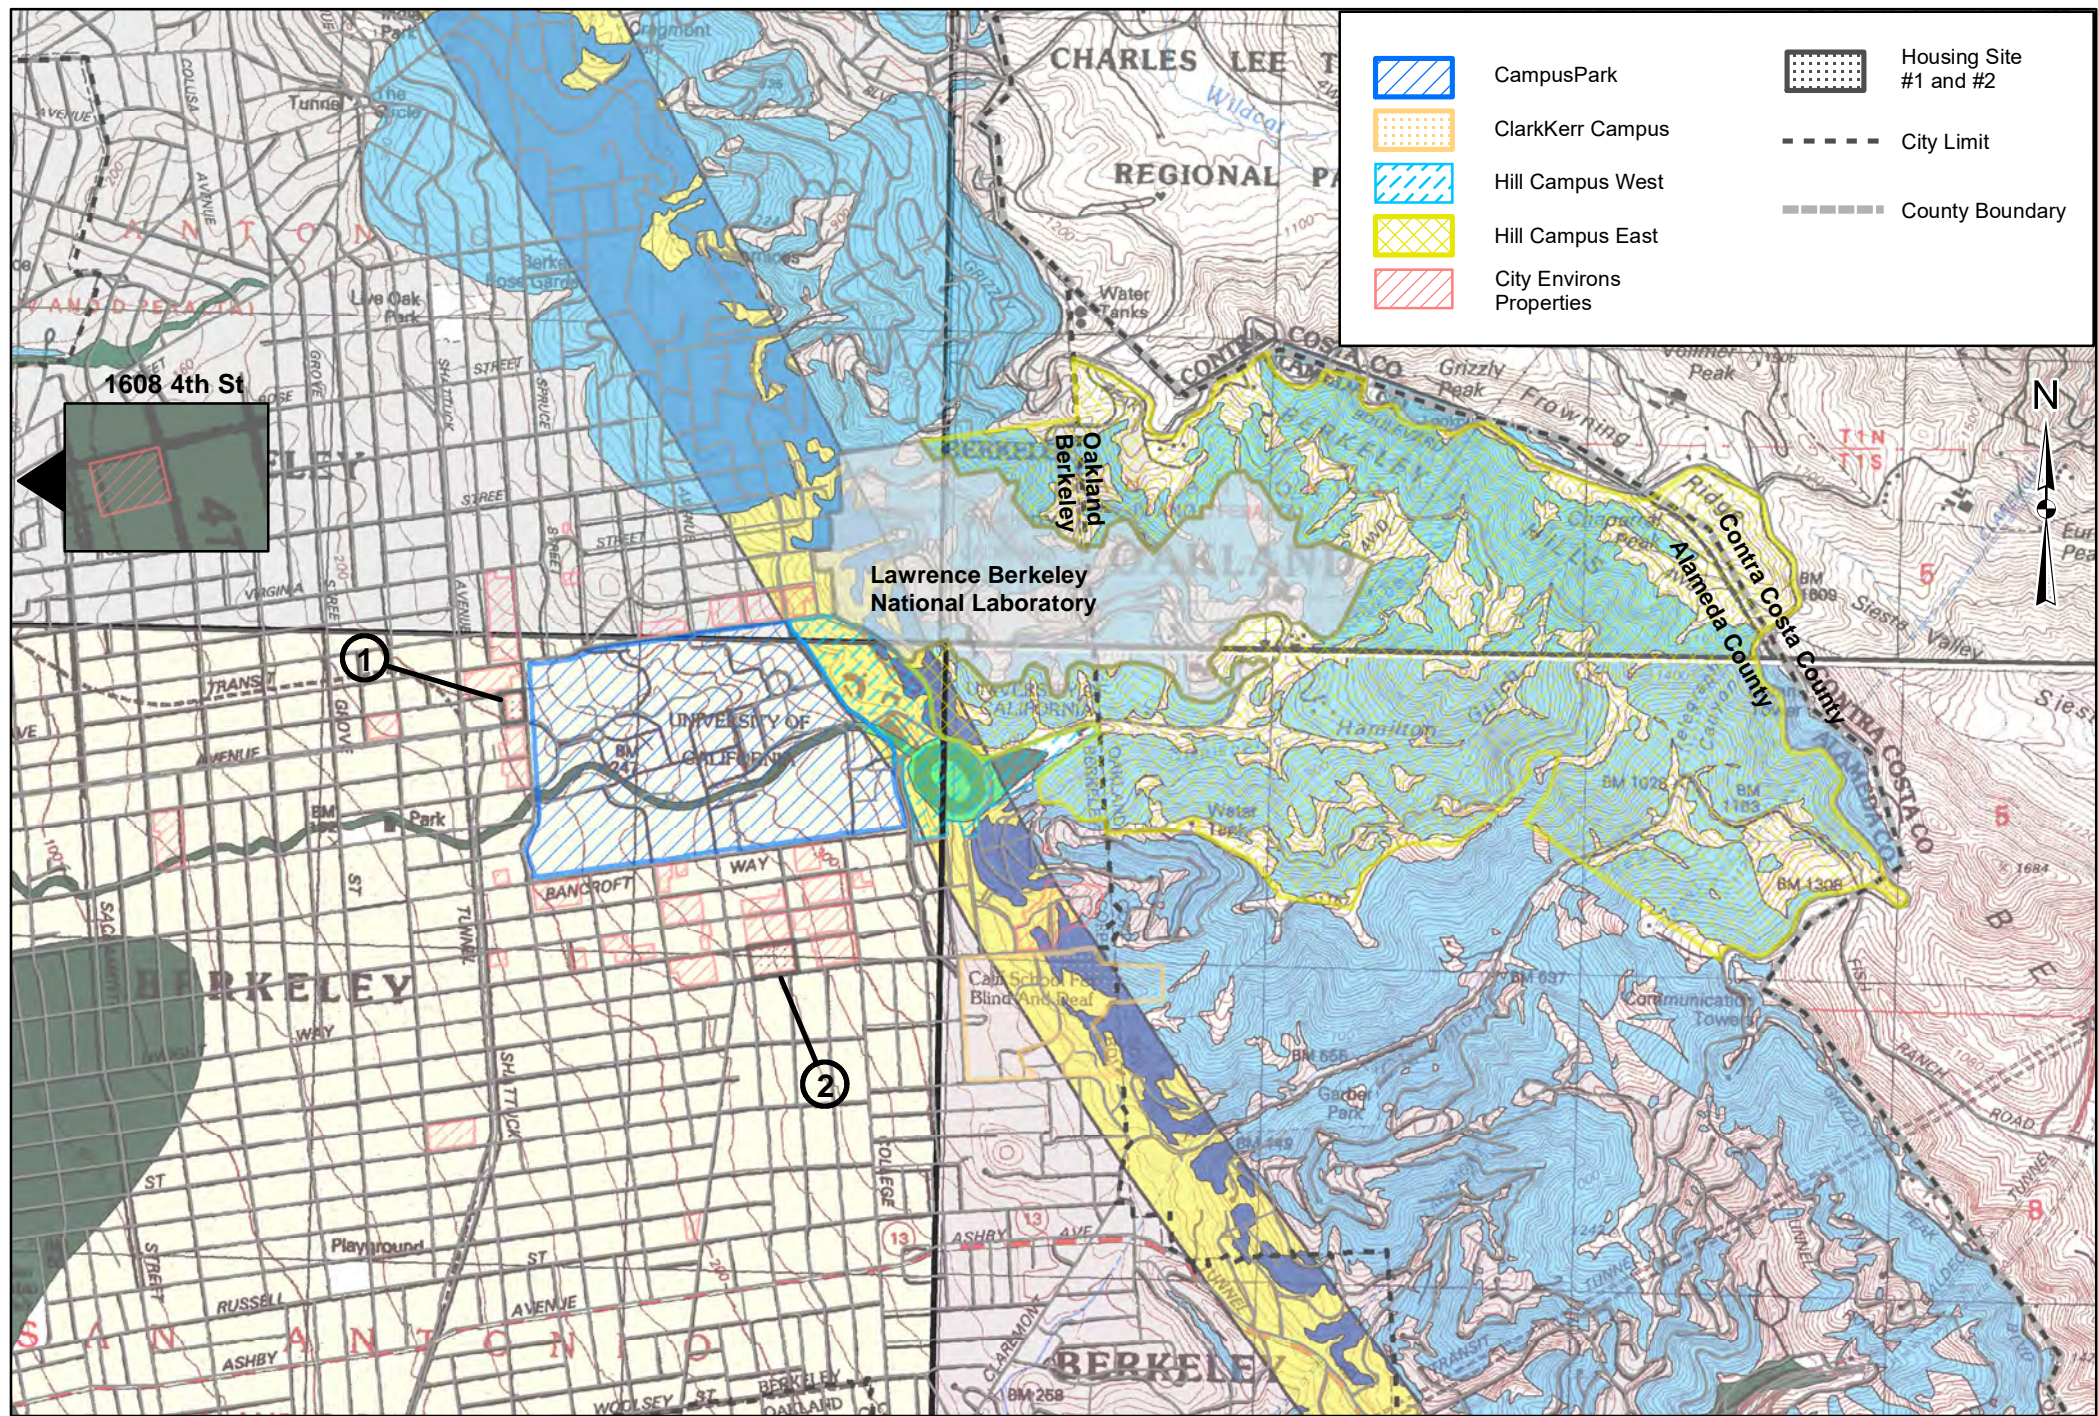
<b>GEOLOGIC HAZARDS</b>		
	UC BERKELEY - LRDCMP EIR Berkeley, California		
	PROJECT NO.	DATE	FIGURE <b>3</b>
	2500-18	September 2020

Source: Earthquake Zones of Required Investigation  
Oakland West, Oakland East, Richmond and Briones Valley  
Quadrangles, California Geological Surveys, 2016.

**Earthquake Fault Zones**  
Zone boundaries are delineated by straight-line segments; the boundaries define the zone encompassing active faults that constitute a potential hazard to structures from surface faulting or fault creep such that avoidance as described in Public Resources Code Section 2621.5(a) would be required.

**Active Fault Traces**  
Faults considered to have been active during Holocene time and to have potential for surface rupture: Solid Line in Black or Red where Accurately Located; Long Dash in Black or Solid Line in Purple where Approximately Located; Short Dash in Black or Solid Line in Orange where Inferred; Dotted Line in Black or Solid Line in Rose where Concealed; Query (?) indicates additional uncertainty. Evidence of historic offset indicated by year of earthquake-associated event or C for displacement caused by fault creep.

**Liquefaction Zones**  
Areas where historical occurrence of liquefaction, or local geological, geotechnical and ground water conditions indicate a potential for permanent ground displacements such that mitigation as defined in Public Resources Code Section 2693(c) would be required.

**Earthquake-Induced Landslide Zones**  
Areas where previous occurrence of landslide movement, or local topographic, geological, geotechnical and subsurface water conditions indicate a potential for permanent ground displacements such that mitigation as defined in Public Resources Code Section 2693(c) would be required.

**Overlap of Earthquake Fault Zone and Earthquake-Induced Landslide Zone**  
Areas that are covered by both Earthquake Fault Zone and Earthquake-Induced Landslide Zone.

should be noted that these landslides may fail in the future during large earthquakes, and Figure 3 illustrates the areas that the California Geologic Survey considers may be susceptible to earthquake-induced landsliding on their Seismic Hazard Map of the area: they recommend a site should be evaluated for such a hazard before development. This is the third significant geologic hazard in the study area, but it is only a concern in the Hill Campus East.

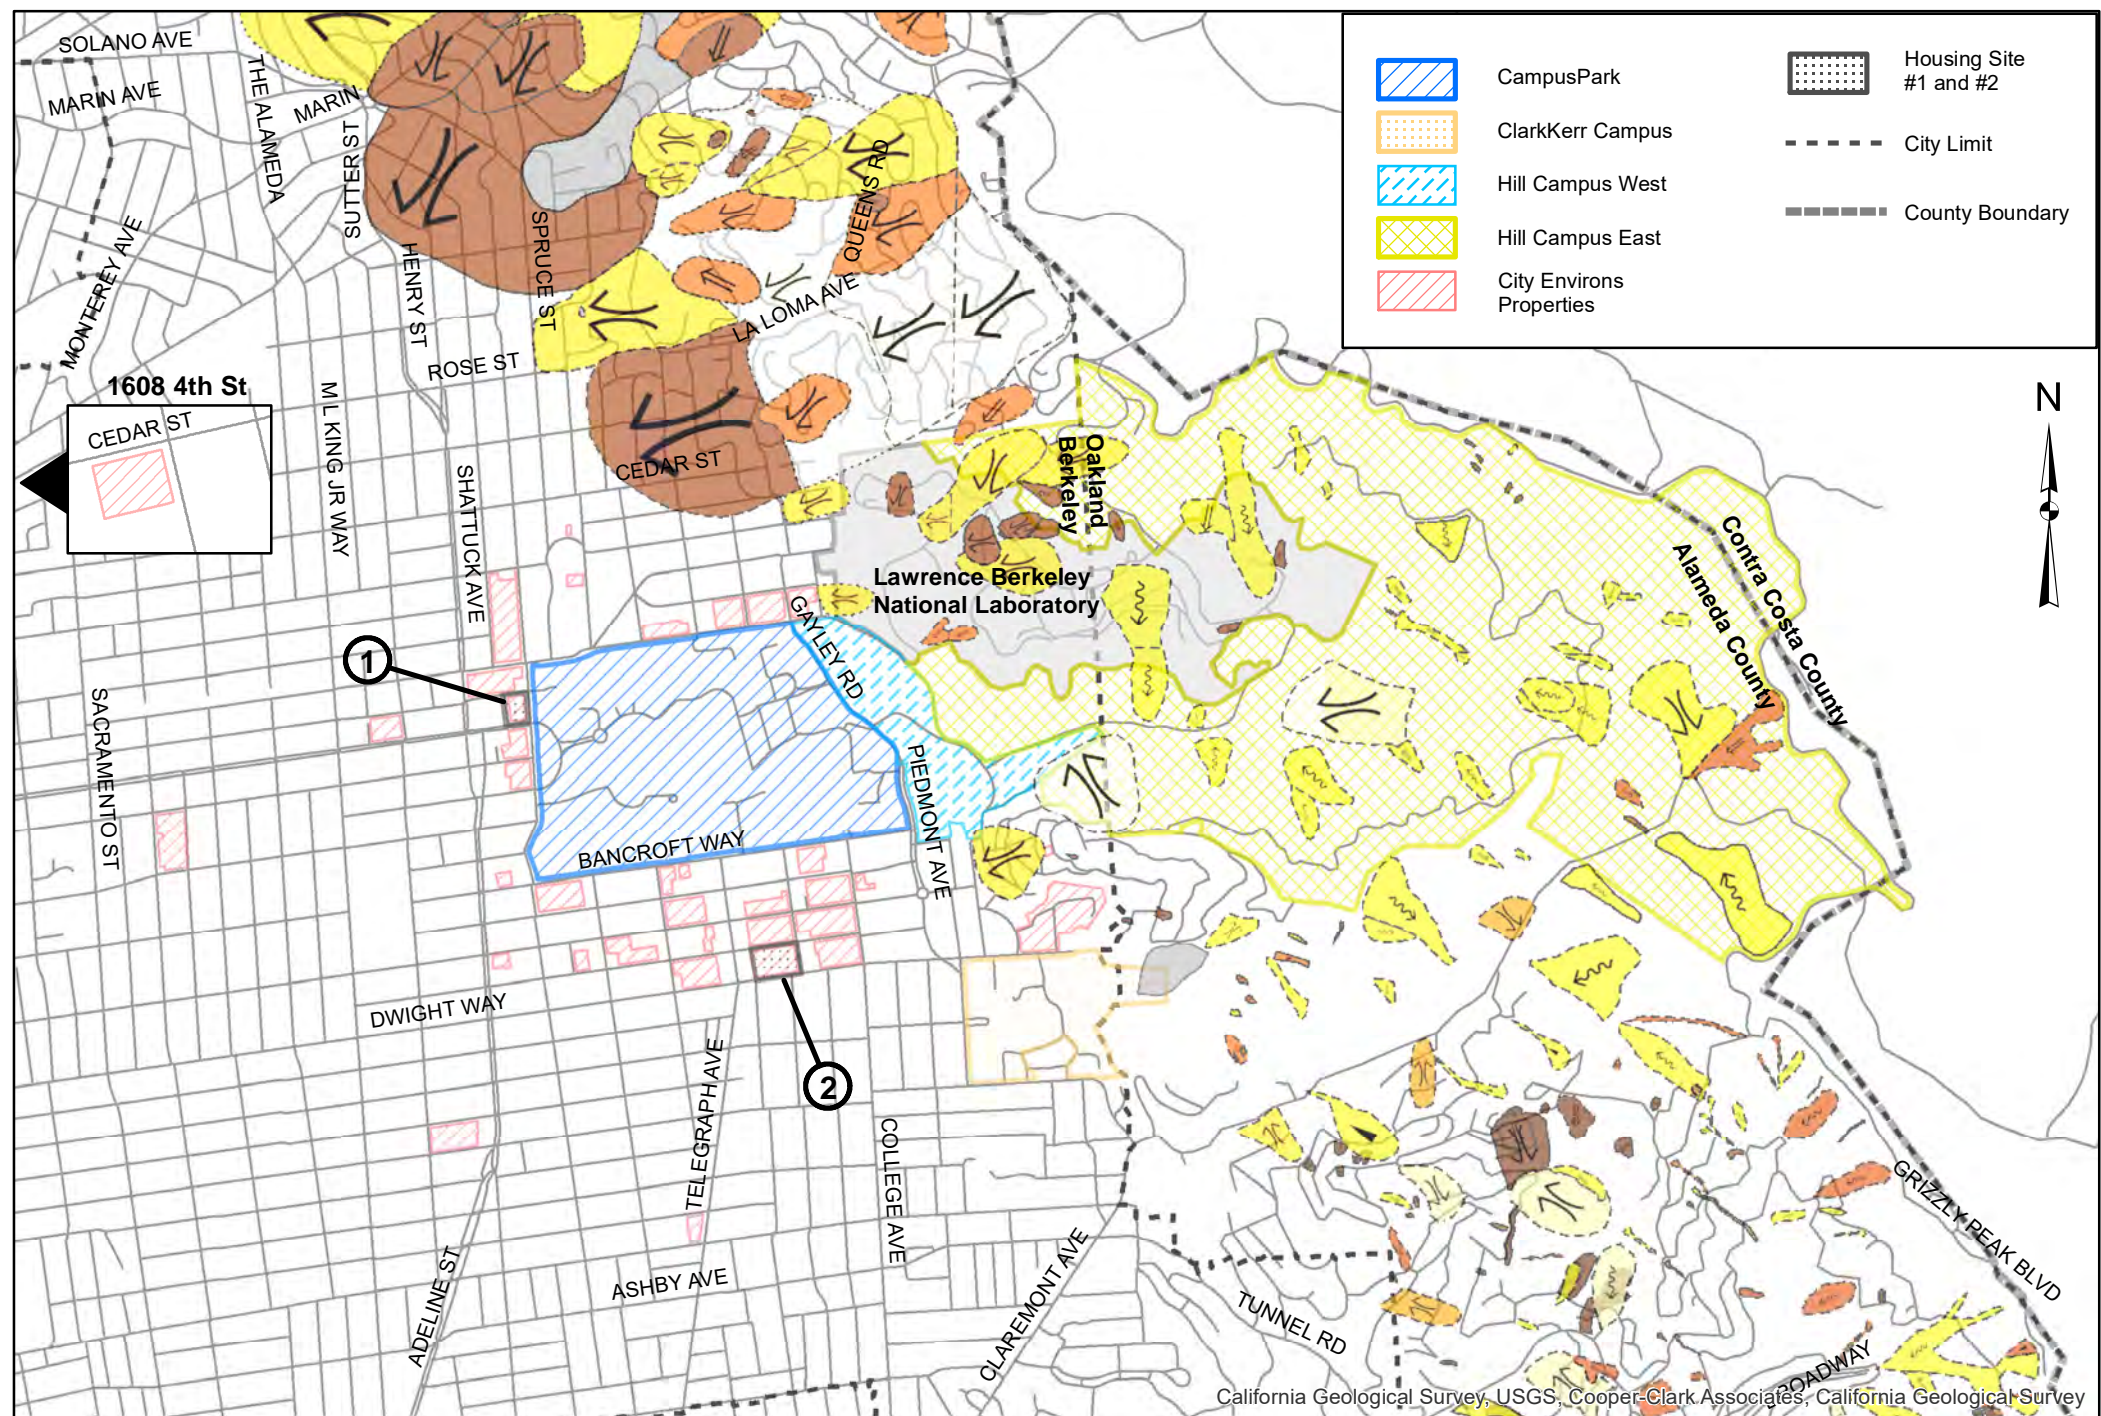
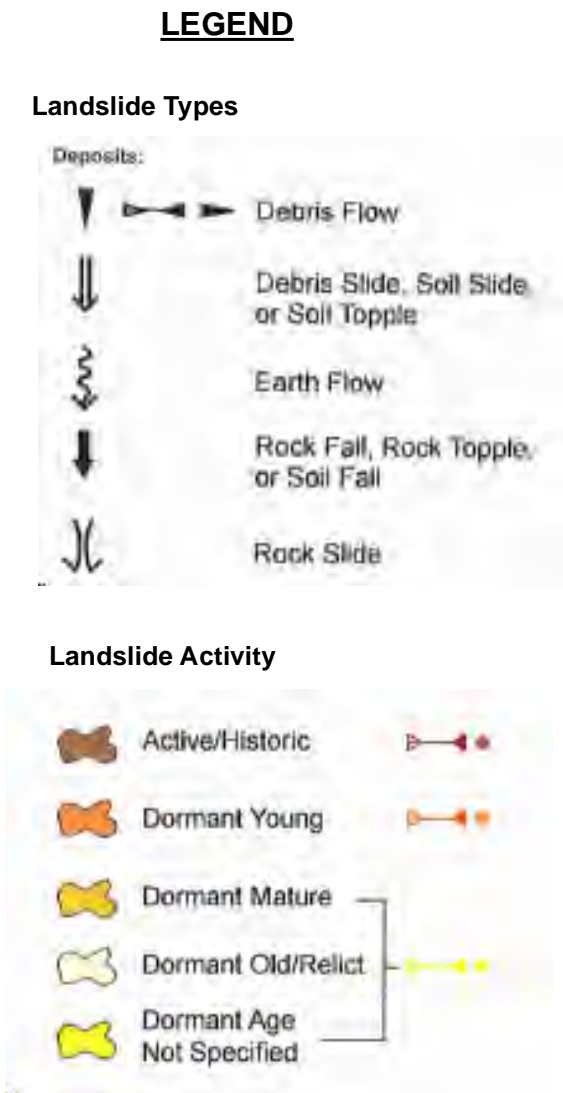
<b>ALAN KROPP &amp; ASSOCIATES</b> <i>Geotechnical Consultants</i>	<b>LANDSLIDE MAP</b>		
	UC BERKELEY - LRDPCMP EIR Berkeley, California		
	PROJECT NO.	DATE	FIGURE <b>4</b>
	2500-18	September 2020

Source: Landslide Inventory (Beta), California Geological Surveys, downloaded September 2020.

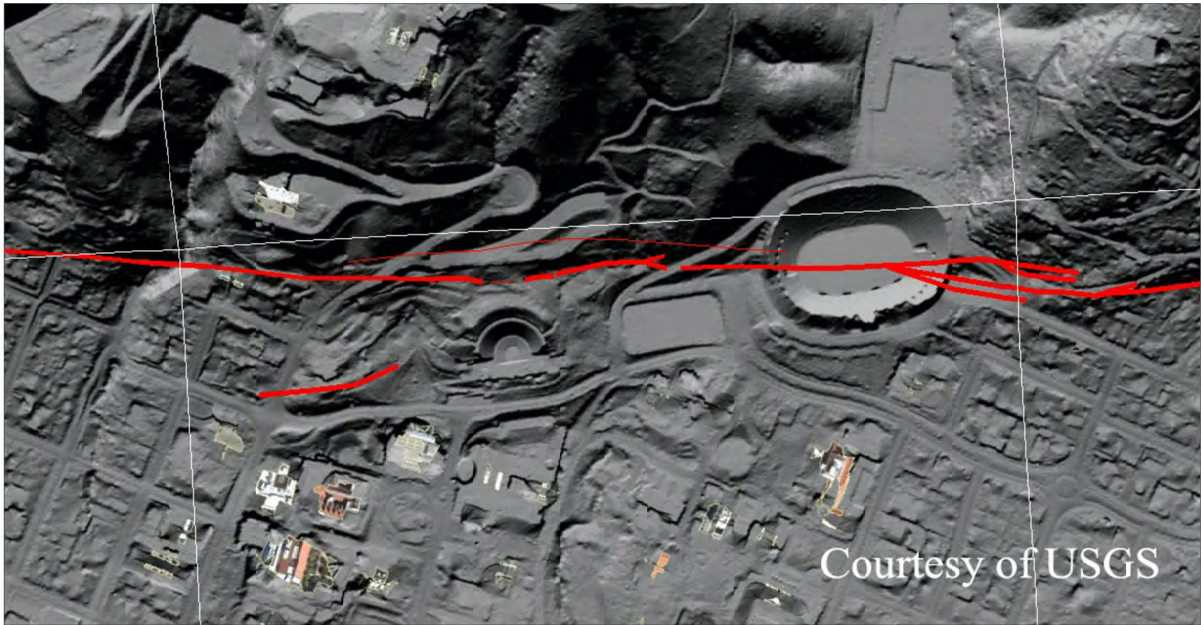
Hayward Fault- Northern Portion of Study Area

Source: <http://seismo.berkeley.edu/hayward/index.html>

- NOTES:
- 1. These images illustrate the active Hayward fault traces from Lienkaemper, 2006 on a hillshade output from LiDAR data
  - 2. Original figure produced in color.

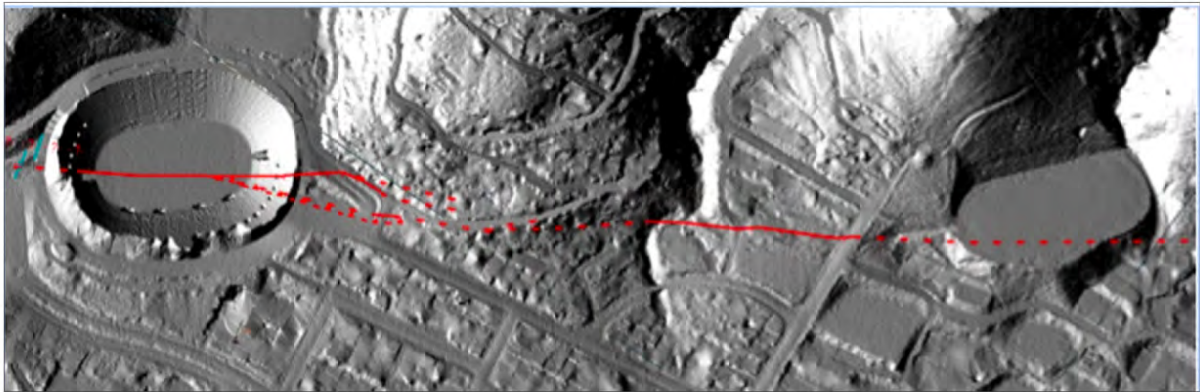
Hayward Fault- Southern Portion of Study Area

Source: <https://haywardfaultucberkeley.pressbooks.com/front-matter/cover-picture/>
