Project No. G19-1691-20

Preliminary Infiltration Testing Investigation for Onsite Storm Water Infiltration Devices for the Proposed 42 Lot Residential Project, 5553 Mission Boulevard, Montclair Area, County of San

Bernardino, California.

# INFILTRATION TEST TRENCH LOGS AND EXPLORATORY BORING LOG

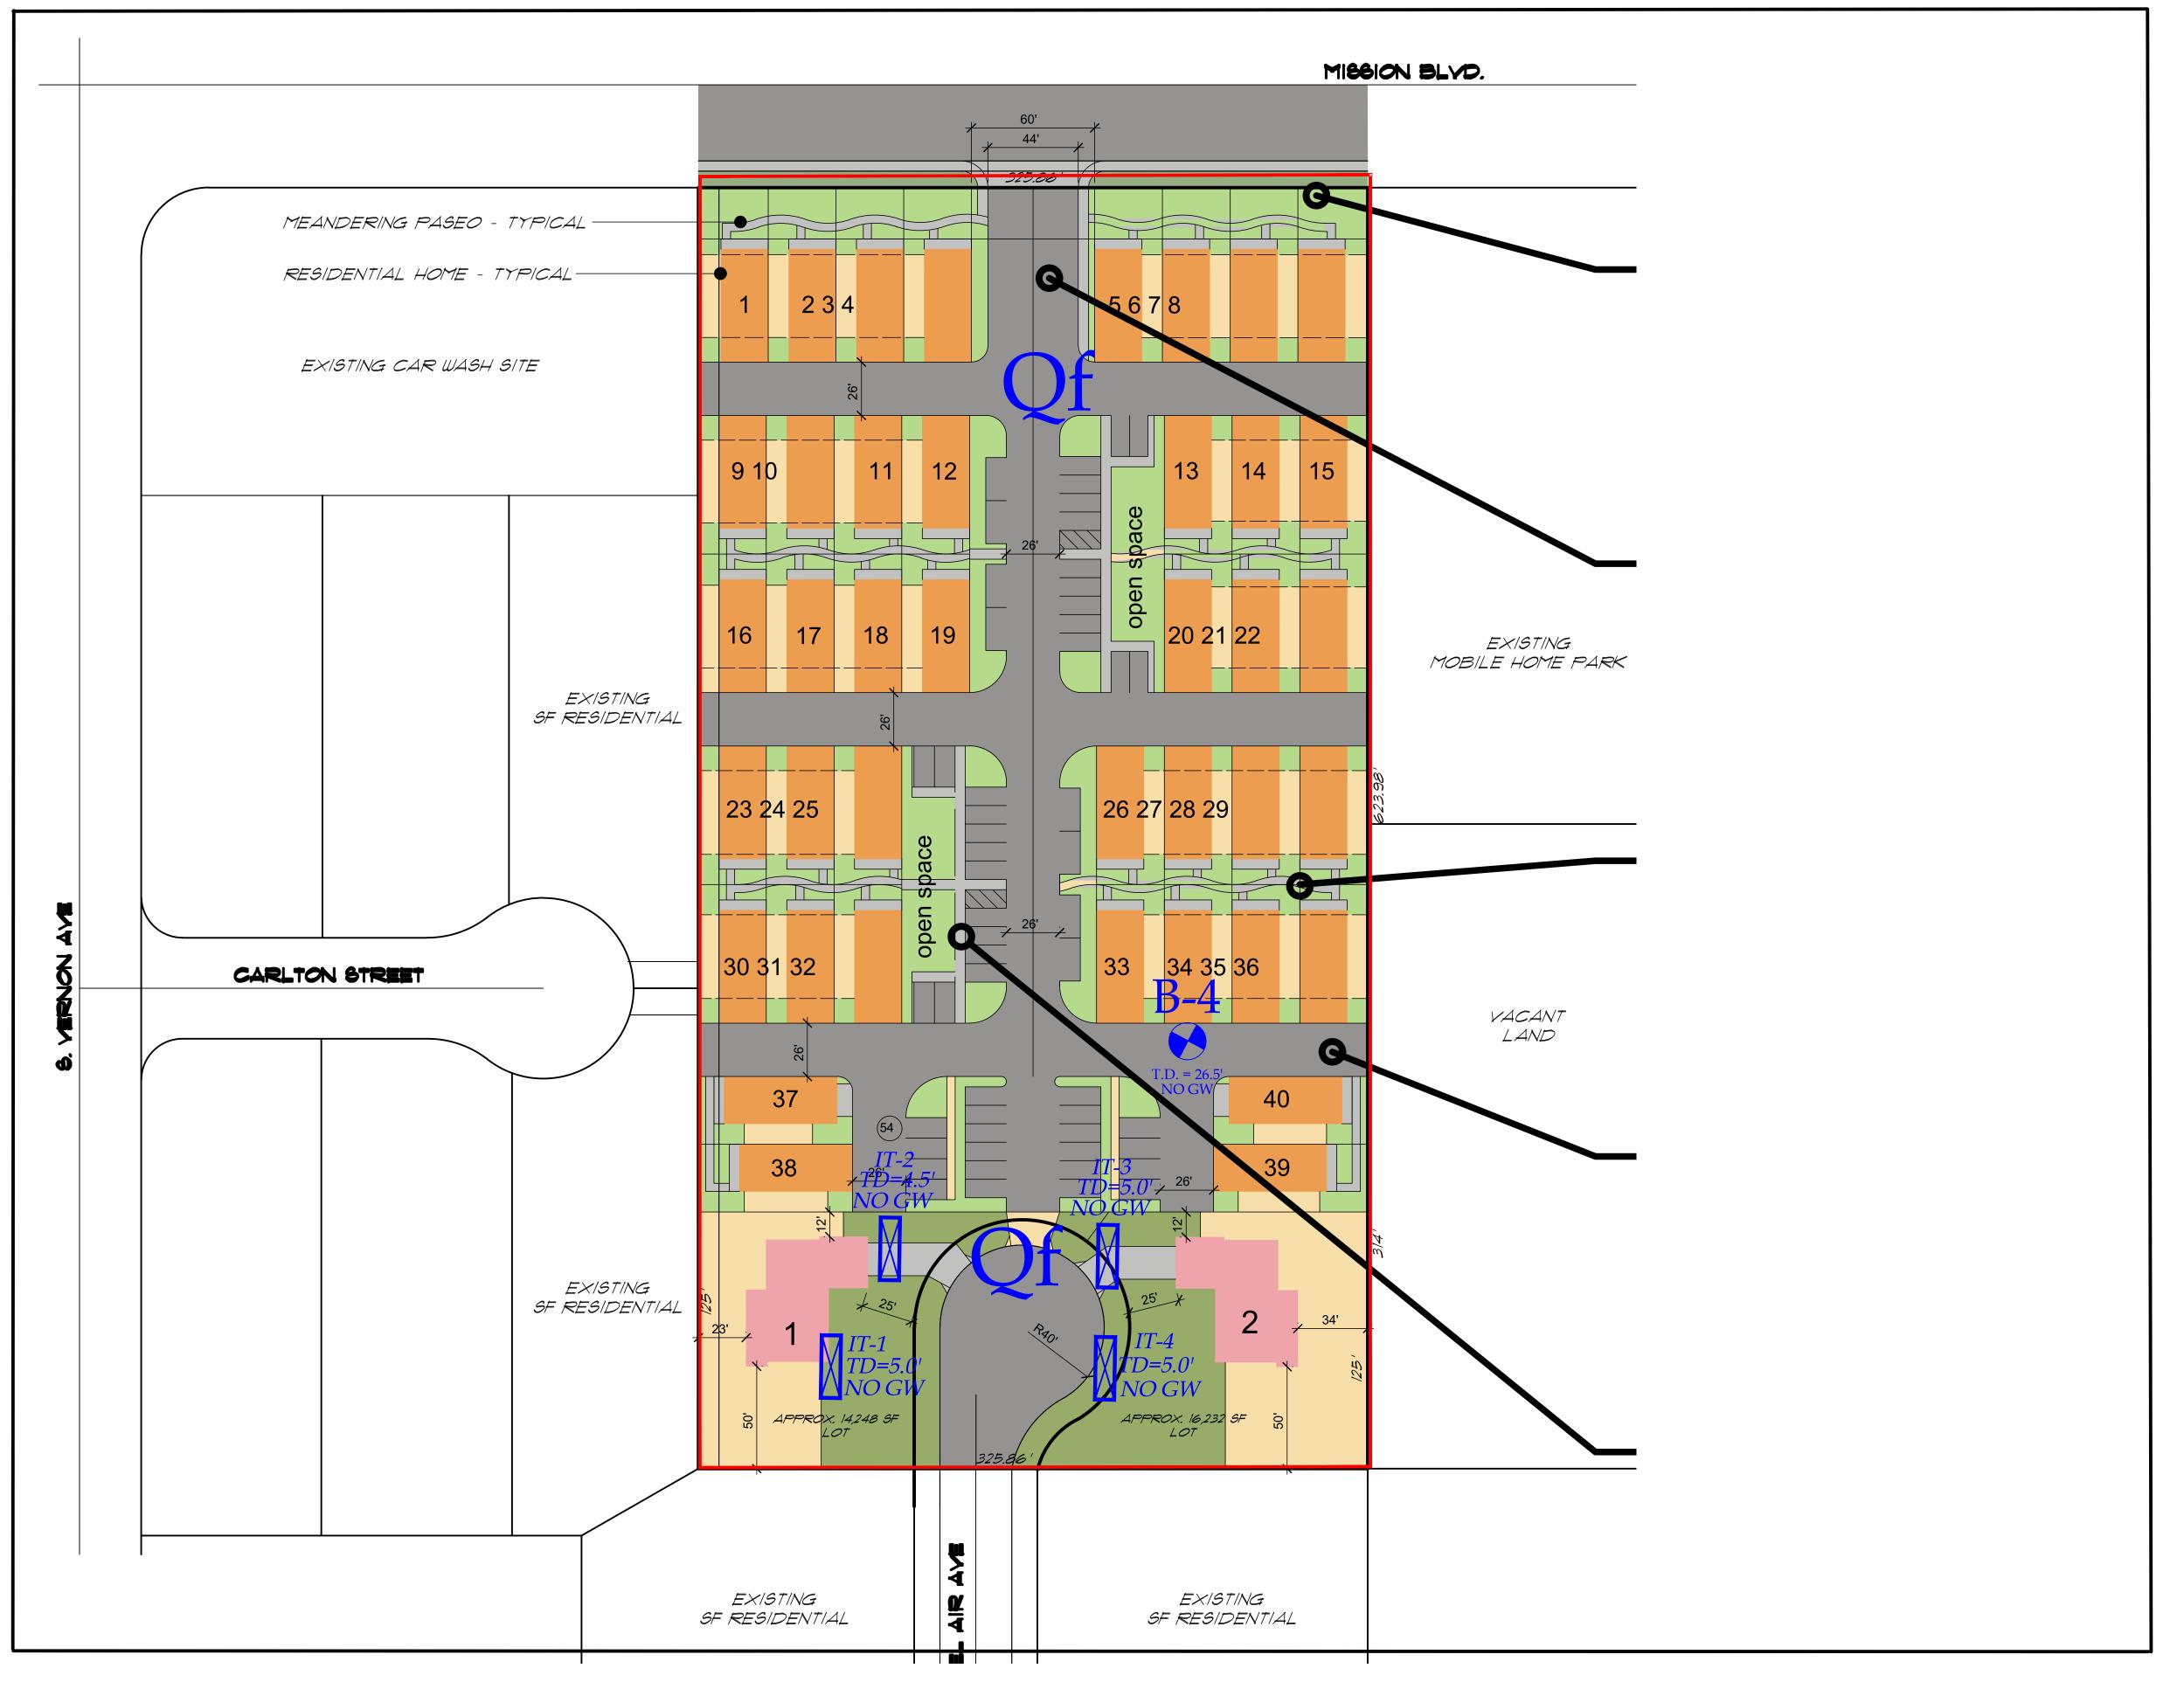
INFILTRATION TEST TRENCH LOCATION MAP

<u>LEGEND</u>
(Locations are Approximate)

- Infiltration Trench Location
