Reference: Biological Resources Letter Report for the County of San Diego Sanitation District: Los Coches
Sanitary Sewer Improvements from LSMH0555 to LSMH0599 Project
(RECON Number 9009-12)

This report summarizes the biological resources survey methods and results, assessment of potential impacts to biological resources, and recommended mitigation measures for the proposed Los Coches Sanitary Sewer Improvements from LSMH0555 to LSMH0599 Project (project).

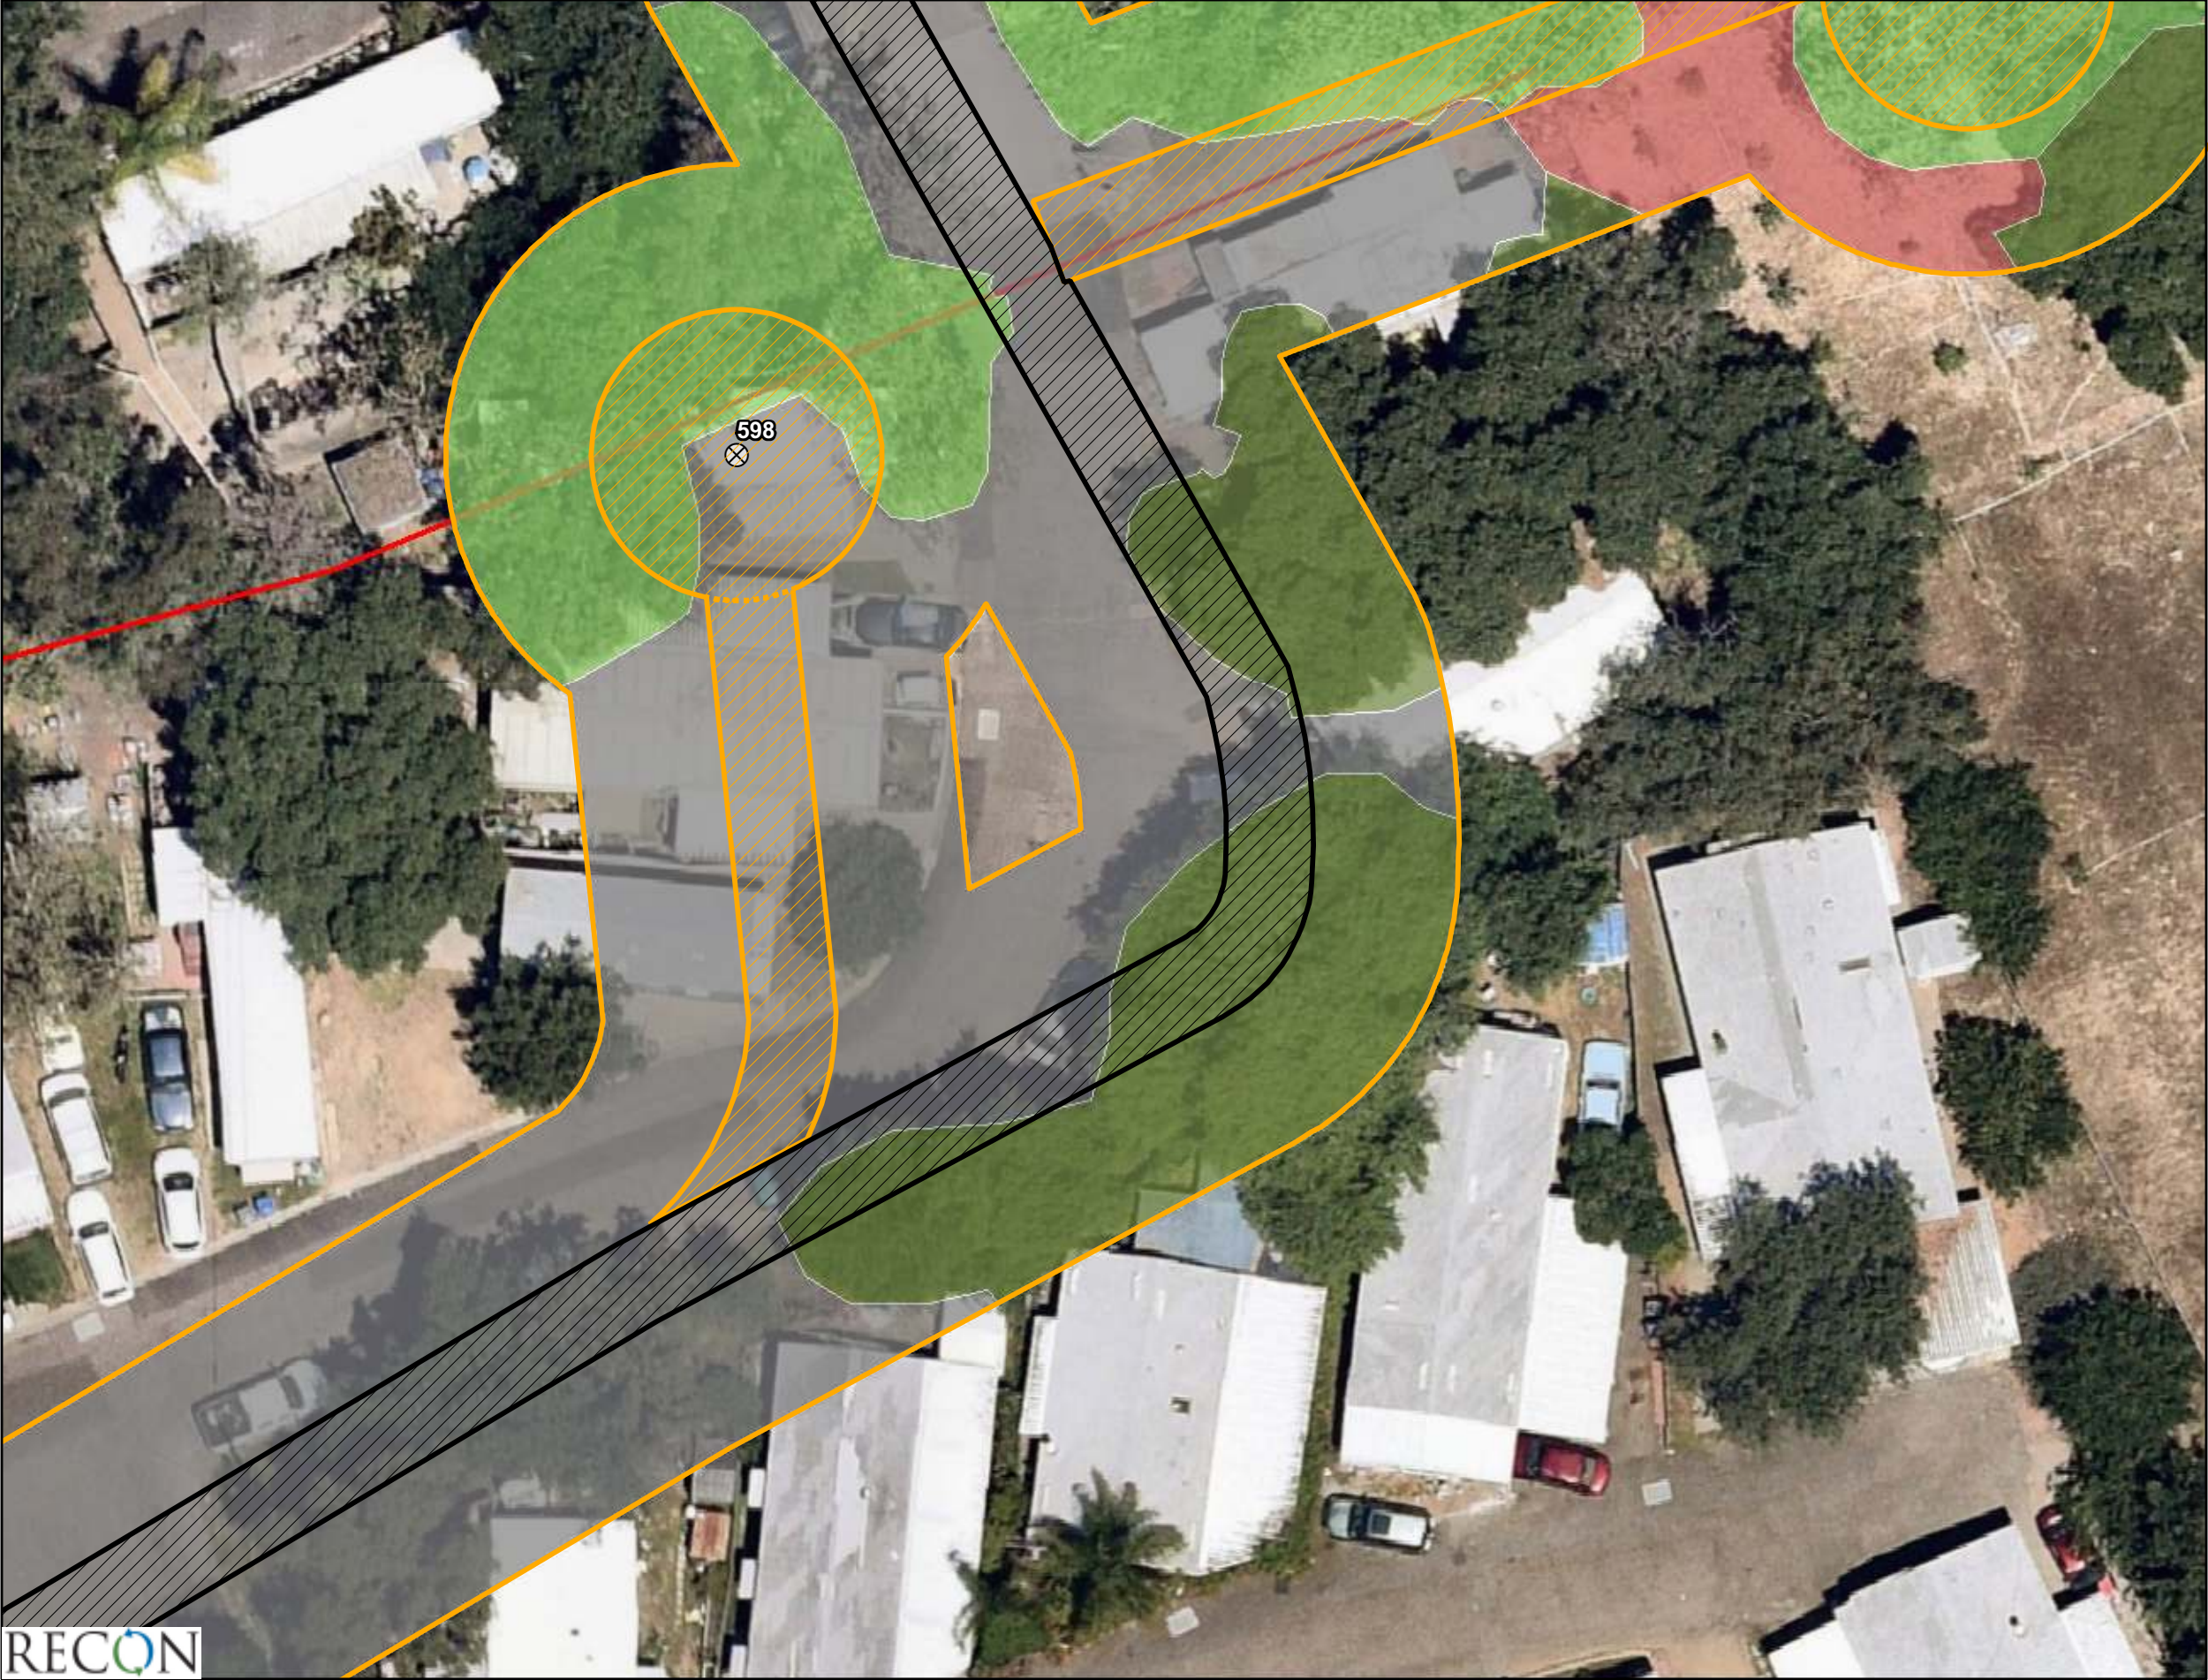
FIGURE 4
Existing Biological Resources

- Survey Area
- Manhole
- Proposed Lining Segments
- Impact Areas**
 - Temporary Impact Areas
 - No Impact Areas
- Vegetation Community**
 - Coast Live Oak Riparian Forest
 - Disturbed Habitat
 - Southern Riparian Forest
 - Urban/Developed

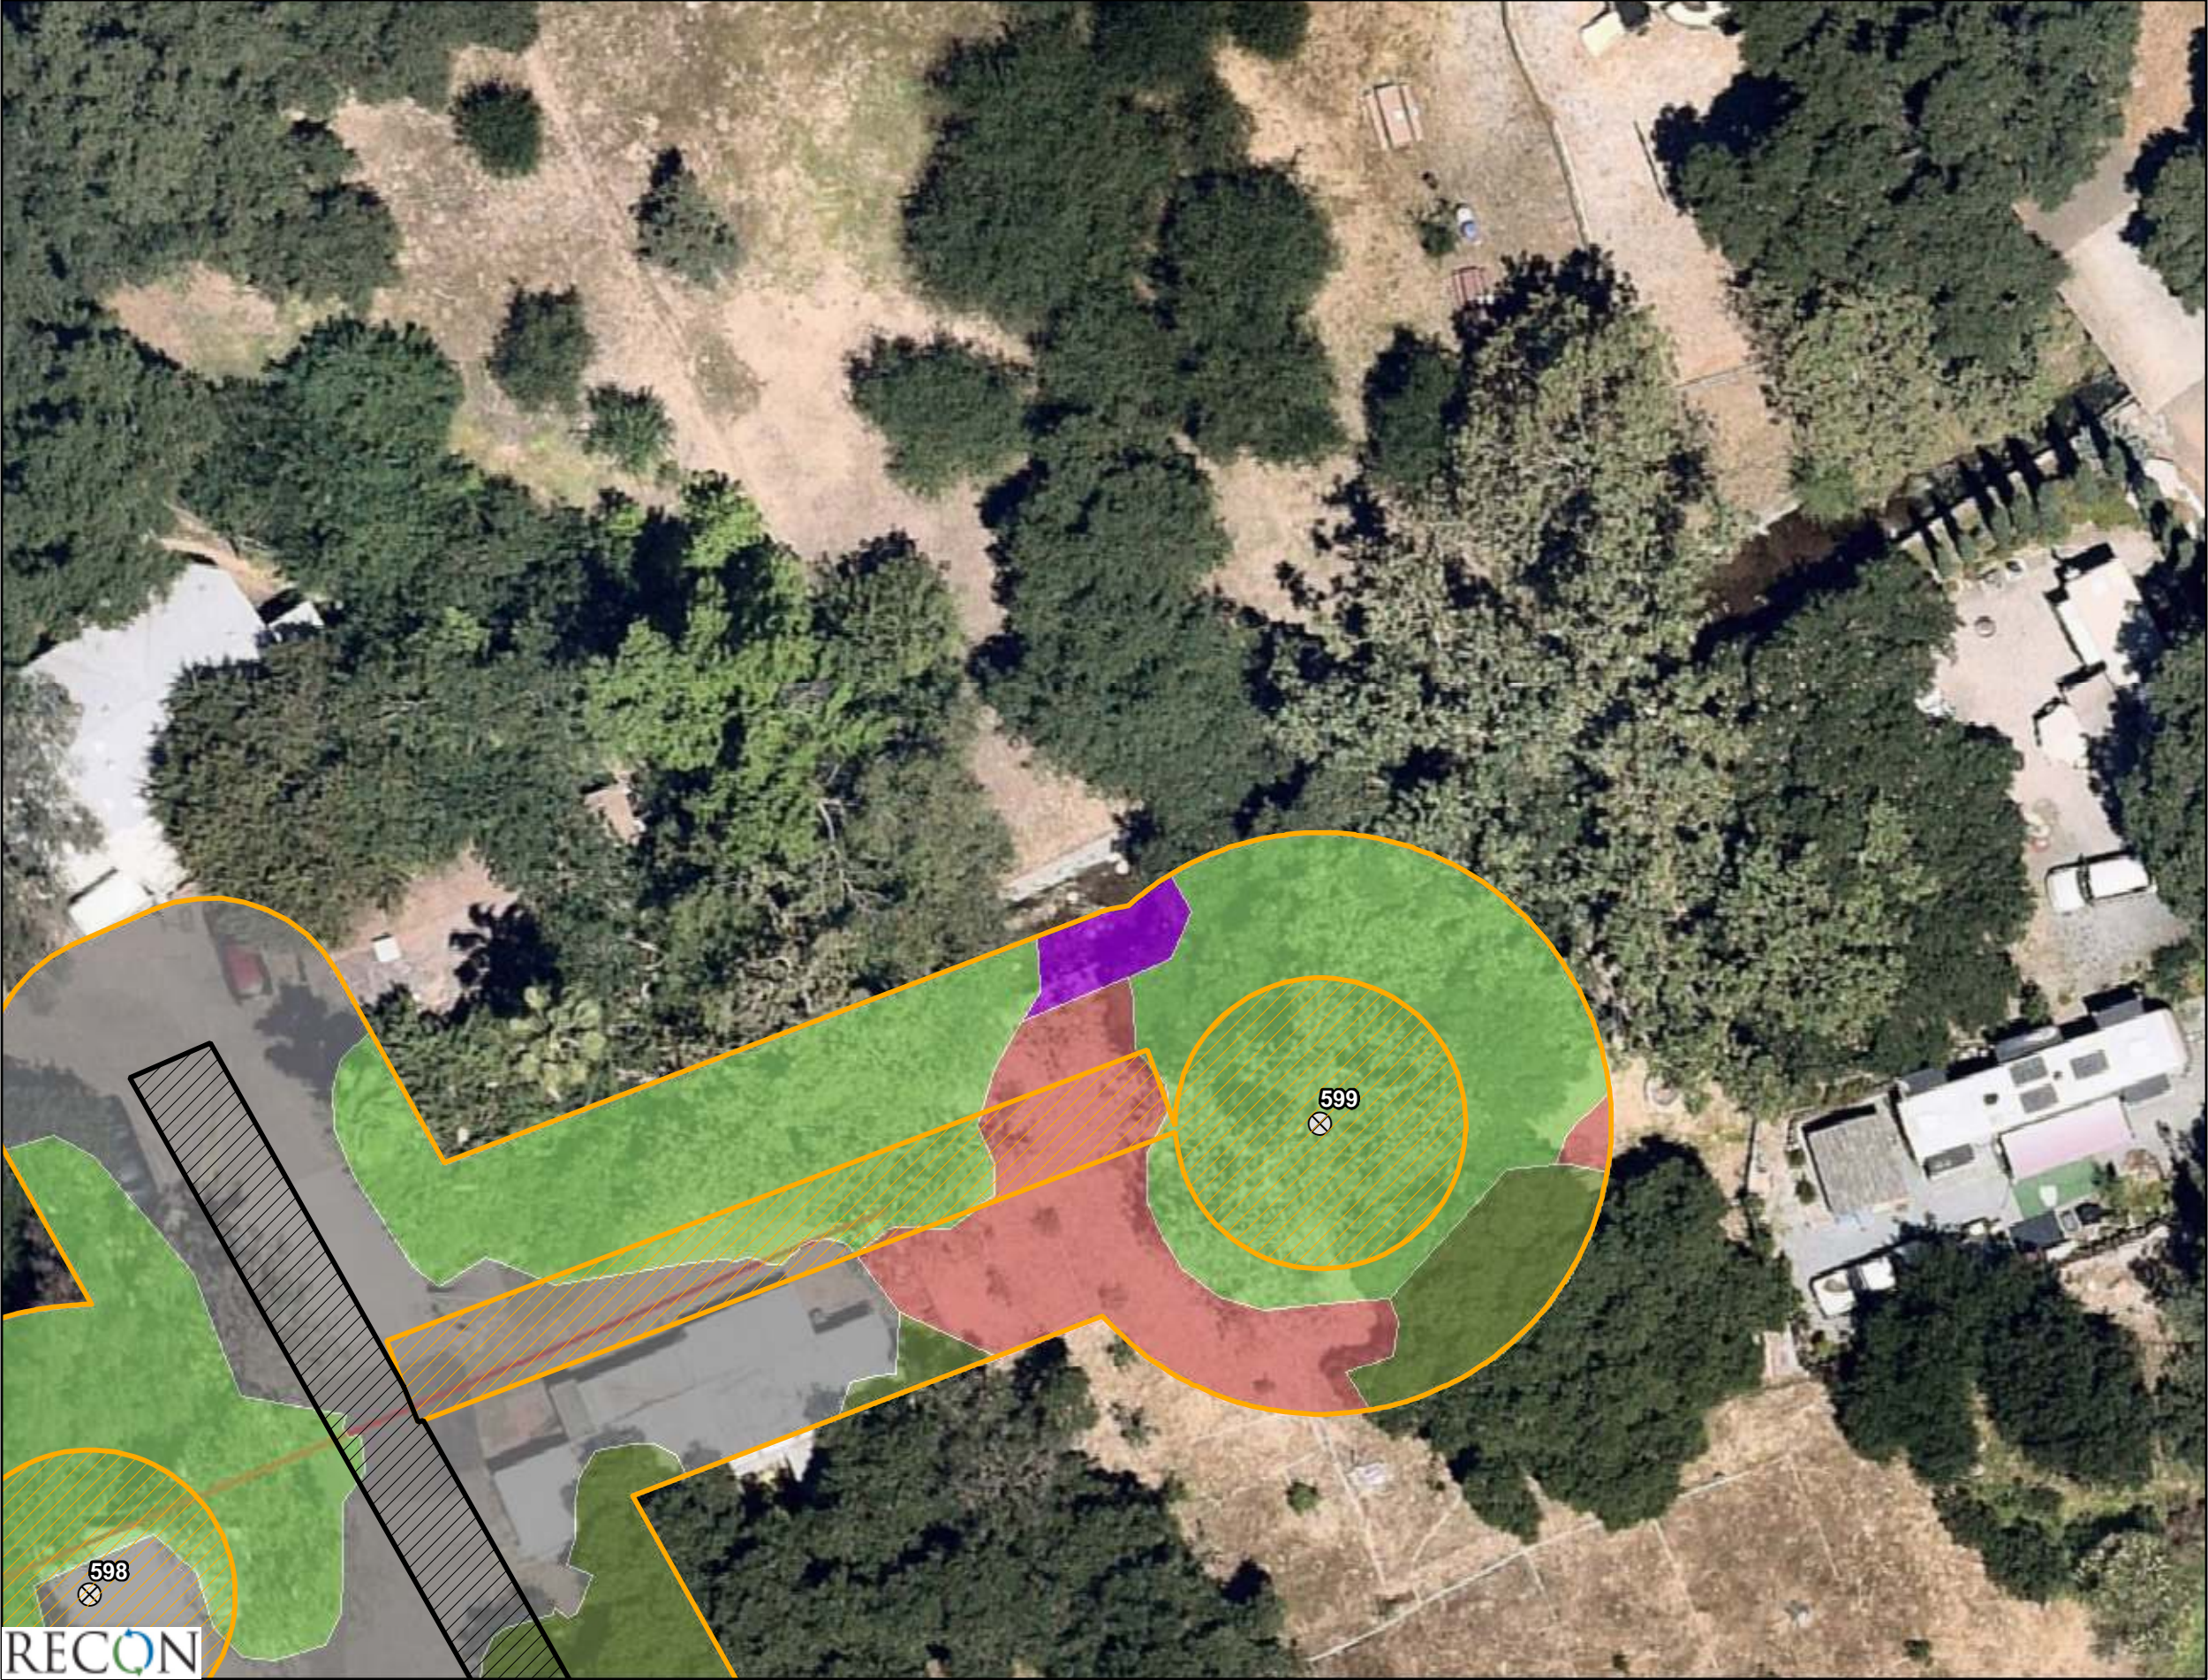
FIGURE 4
Existing Biological Resources

- Survey Area
- Manhole
- Proposed Lining Segments
- Impact Areas**
 - Temporary Impact Areas
 - No Impact Areas
- Vegetation Community**
 - Coast Live Oak Riparian Forest
 - Disturbed Habitat
 - Non-vegetated Channel
 - Southern Riparian Forest
 - Urban/Developed

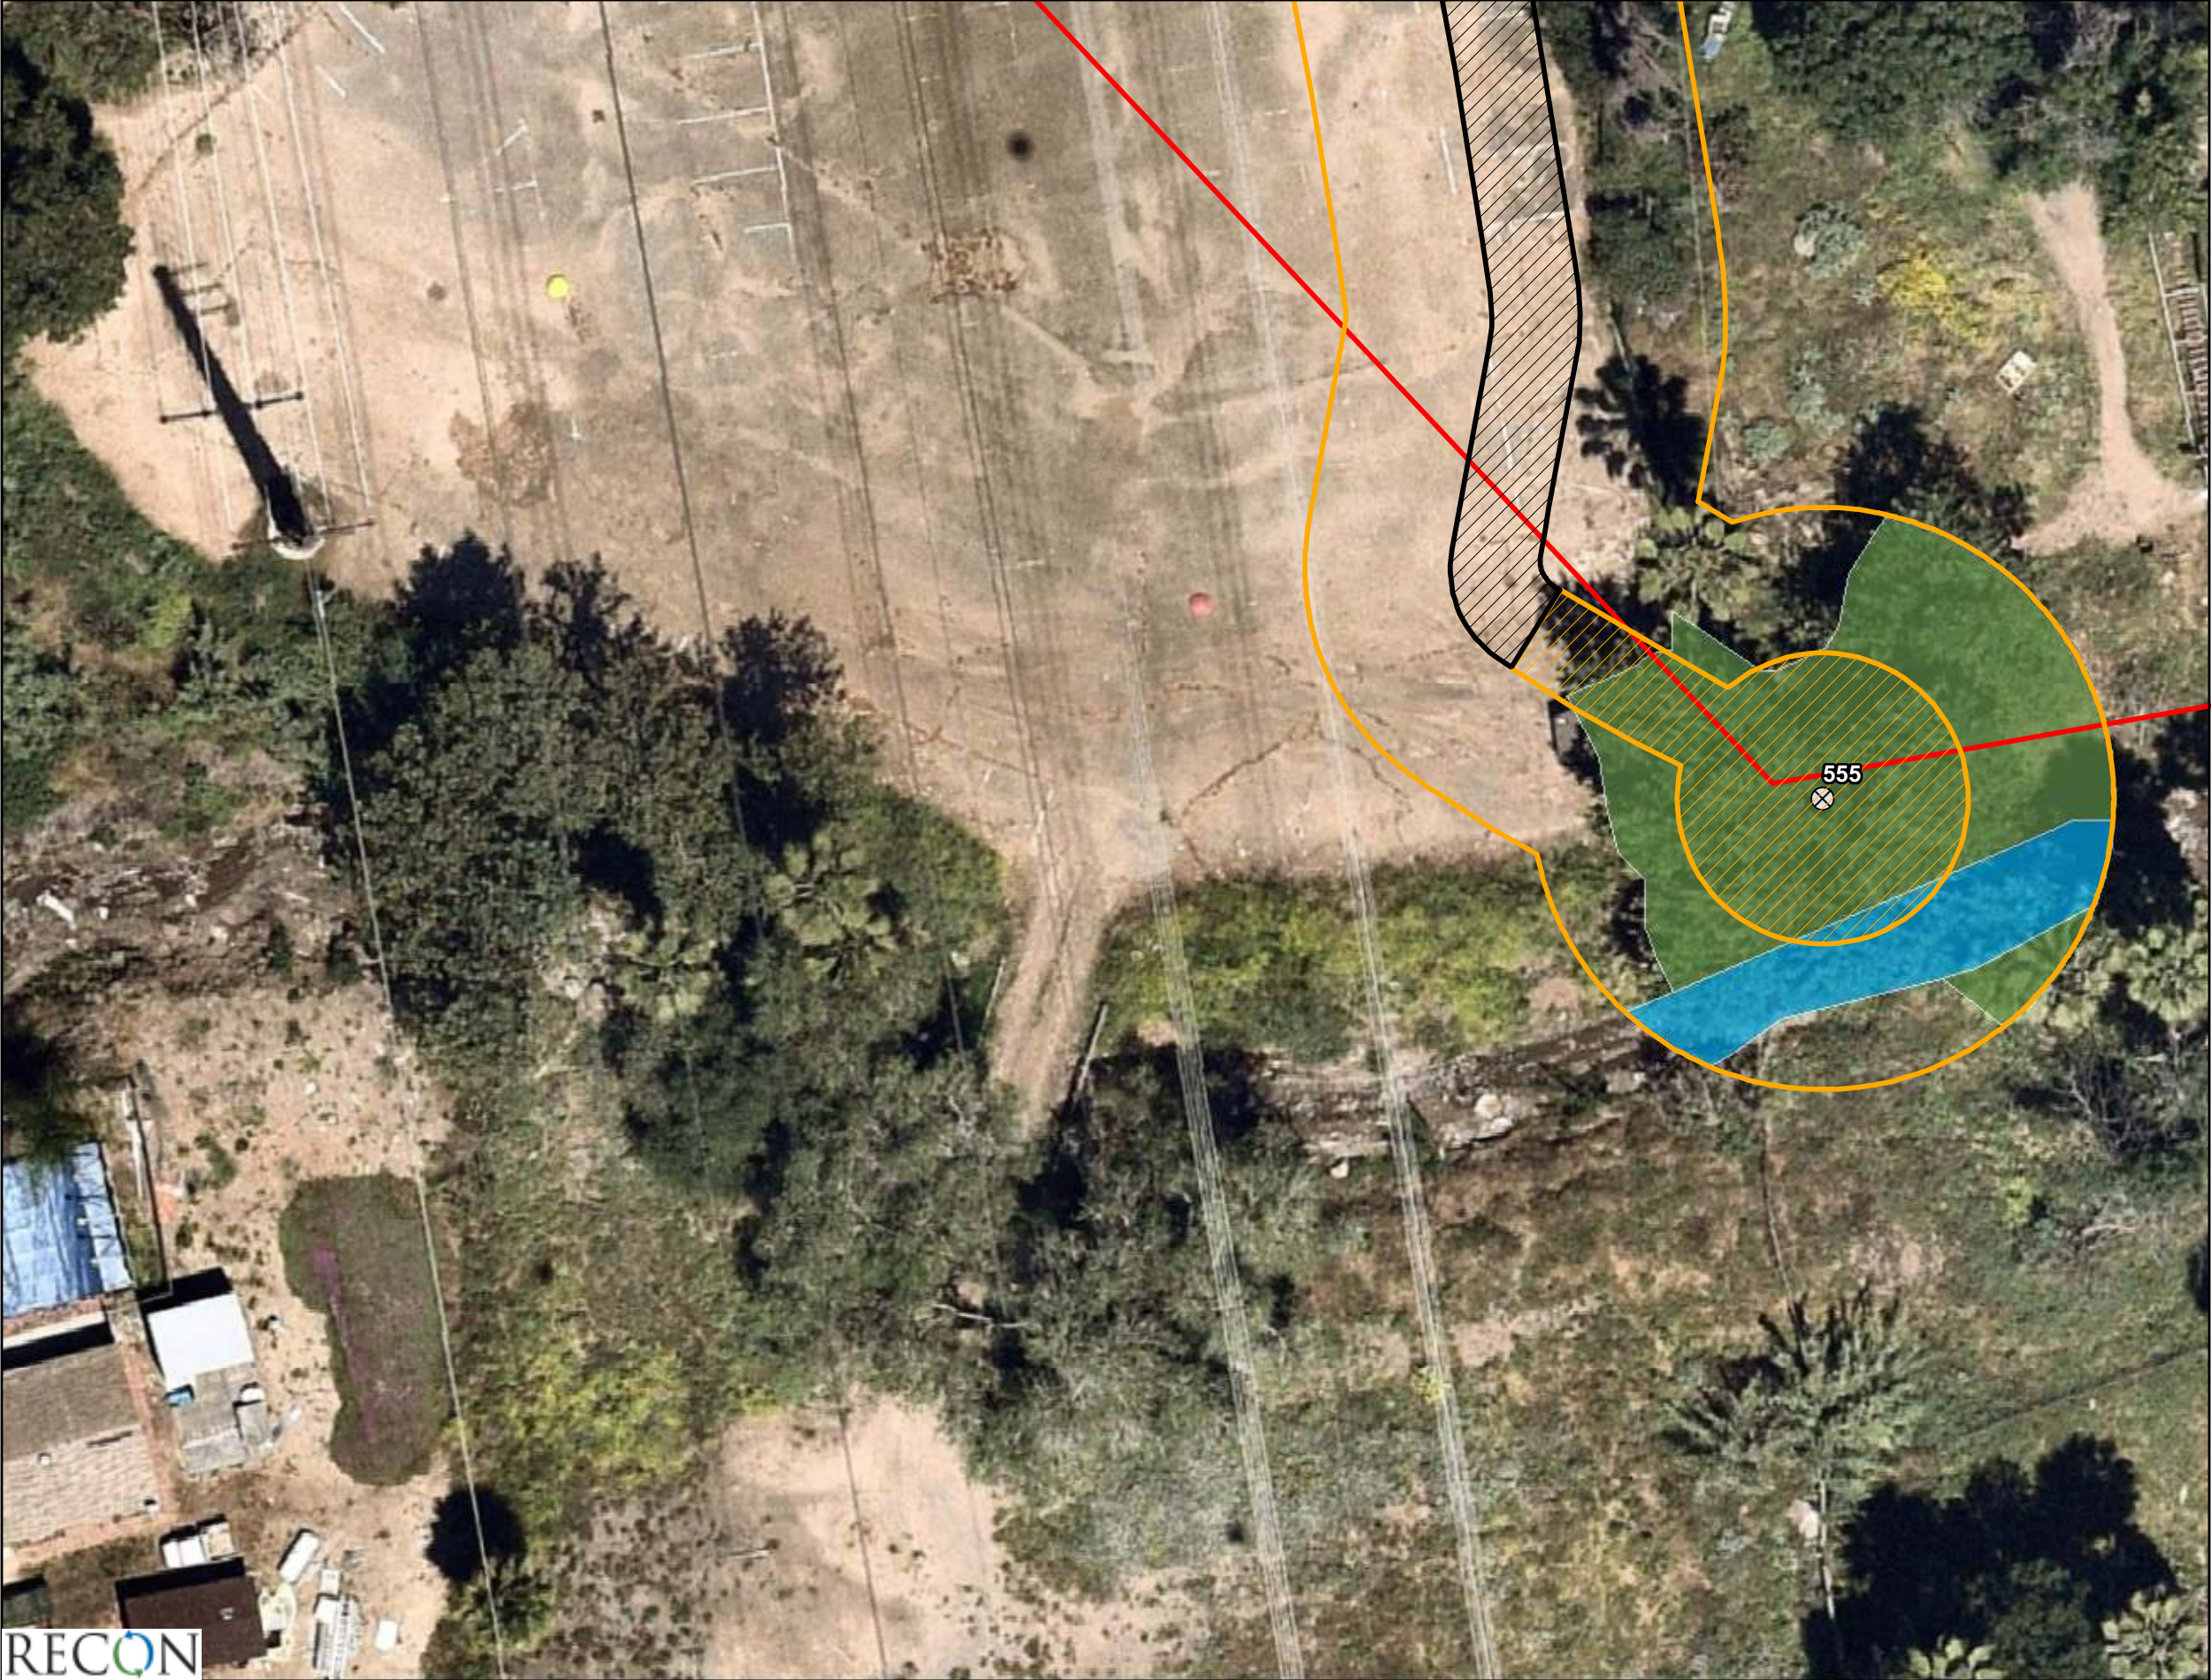
FIGURE 5
Existing Jurisdictional Resources

- Survey Area
- Impact Areas**
 - Temporary Impact Areas
 - No Impact Areas
 - Manhole
 - Proposed Lining Segments
- Jurisdictional Resources**
 - USACE Non-Wetland Waters of the U.S., CDFW Streambed, RWQCB Non-Wetland Waters of the State
 - CDFW Riparian, RWQCB Wetland Waters of the State

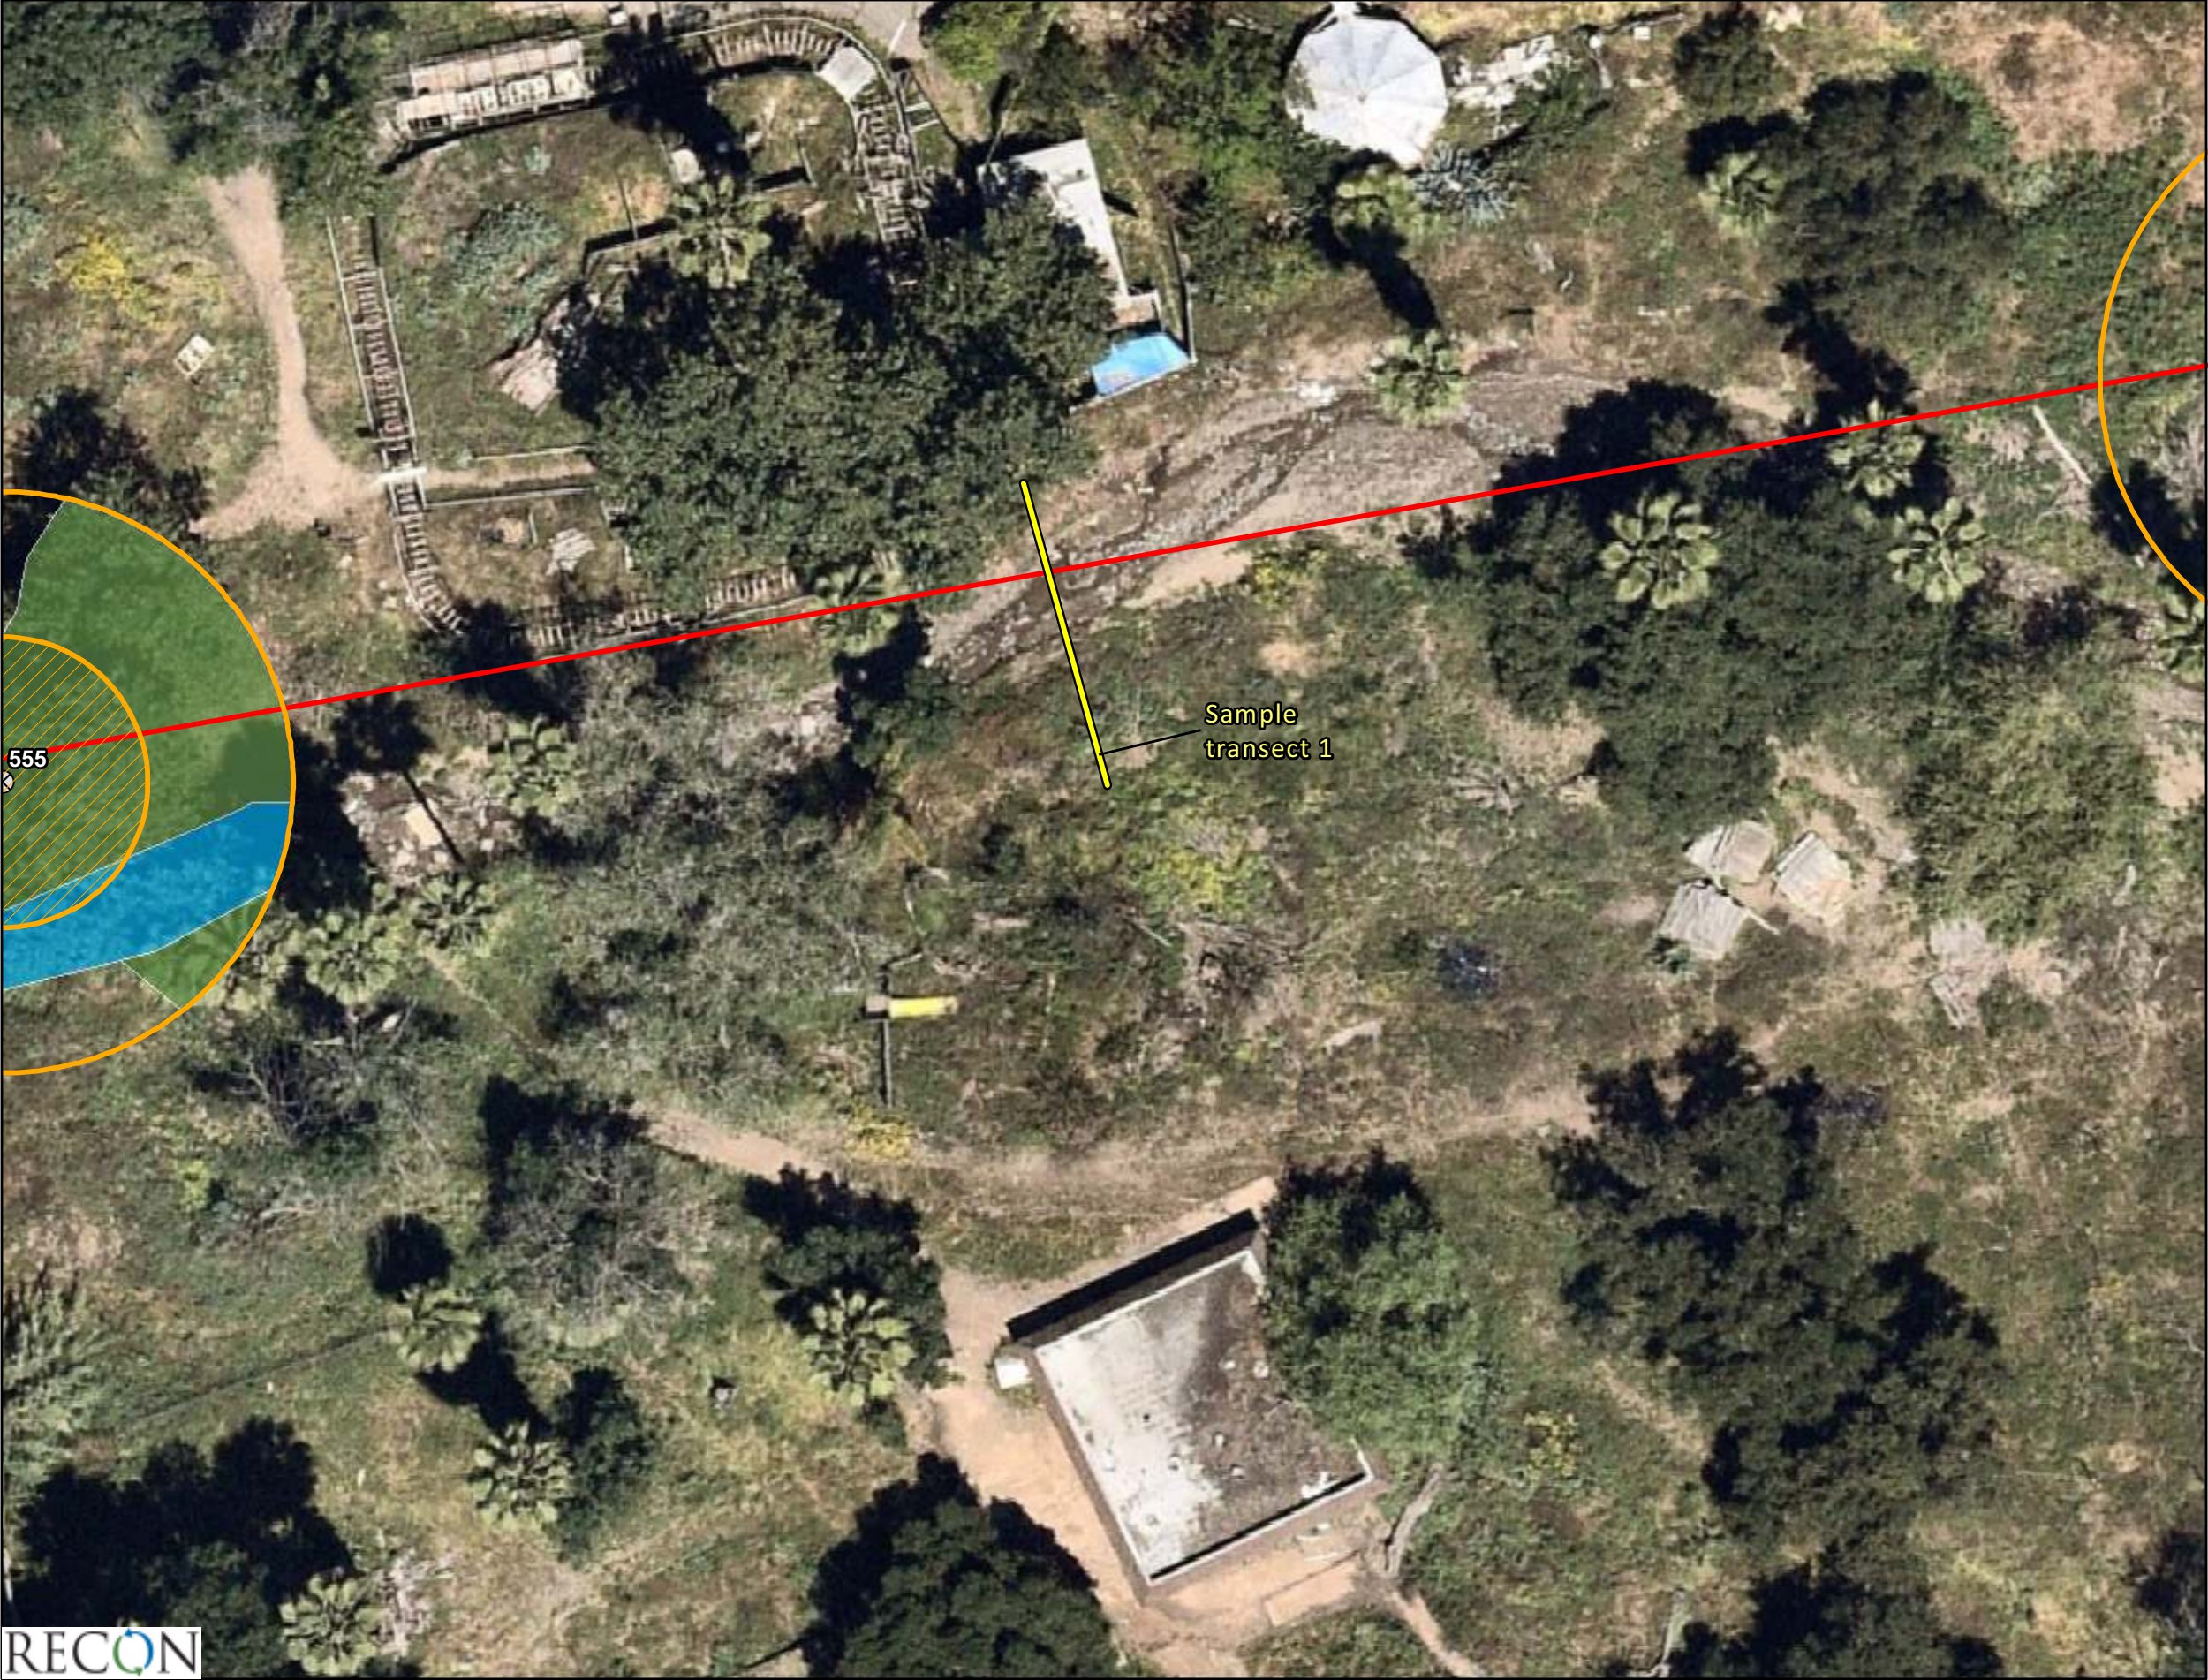
FIGURE 5
Existing Jurisdictional Resources

- Survey Area
- Impact Areas**
- Temporary Impact Areas
- Sample Transect
- Manhole
- Proposed Lining Segments

- Jurisdictional Resources**
- USACE Non-Wetland Waters of the U.S., CDFW Streambed, RWQCB Non-Wetland Waters of the State
- CDFW Riparian, RWQCB Wetland Waters of the State

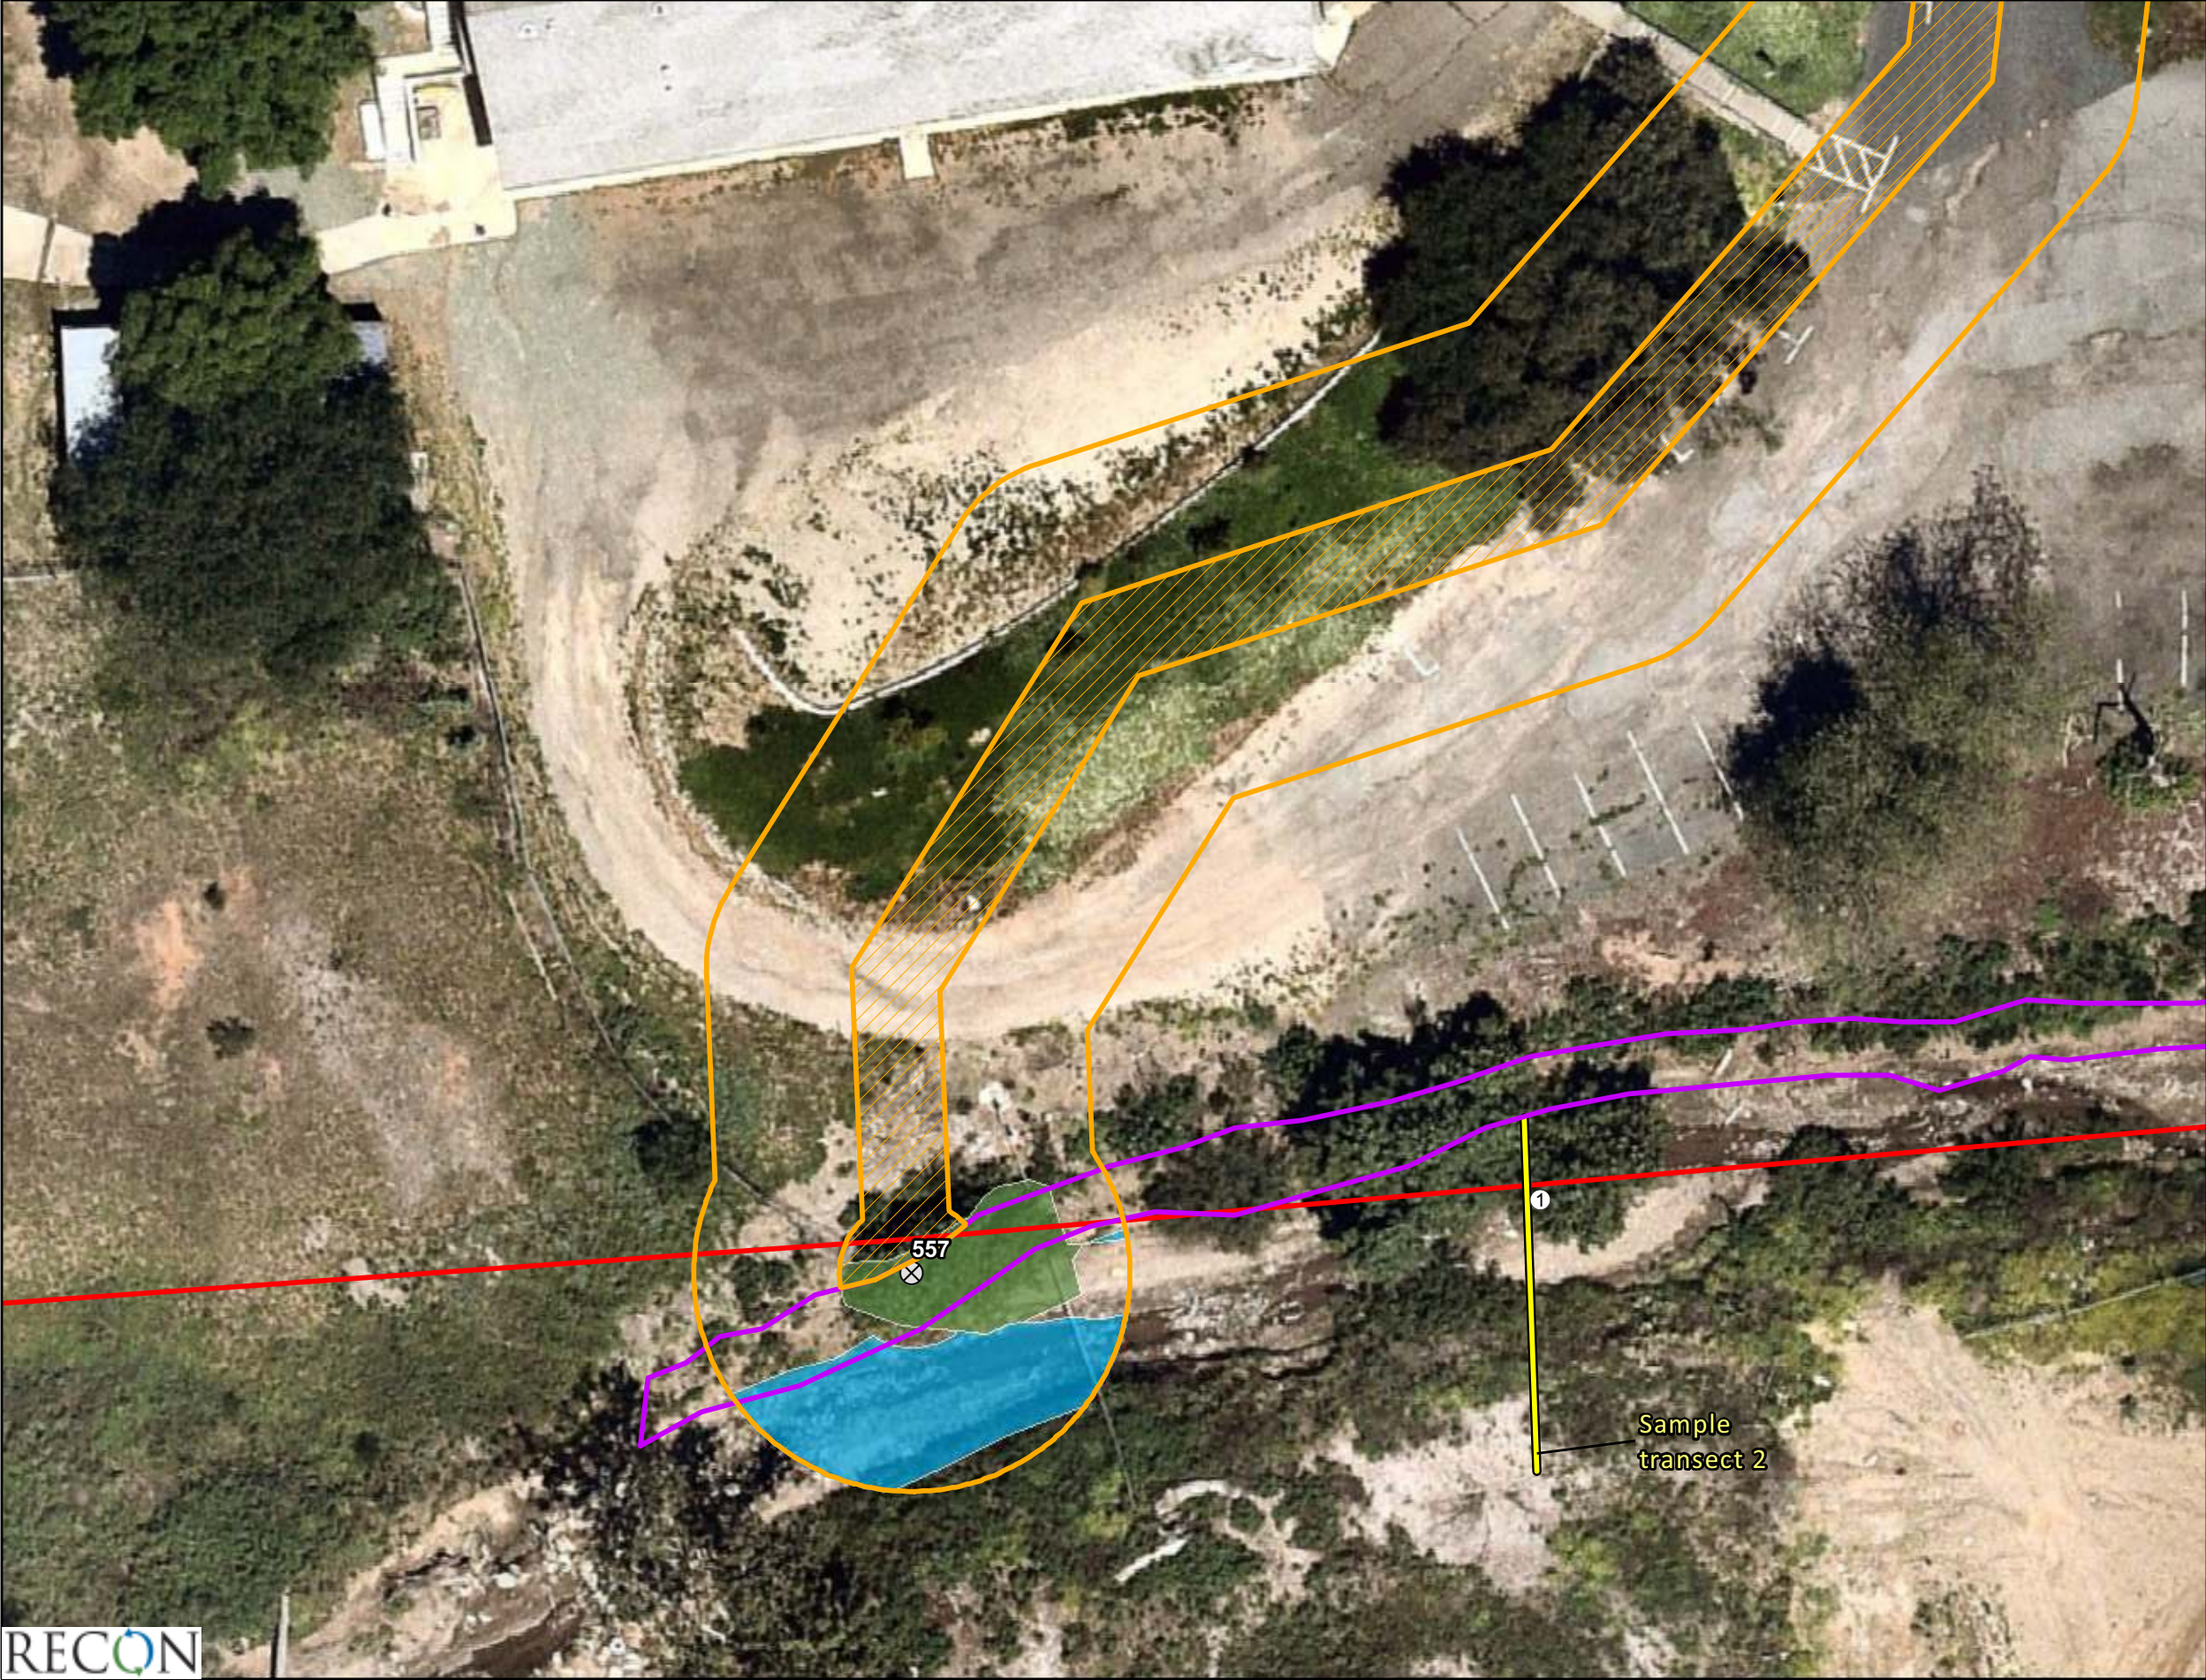
FIGURE 5
Existing Jurisdictional Resources

- Survey Area
- Impact Areas**
- Temporary Impact Areas
- Mitigation Areas**
- Mitigation Area 2
- Sample Point
- Sample Transect
- Manhole
- Proposed Lining Segments

- Jurisdictional Resources**
- USACE Non-Wetland Waters of the U.S., CDFW Streambed, RWQCB Non-Wetland Waters of the State
- CDFW Riparian, RWQCB Wetland Waters of the State

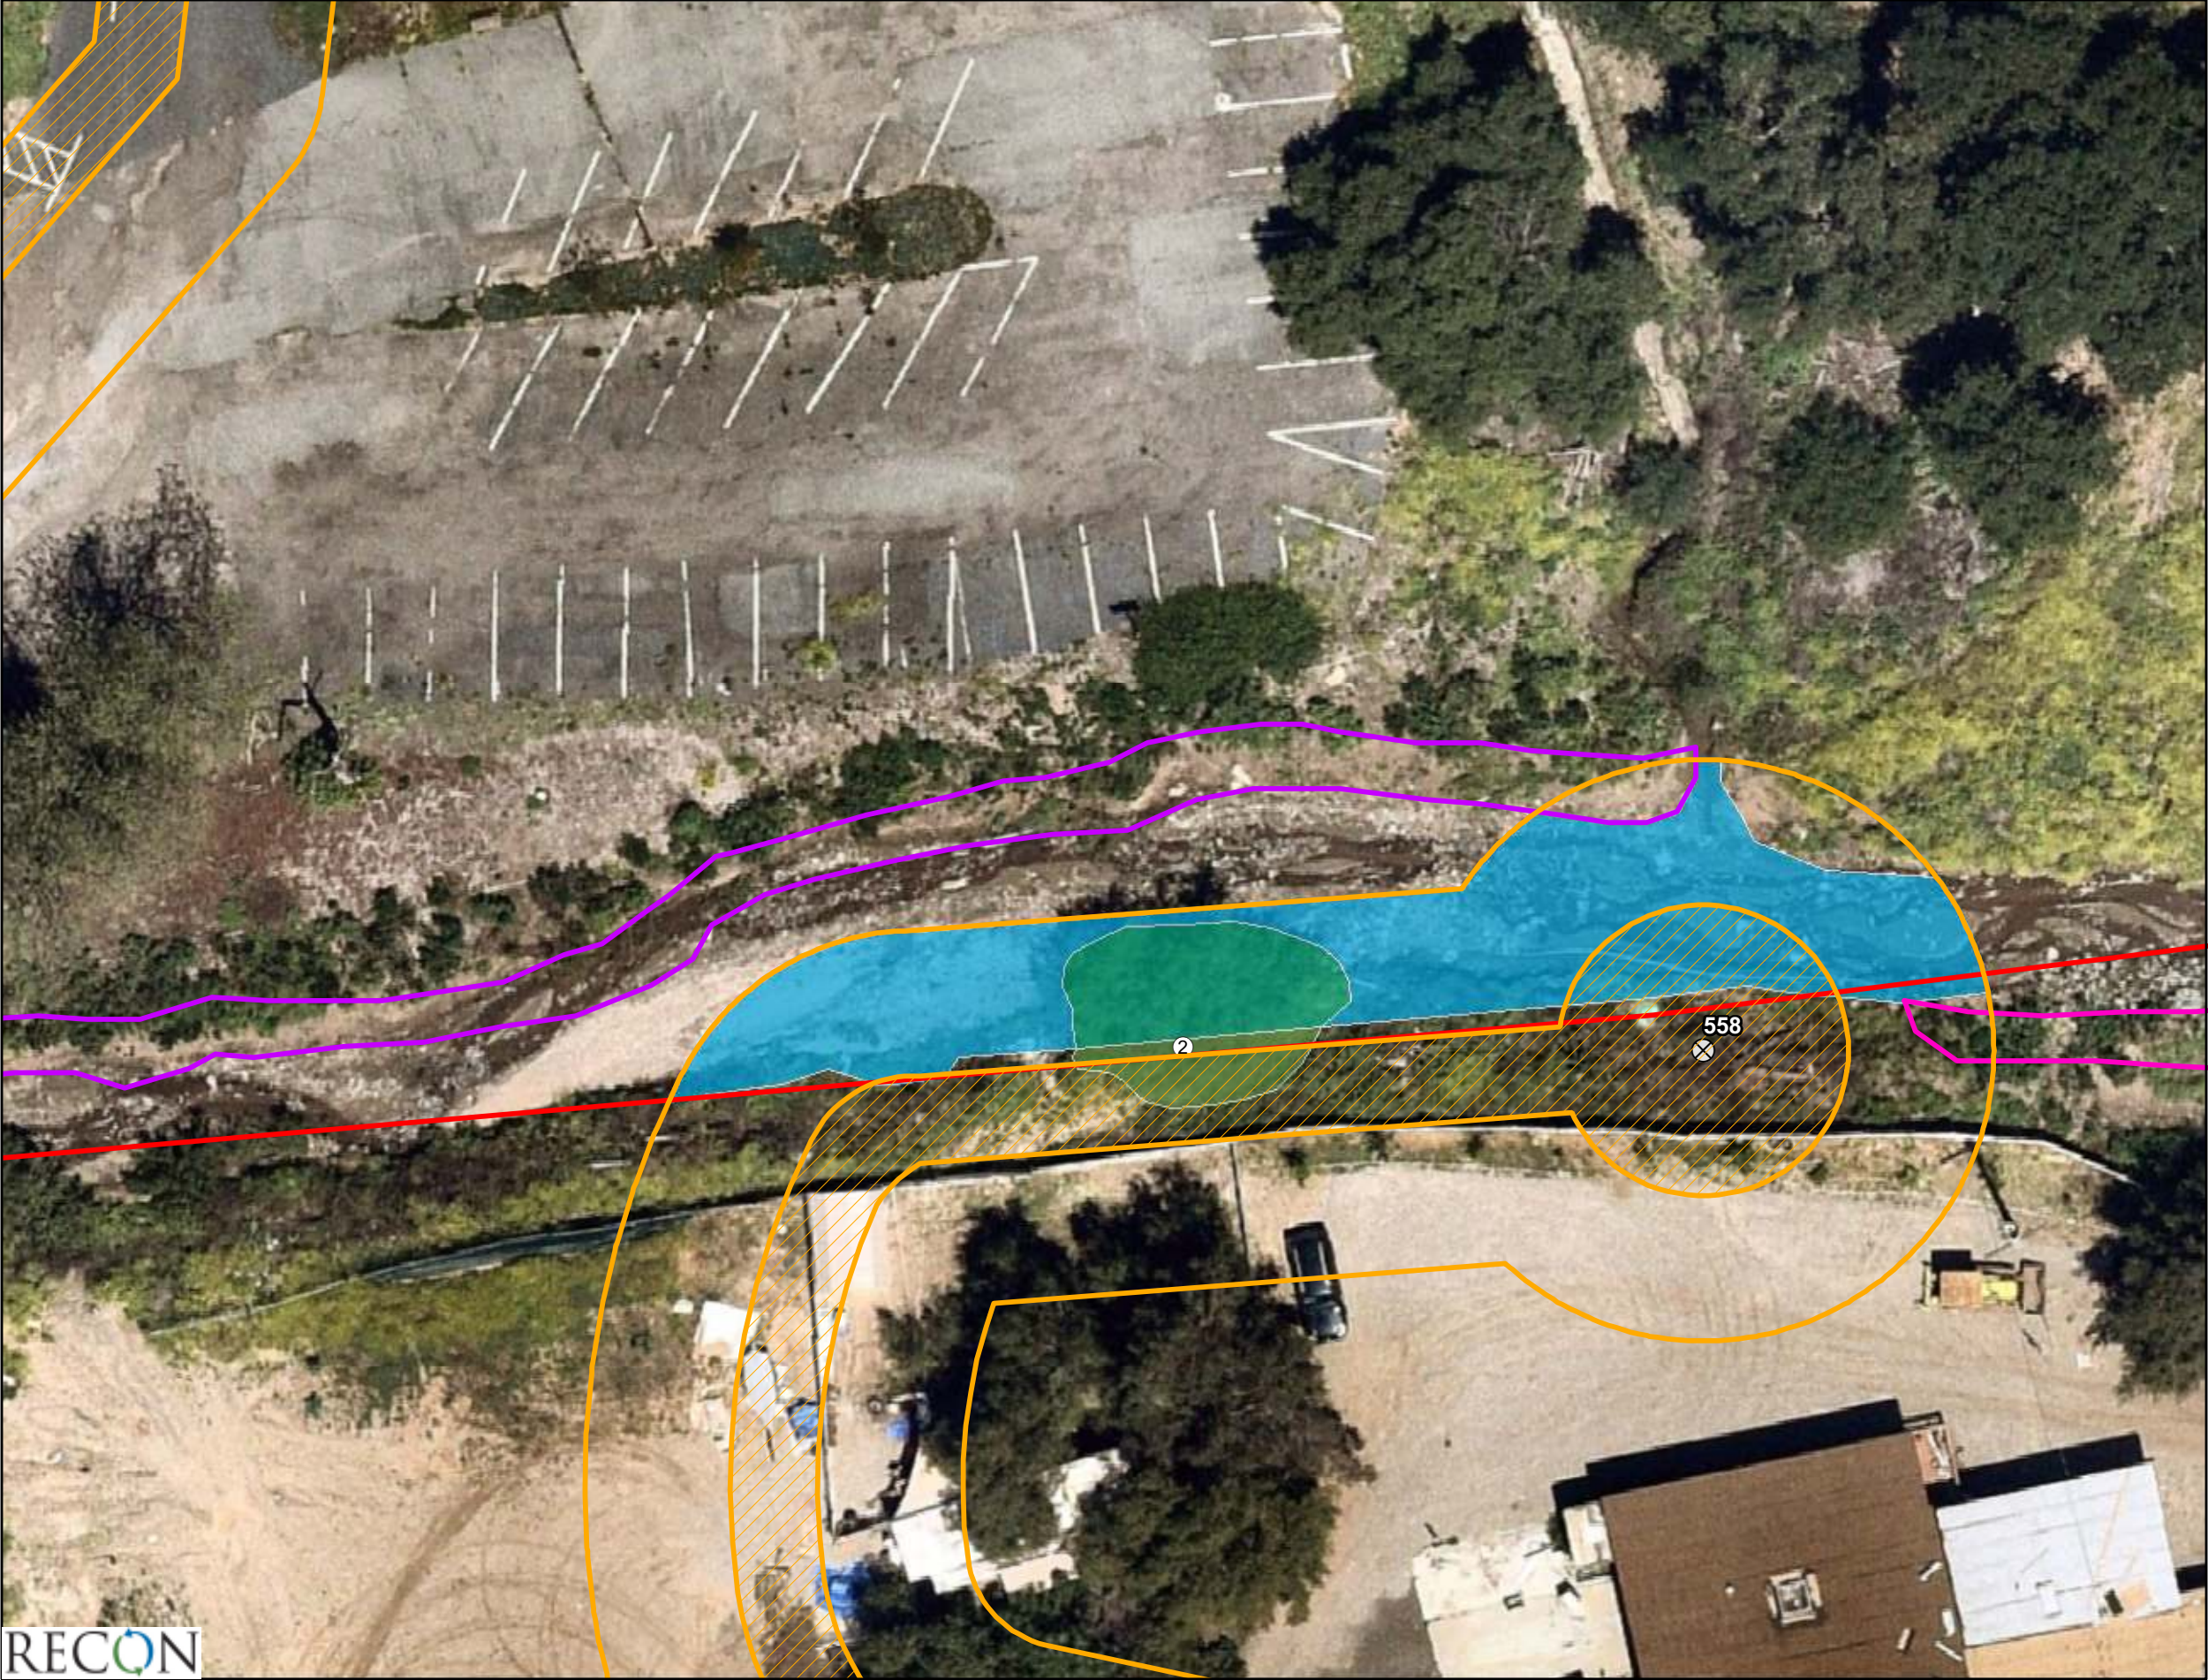
FIGURE 5
Existing Jurisdictional Resources

- Survey Area
- Impact Areas**
 - Temporary Impact Areas
- Mitigation Areas**
 - Mitigation Area 1
 - Mitigation Area 2
 - Sample Point
 - Manhole
 - Proposed Lining Segments
- Jurisdictional Resources**
 - USACE Non-Wetland Waters of the U.S., CDFW Streambed, RWQCB Non-Wetland Waters of the State
 - USACE Wetland Waters of the U.S., CDFW Wetland, RWQCB Wetland
 - CDFW Riparian, RWQCB Wetland Waters of the State
