Reference: Biological Resources Letter Report for the County of San Diego Sanitation District: Los Coches
Sanitary Sewer Improvements from LSMH0555 to LSMH0599 Project
(RECON Number 9009-12)

This report summarizes the biological resources survey methods and results, assessment of potential impacts to biological resources, and recommended mitigation measures for the proposed Los Coches Sanitary Sewer Improvements from LSMH0555 to LSMH0599 Project (project).

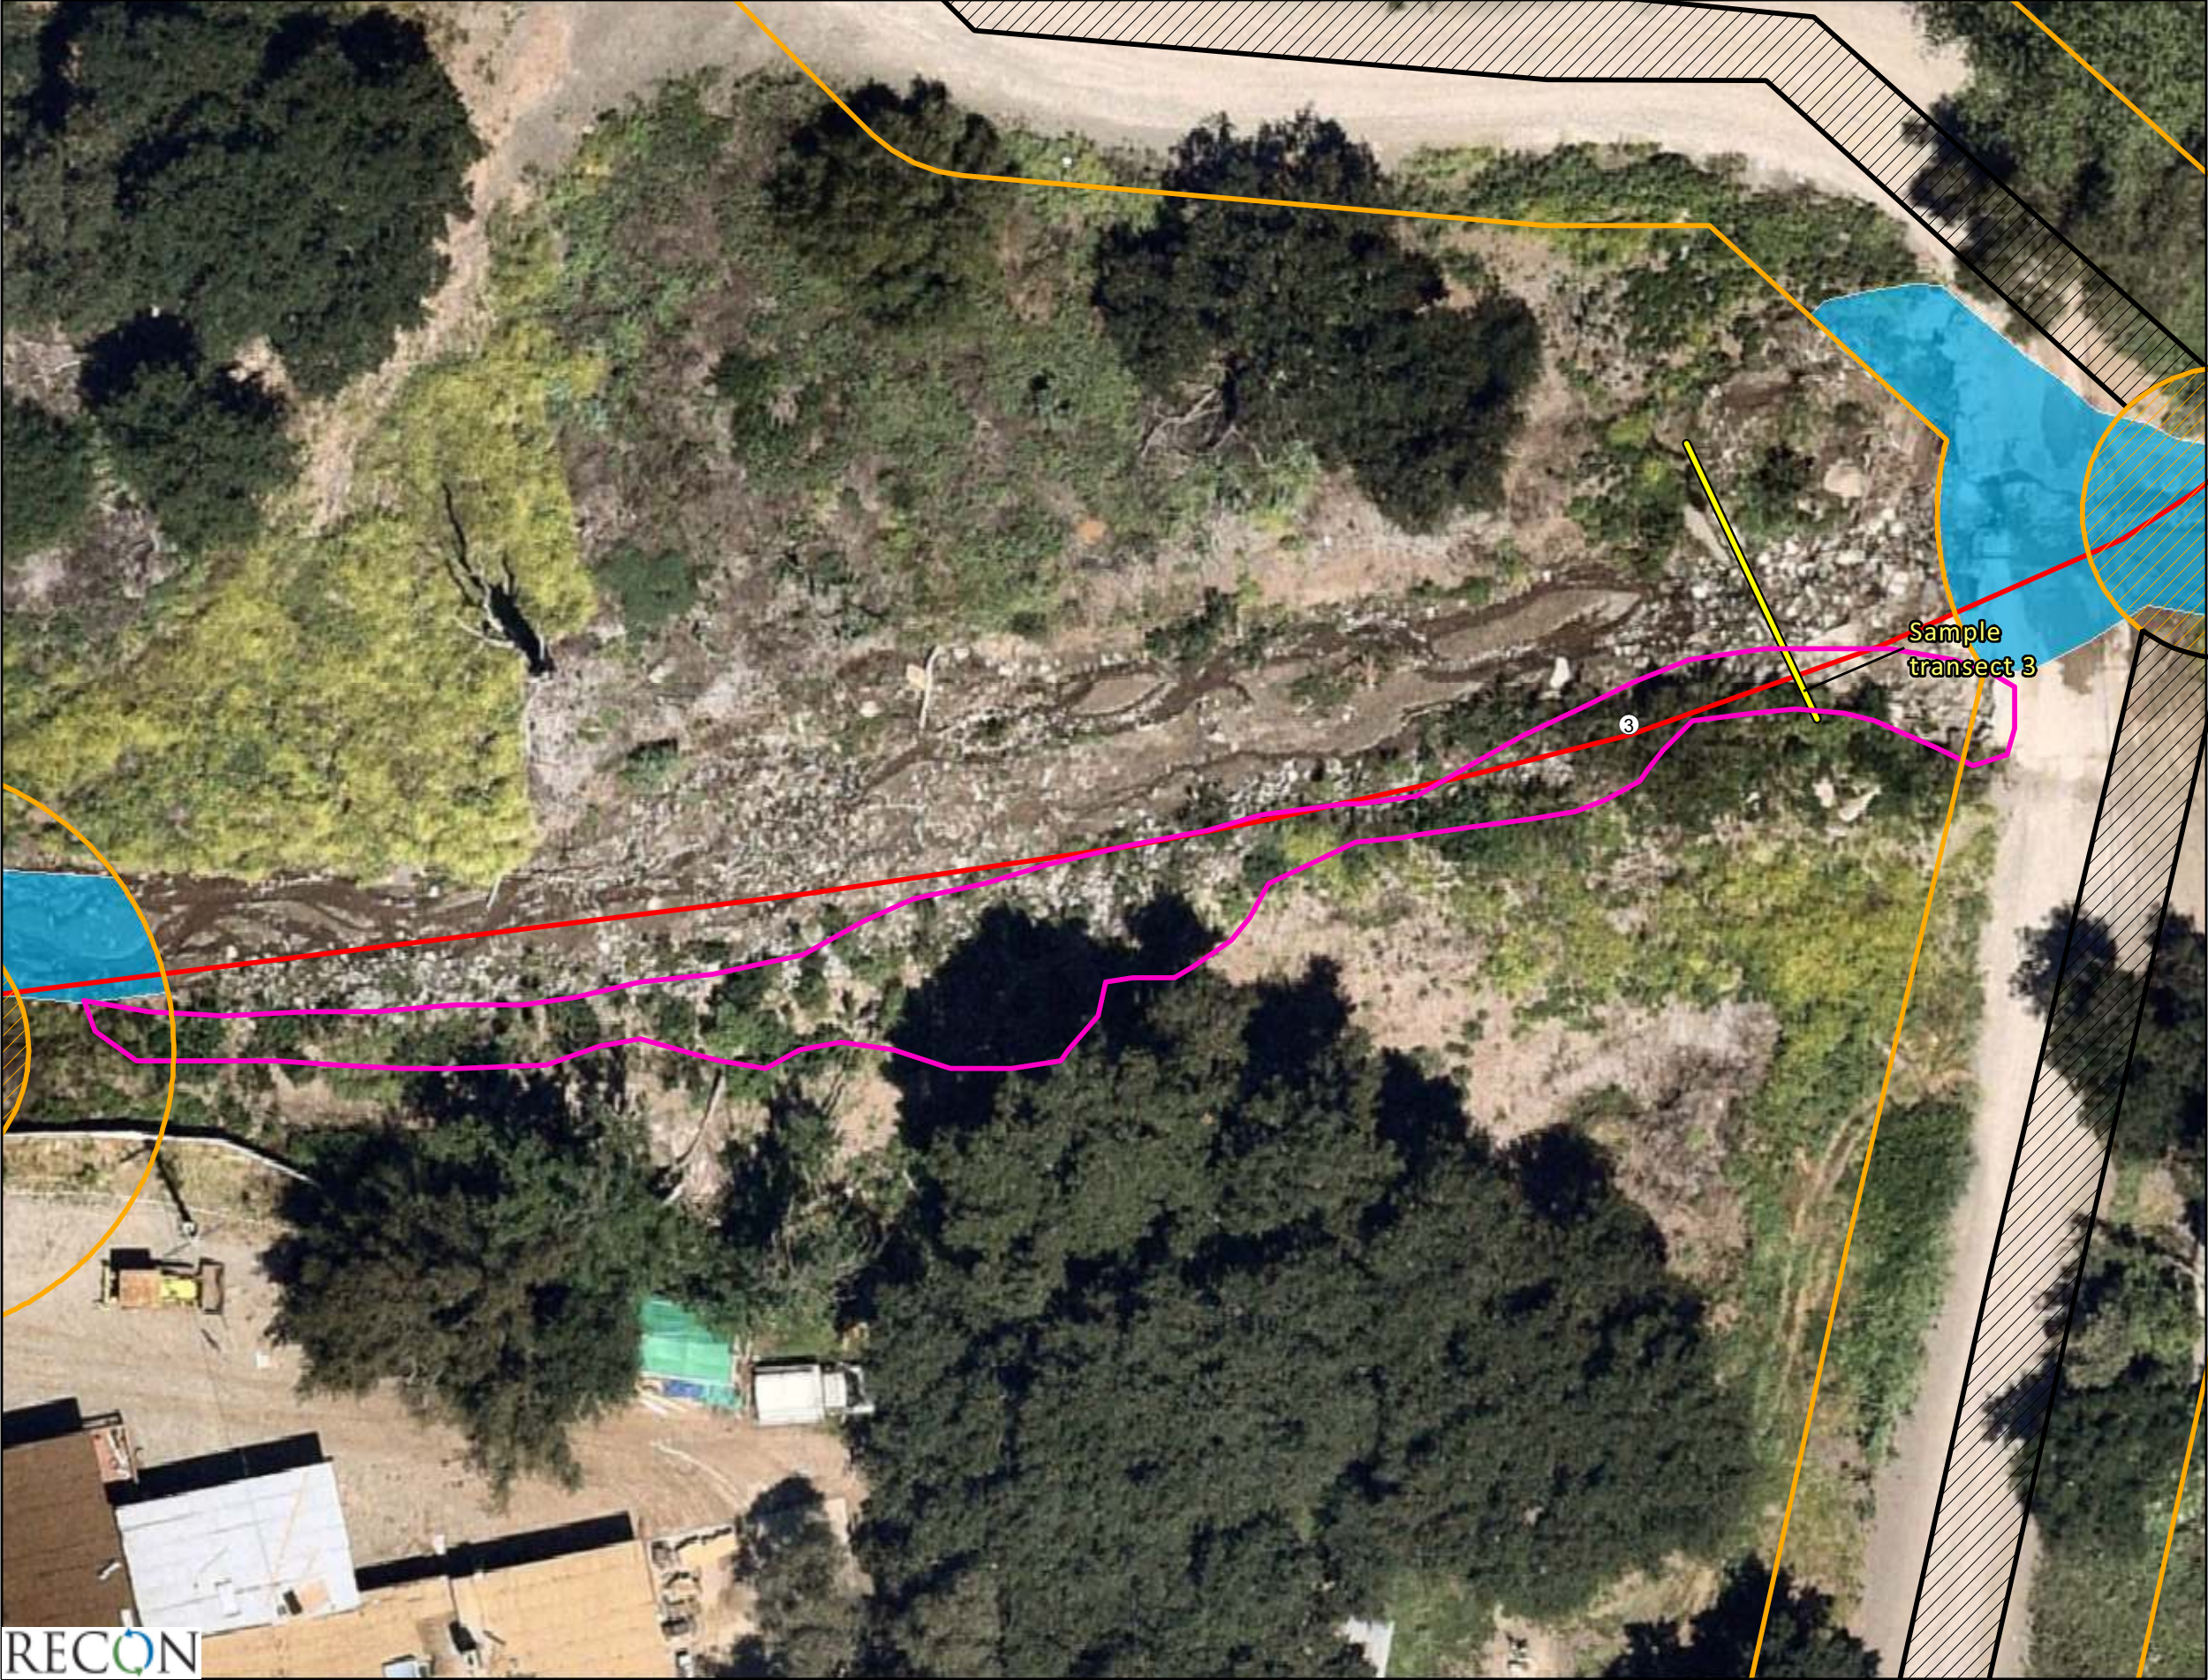
FIGURE 5
Existing Jurisdictional Resources

- Survey Area
- Impact Areas**
 - Temporary Impact Areas
 - No Impact Areas
- Mitigation Areas**
 - Mitigation Area 1
 - Sample Point
- Sample Transect
- Proposed Lining Segments
- Jurisdictional Resources**
 - USACE Non-Wetland Waters of the U.S., CDFW Streambed, RWQCB
 - Non-Wetland Waters of the State

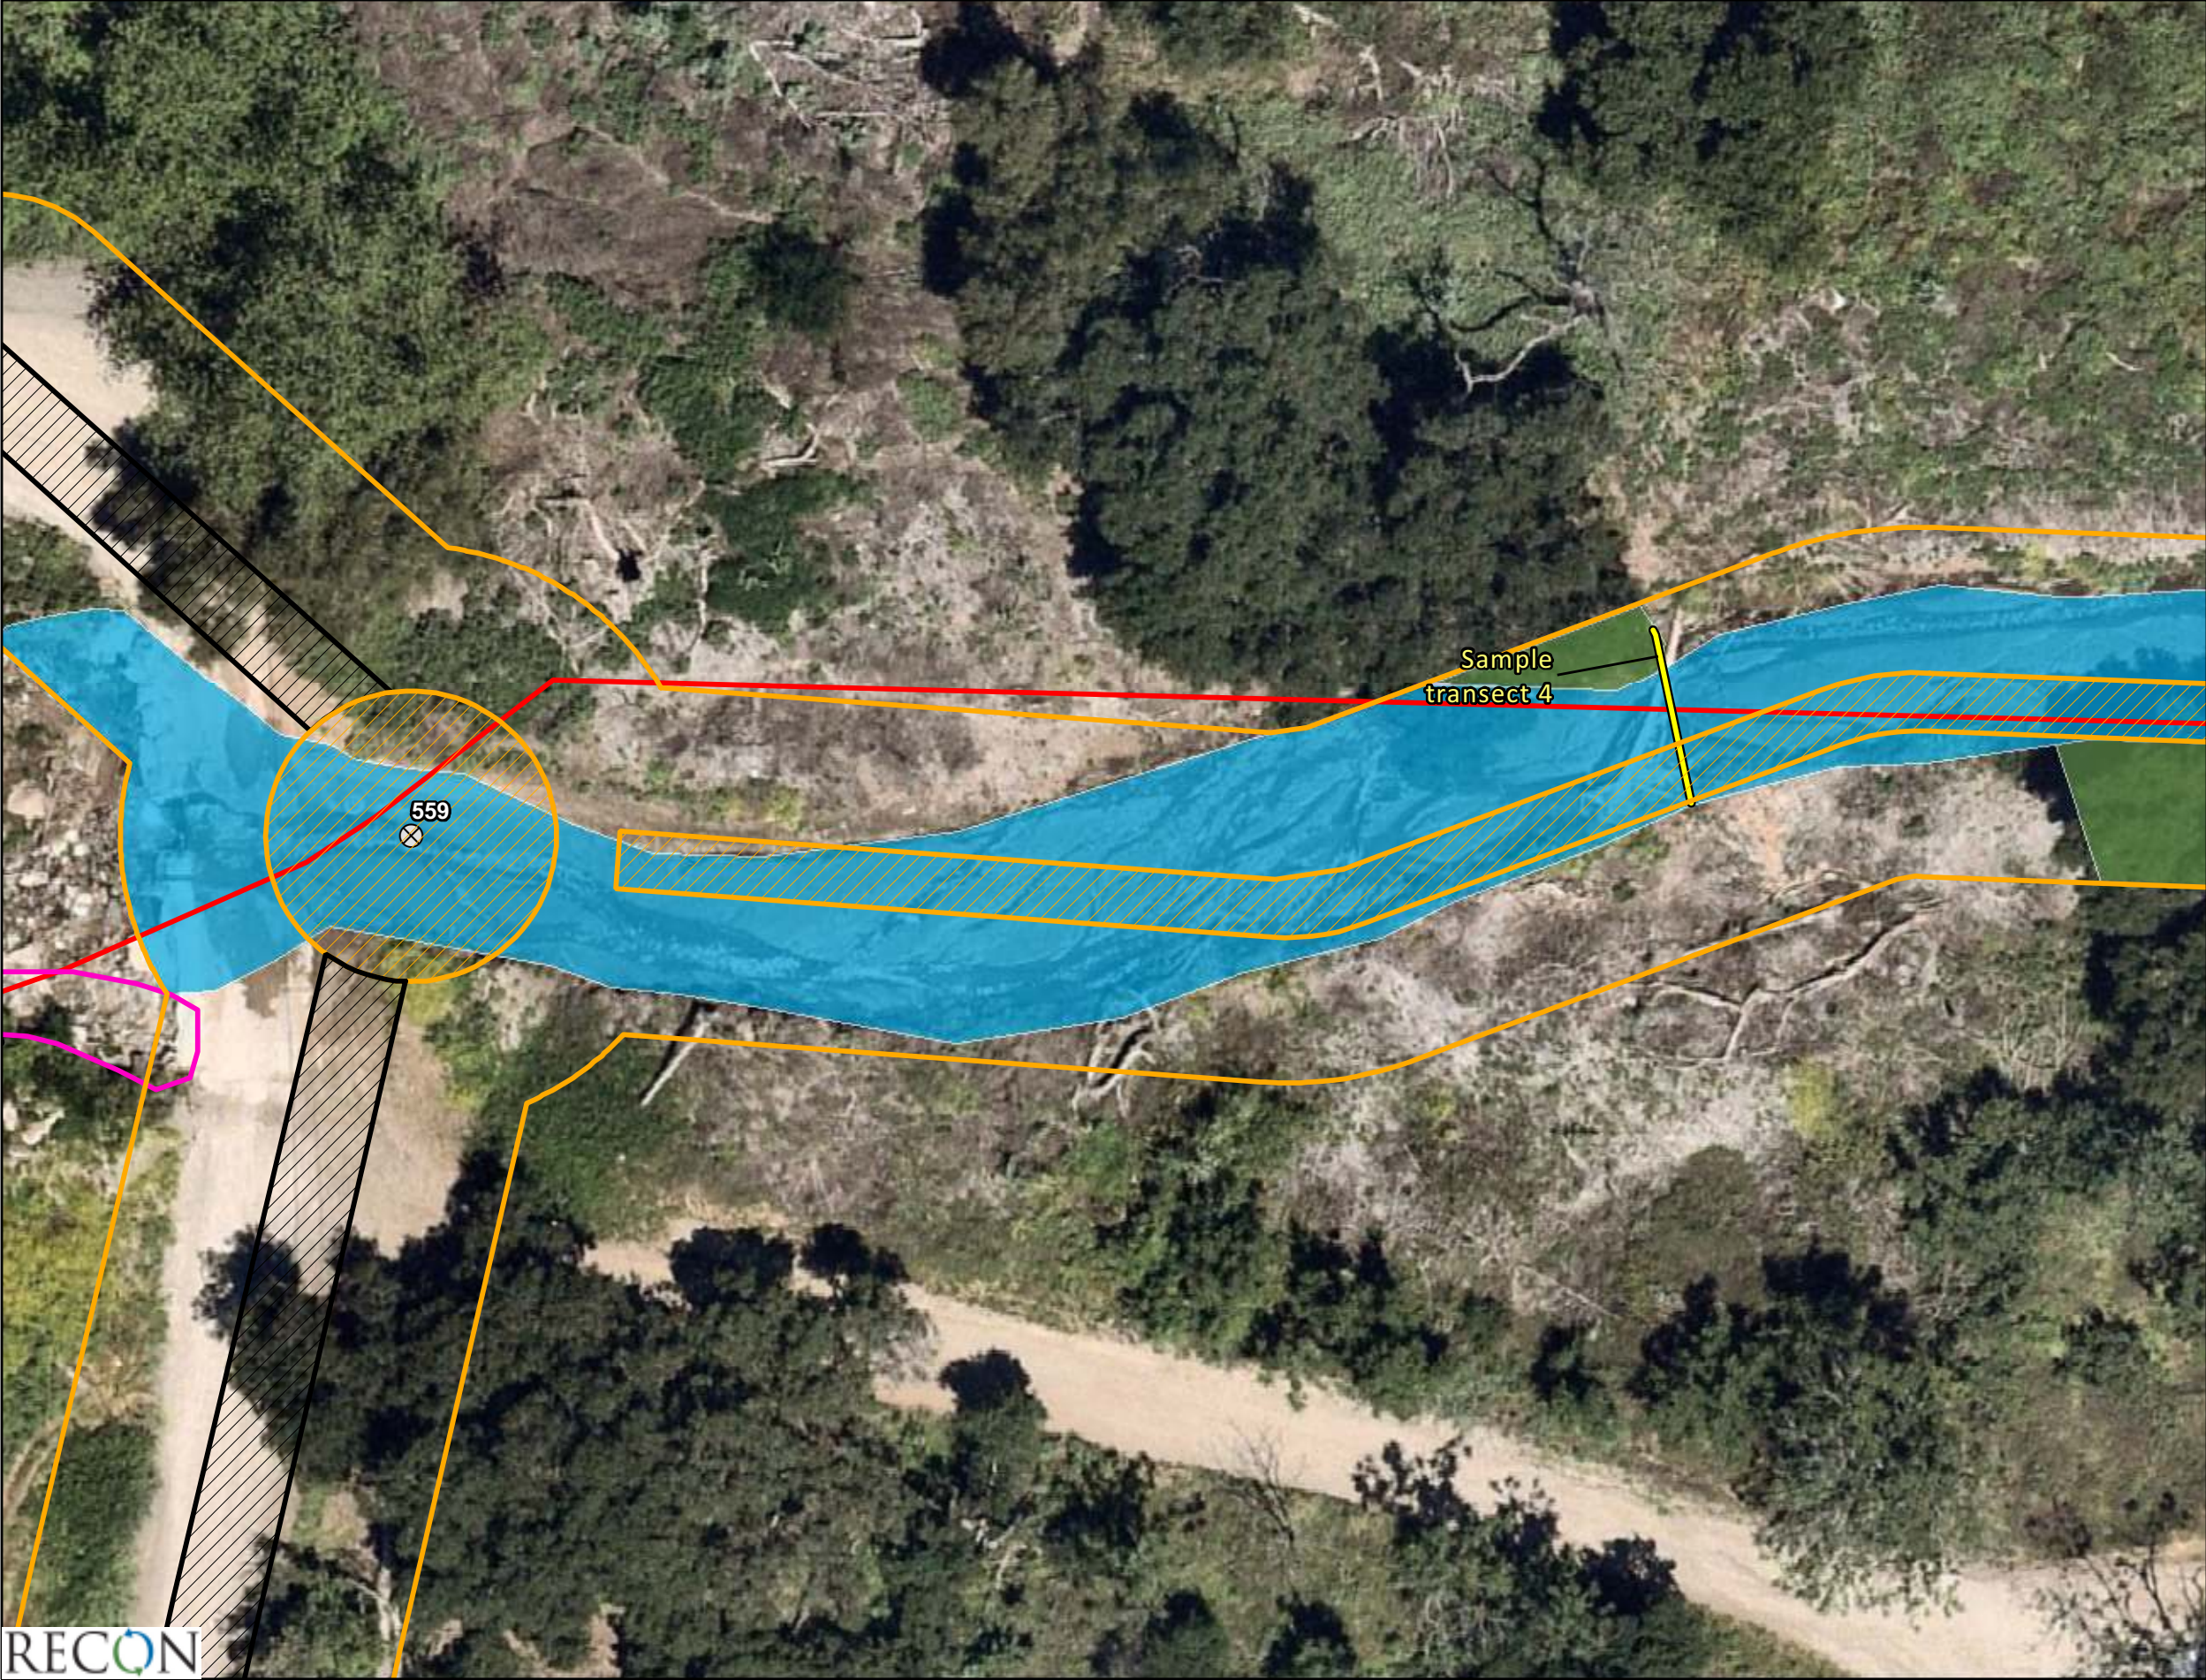
FIGURE 5
Existing Jurisdictional Resources

- Survey Area
- Impact Areas**
 - Temporary Impact Areas
 - No Impact Areas
- Mitigation Areas**
 - Mitigation Area 1
- Sample Transect
- Manhole
- Proposed Lining Segments
- Jurisdictional Resources**
 - USACE Non-Wetland Waters of the U.S., CDFW Streambed, RWQCB Non-Wetland Waters of the State
 - CDFW Riparian, RWQCB Wetland Waters of the State

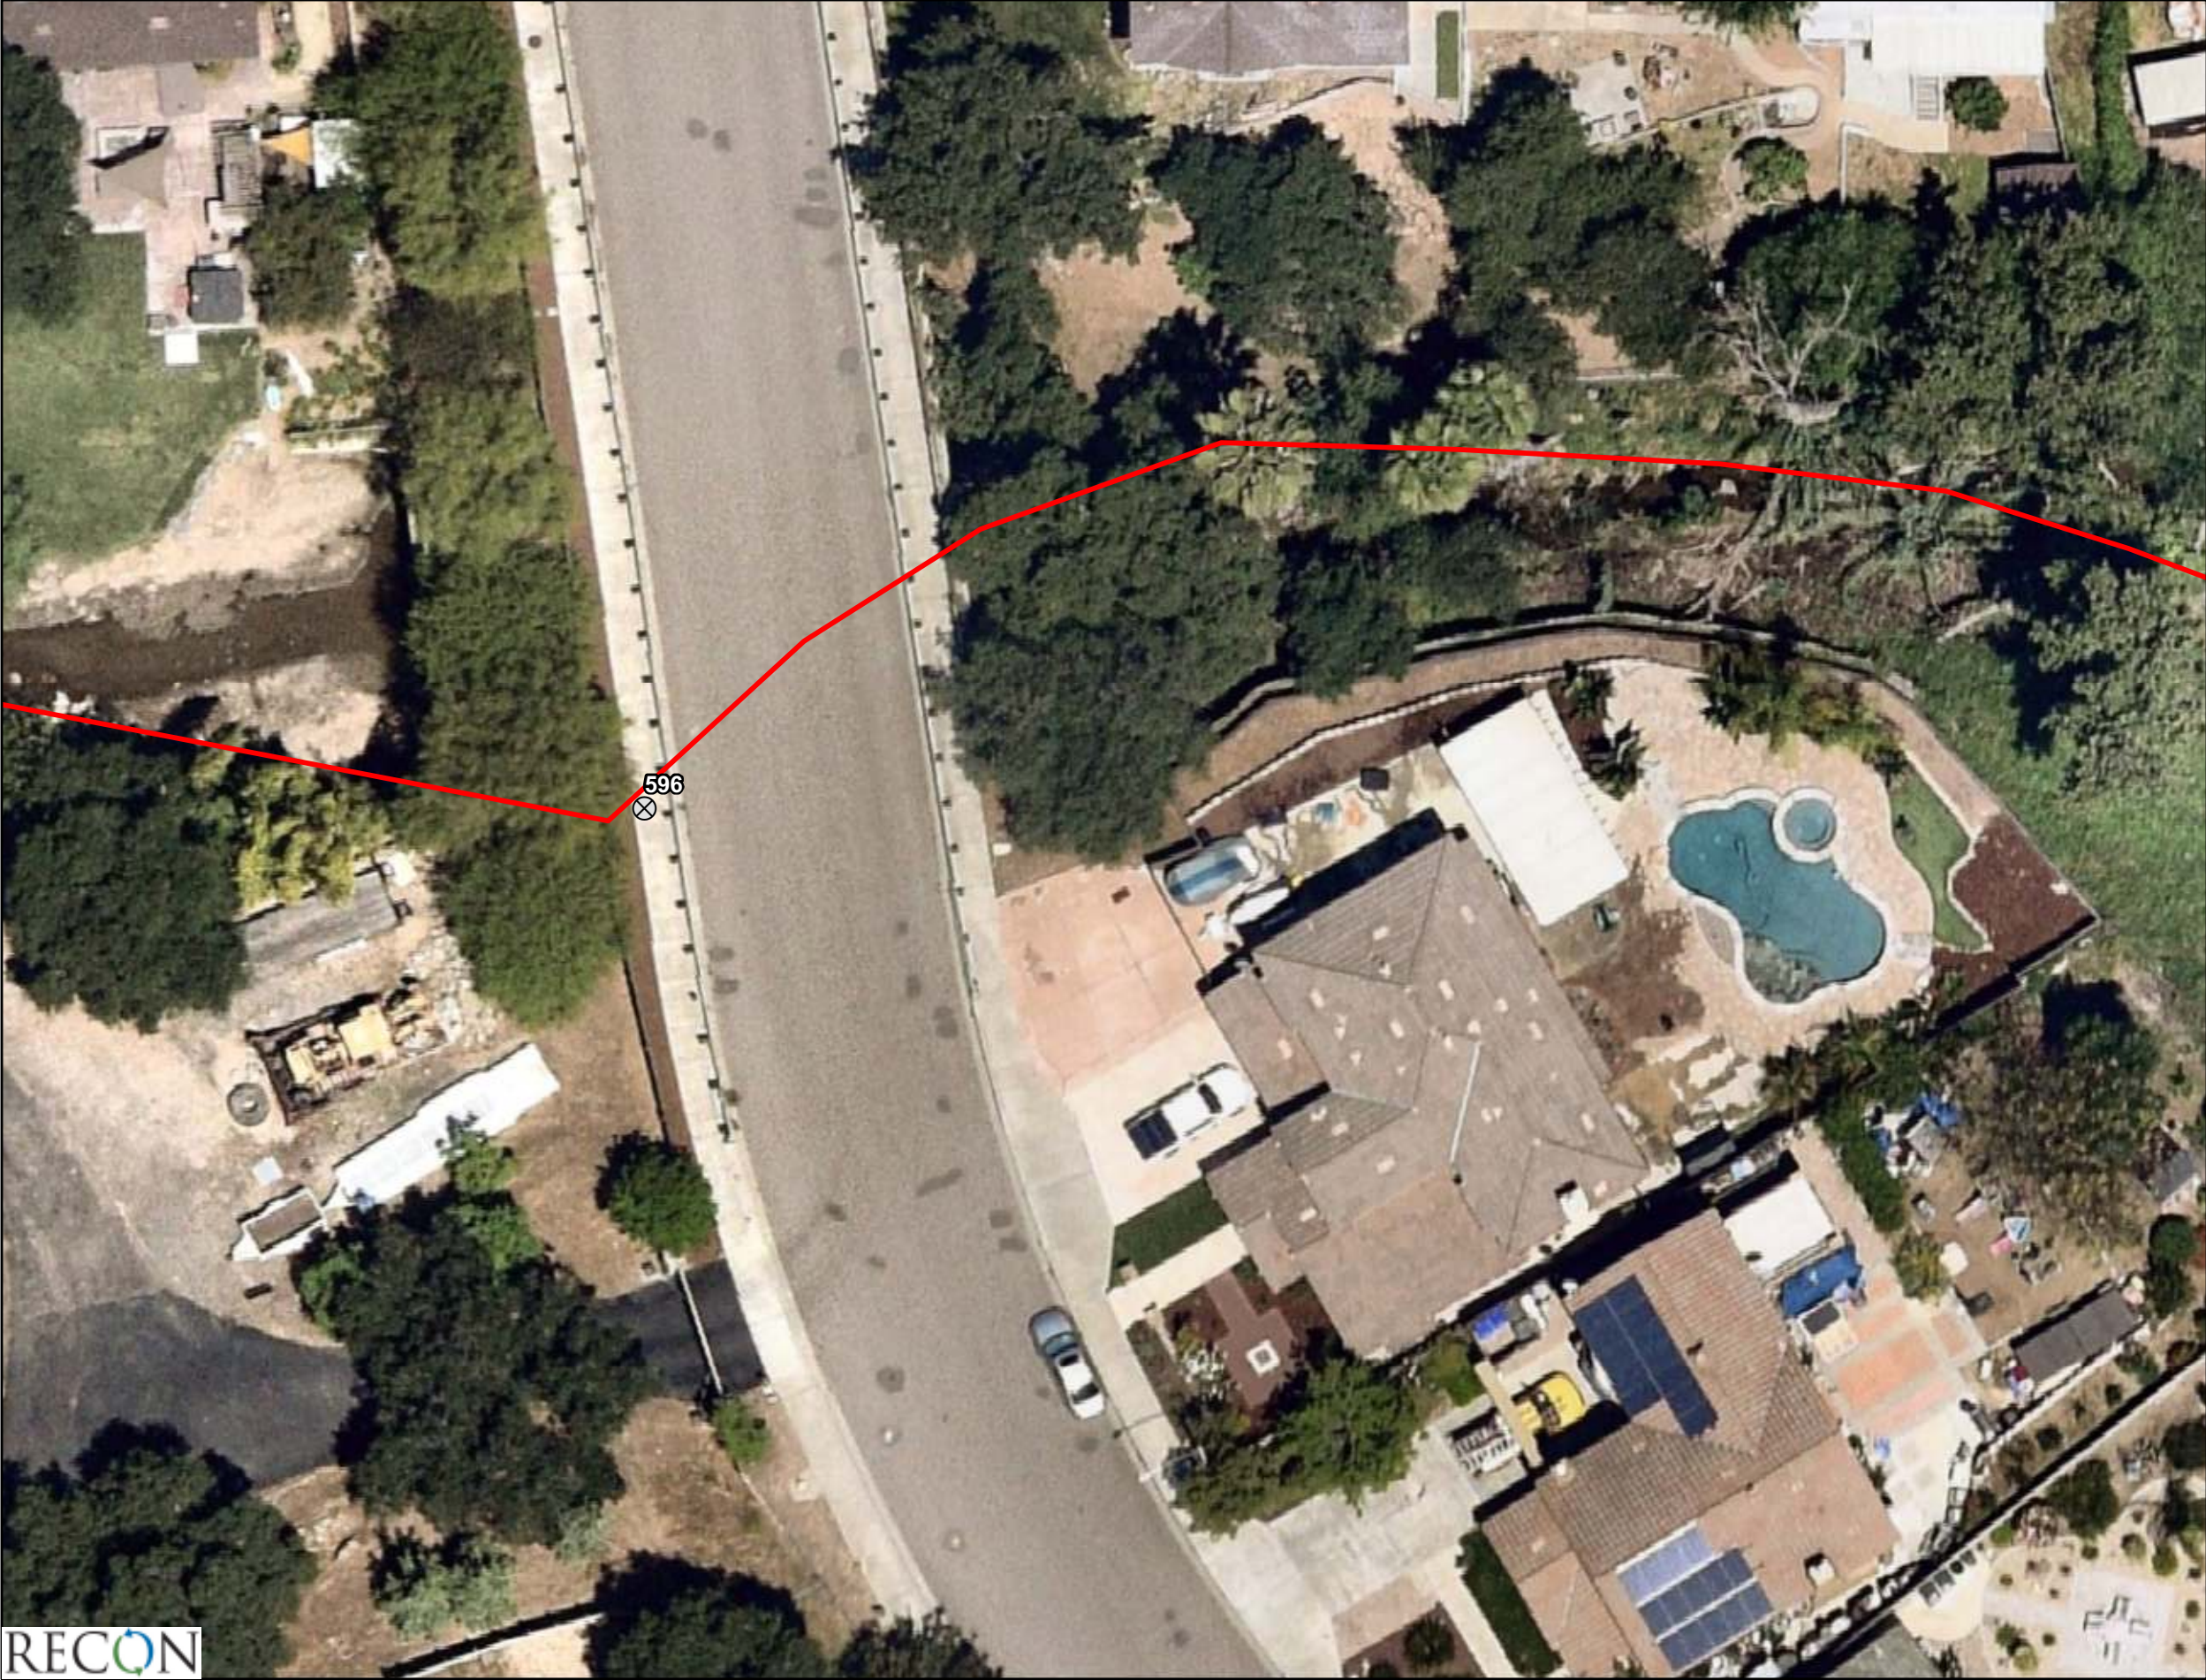
FIGURE 5
Existing Jurisdictional Resources

- ⊗ Manhole
- Proposed Lining Segments

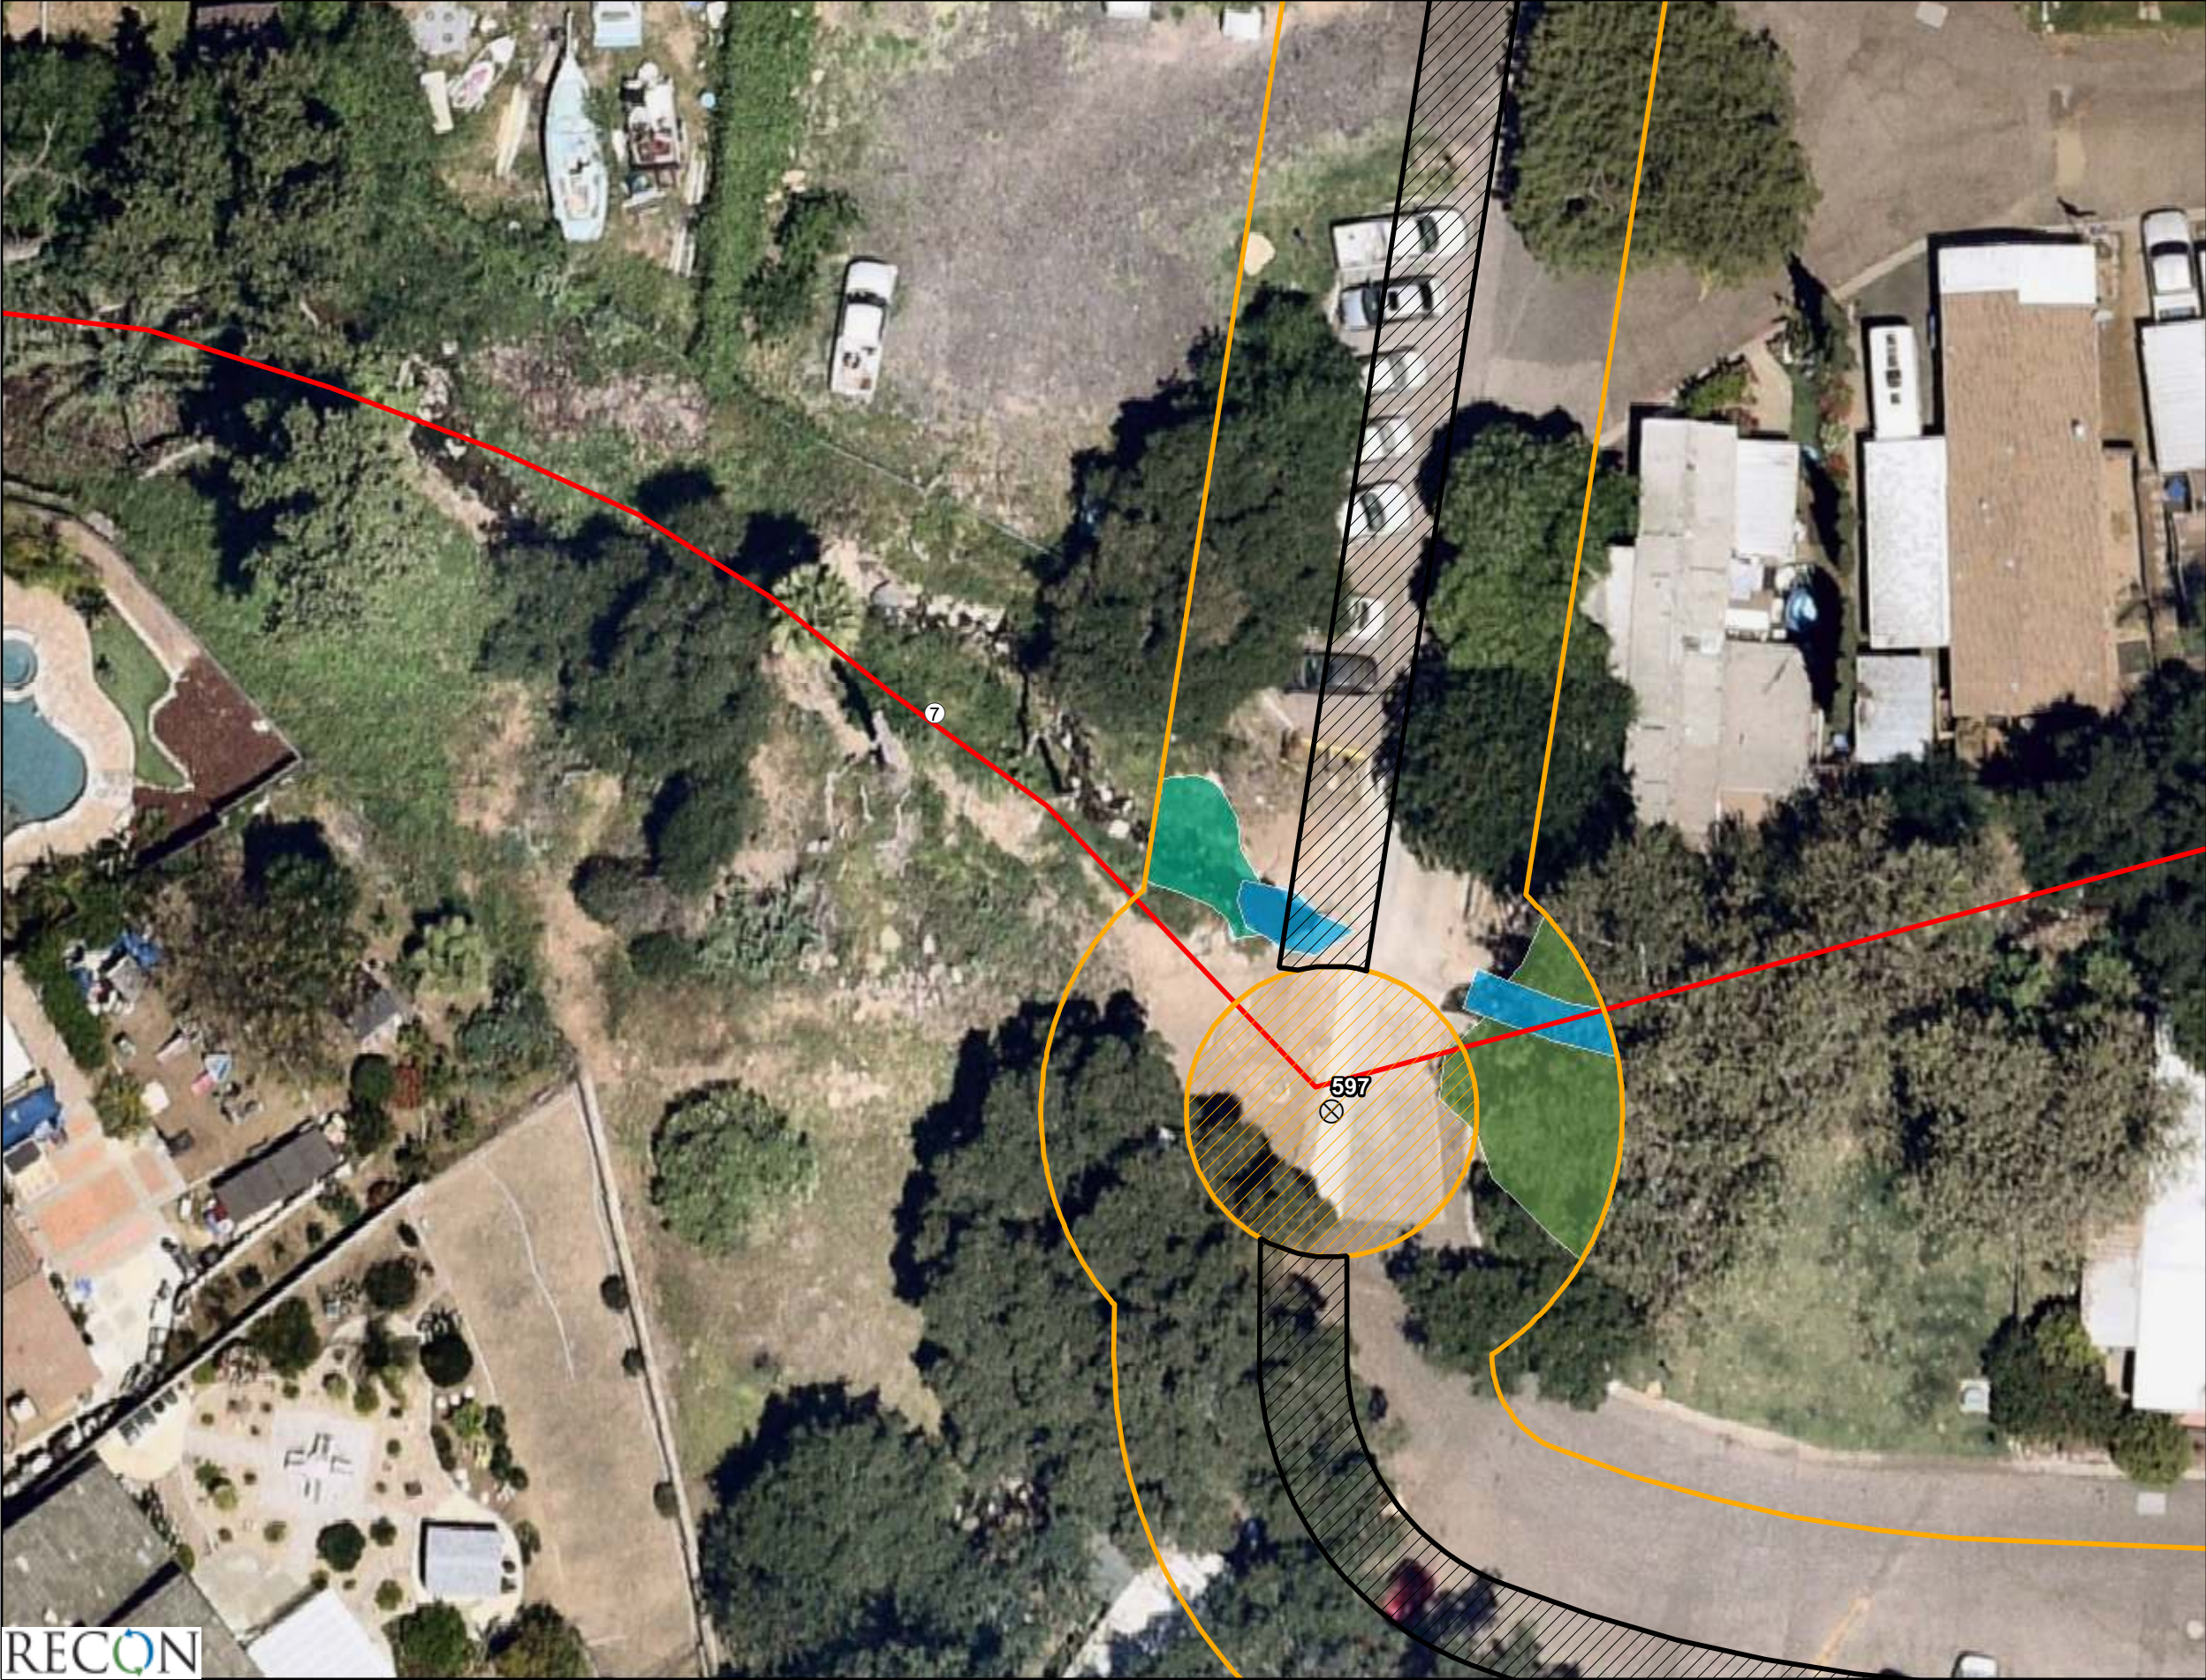
FIGURE 5
Existing Jurisdictional Resources

- Survey Area
- Impact Areas**
 - Temporary Impact Areas
 - No Impact Areas
- Sample Point
- Manhole
- Proposed Lining Segments

- Jurisdictional Resources**
 - USACE Non-Wetland Waters of the U.S., CDFW Streambed, RWQCB Non-Wetland Waters of the State
 - USACE Wetland Waters of the U.S., CDFW Wetland, RWQCB Wetland
 - CDFW Riparian, RWQCB Wetland Waters of the State

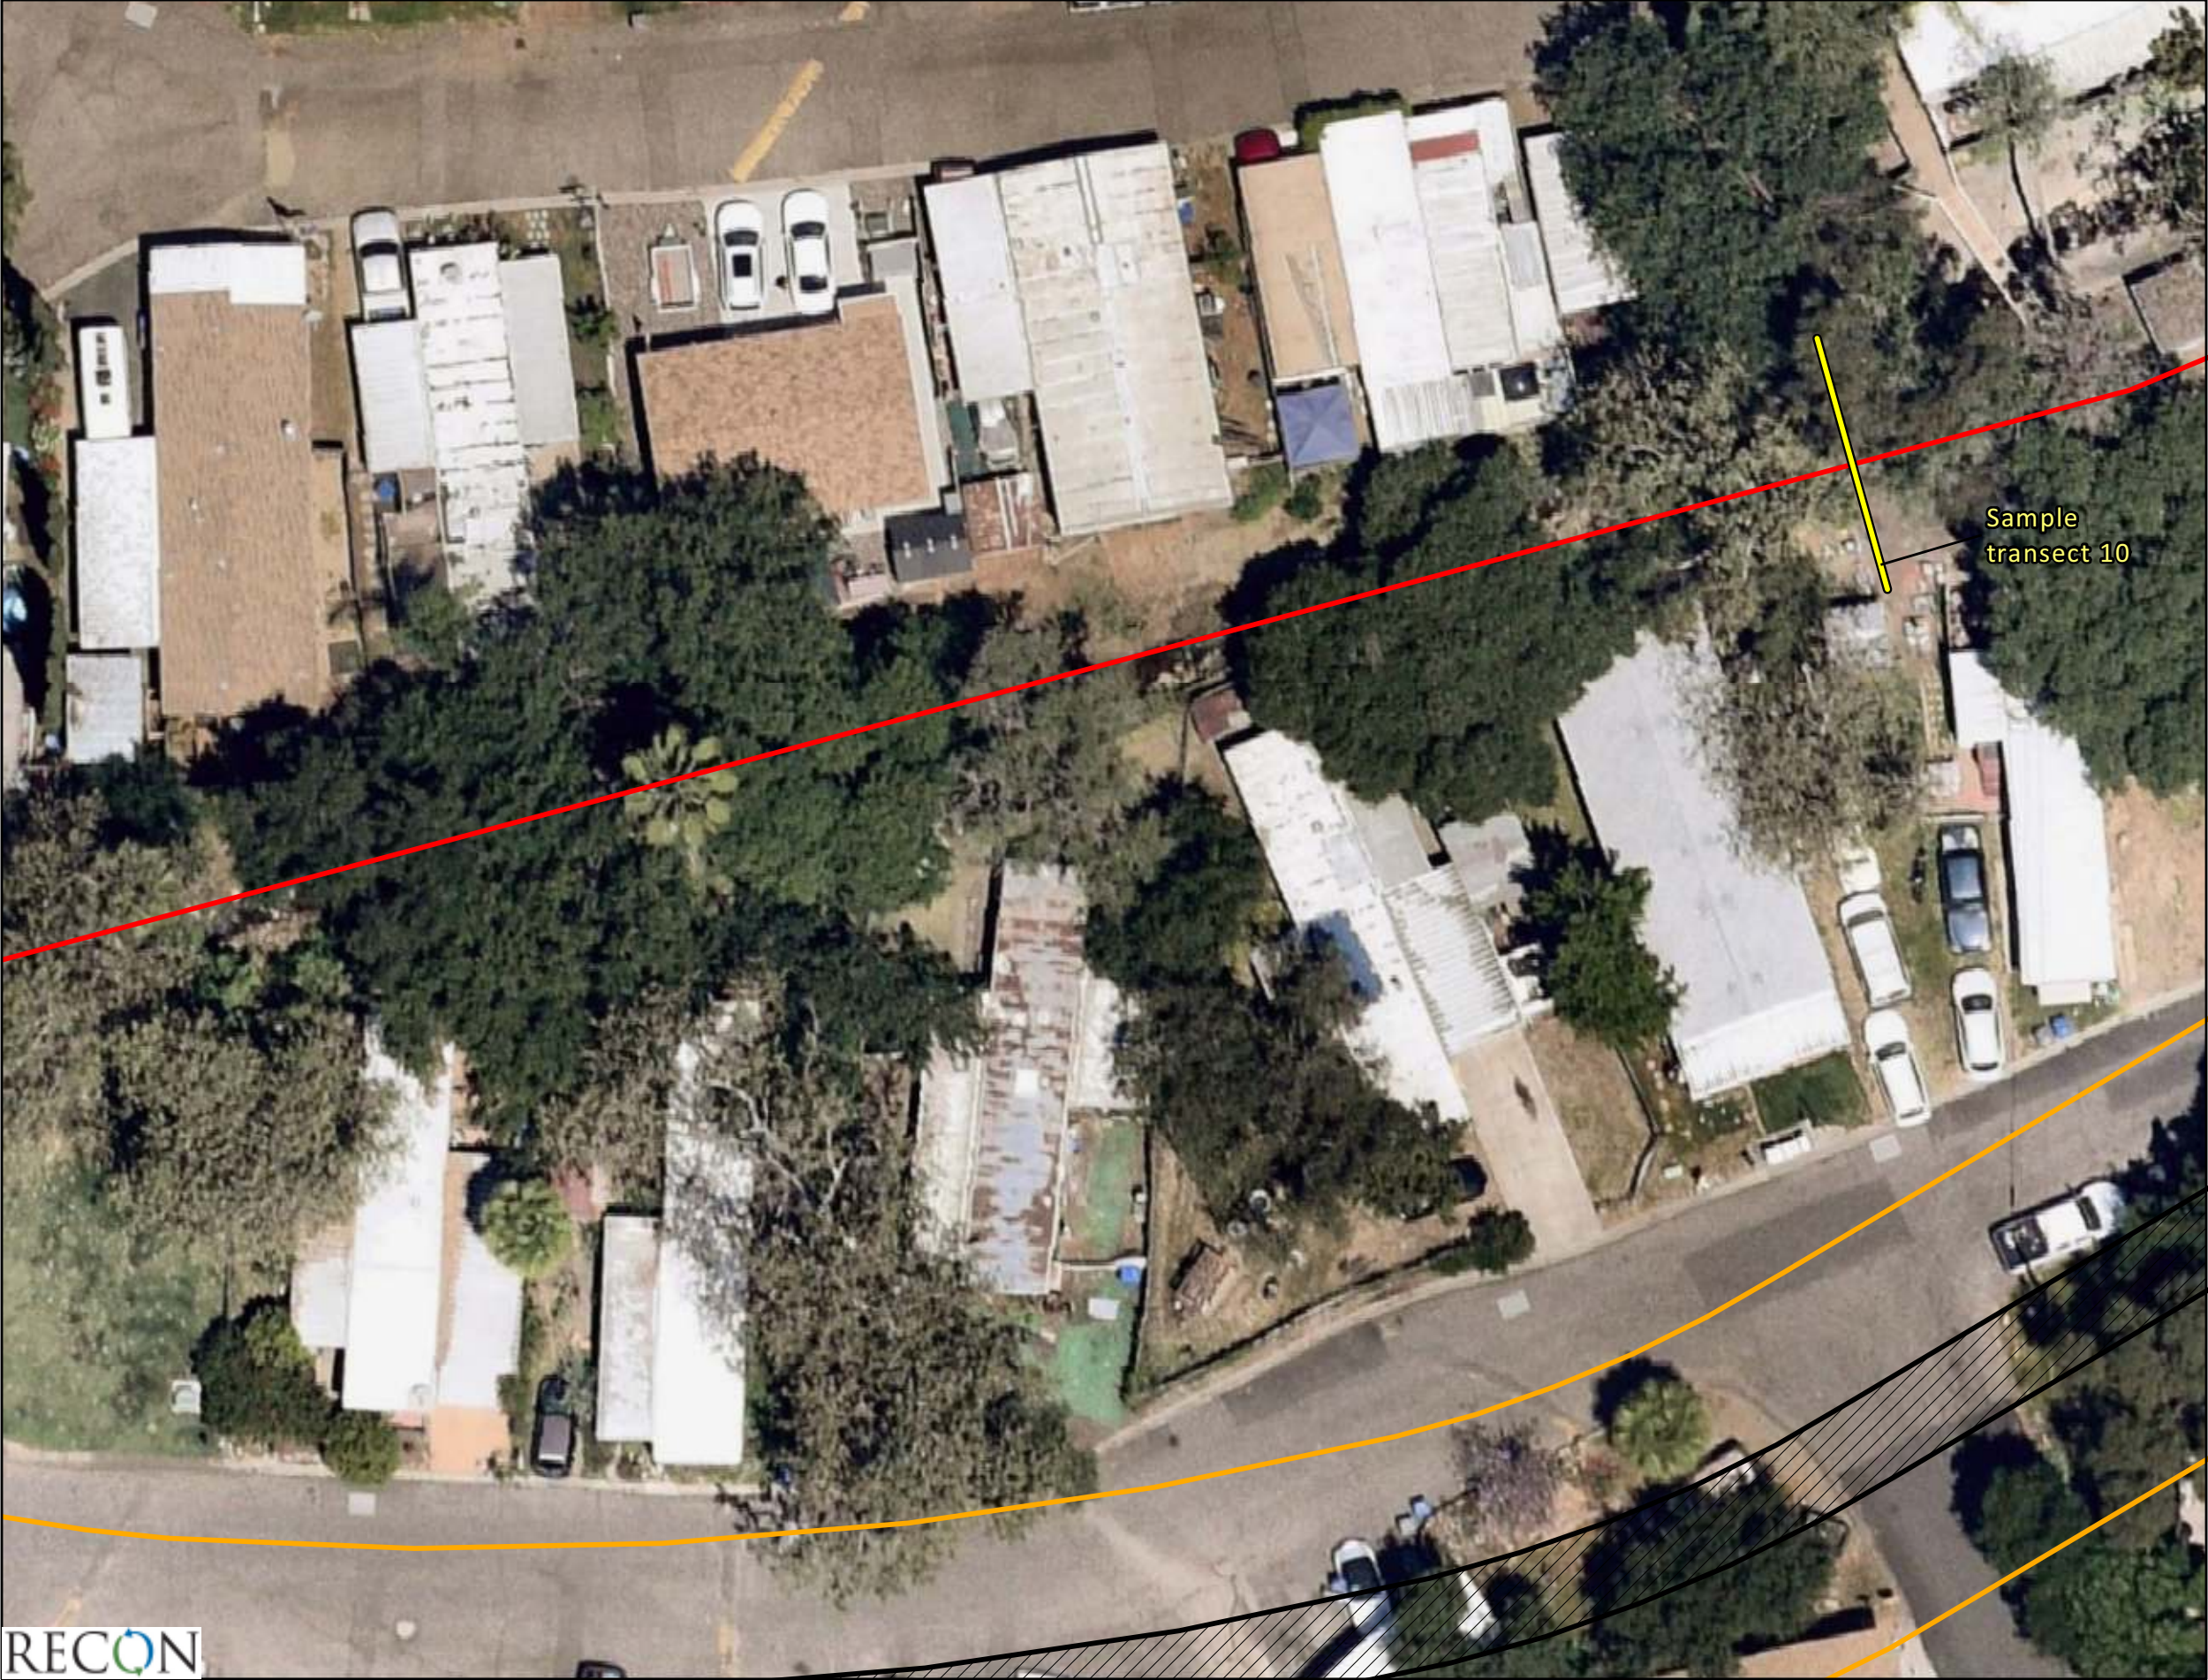
FIGURE 5
Existing Jurisdictional Resources

- Survey Area
- Impact Areas**
- No Impact Areas
- Sample Transect
- Proposed Lining Segments

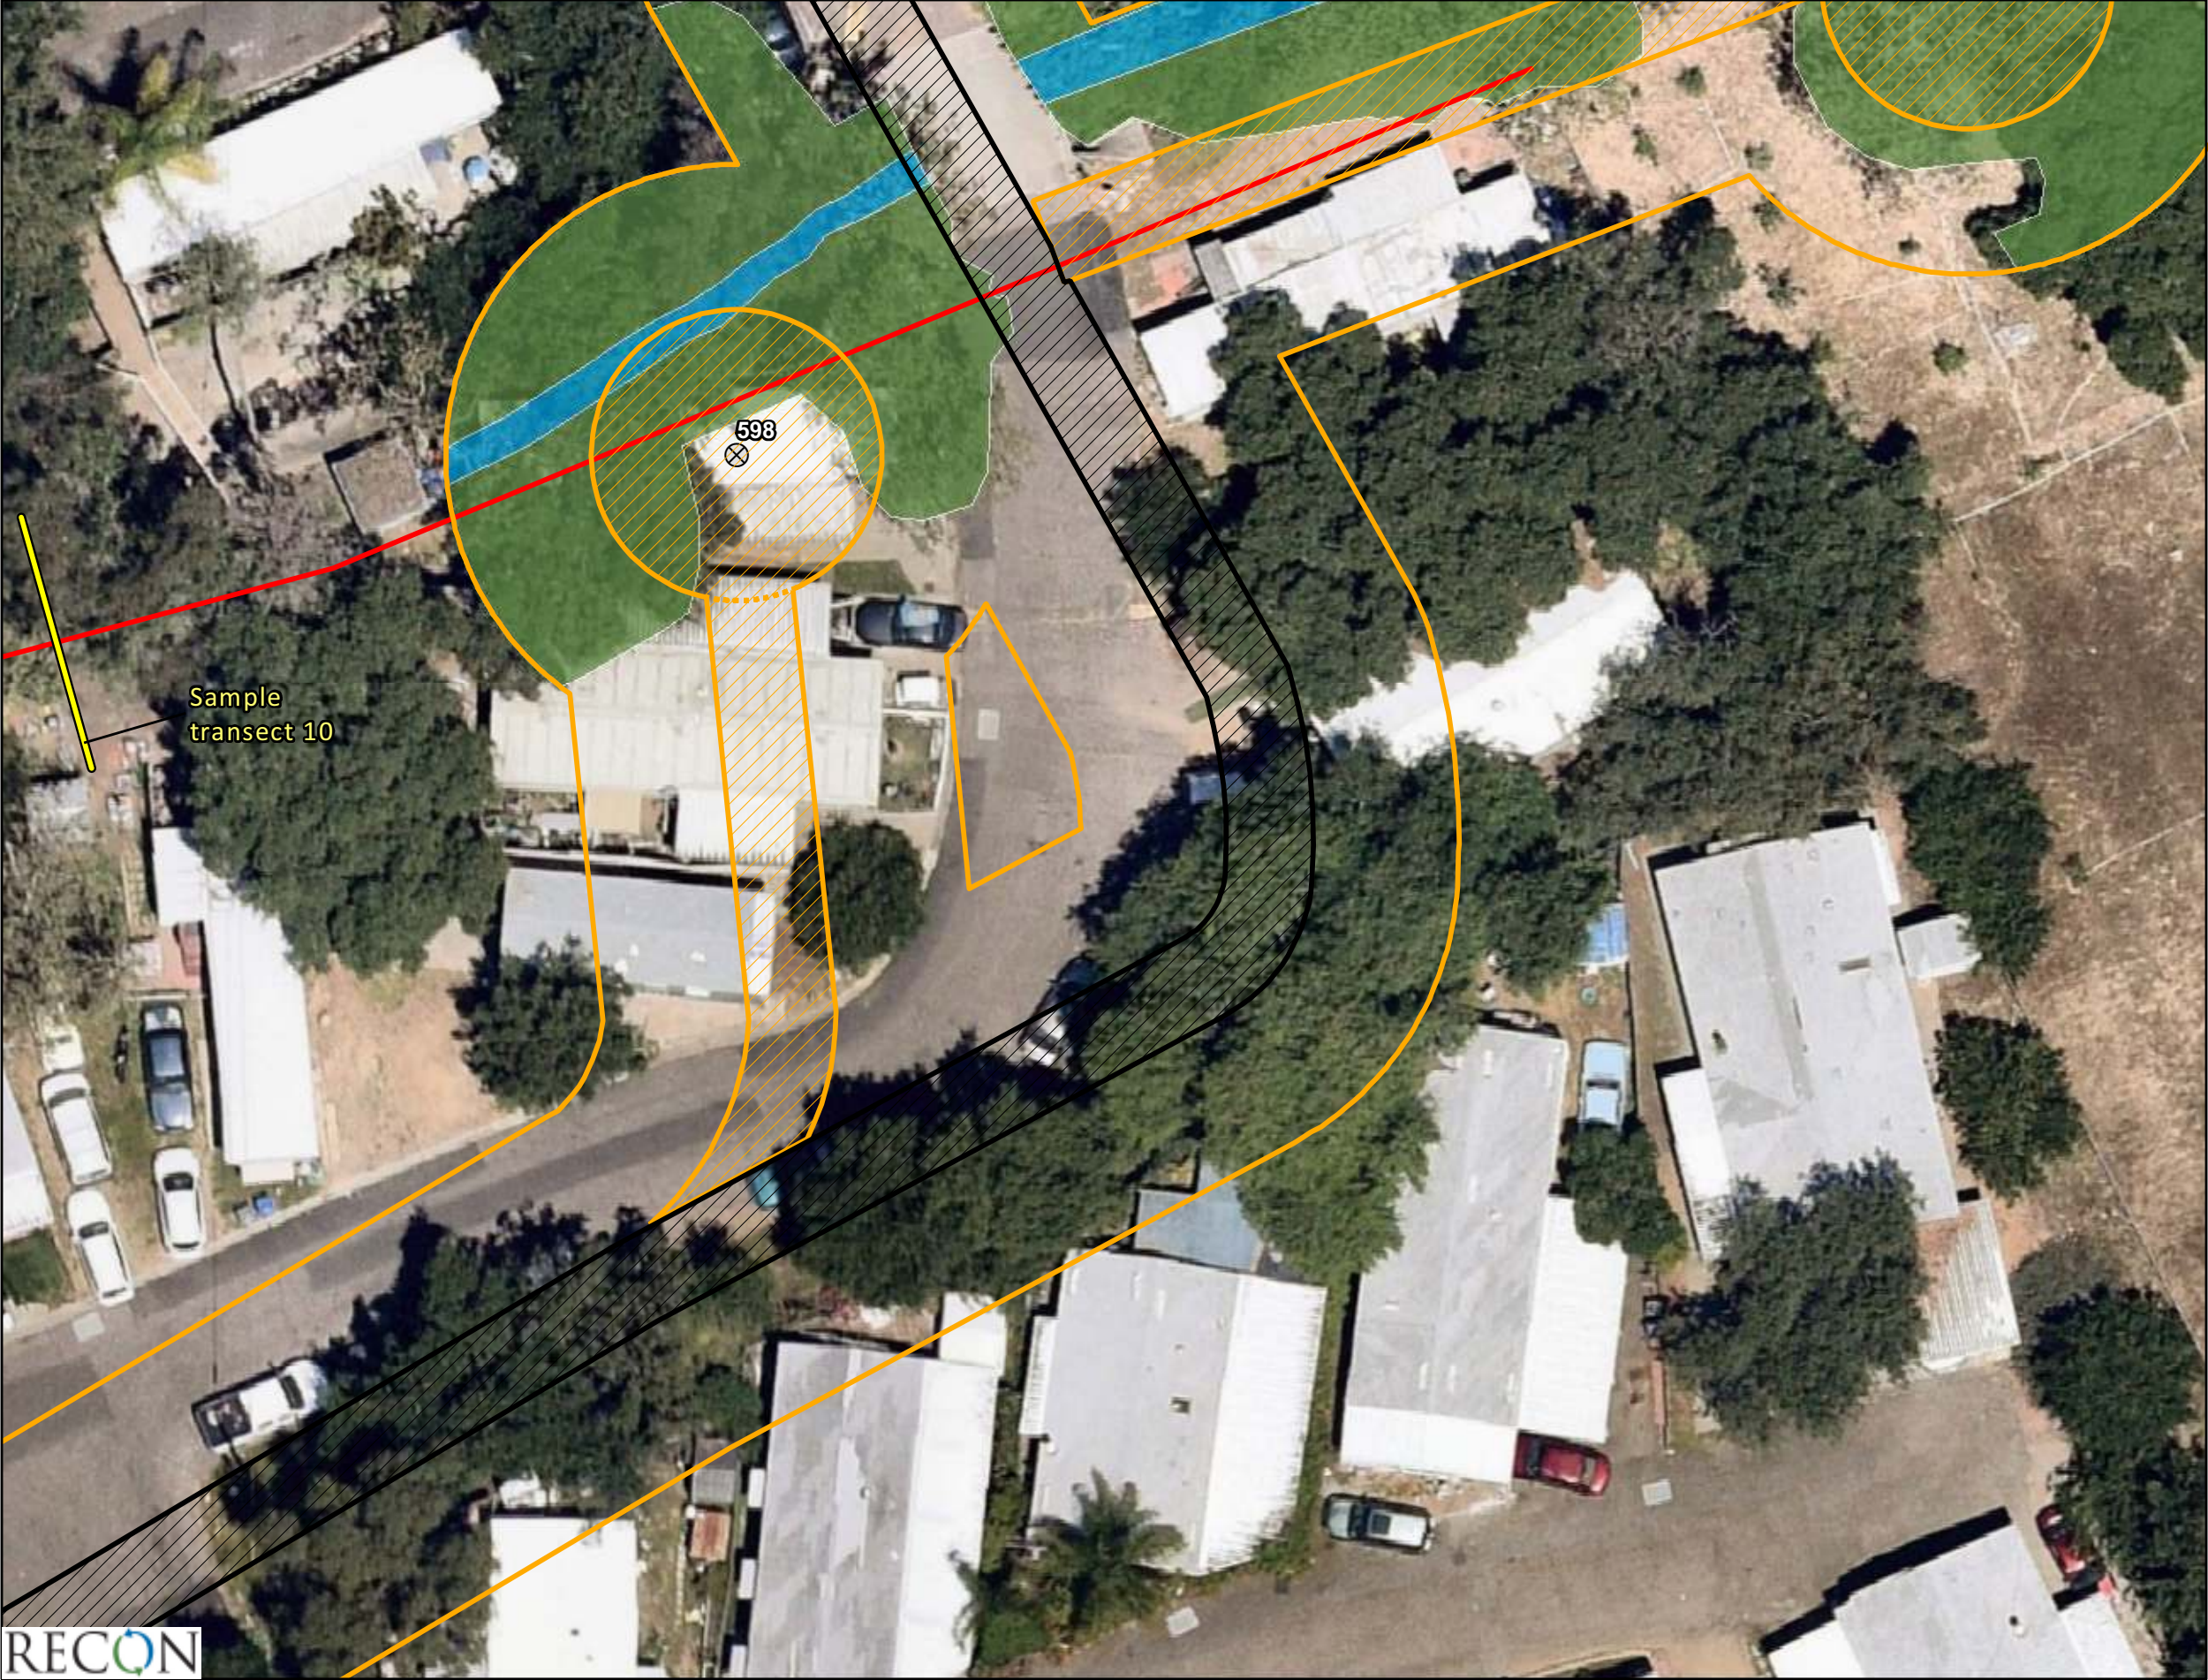
FIGURE 5
Existing Jurisdictional Resources

- Survey Area
- Impact Areas**
 - Temporary Impact Areas
 - No Impact Areas
- Sample Transect
- Manhole
- Proposed Lining Segments
- Jurisdictional Resources**
 - USACE Non-Wetland Waters of the U.S., CDFW Streambed, RWQCB Non-Wetland Waters of the State
 - CDFW Riparian, RWQCB Wetland Waters of the State
