Reference: Biological Resources Letter Report for the County of San Diego Sanitation District: Los Coches
Sanitary Sewer Improvements from LSMH0555 to LSMH0599 Project
(RECON Number 9009-12)

This report summarizes the biological resources survey methods and results, assessment of potential impacts to biological resources, and recommended mitigation measures for the proposed Los Coches Sanitary Sewer Improvements from LSMH0555 to LSMH0599 Project (project).

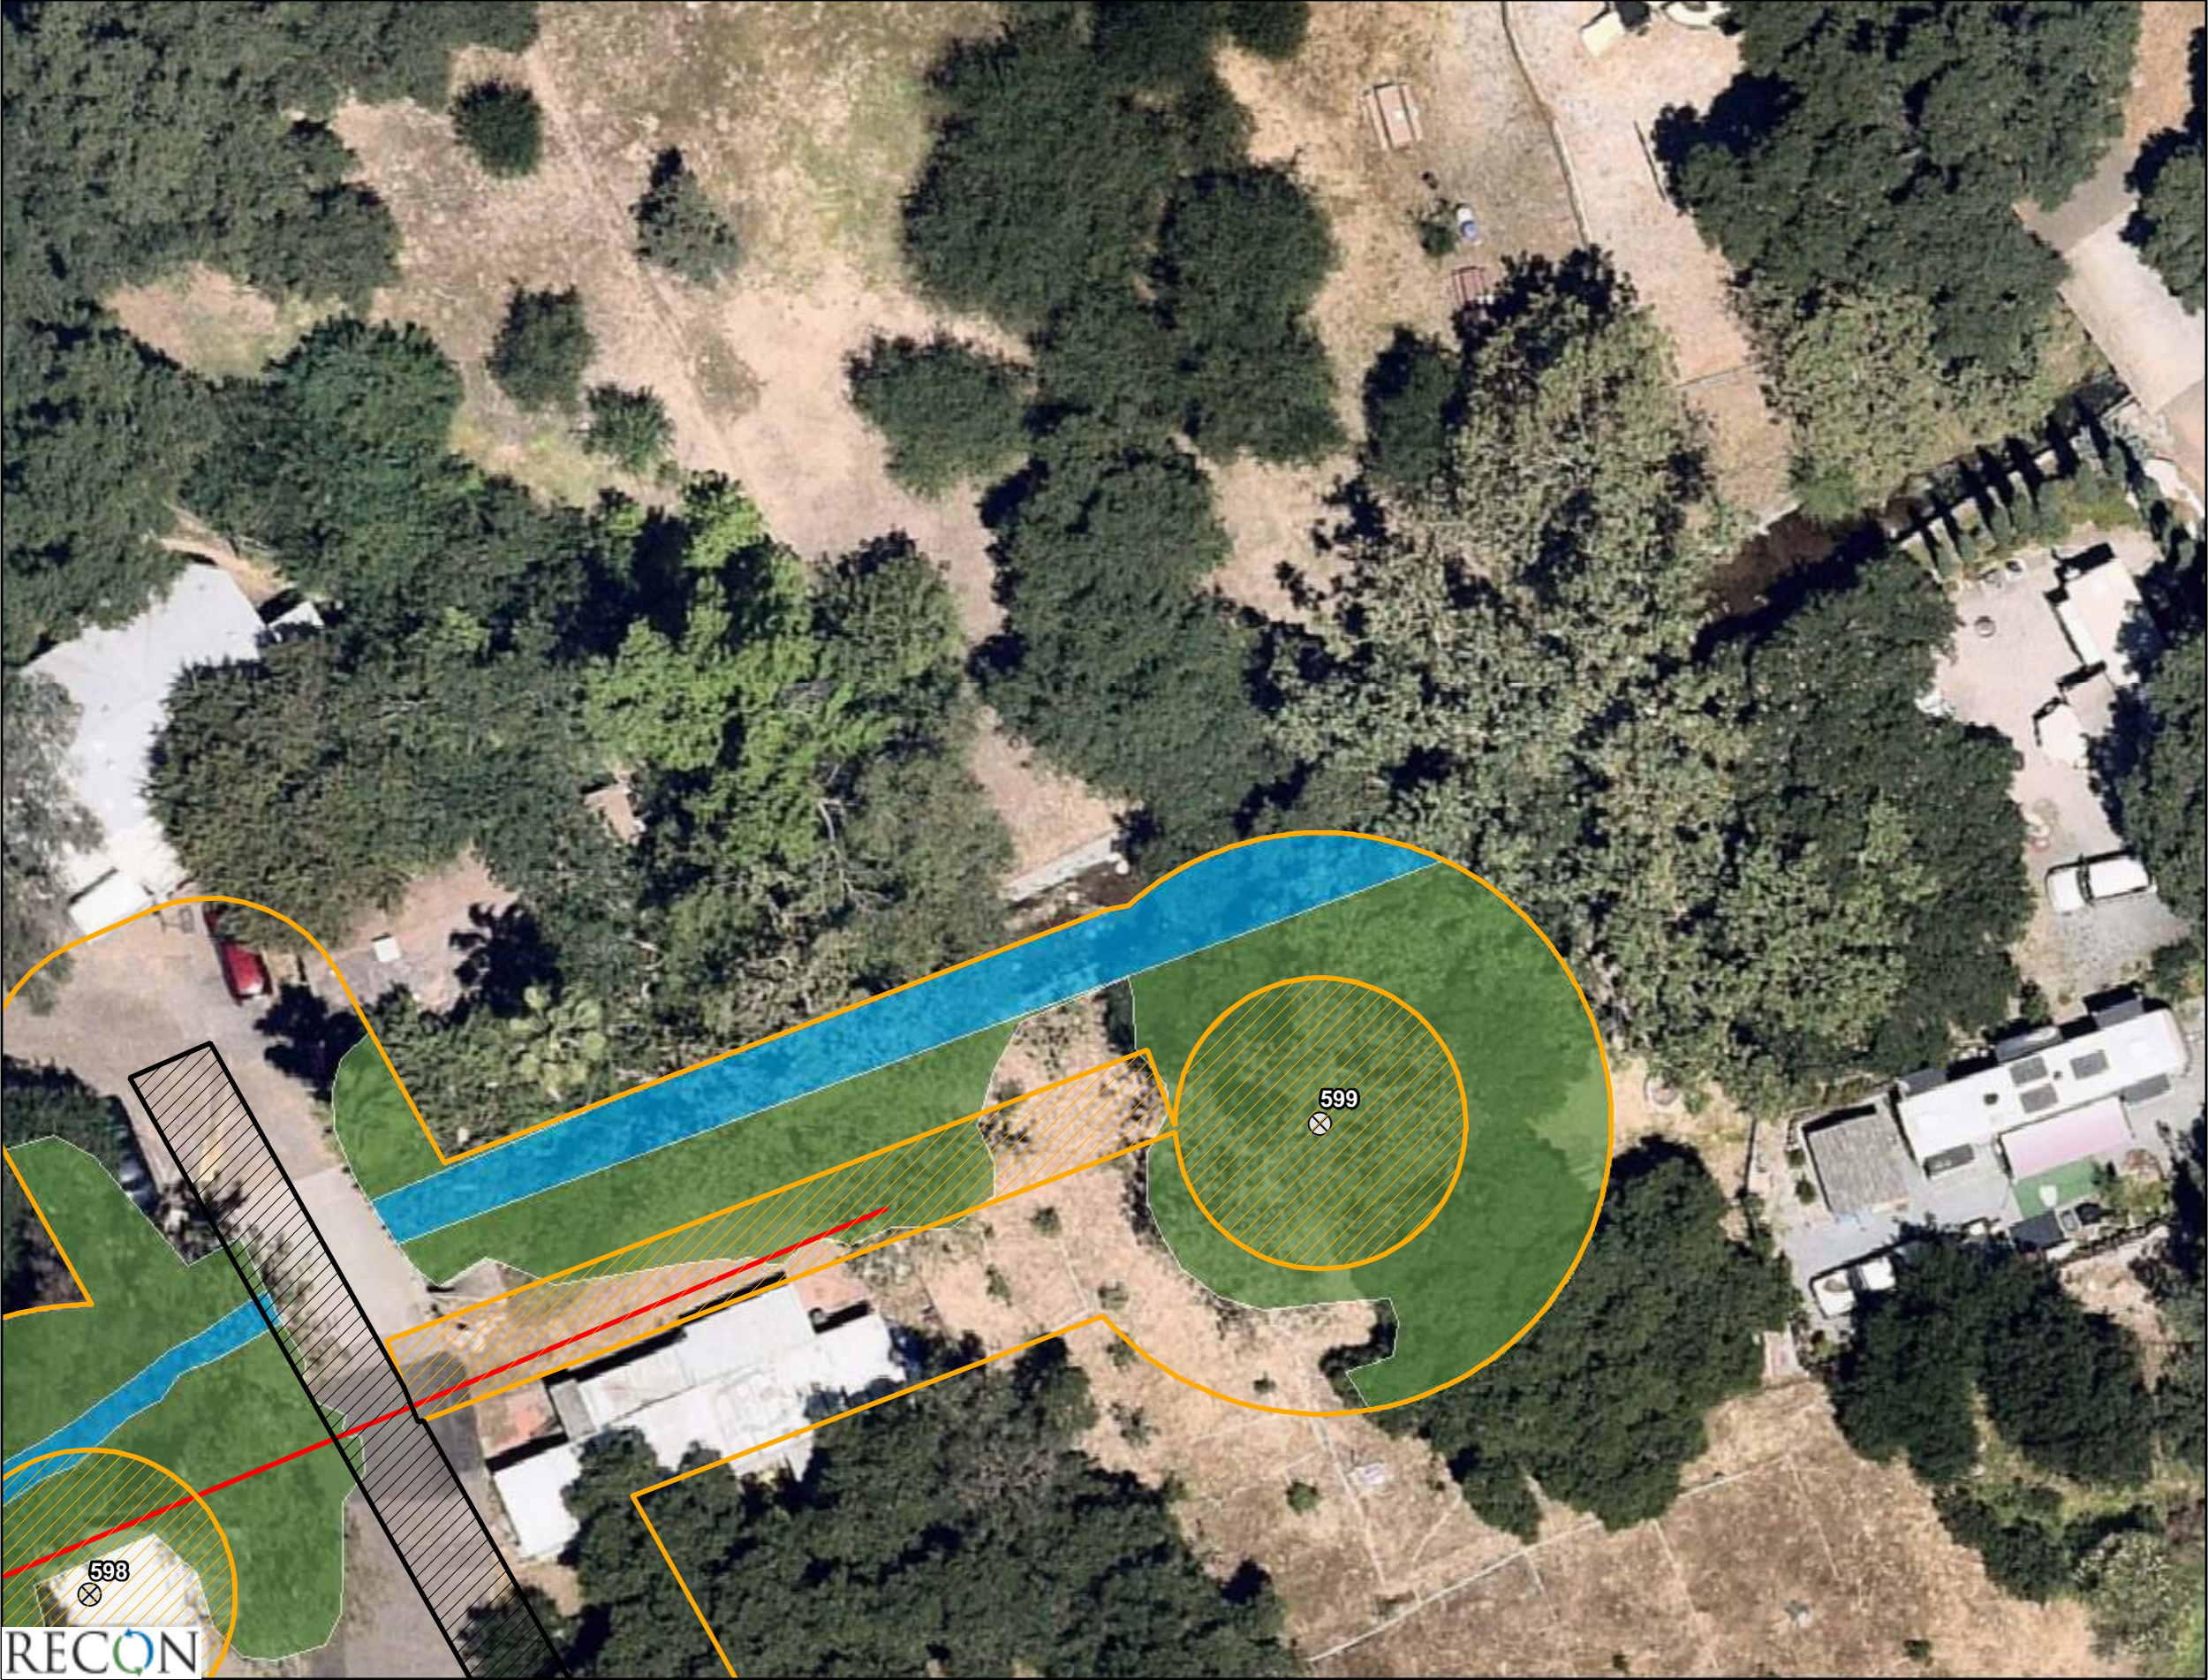
FIGURE 5
Existing Jurisdictional Resources

- Survey Area
- Impact Areas**
- Temporary Impact Areas
- No Impact Areas
- Manhole
- Proposed Lining Segments
- Jurisdictional Resources**
- USACE Non-Wetland Waters of the U.S., CDFW Streambed, RWQCB Non-Wetland Waters of the State
- CDFW Riparian, RWQCB Wetland Waters of the State

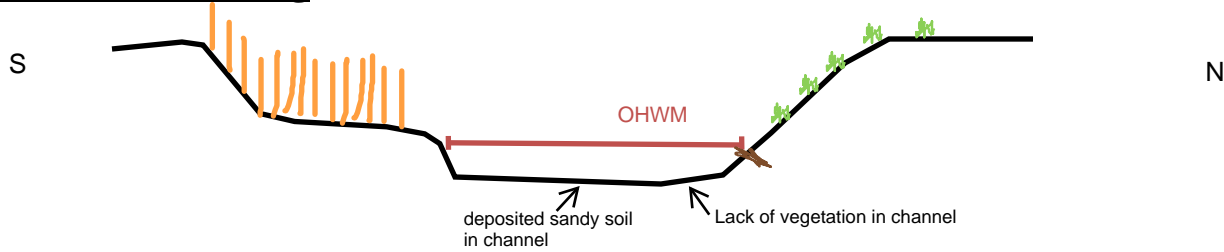
Cross section drawing:

**OHWM**

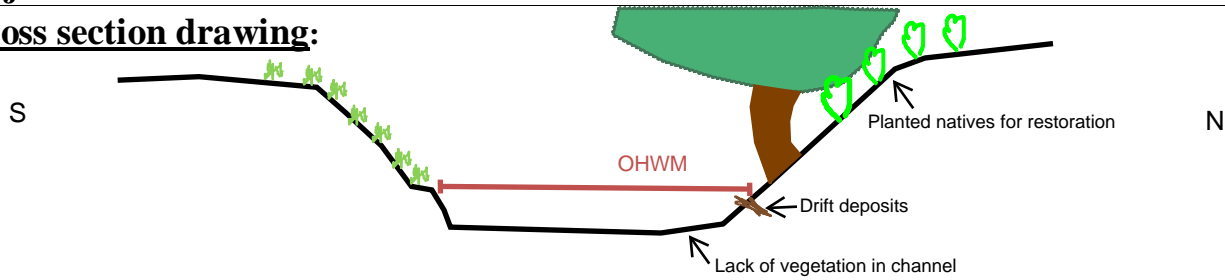
Cross section drawing:

OHWM

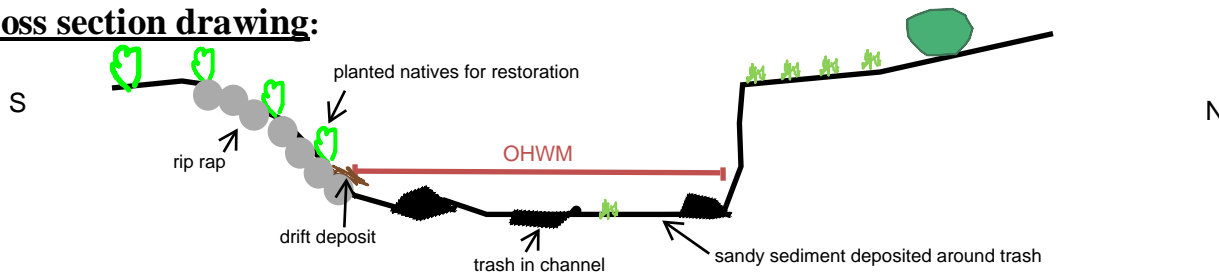
Cross section drawing:

**OHWM**

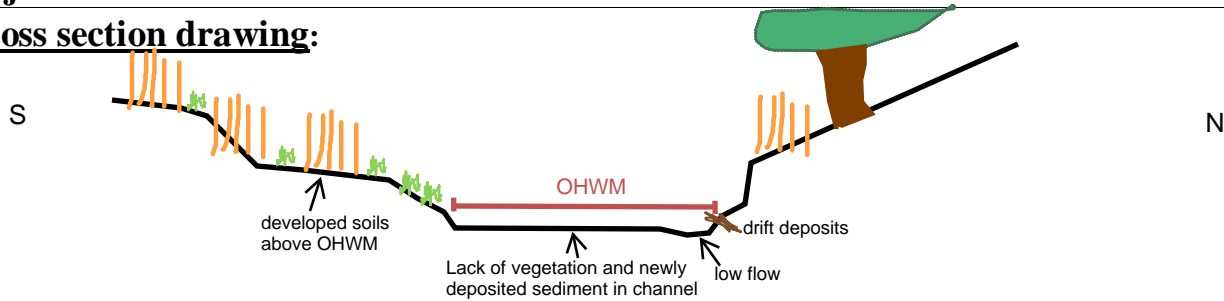
Cross section drawing:

**OHWM**

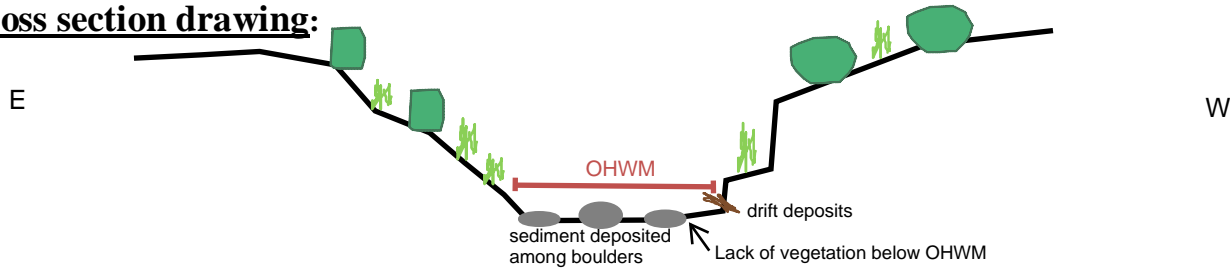
Cross section drawing:

OHWM

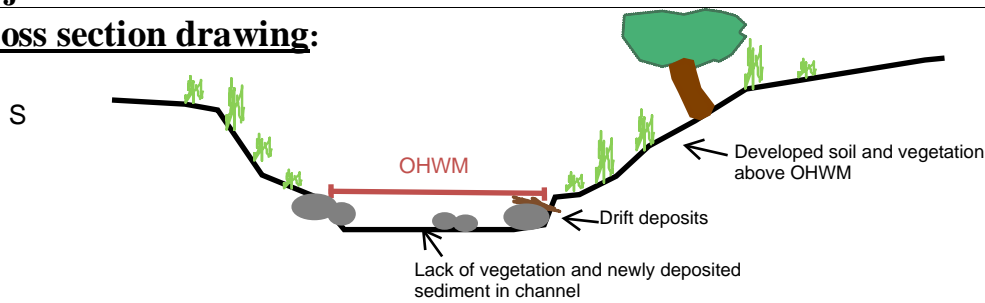
Cross section drawing:

**OHWM**

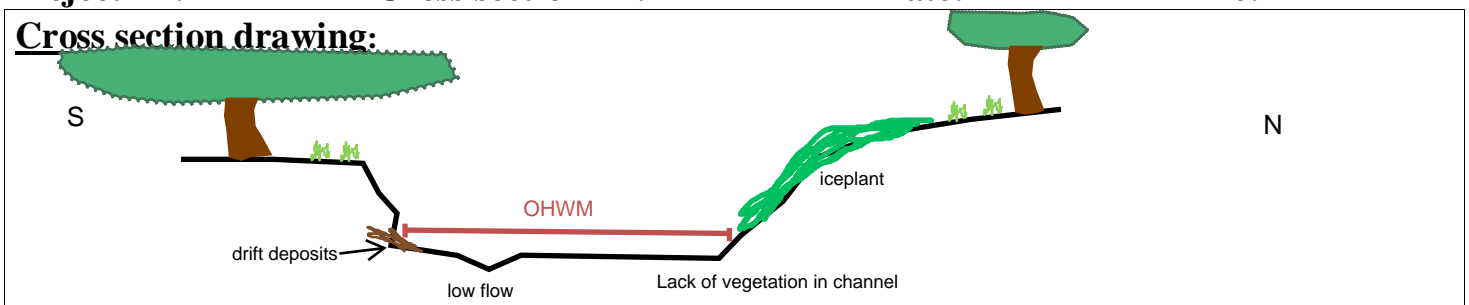
Cross section drawing:

OHWM
