**Preliminary Geotechnical Investigation Report for Entitlement/EIR,
Proposed Legacy Club,
California Grand Villages,
Coto de Caza, County of Orange, California**

**Prepared For
CGV Coto, LLC.**

January 7, 2020

GMU Project No. 18-213-00

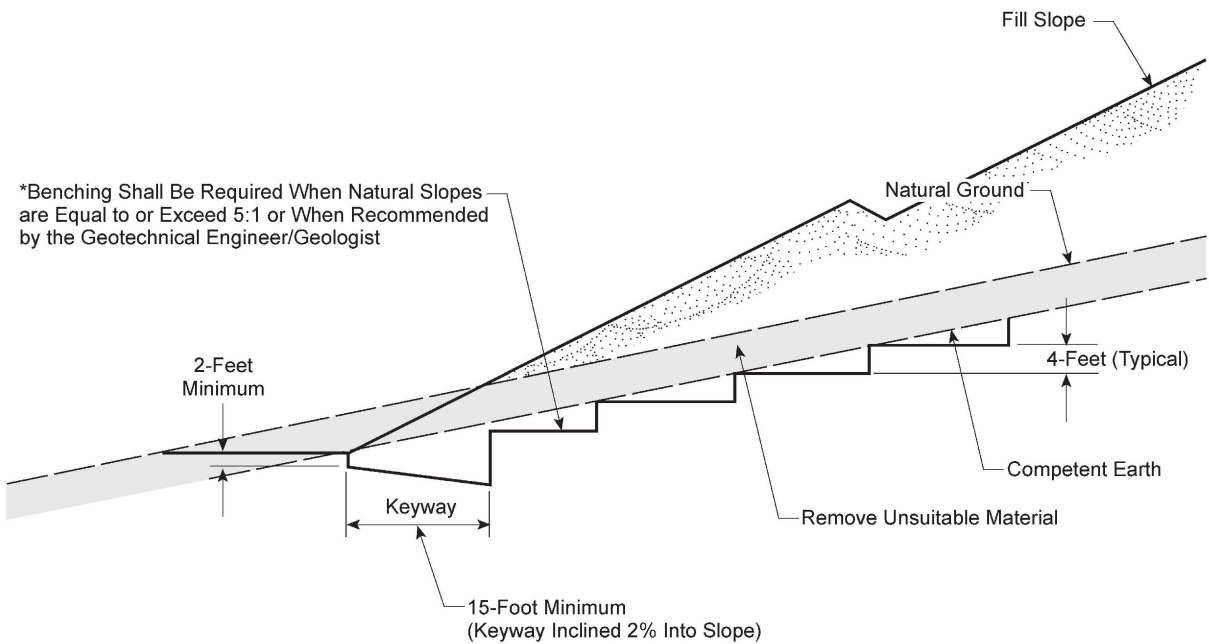
BENCHED FILL OVER NATURAL

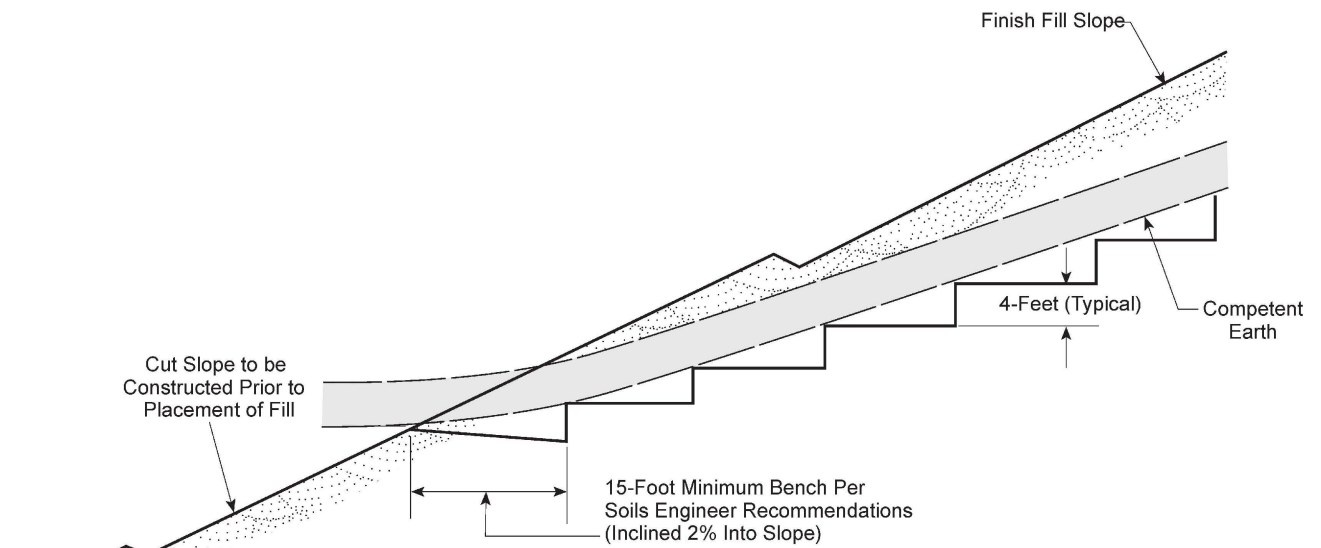
BENCHED FILL OVER CUT
