# Geologic Impact Analysis

Lillian Commons/Morgan Hill Medical Campus

EMC Planning Group Inc.

October 16, 2019 | Project No. 403487001

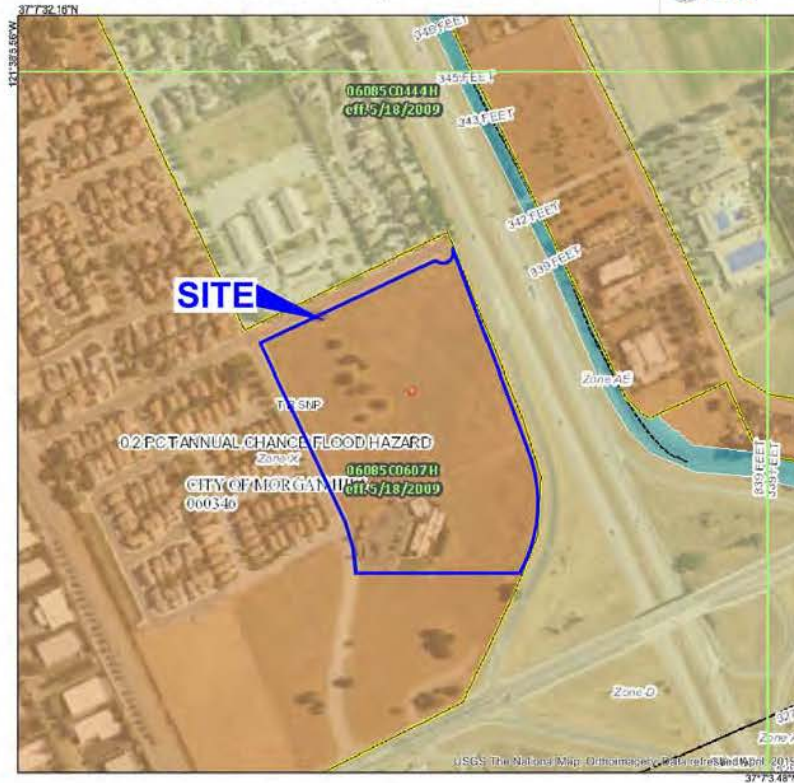
FIGURE 7

# National Flood Hazard Layer FIRMette

Our review of the flood hazard map covering the property (FEMA, 2009) indicates that the site lies within the 0.2 percent annual chance flood plain (Figure 7). Flooding should be considered during design phases of the proposed development.
