### **GEOTECHNICAL AND GEOHAZARDS INVESTIGATION REPORT**

**NEW OUTDOOR POOL FACILITY AND SOUTH CAMPUS IMPROVEMENTS  
LA CAÑADA HIGH SCHOOL  
4463 OAK GROVE DRIVE  
LA CAÑADA, CALIFORNIA 91011**

**GEO-ADVANTEC, INC.  
457 W. ALLEN AVENUE, SUITE 113  
SAN DIMAS, CALIFORNIA 91773  
PROJECT NO. 19-1093(R.01)  
OCTOBER 10, 2019**

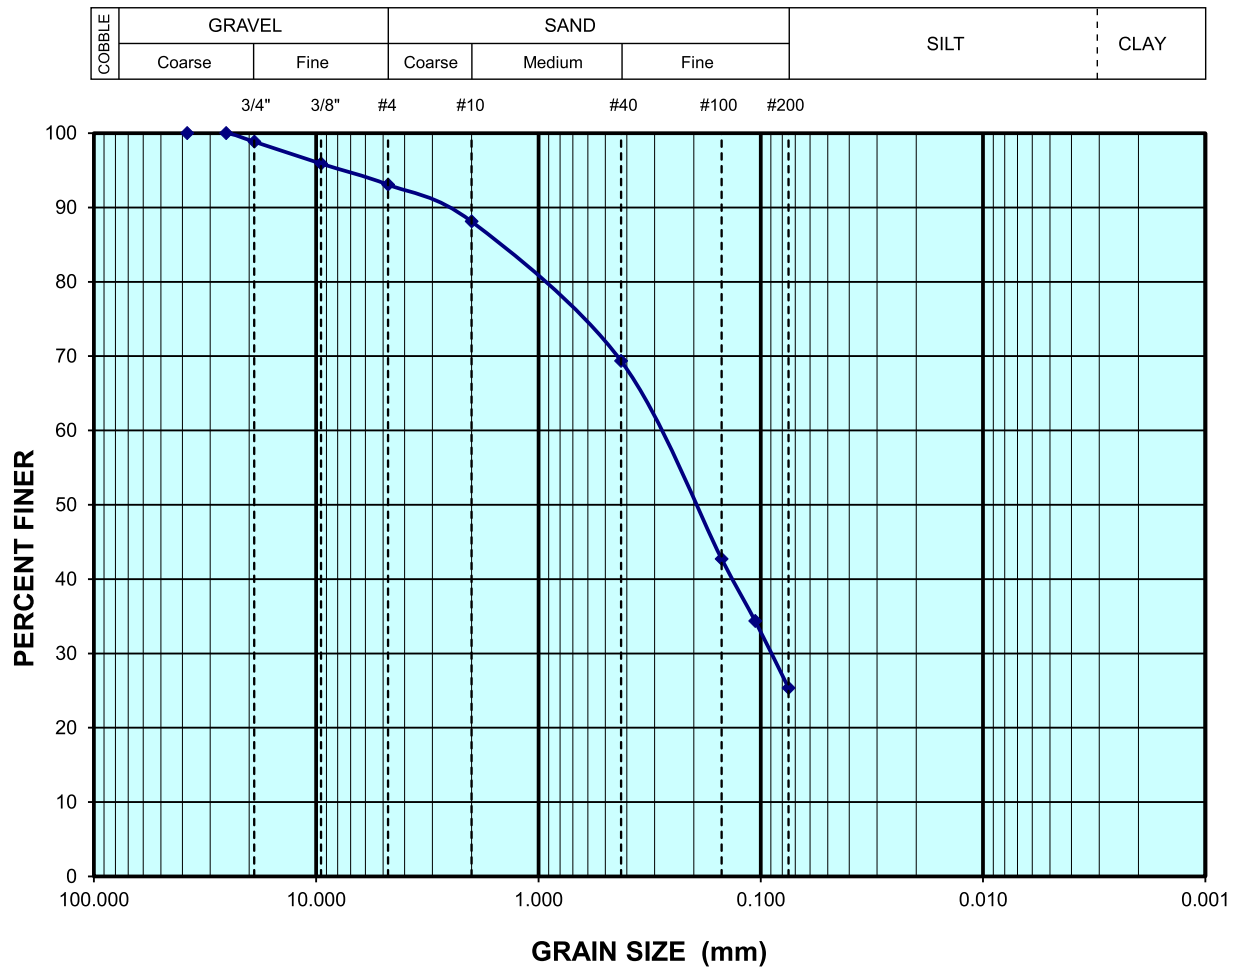
**SIEVE ANALYSIS**

| Sieve | Mesh Opening<br>(mm) | Percent Passing<br>(%) |
|---|---|---|
| No. 140 | 0.106 | 34.4 % |
| No. 200 | 0.075 | 25.4 % |

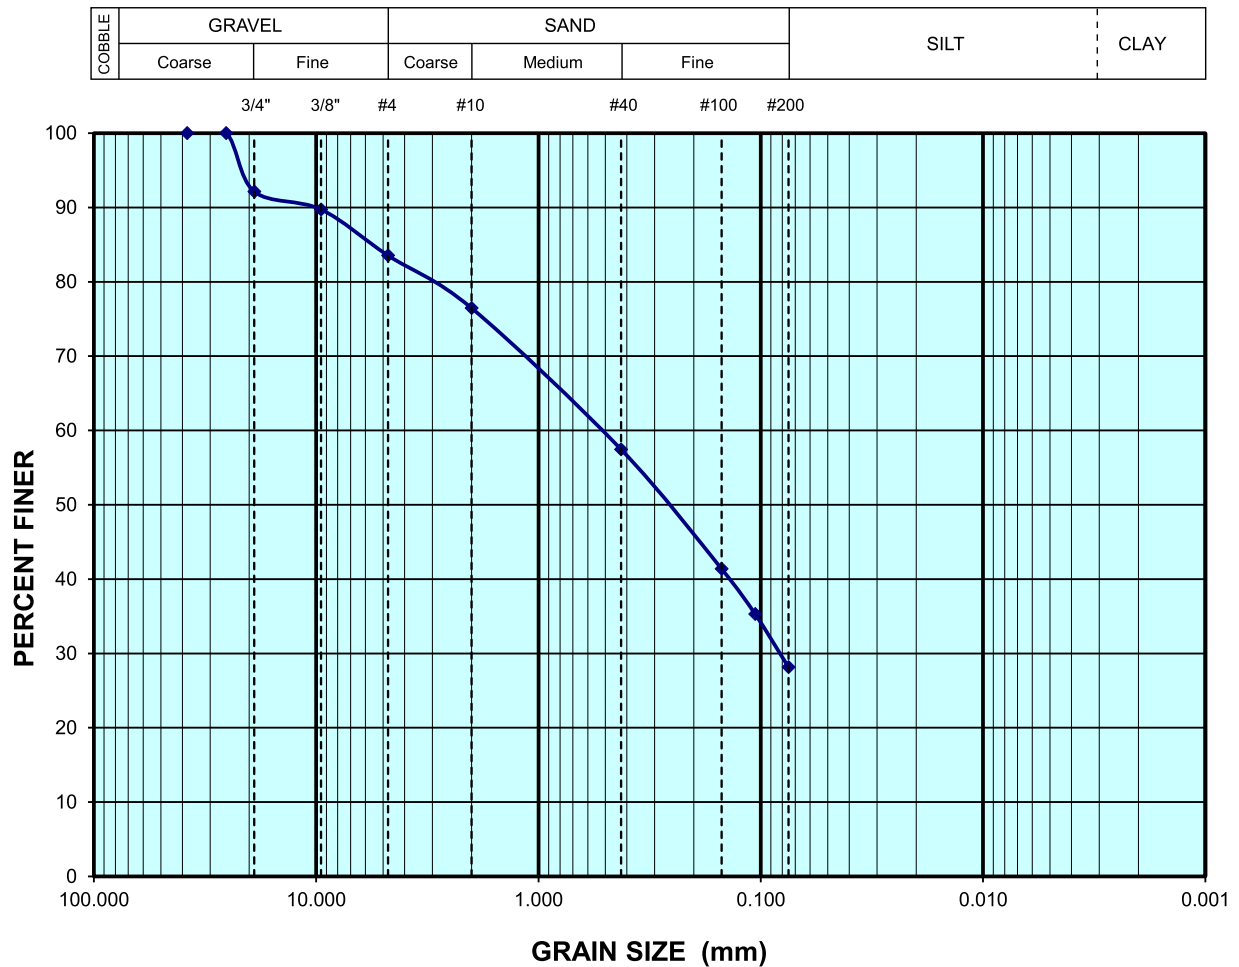
**SIEVE ANALYSIS**

| Sieve | Mesh Opening (mm) | Percent Passing (%) |
|---|---|---|
| No. 140 | 0.106 | 35.3 % |
| No. 200 | 0.075 | 28.1 % |

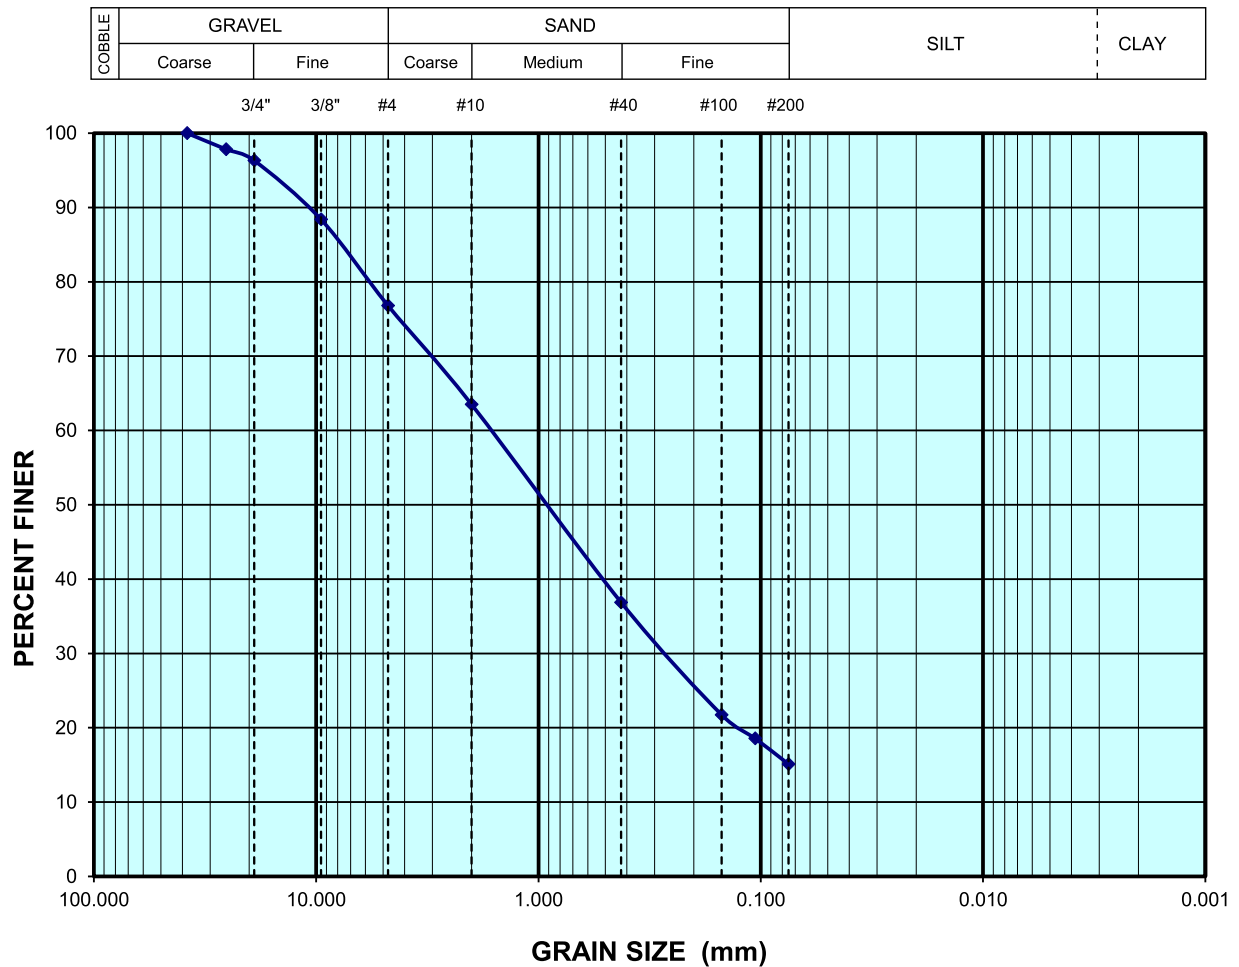
SIEVE ANALYSIS

| Sieve | Mesh Opening (mm) | Percent Passing (%) |
|---|---|---|
| No. 140 | 0.106 | 18.6 % |
| No. 200 | 0.075 | 15.1 % |

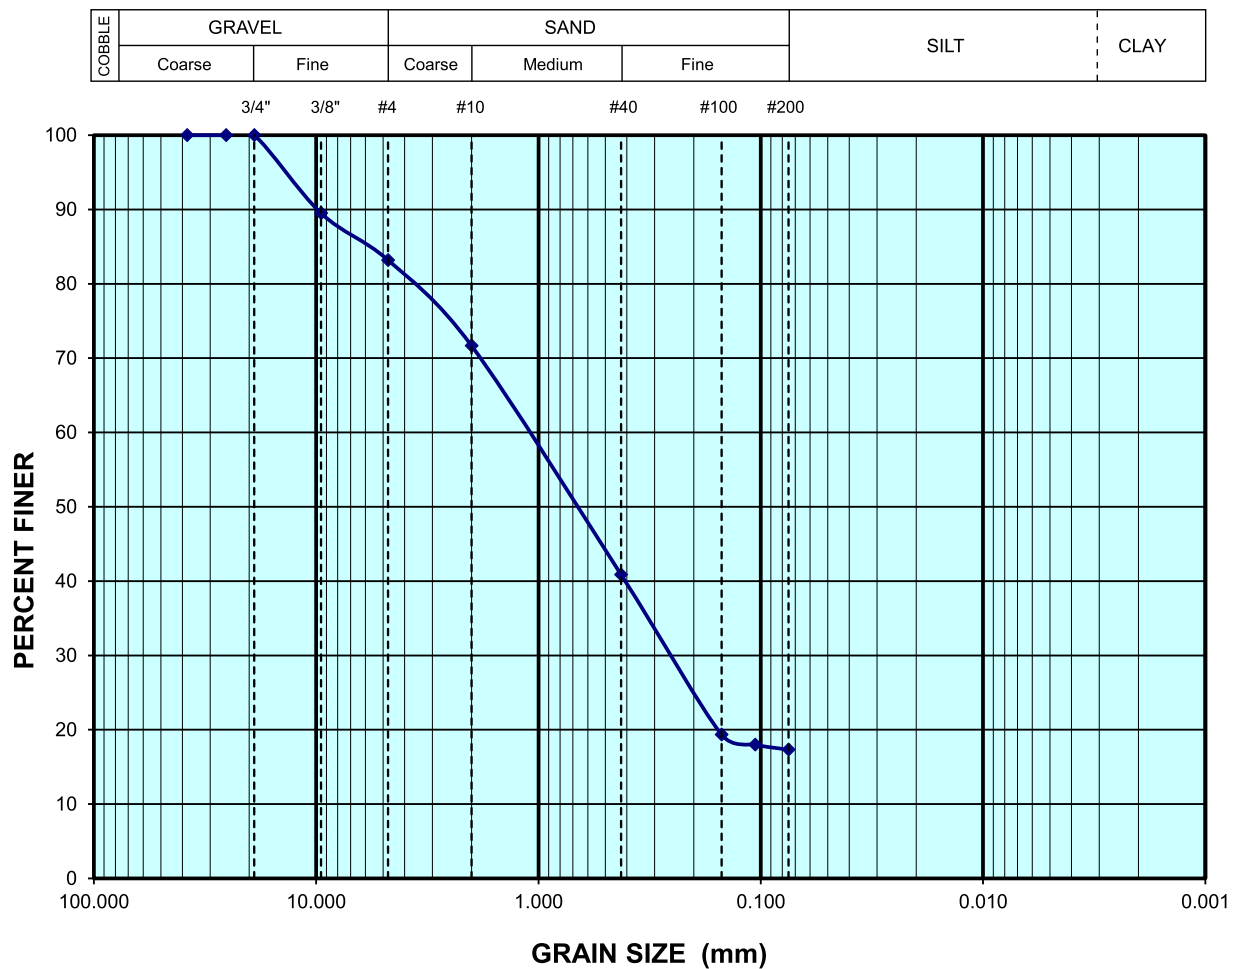
**SIEVE ANALYSIS**

| Sieve | Mesh Opening (mm) | Percent Passing (%) |
|---|---|---|
| No. 140 | 0.106 | 18.0 % |
| No. 200 | 0.075 | 17.3 % |

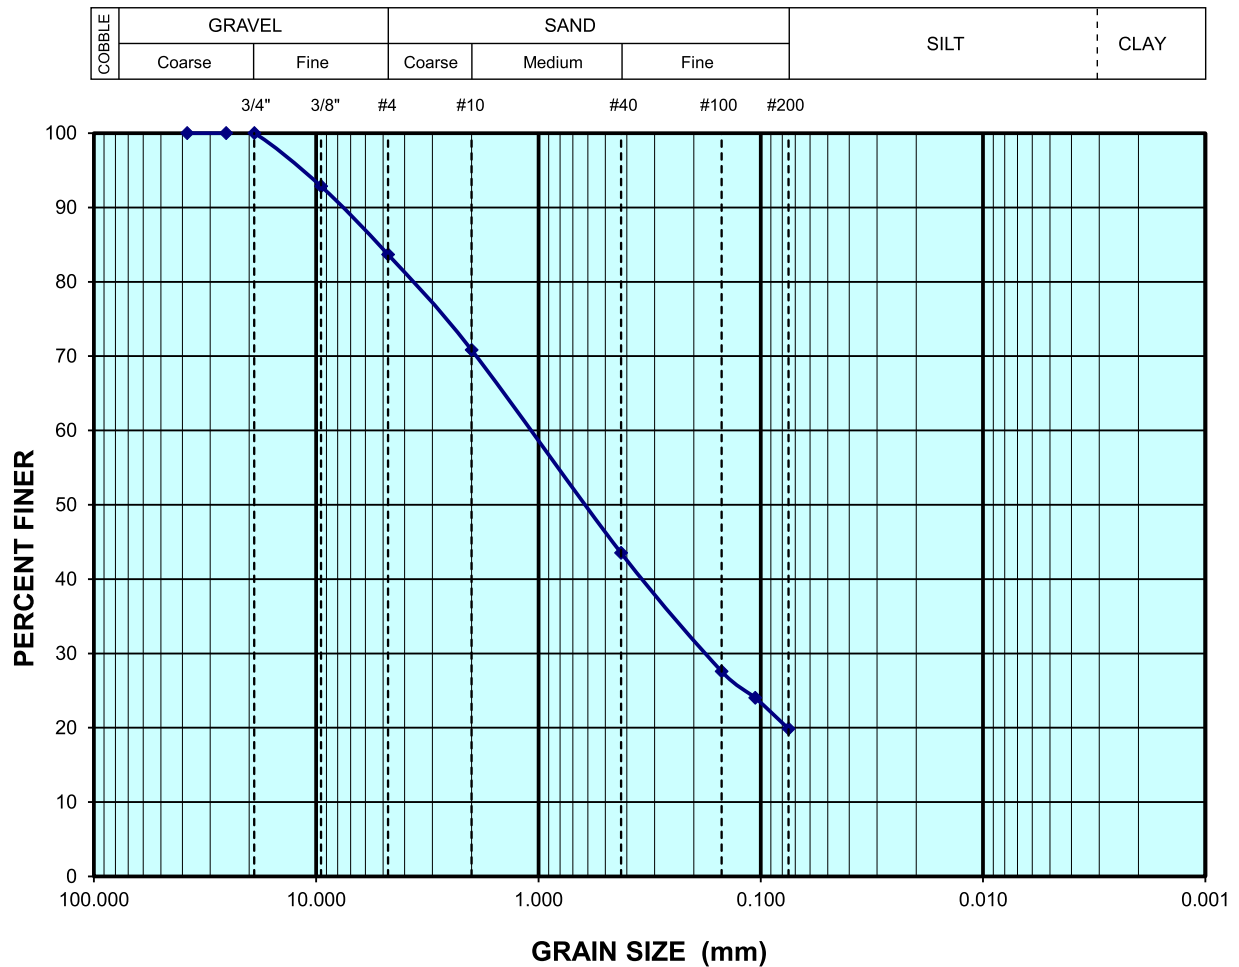
**SIEVE ANALYSIS**

| Sieve | Mesh Opening (mm) | Percent Passing (%) |
|---|---|---|
| No. 140 | 0.106 | 24.0 % |
| No. 200 | 0.075 | 19.9 % |

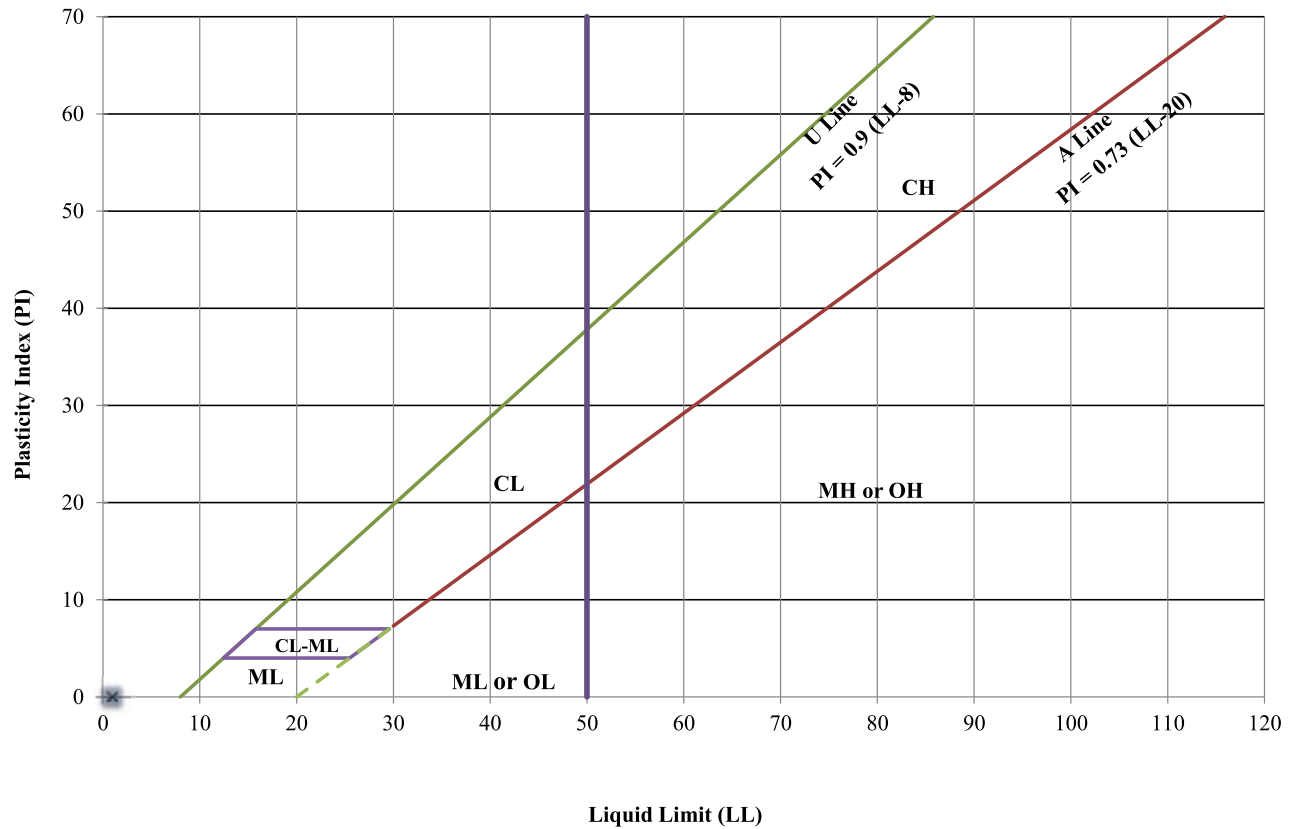
## PLASTICITY CHART (ASTM D4318)

| Symbol | Source | Depth (ft) | Classification | Natural M.C. (%) | Liquid Limit (LL) | Plasticity Index (PI) | %Passing #200 Sieve |
| x | B-4 | 10 | Silty SAND with gravel (SM) | - | NP | NP | 28 |

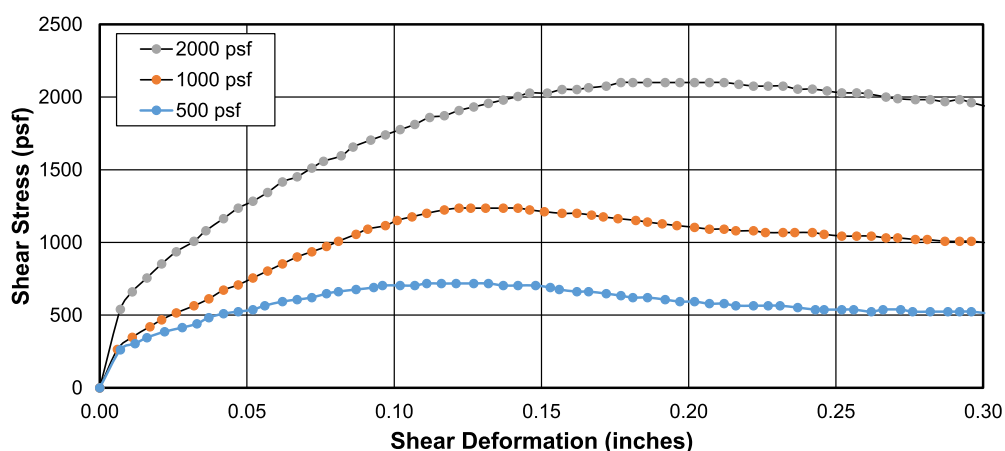
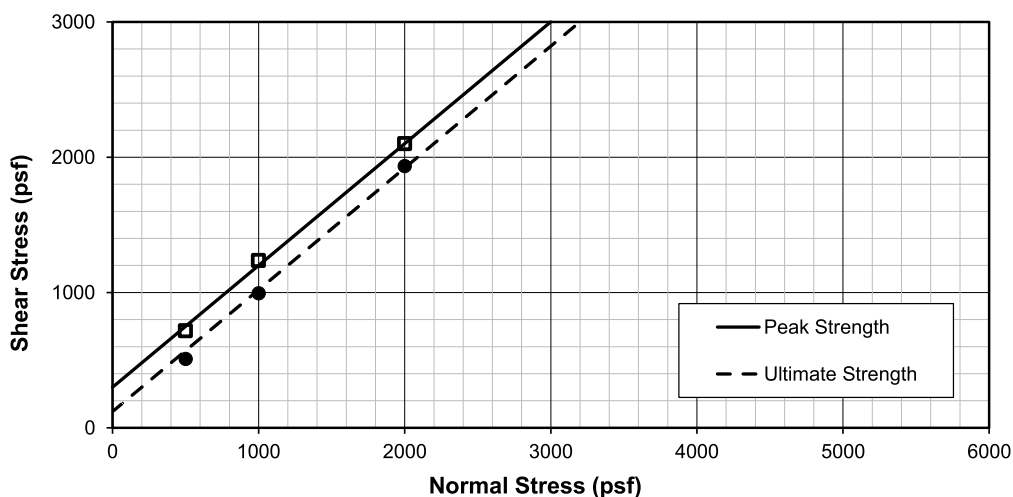
Test Condition Inundated

| STRENGTH TYPE | COHESION (psf) | FRICTION ANGLE (degrees) |
| Peak Strength | 300 | 42 |

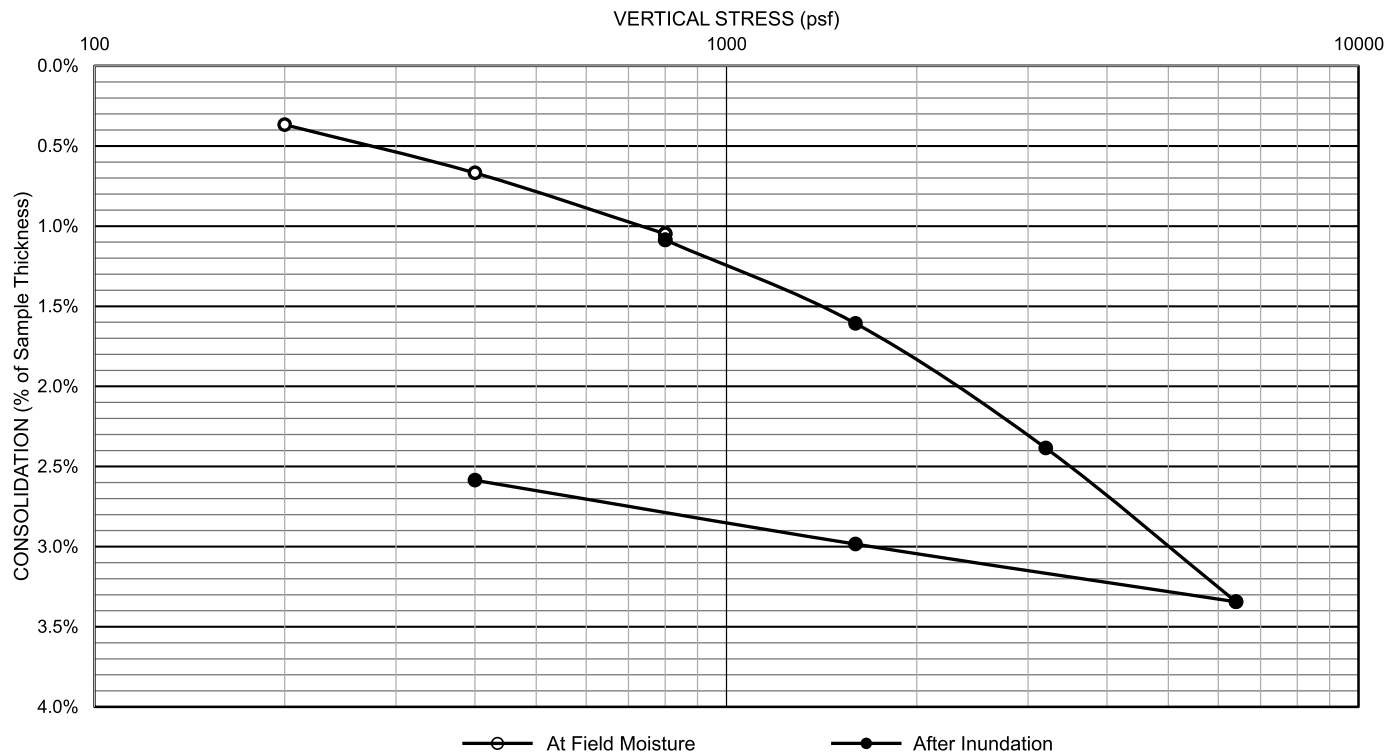
## CONSOLIDATION CURVE

Water added 800 psf

Initial Moisture Content 13.4%

Final Moisture Content 19.3%

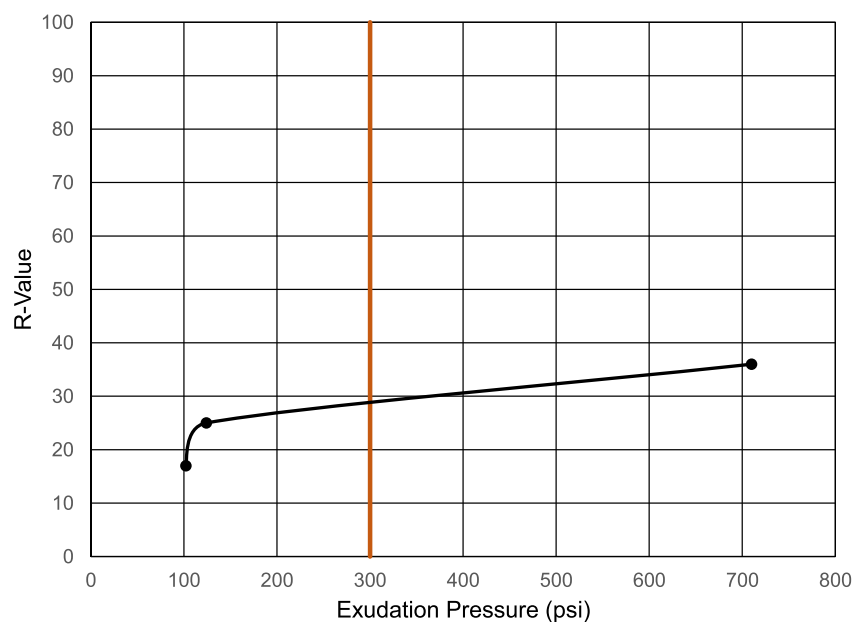
R-VALUE TEST RESULTS

| | By Exudation (Corrected) | 29 |
| Remarks | Moisture: 9.1% | |

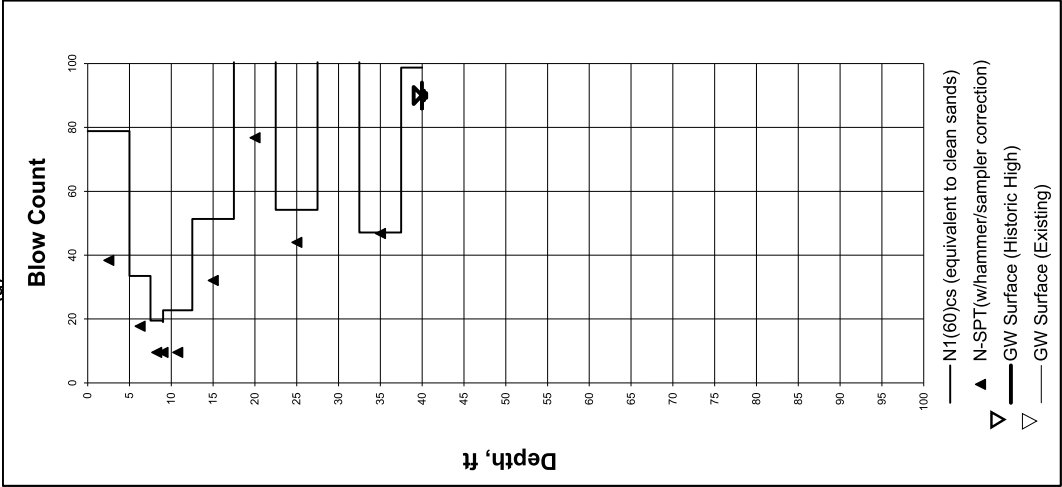
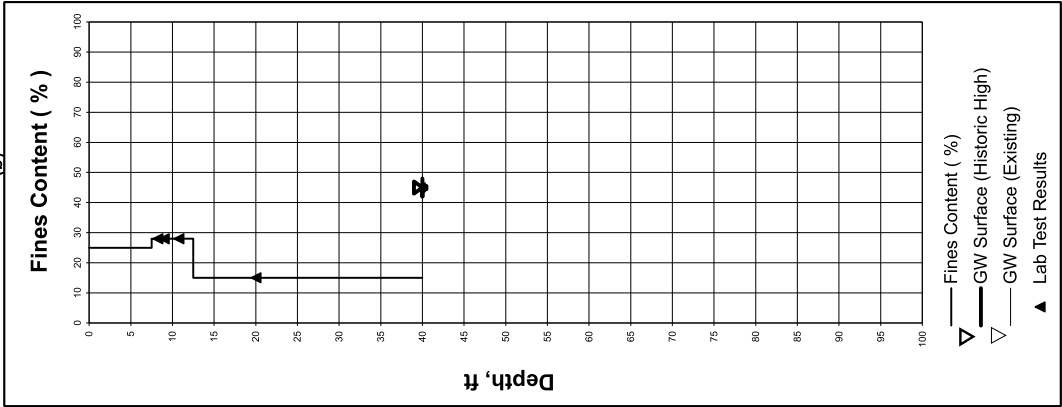
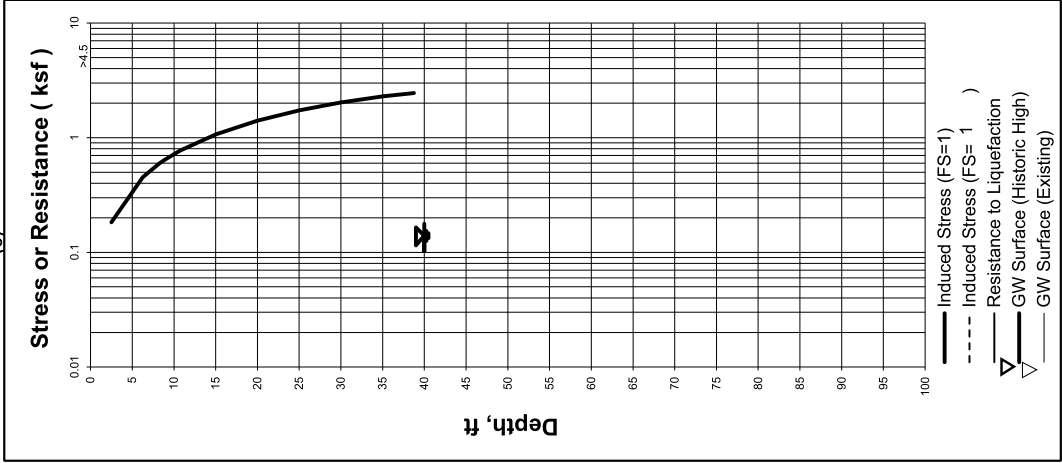
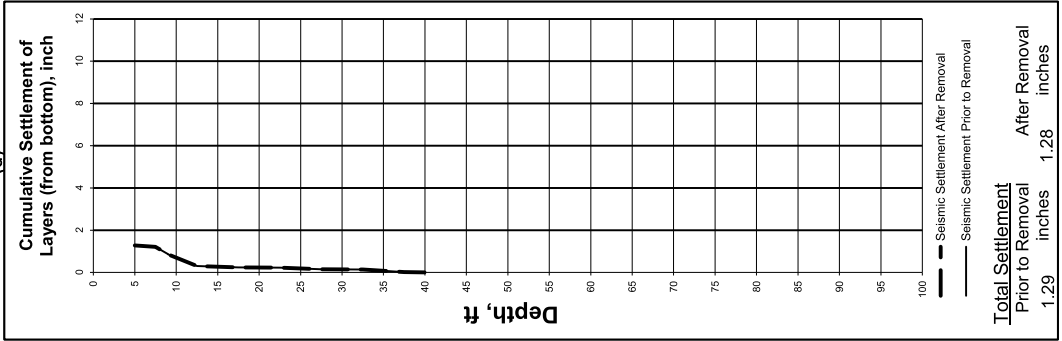
Surcharge 0.00 ksf

NOTE: If the total settlement is very small (e.g.<0.05"), it will not be seen due to the scale used, and should be reported as "negligible".

Weighted Ground Accel. ( $M=7.5$ ) = 0.87 g Site Magnitude = 7.1

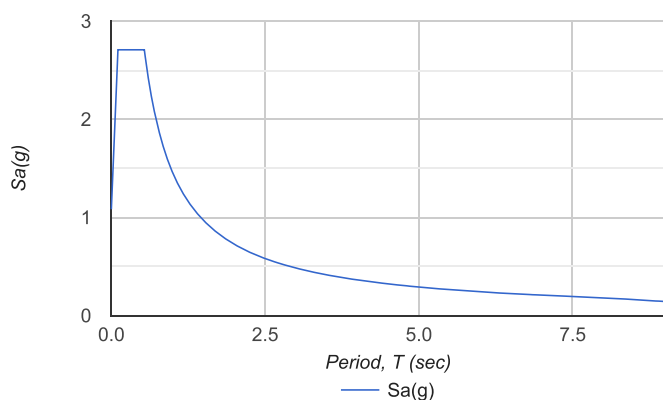
MCER Response Spectrum

Date 8/7/2019, 2:57:26 PM  
Design Code ASCE7-10  
Risk Category II  
Site Class D - Stiff Soil
