# **REPORT GEOTECHNICAL INVESTIGATION**

Proposed 32<sup>nd</sup> & Broadway Homes  
1000 Block 32<sup>nd</sup> Street, San Diego, CA 92102

May 24, 2019  
NOVA Project 2019066

City of San Diego Project No. 637438

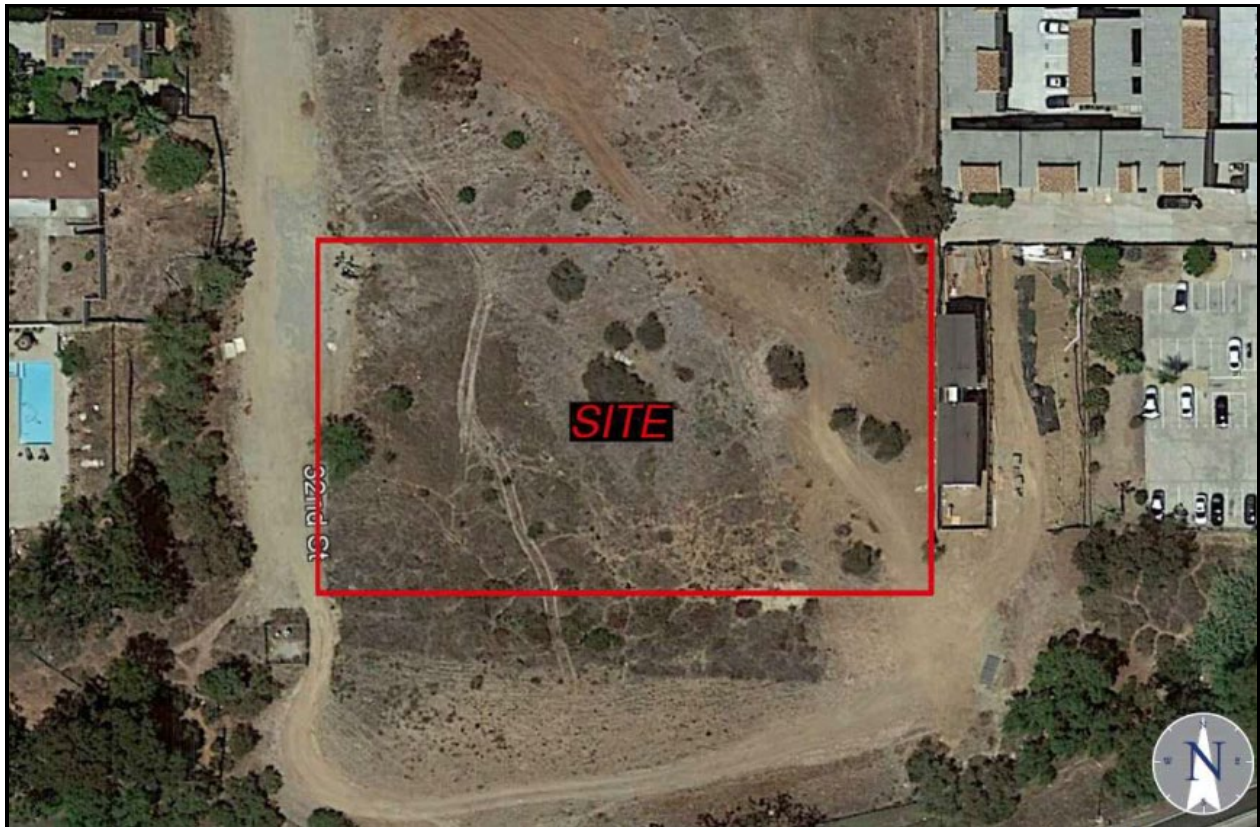
**Figure 2-1. Site Location and Limits**  
(source: adapted from Google Earth 2018)

The subject site is located southeast of the intersection of 32<sup>nd</sup> Street and C Street in San Diego, California (hereinafter, 'the site'). The site is bounded to the north by a vacant lot, to the west by 32<sup>nd</sup> street, to the south by vacant land, and to the east by an existing apartment development. Figure 2-1 depicts the location and limits of the site on a recent aerial view.

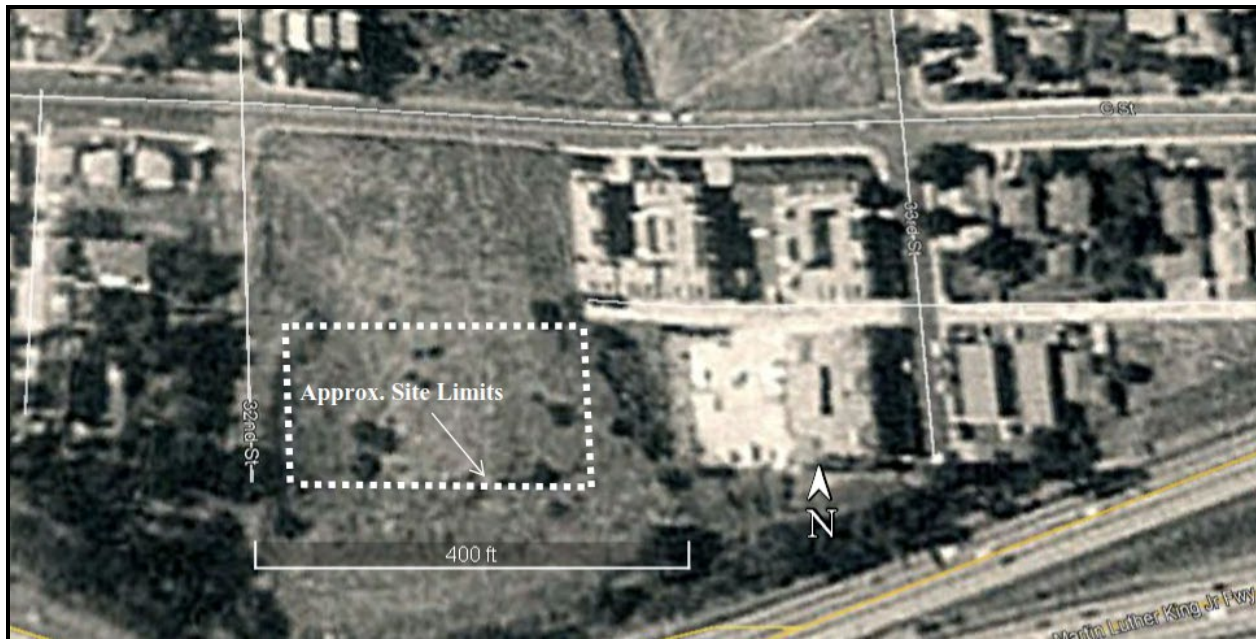
**Figure 2-2. 1994 Aerial Photo**  
(source: adapted from Google Earth 2019)

Review of aerial photography dating to 1994 indicates that the site has been vacant since at least that time. Figure 2-2 (following page) provides an aerial photograph depicting the site in 1994.

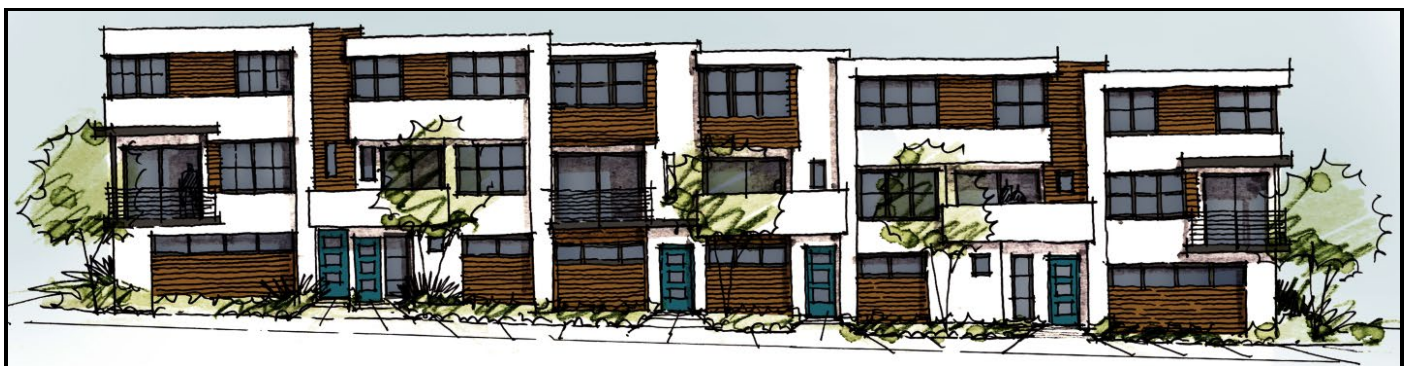
**Figure 2-3. Conceptual Development Plan**  
(source: WAG 2019)

WAG 2019 indicates that the development will consist of  $\pm$  42 zero lot line, three-level residences. Parking at each of the residences will be developed at grade, with the living space developed in two levels above the parking. Figure 2-3 reproduces an architectural graphic that depicts the planning concept.

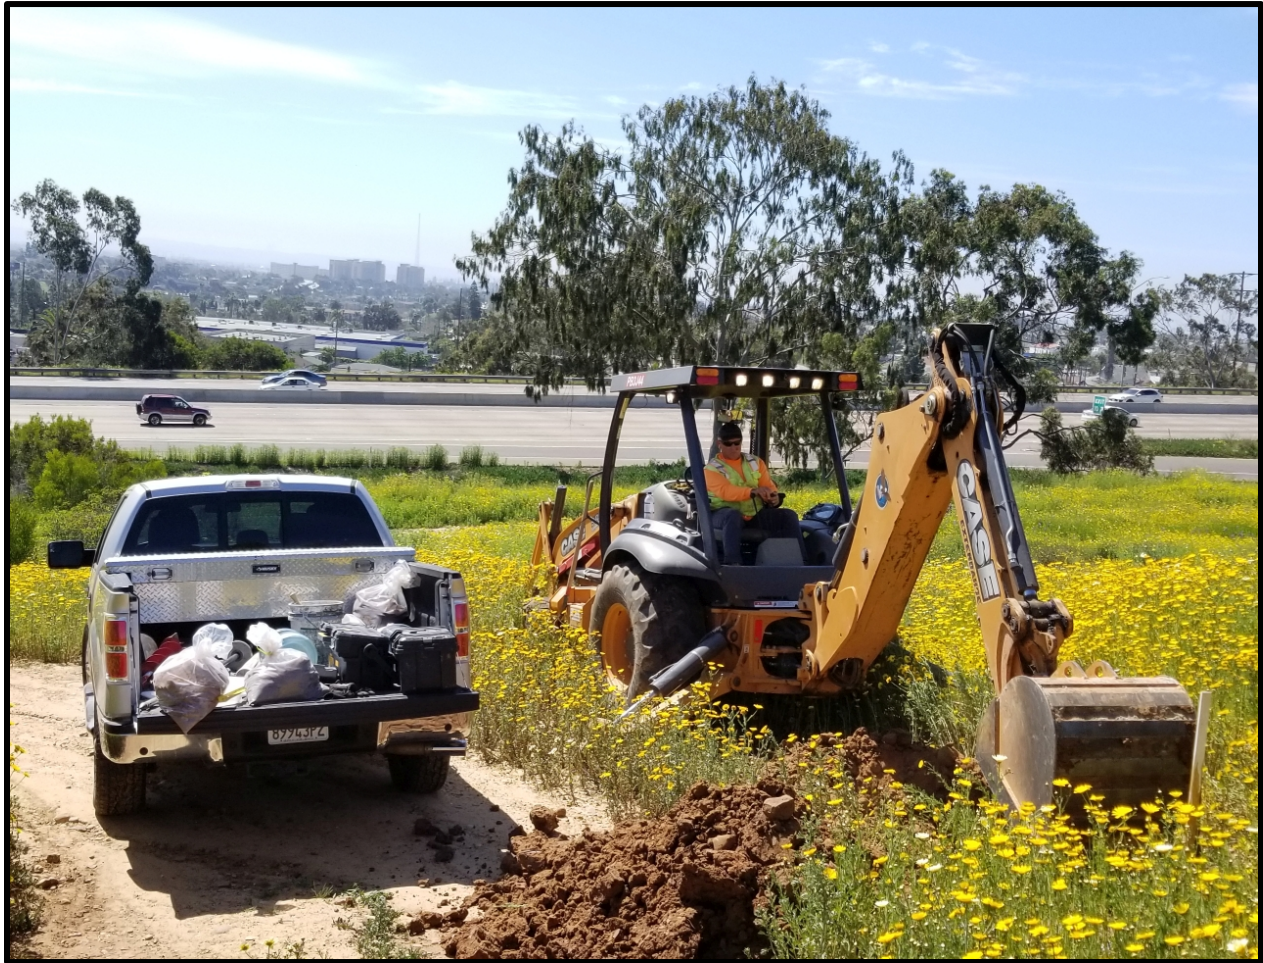
**Figure 3-2. Backhoe Operations, Trench T-4 (4/1/19)**

Figure 3-2 (following page) provides a photograph depicting backhoe operations

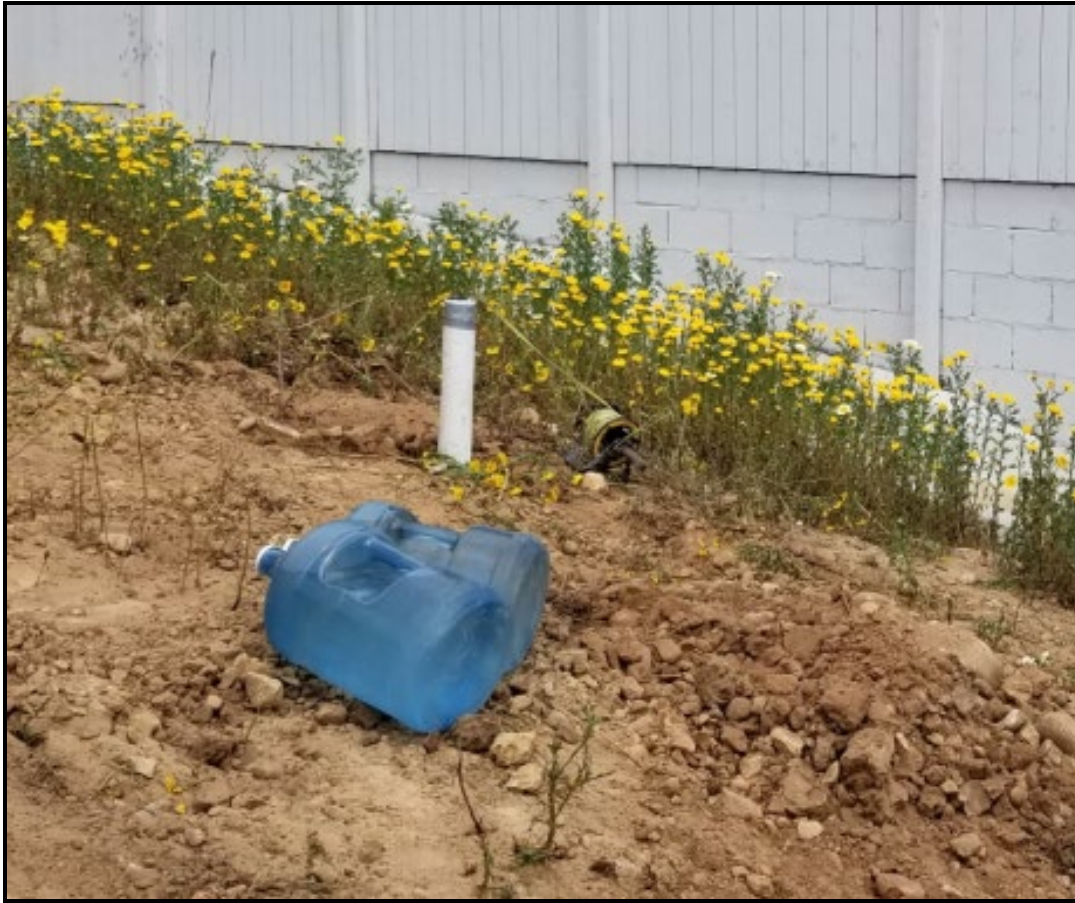
**Figure 3-3. Percolation Test Well P-1**

Figure 3-3 (following page) depicts percolation test well P-1.

The boring was drilled with an 8-inch hand auger to a depth of 3.5 feet bgs. Field measurements were taken to confirm that the boring was excavated to approximately 8-inches in diameter. The boring was logged by a NOVA geologist, who observed and recorded exposed soil cuttings and the boring conditions.

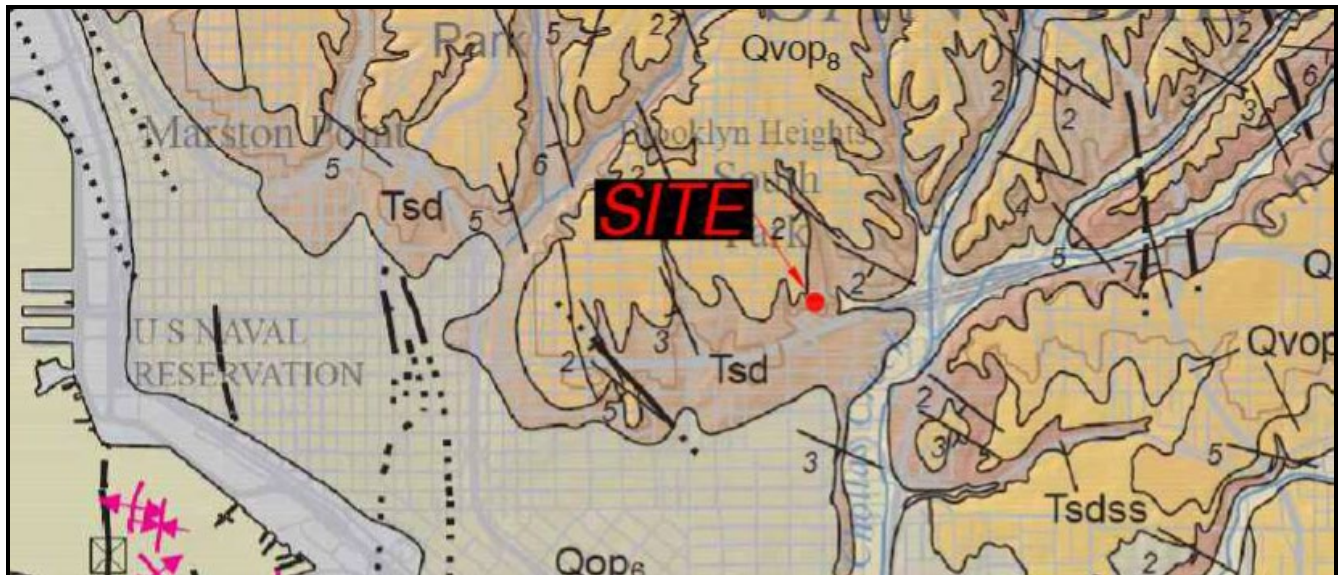
The Very Old Paralic deposits are interfingering strandline, beach, estuarine and colluvial deposits of middle to early Pleistocene age. Sedimentary rocks of this Formation are primarily siltstone, sandstone and conglomerate.

The San Diego Formation is largely comprised of poorly indurated fossiliferous marine sandstones, and marine and nonmarine pebble and cobble conglomerates of early Pleistocene and late Pliocene age.

Tsd	SAN DIEGO FORMATION, UNDIVIDED	Tsdss	SAN DIEGO FORMATION, MARINE SANDSTONE	Qop <sub>6</sub>	OLD PARALIC DEPOSITS, UNIT 6
Qvop <sub>8</sub>	VERY OLD PARALIC DEPOSITS, UNIT 8	Qya	YOUNG ALLUVIAL FLOOD-PLAIN DEPOSITS	Qvop	VERY OLD PARALIC DEPOSITS

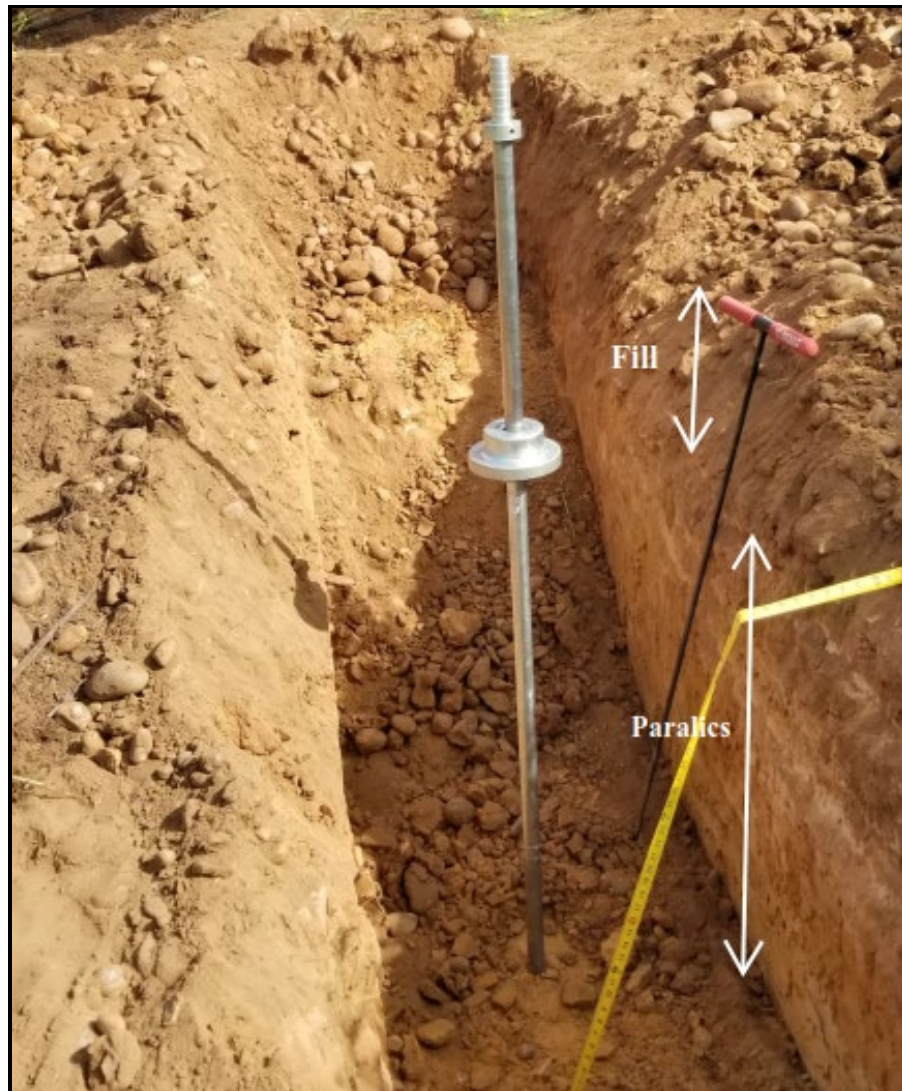
**Figure 4-2. DCP Testing and Unit 2 Paralics Exposures at Trench T-2**

The unit is very dense, characterized by high resistance to the Dynamic Cone Penetrometer. The backhoe met refusal on very dense Paralics in trenches T-3, T-4 and T-5. The unit will be incompressible under loads from future earth fills and structures.

The Paralics extend to below the depths explored in trenches T-1 through T-5. Figure 4-2 depicts the Paralics at T-2, depicting the upper 'cobbly' zone and dense sandstones below that level.

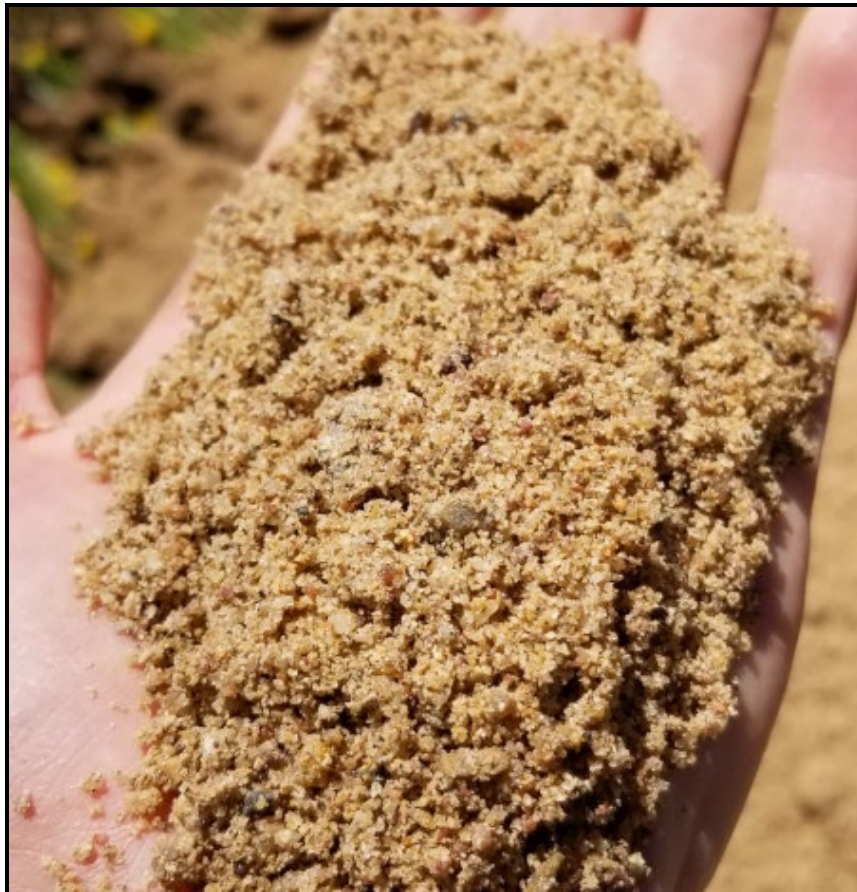
**Figure 4-3. Unit 3 San Diego Formation**

3. Unit 3, San Diego Formation. Trench T-6 disclosed that the site is underlain by the Pleistocene/Pliocene-aged San Diego Formation (Tsd) below the Very Old Paralics. Trenches T-1 through T-5 did not extend through the Very Old Paralics to expose this unit. As encountered at the site, San Diego Formation consists of medium dense and friable well-graded sandstone, similar in quality (low compressibility, high strength) to the Very Old Paralics. Figure 4-3 depicts soil recovered from this unit.

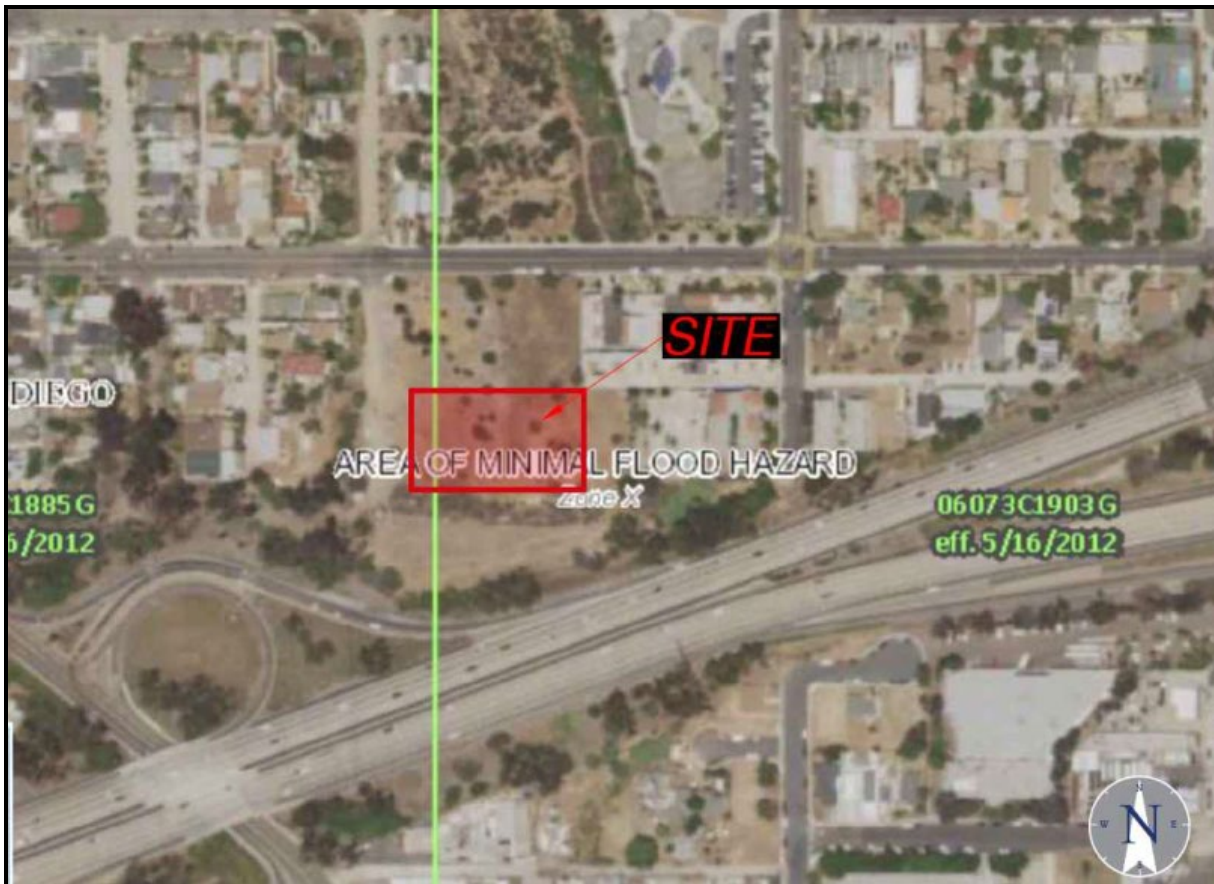
**Figure 5-4. Flood Mapping of the Site Area**

The site is located within a FEMA-designated flood zone, flood map No. 06073C1903G dated May 16, 2012. The site area is designated “Zone X,” indicating the site is within an area of minimal flood hazard. Figure 5-4 reproduces flood mapping by FEMA of the site area.

(source: adapted from FEMA Flood Map 06073C1903G, Revised May 16, 2012)

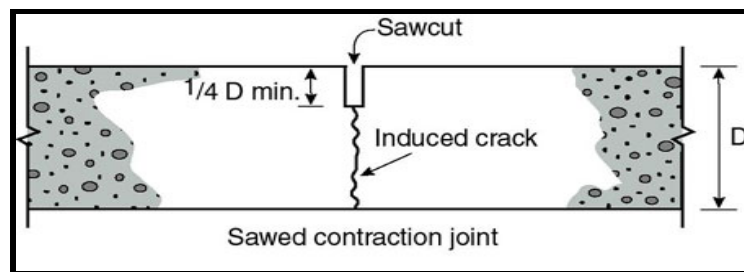
**Figure 6-1. Sawed Contraction Joint**

Proper joint spacing and depth are essential to effective control of random cracking. Joints are commonly spaced at distances equal to 24 to 30 times the slab thickness. Joint spacing that is greater than 15 feet should include the use of load transfer devices (dowels or diamond plates).

Contraction/control joints should be established to a depth of  $\frac{1}{4}$  the slab thickness, as depicted in Figure 6-1 (following page).

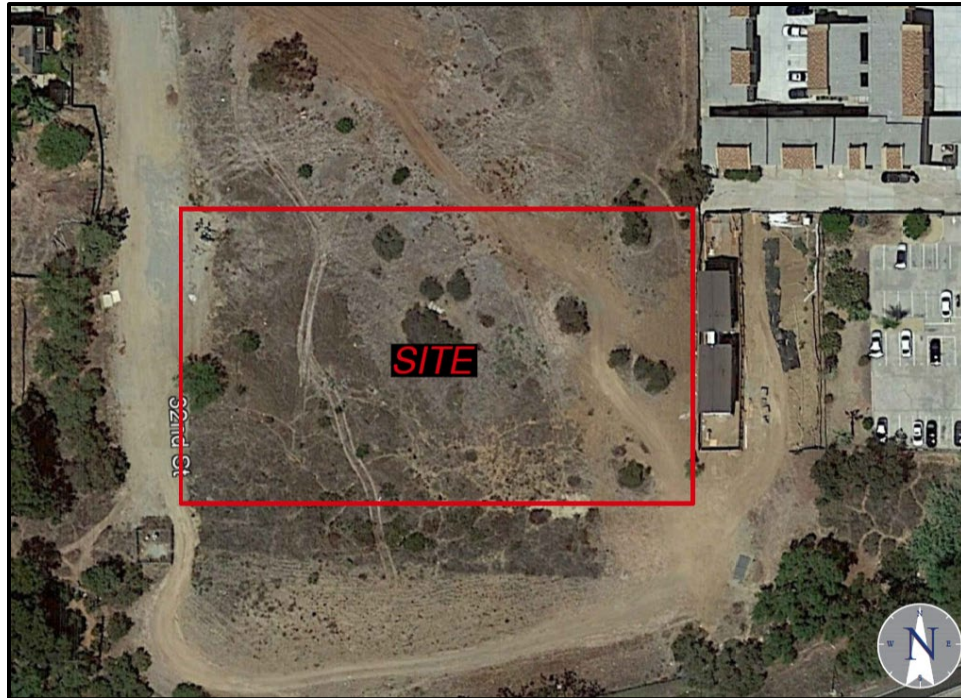
**Figure 1. Site Location and Limits**  
(source: adapted from Google Earth 2019)

The residential development is proposed to be developed on a vacant parcel located southeast of the intersection of 32<sup>nd</sup> Street and C Street (hereafter, 'the site'). It is bounded to the north by a vacant lot, to the west by 32<sup>nd</sup> street, to the south by vacant land, and to the east by an existing apartment development. The apartment development abuts the property line to the east of the site. Figure 1 (following page) provides a recent aerial image depicting the site location.

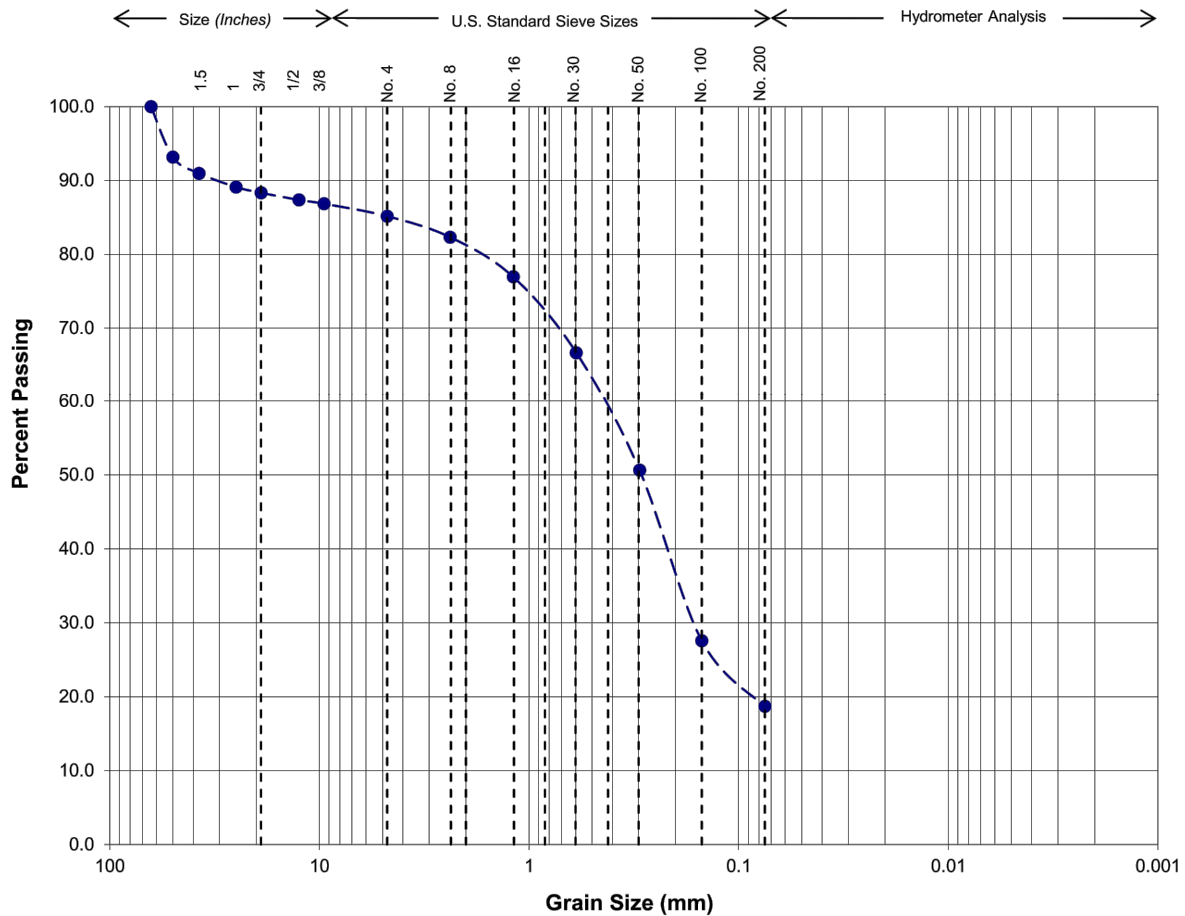
APPENDIX: D.2

Gravel		Sand			Silt or Clay
Coarse	Fine	Coarse	Medium	Fine

Sample Location: T-1

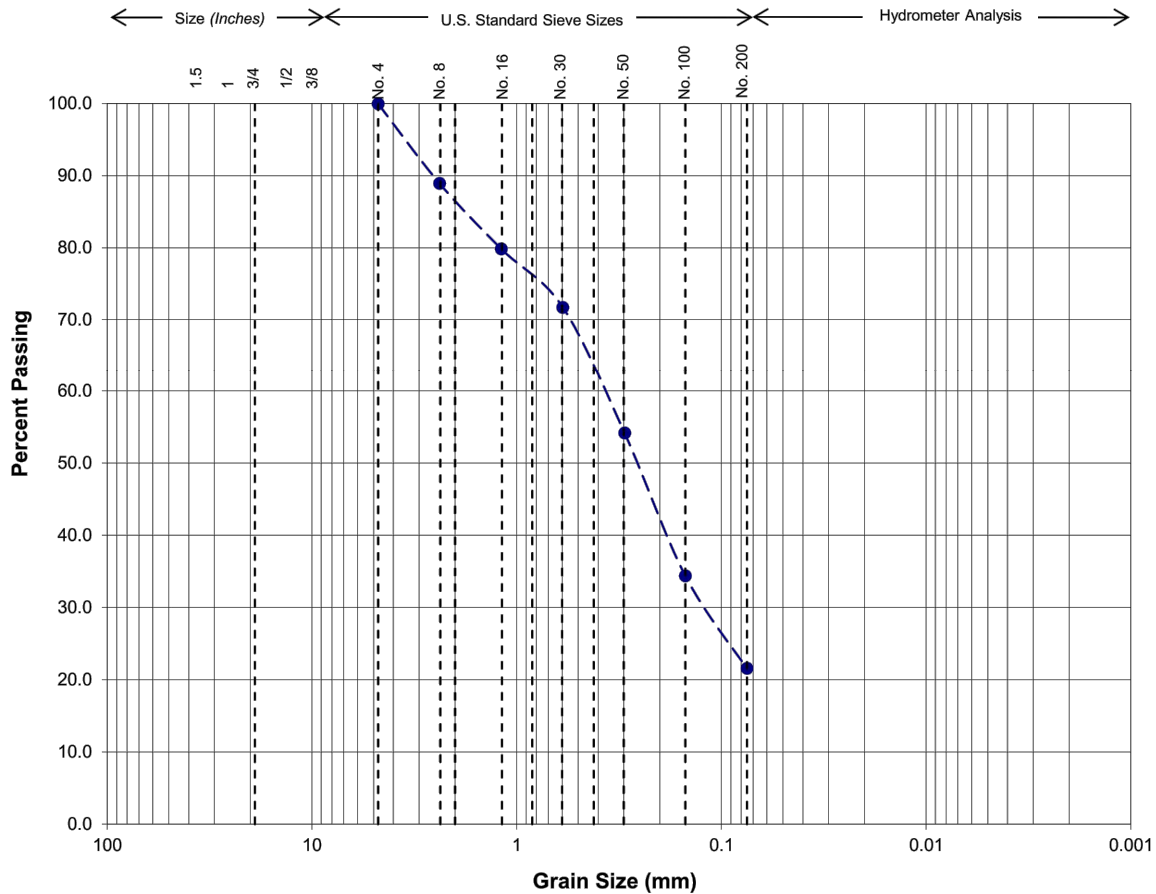
APPENDIX: D.3

Gravel		Sand			Silt or Clay
Coarse	Fine	Coarse	Medium	Fine

Sample Location: T-4  
 Depth (ft): 2.0'-3.0'  
 USCS Soil Type: SM  
 Passing No. 200 (%): 22

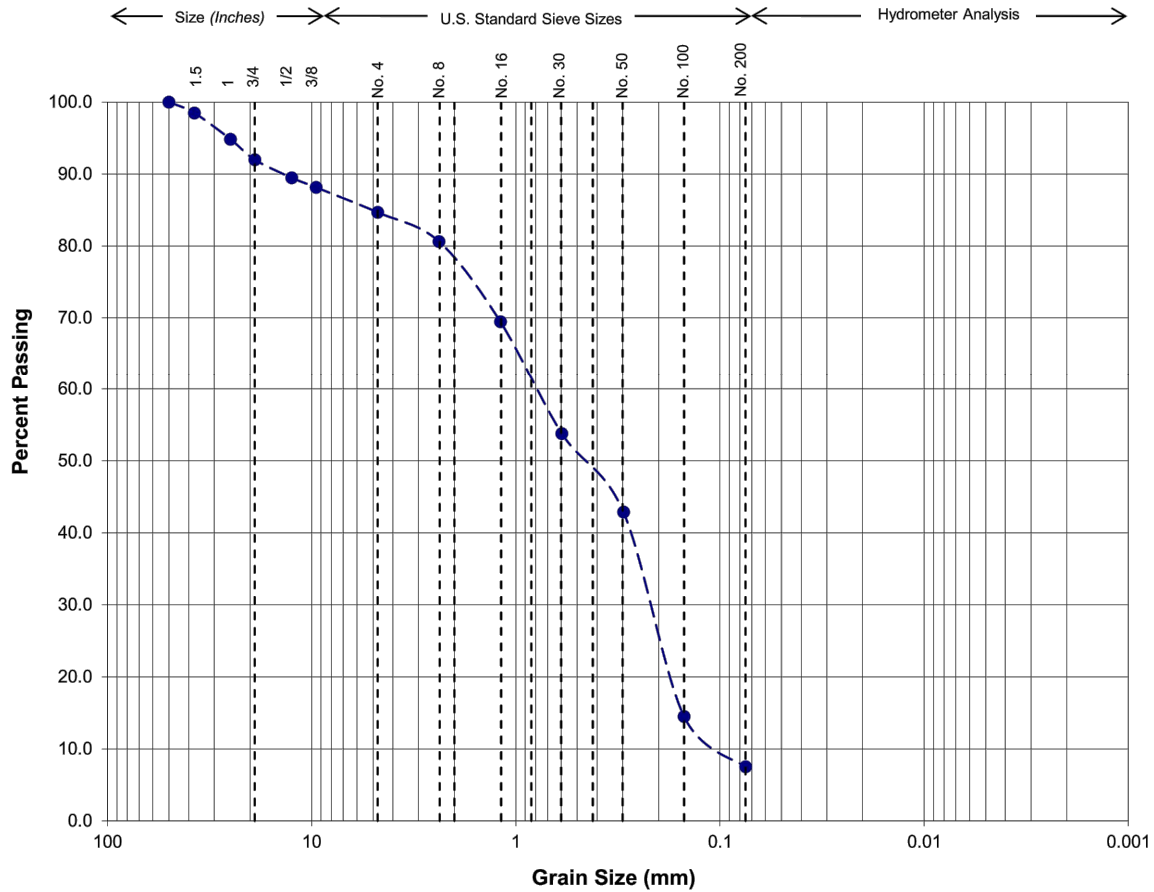
APPENDIX: D.4

Gravel		Sand			Silt or Clay
Coarse	Fine	Coarse	Medium	Fine

Sample Location: T-5  
 Depth (ft): 2.0'-3.0'  
 USCS Soil Type: SP-SM  
 Passing No. 200 (%): 8

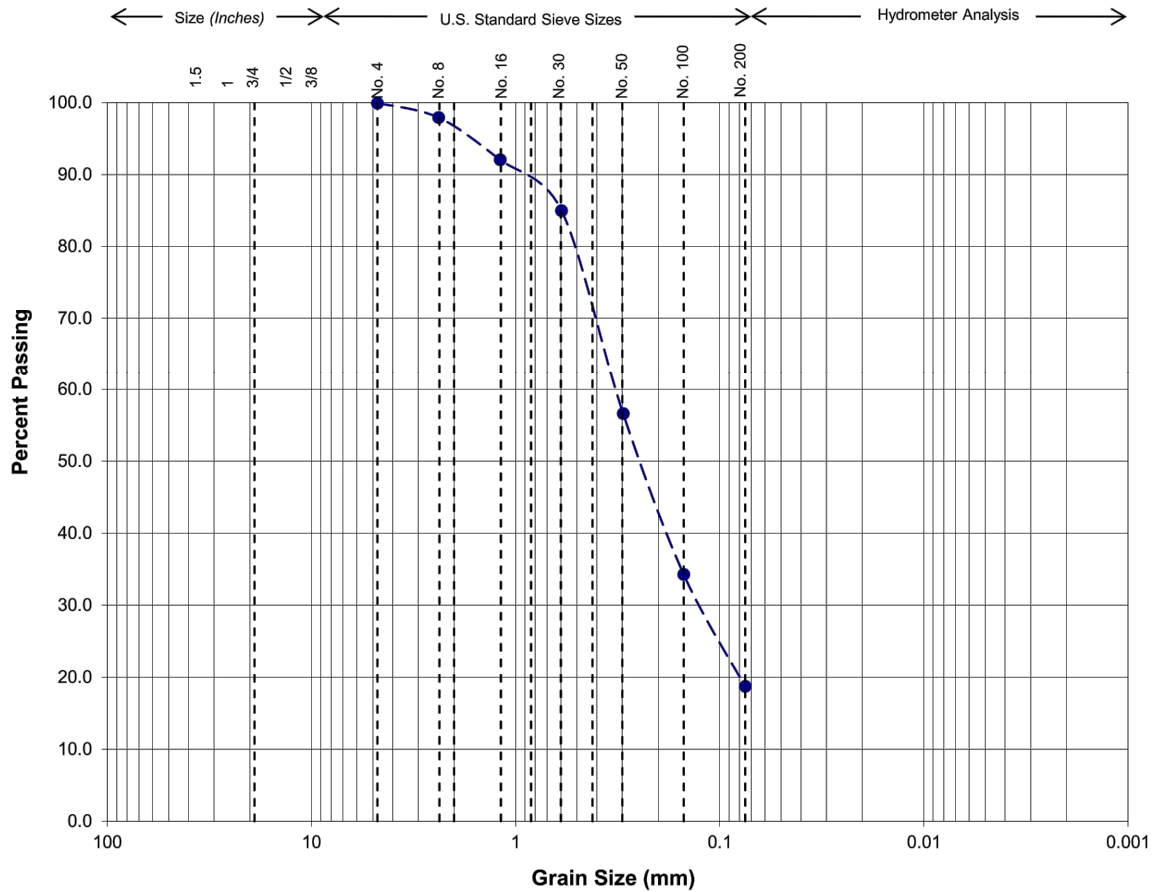
APPENDIX: D.5

Gravel		Sand			Silt or Clay
Coarse	Fine	Coarse	Medium	Fine

Sample Location: T-6  
 Depth (ft): 2.0'-3.0'  
 USCS Soil Type: SM  
 Passing No. 200 (%): 19
