## ENGINEERING GEOLOGY INVESTIGATION

2420 Paradise Lane  
Los Osos area  
San Luis Obispo County,  
California

This report presents the results of the geologic investigation for the proposed single-family residence, studio and barn to be located at 2420 Paradise Lane, APN: 067-171-049, in the Los Osos area of San Luis Obispo County, California. See Figure 1: Area Location Map for the general location of the project area, which was obtained from the computer program *TopoView* (TopoView, 2020).

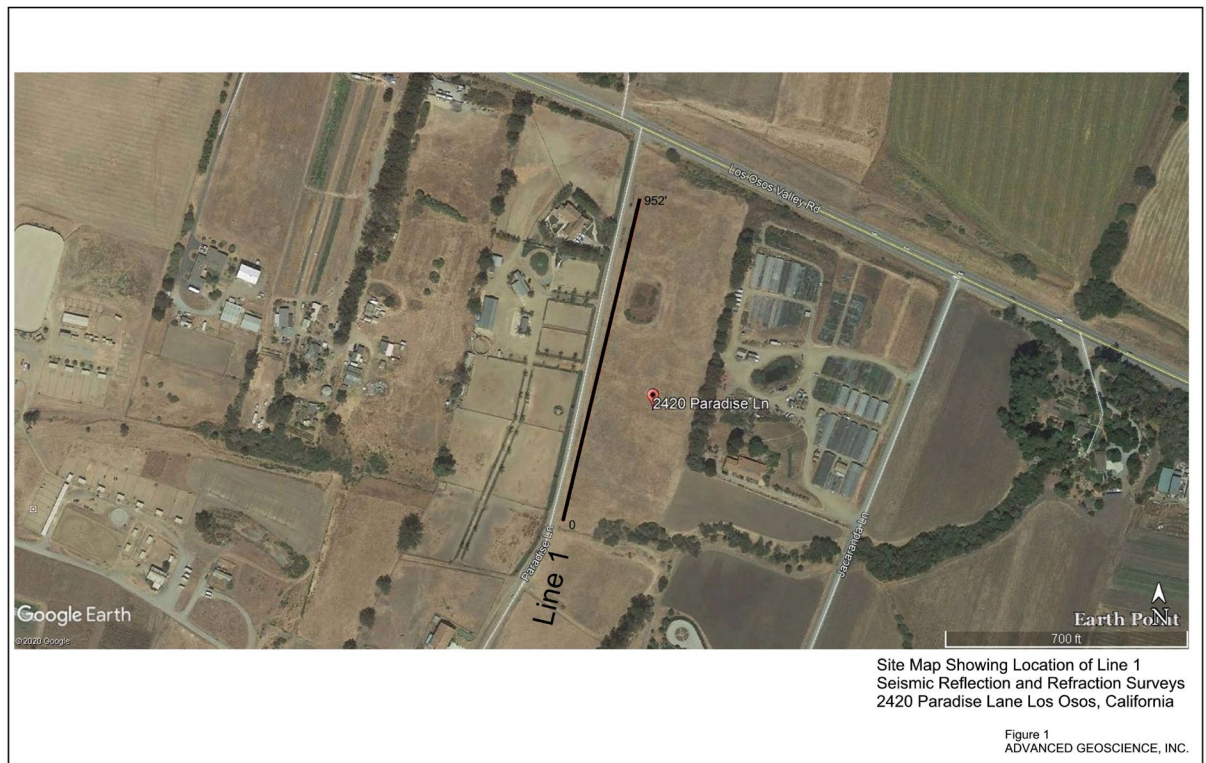
Figure 5: Seismic Refraction and Reflection Line Location

A subsurface fault investigation was conducted at the site to determine if faulting was present in the vicinity of the Site as depicted on Lettis and Hall, 1994 and Wiegiers, 2009. A seismic reflection and refraction survey was performed along the western property boundary (identified as Line 1 on Figure 5 to determine the presence of the fault at the Site due to the depth of Old Alluvial Deposits located at the Site. A detailed discussion of the geophysical investigation is presented in Appendix B.

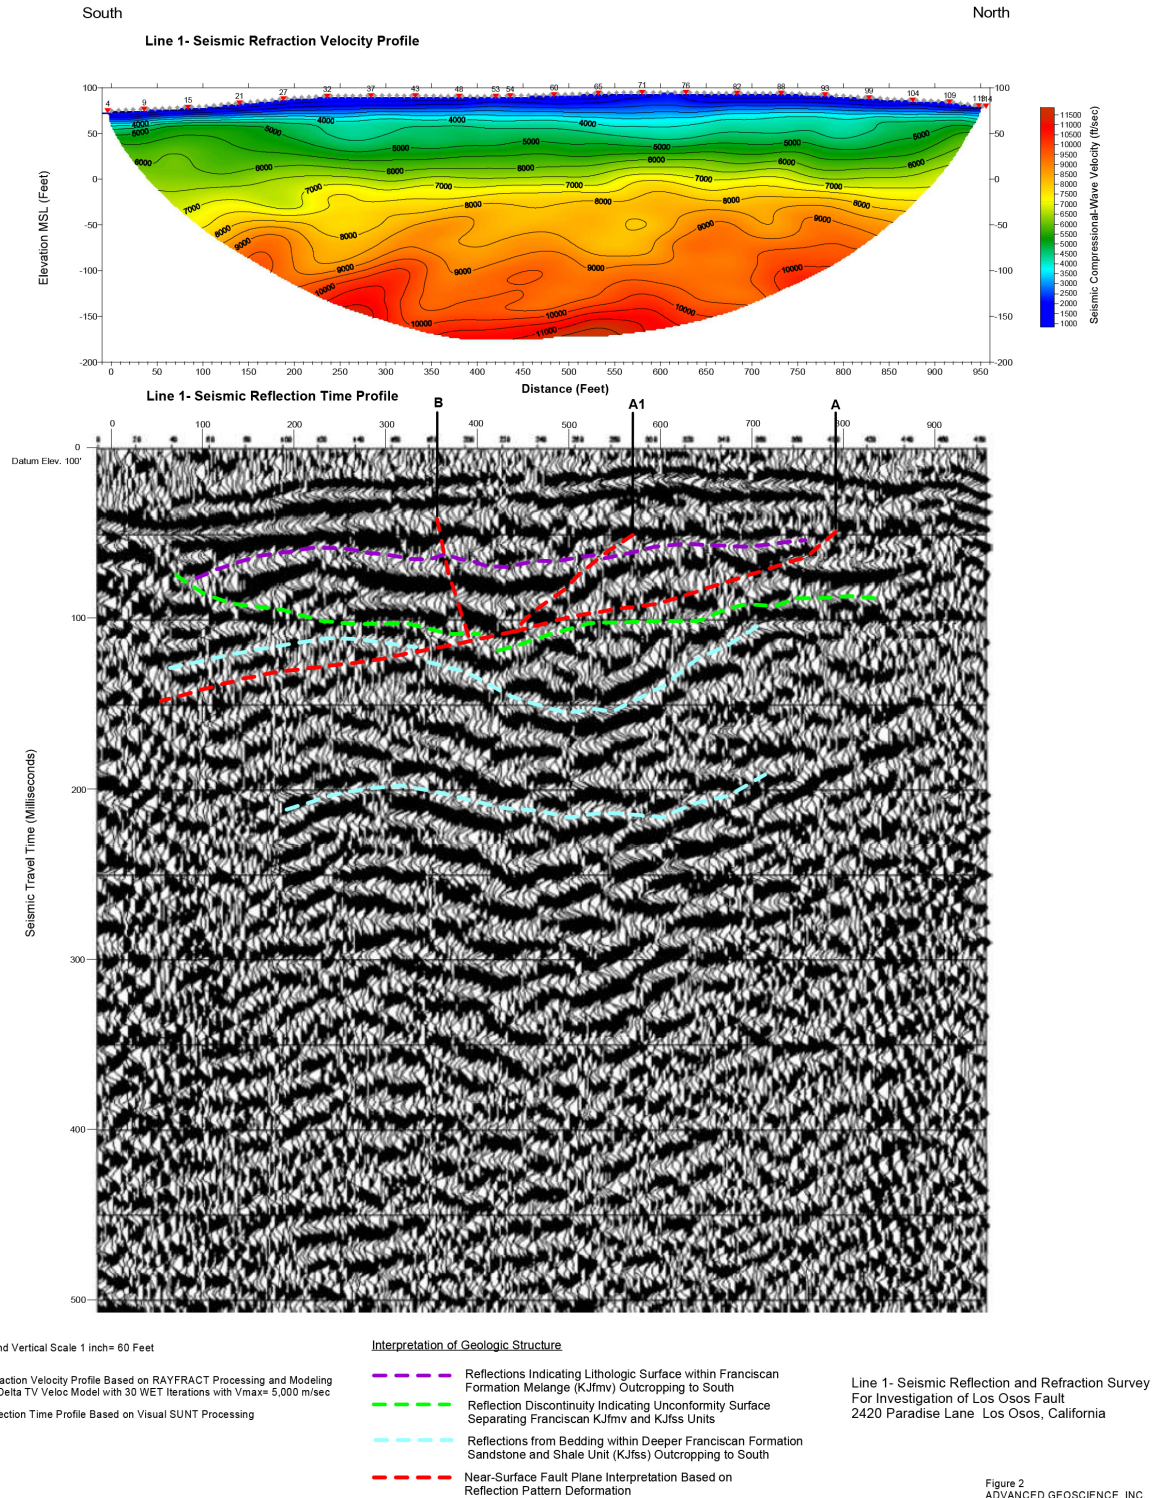
**Figure 6: Line 1 Seismic Refraction and Reflection Profile**

As observed in the seismic reflection profile (see Figure 6), patterns of truncated sequences of Franciscan Complex units were observed greater than 50 feet below ground surface. The near surface interpretation of splays of the lower angle, southwest-dipping thrust faults (identified as A and A1 {see Figure 6}) and steeper angle, northeast dipping secondary faulting (identified as B {see Figure 6}) of the Los Osos Fault Zone. The fault location was extended east in the approximate trend as depicted on Wieggers, 2009. As proposed structures are proposed over 50 feet away from identified fault splays, additional investigations were not performed to verify the trend, age of faulting or depth of faulting through the Site. To account for multiple splays and uncertainty of fault characteristics observed in the seismic reflection survey a **50-foot setback** for habitable structures (i.e. single-family residence) is recommended on both sides of the surface fault location (see Plate 1A). Non-habitable structures may be located within the setback zone, but it is our understanding that development is not proposed in the area at this time. If the future development is proposed with the setback area, additional investigation should be performed.

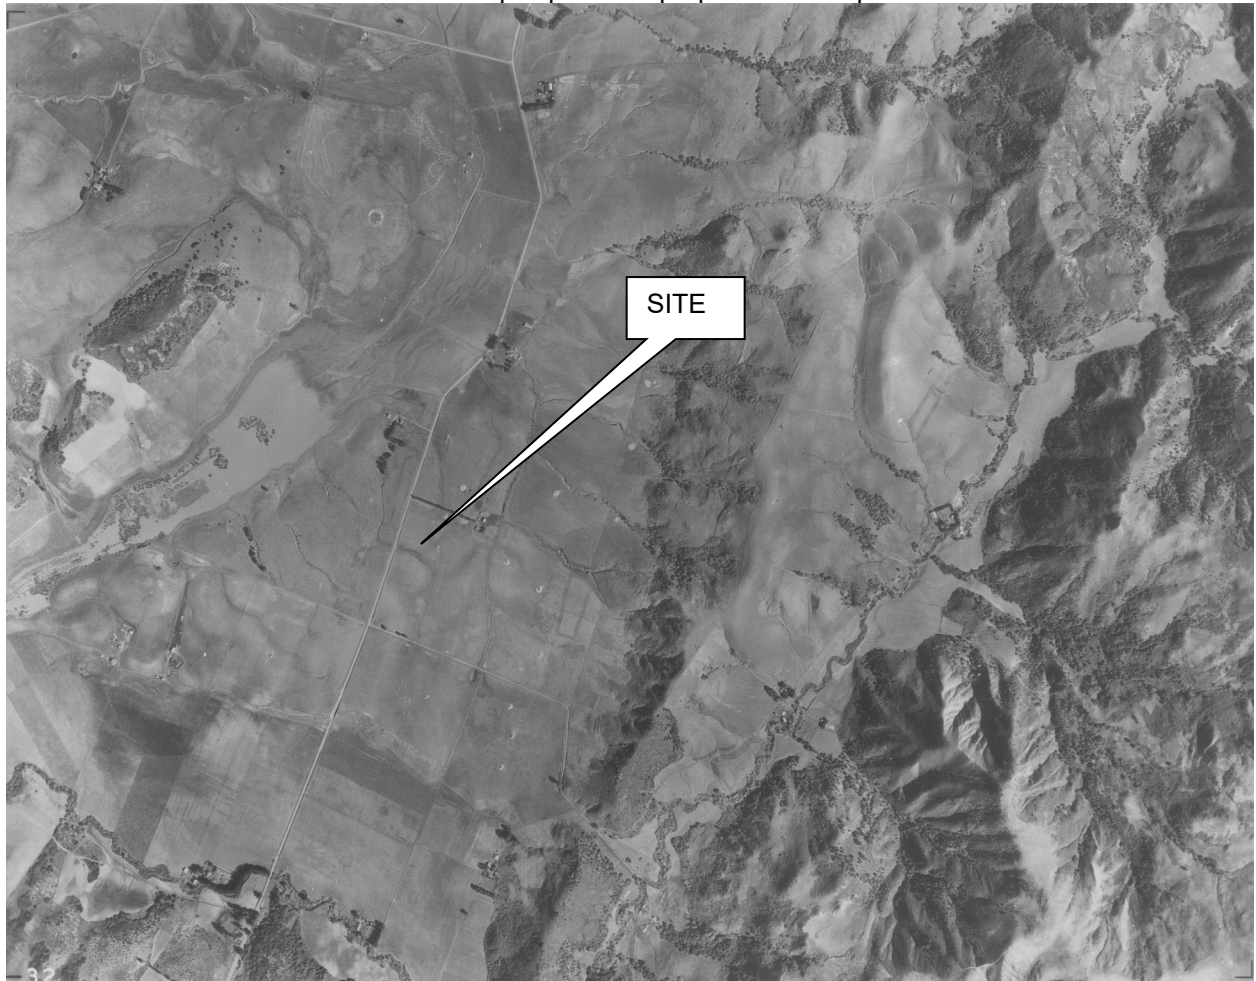
Figure 7: Historical Aerial Photograph (1937)

within the Franciscan Complex in the hills surrounding Los Osos Valley. During site mapping and review of recent and historical (1937, 1949) aerial photography, landslides were not observed at the Site. Plate 4 presents an aerial photograph. There is a low rockfall potential to affect the proposed residence based on the lack of boulders upslope of the proposed development.

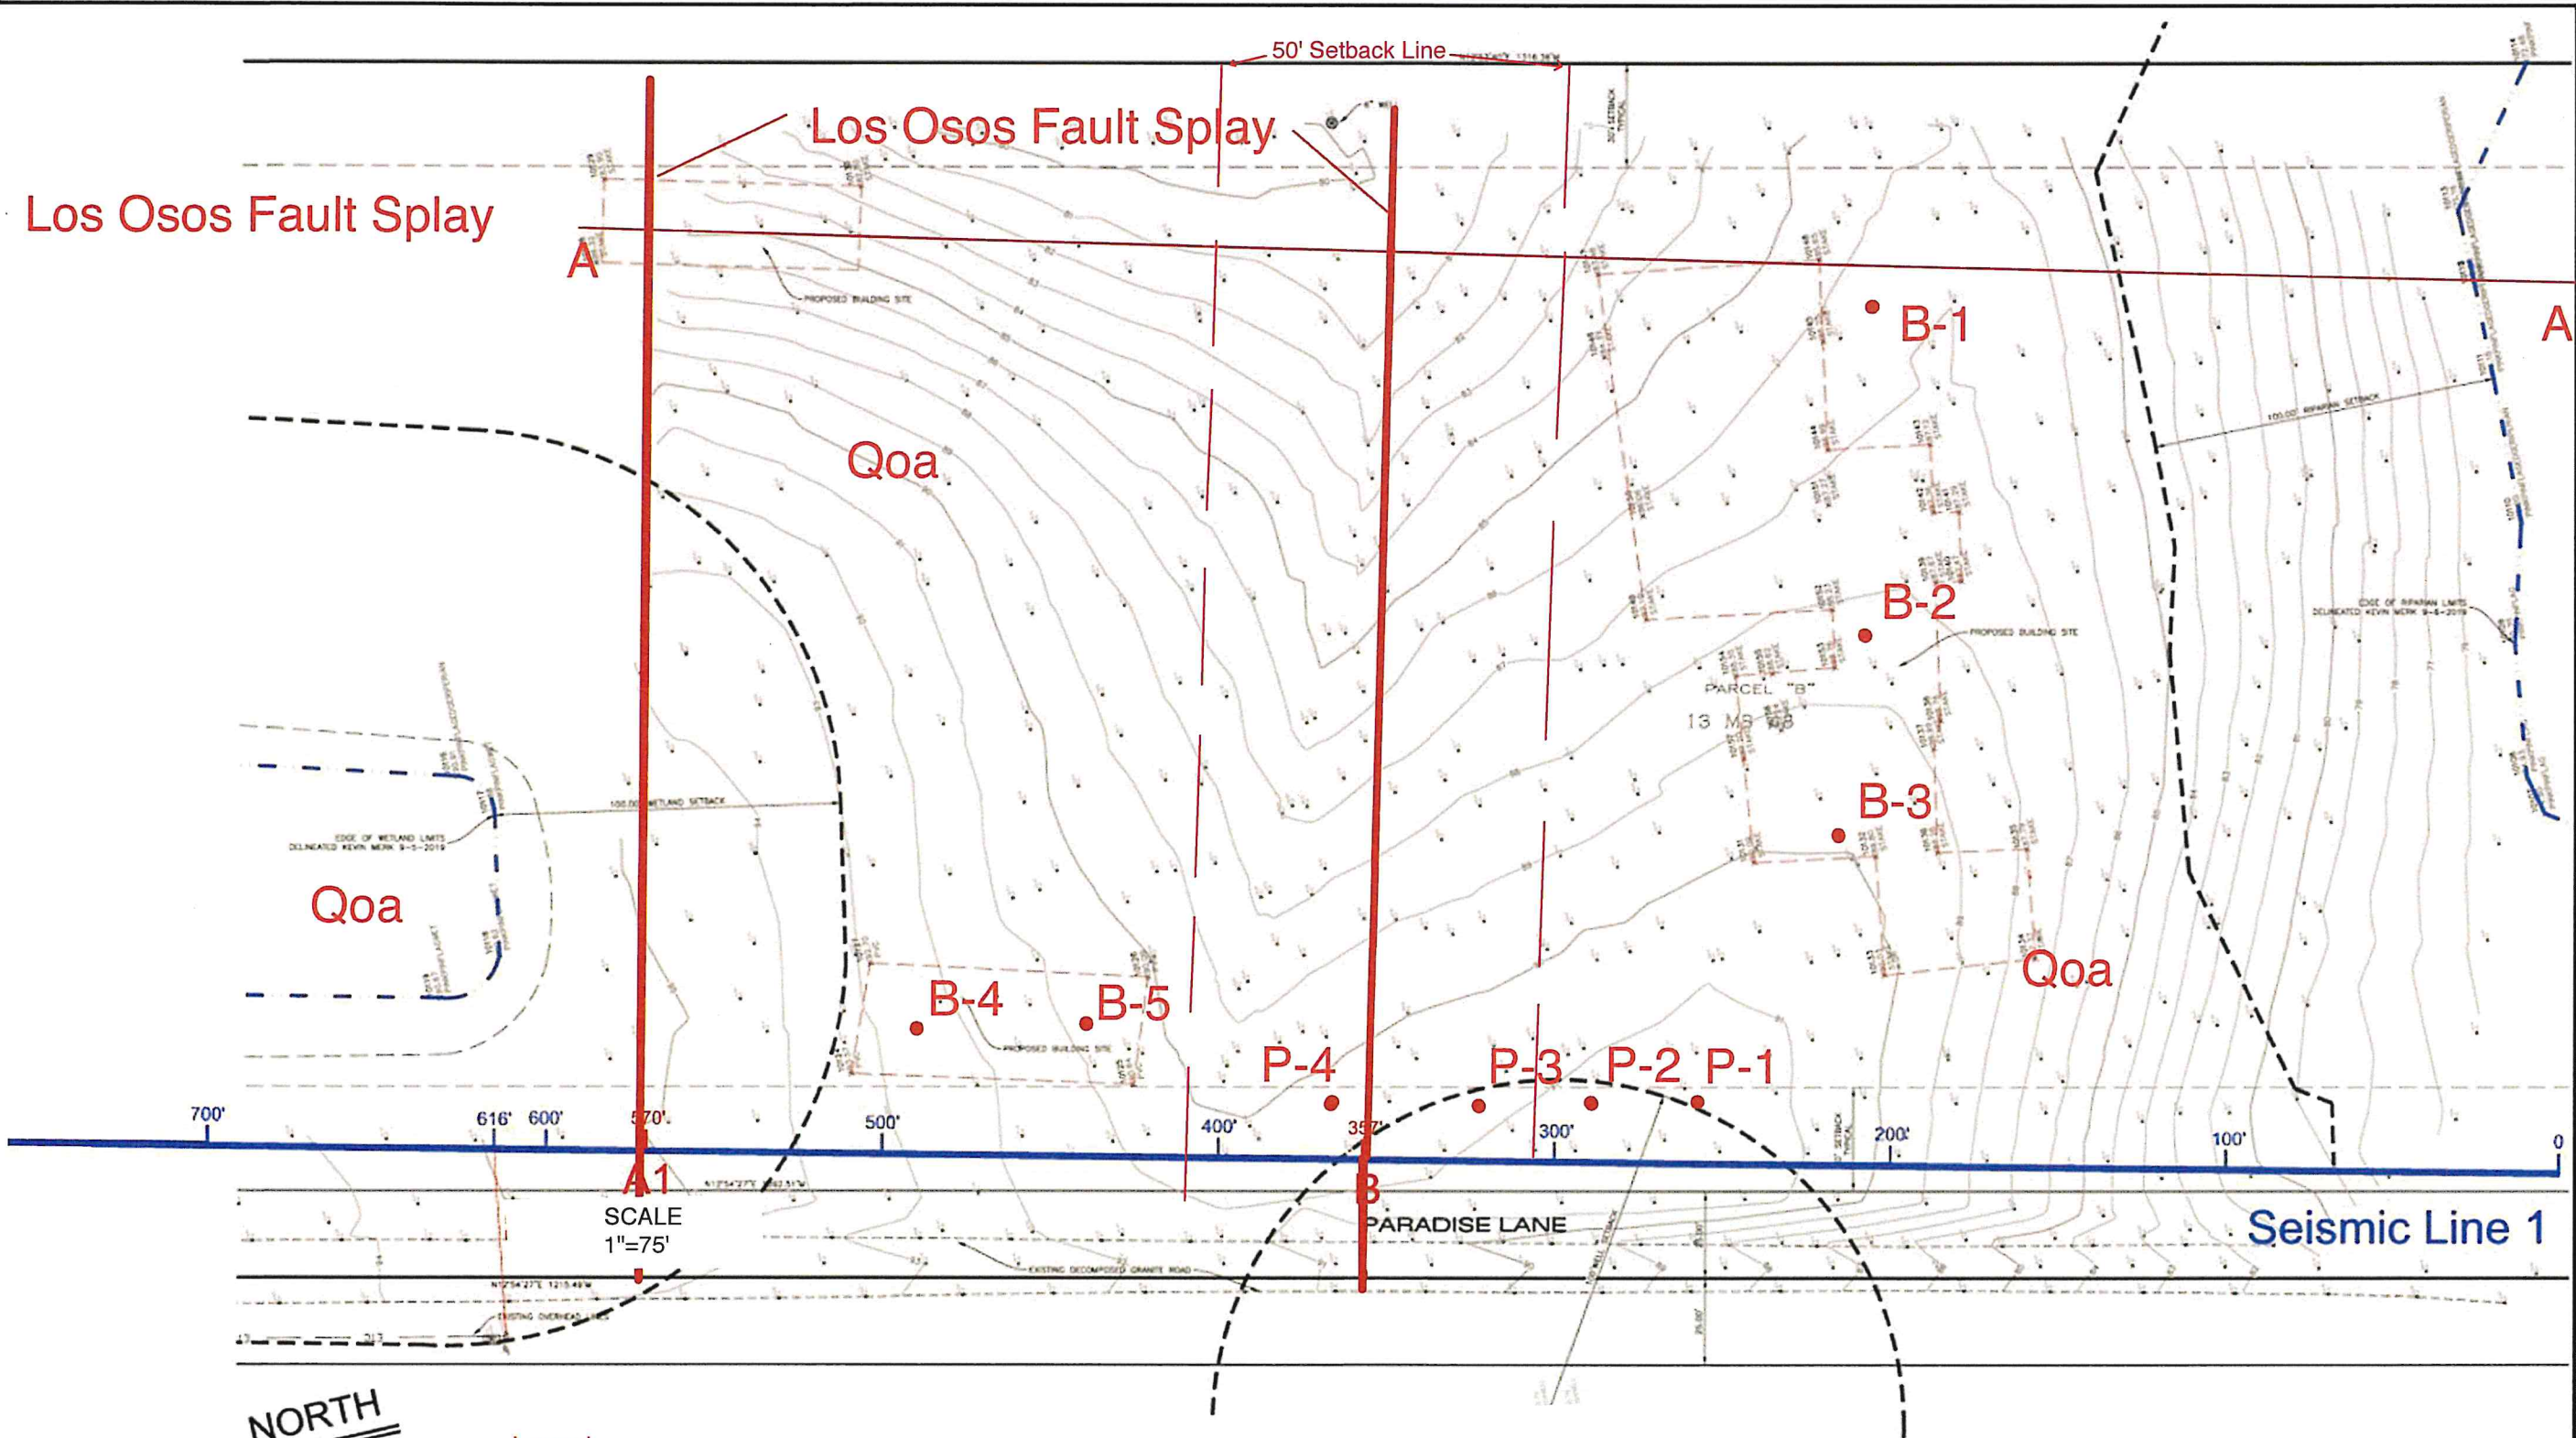
PLATE  
1A

- Legend
- Qoa - Older Alluvial Deposits
  - KJfmv - Franciscan Complex (Cretaceous or Jurassic Age)
  - - Fault (Dashed Where Approximate, Depict to Fault Splays Unknown)
  - B-1 - Boring Location
  - P-1 - Percolation Testing Location

1. A **50-foot setback** for habitable structures (i.e. single-family residence) is recommended on both sides of the surface fault location identified as splays of the Los Osos Fault Zone at the Site (see Plate 1A). Non-habitable structures may be located within the setback zone, but it is our understanding that development is not proposed within the area at this time.

Locally, the site is located within Eolian Deposits as depicted on Plate 1A, Site Engineering Geology Map. Hall, 1973, Lettis and Hall, 1994, Dibblee, 2006 and Wiegers, 2009 mapped the Site as underlain by Holocene to Pleistocene age Sand Dune Deposits/Old Eolian Deposits (Qs/Qoe) units. Information derived from the subsurface exploration for the referenced Soils Engineering Report (GeoSolutions, 2019) was used to classify subsurface soil and formational units and to supplement geologic mapping. Five borings were previously drilled in the vicinity of the proposed single-family residence and barn to a maximum depth of 15 feet below ground surface.

ground surface. Plate 1A depicts Older Alluvial Deposits (Qoa) throughout the property. Boring logs are presented in Appendix A.

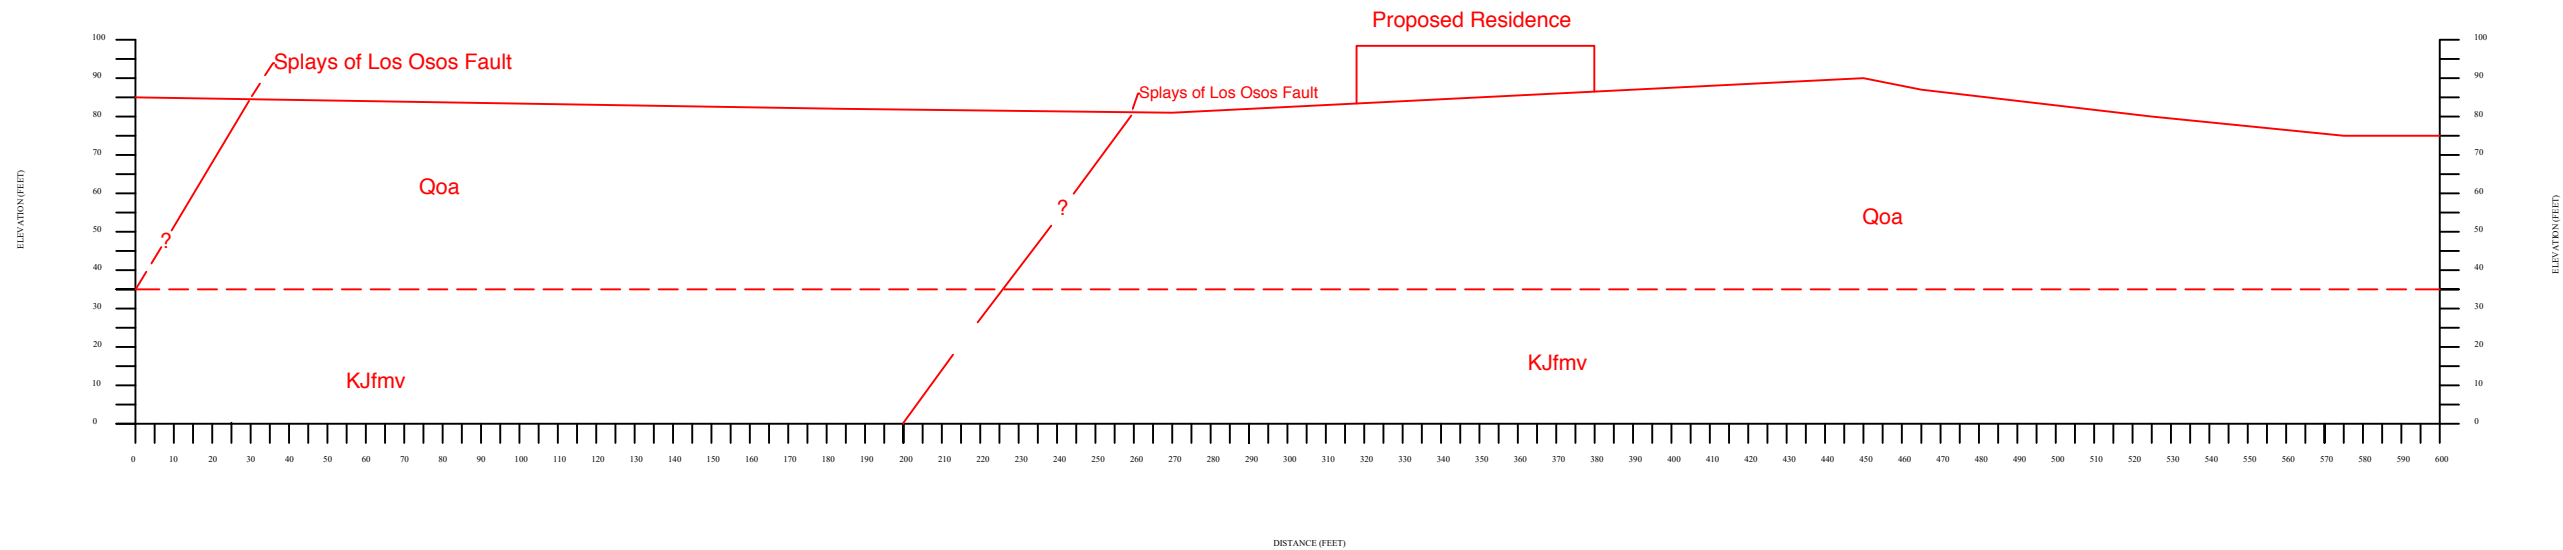
**Legend**  
Qoa - Older Alluvial Deposits  
KJfmv - Franciscan Complex (Cretaceous or Jurassic Age)  
— — - Contact (Dash Where Approximate)  
\_\_ ? \_\_ - Fault (Dashed Where Approximate, Depict to Fault Splays Unknown)

Plate 1A, 1B - Site Engineering Geologic Map and Cross Section

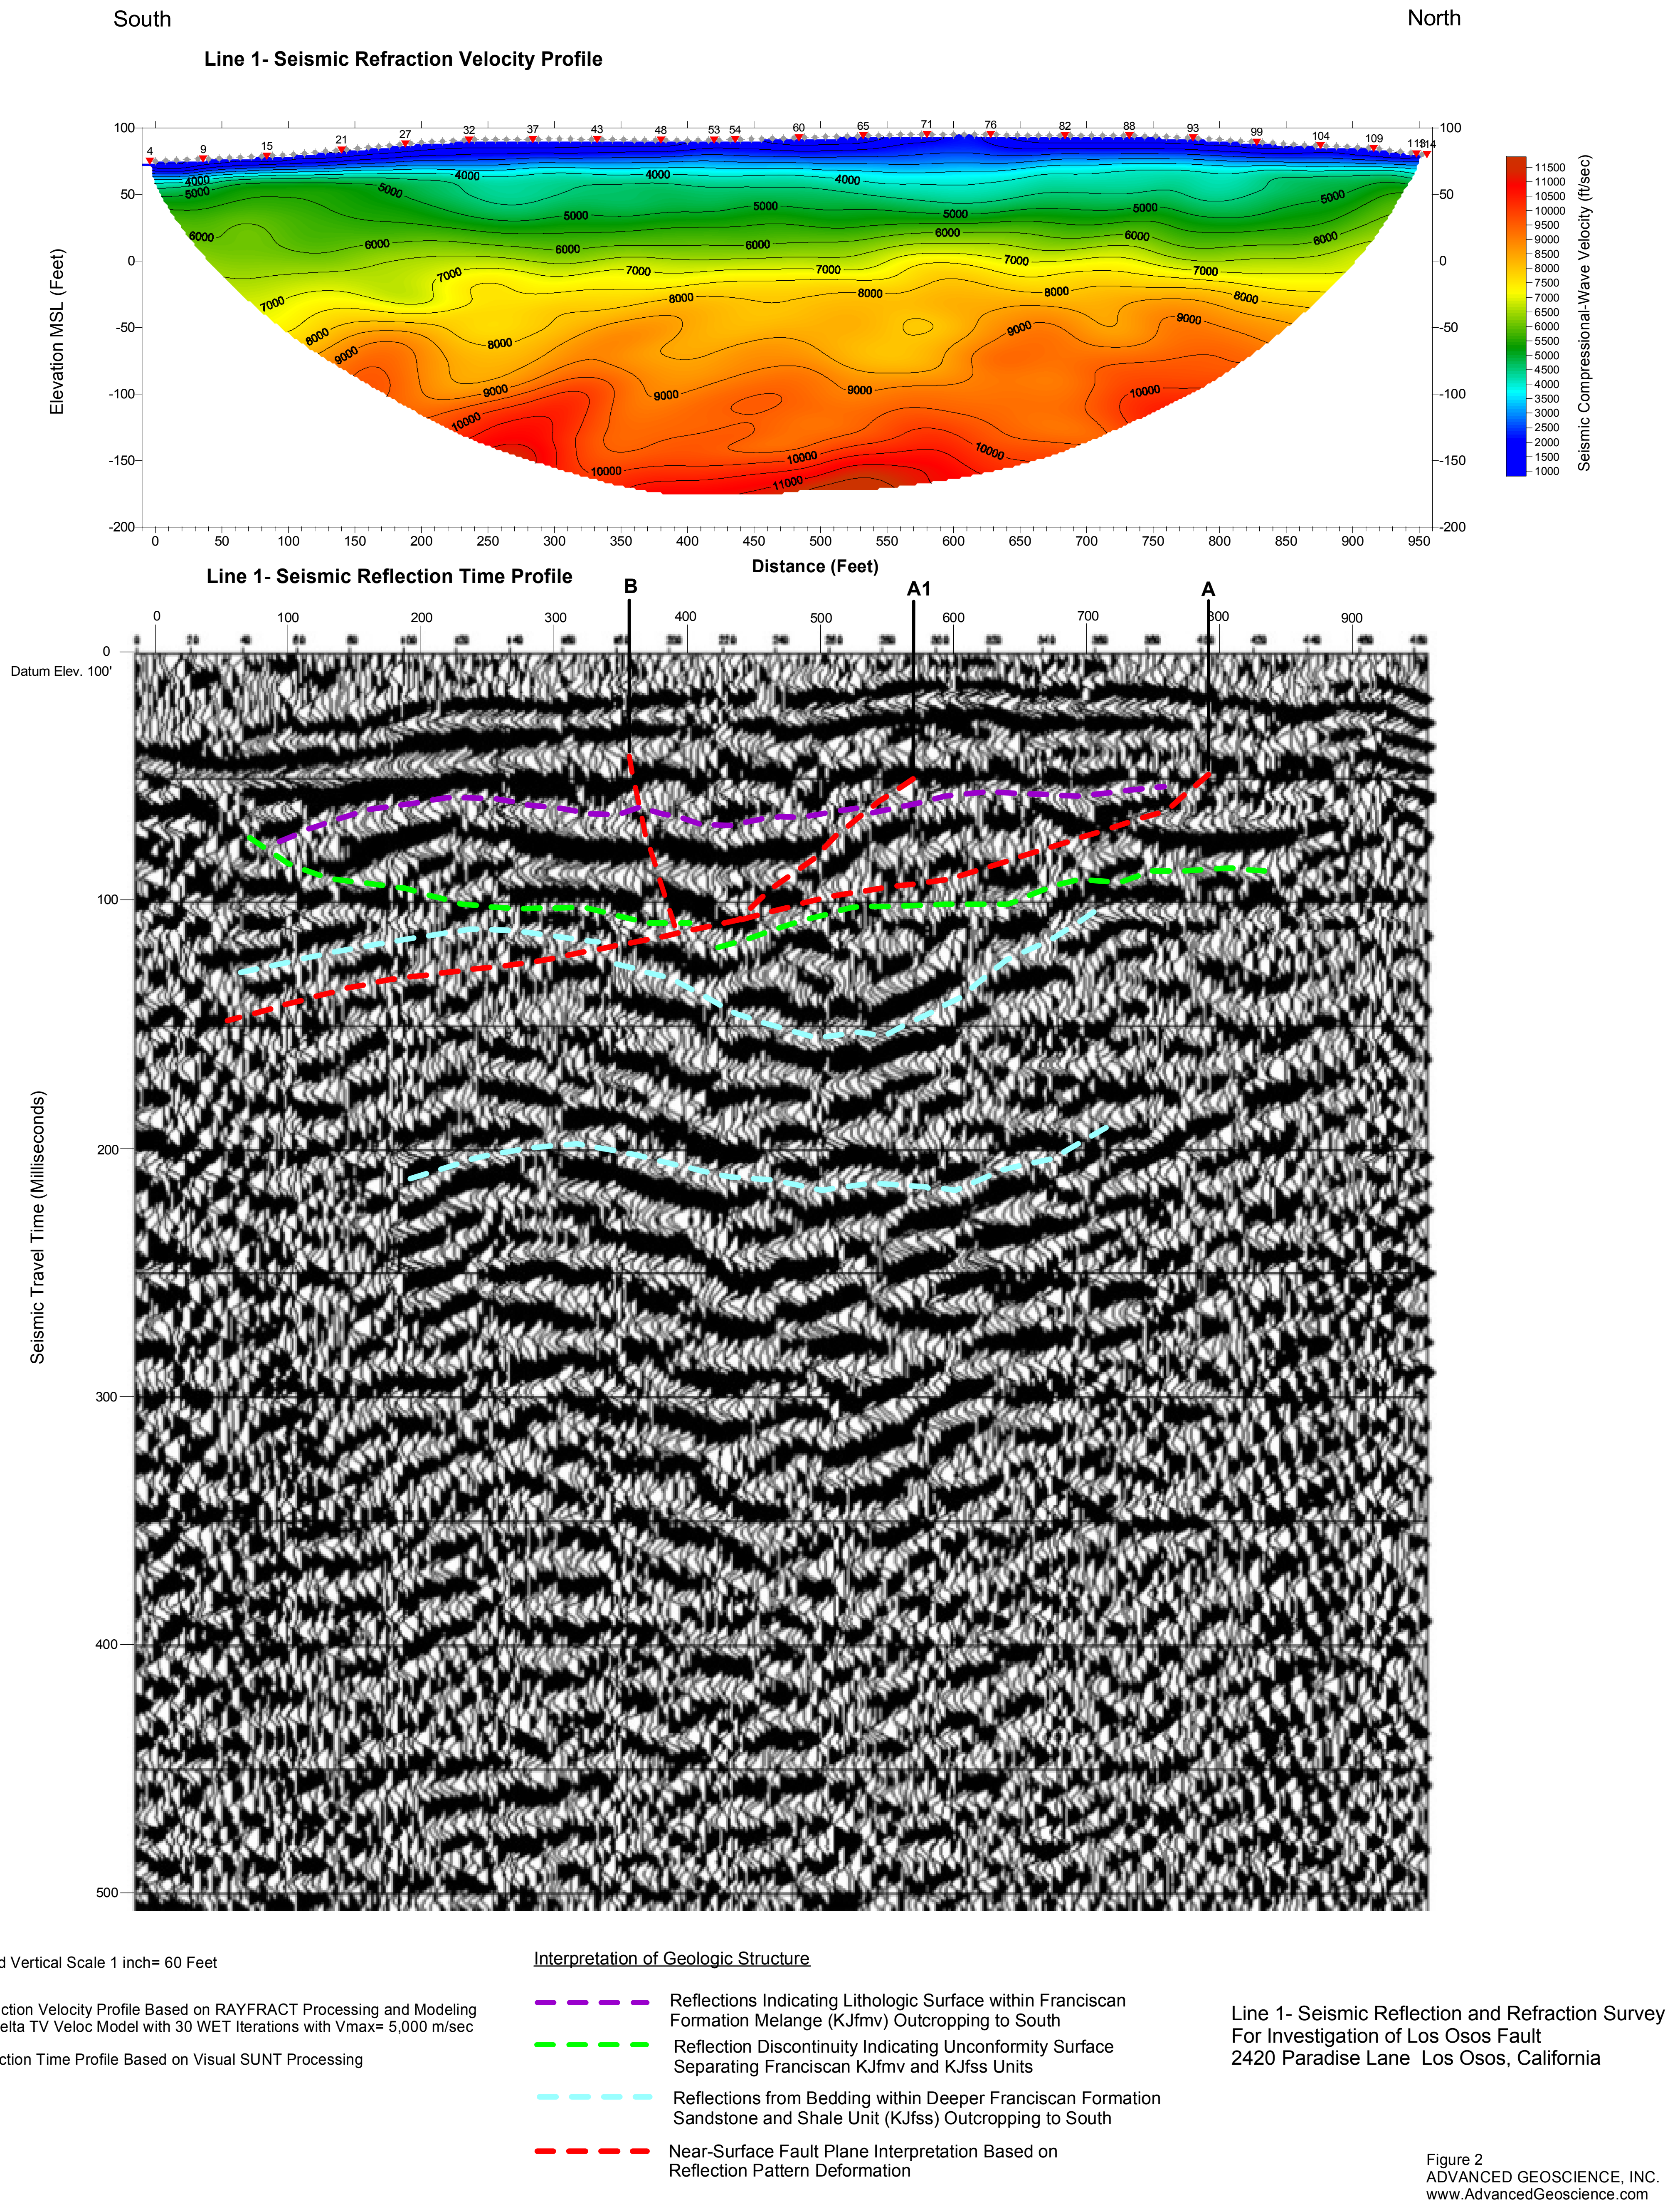
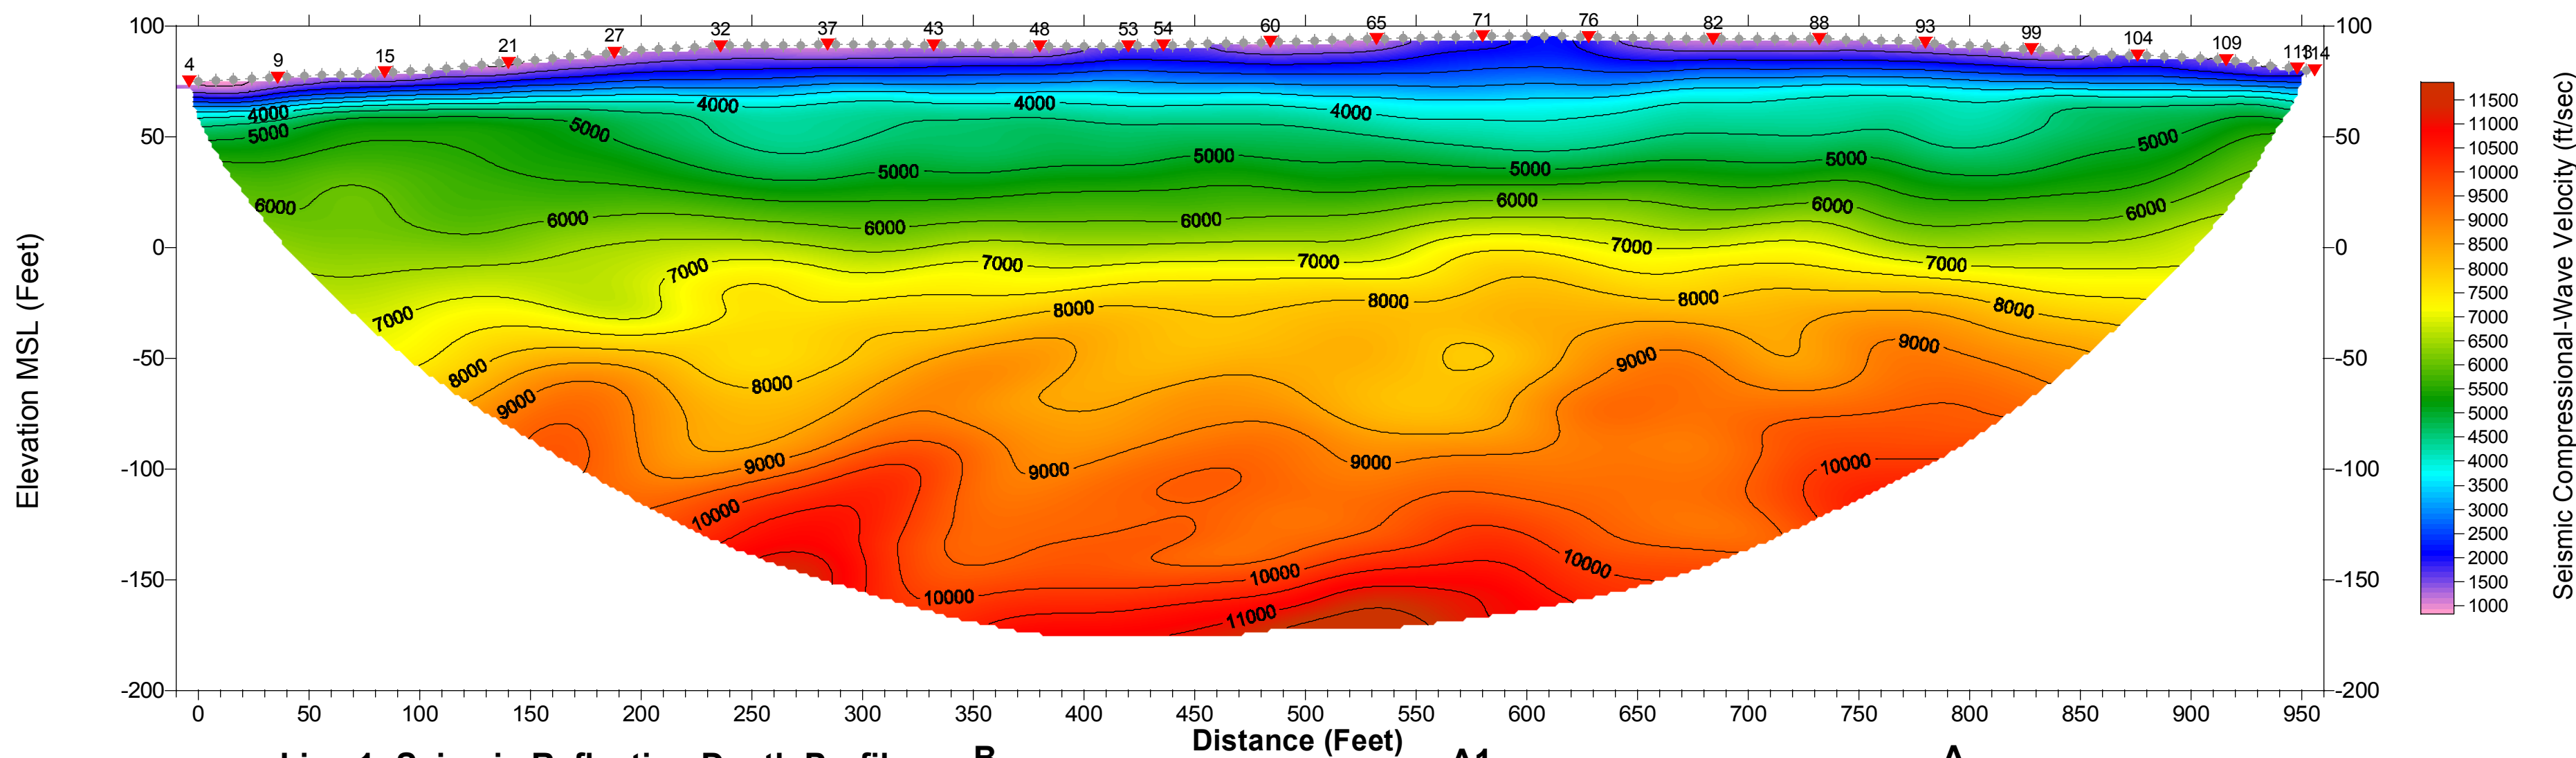
Line 1- Seismic Refraction Velocity Profile

Line 1- Seismic Reflection Depth Profile

Seismic Refraction Velocity Profile Based on RAYFRACT Processing and Modeling  
Using Initial Delta TV Veloc Model with 30 WET Iterations with Vmax= 5,000 m/sec

Seismic Reflection Time Profile Based on Visual SUNT Processing  
Conversion of Time Profile to Depth Based on Refraction and NMO Correction Velocities

The seismic reflection time profile underwent additional Visual\_SUNT processing to prepare an approximate seismic reflection depth profile. The refraction velocity profile was used to prepare a smoothed set of velocity-versus-time functions to convert the reflection travel time profile to a depth profile. Figure 3 shows the resulting seismic reflection depth profile generated from this procedure.

The seismic refraction and reflection depth profiles in Figures 3 are displayed with no vertical exaggeration at the same horizontal and vertical scale 1-inch= 60 feet.

The seismic reflection depth profile in Figure 3 shows similar patterns of reflections approximately converted to depth at 1:1 horizontal to vertical scale. The stratigraphic interpretation shown on the reflection profile in Figure 2 is also visible and drawn on this depth profile.

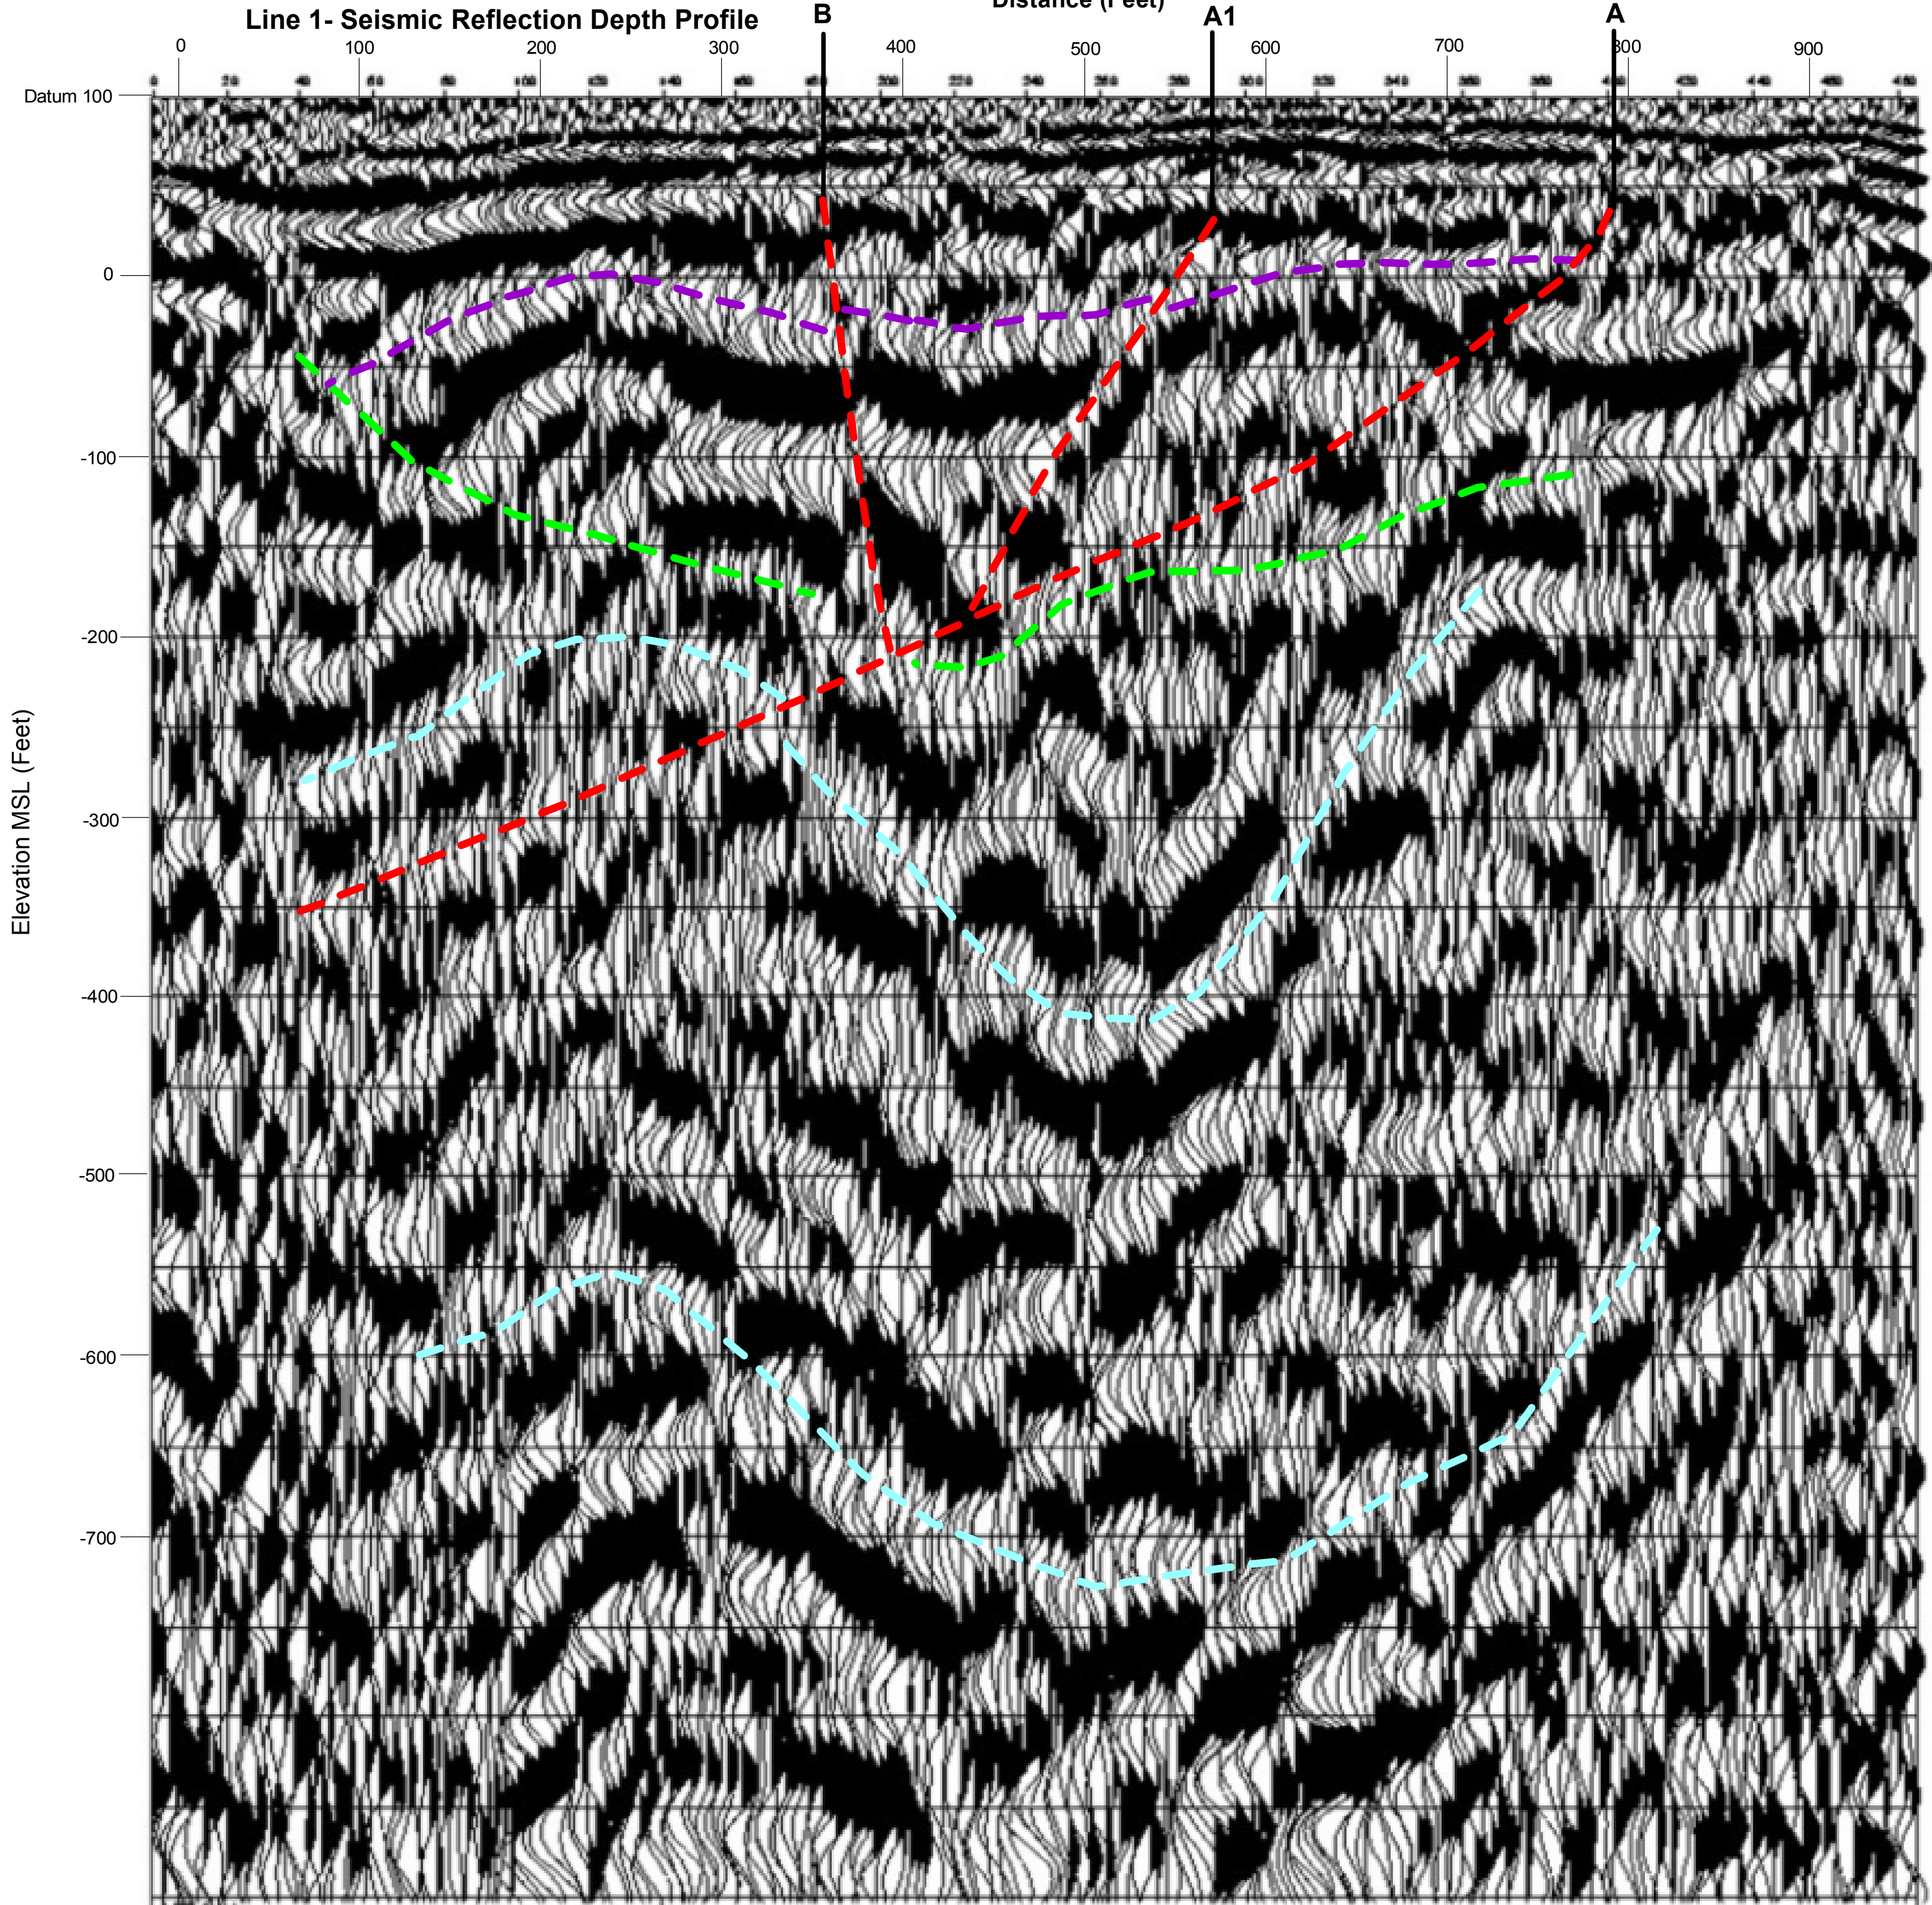
Interpretation of Geologic Structure

Horizontal and Vertical Scale 1 inch= 60 Feet
