**GEOTECHNICAL INVESTIGATION  
MIXED-INCOME TRANSIT-ORIENTED  
HOUSING DEVELOPMENT  
LA MESA, CALIFORNIA**

Project No. SD634  
October 14, 2019

**SUBJECT: GEOTECHNICAL INVESTIGATION**  
**Mixed-Income Transit-Oriented Housing Development**  
**La Mesa, California**

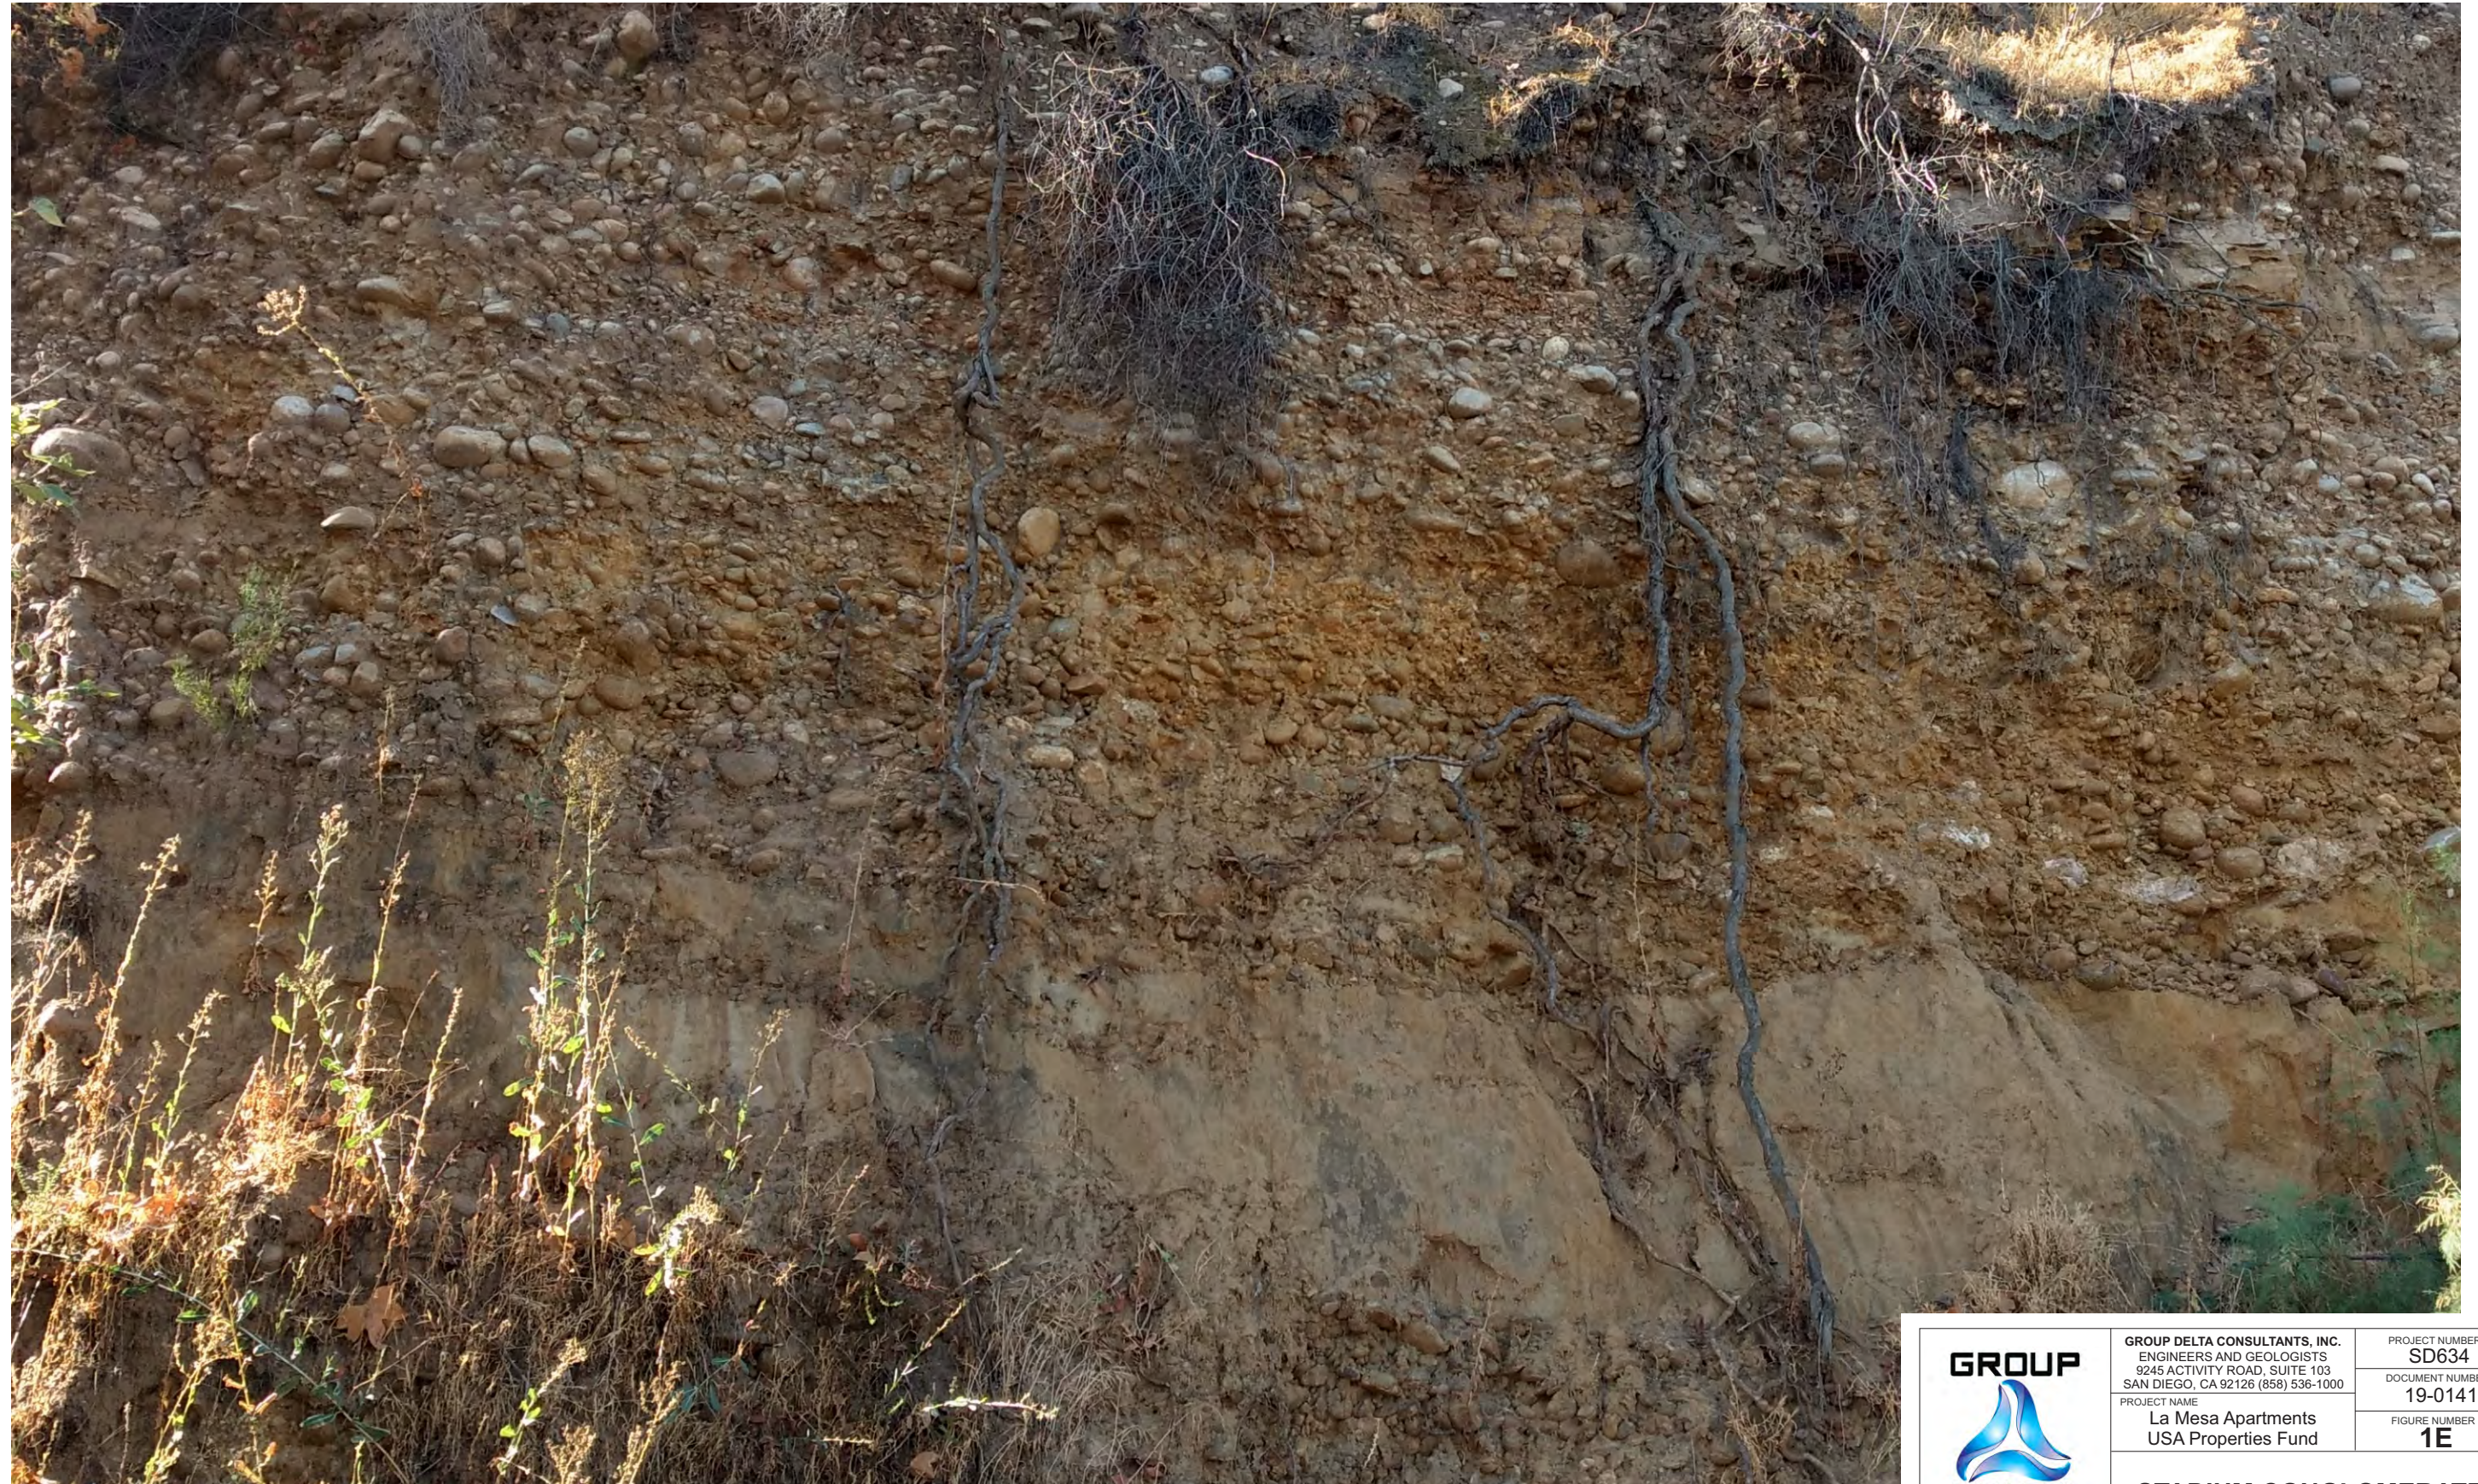
PROJECT NUMBER  
SD634  
DOCUMENT NUMBER  
19-0141  
FIGURE NUMBER  
1E

**STADIUM CONGLOMERATE**

The 1.3-acre site consists of Assessor's Parcel Number (APN) 470-572-22 located within the City of La Mesa, as shown on the Site Location Map, Figure 1A. The site is situated southeast of the intersection between Allison and Date Avenues, as shown on the Site Vicinity Plan, Figure 1B. Photographs depicting the existing condition of the site at the time of our field investigation are provided in Figures 1C and 1D. A photograph of a nearby outcrop showing the typical composition of the formational material underlying the property is provided in Figure 1E.

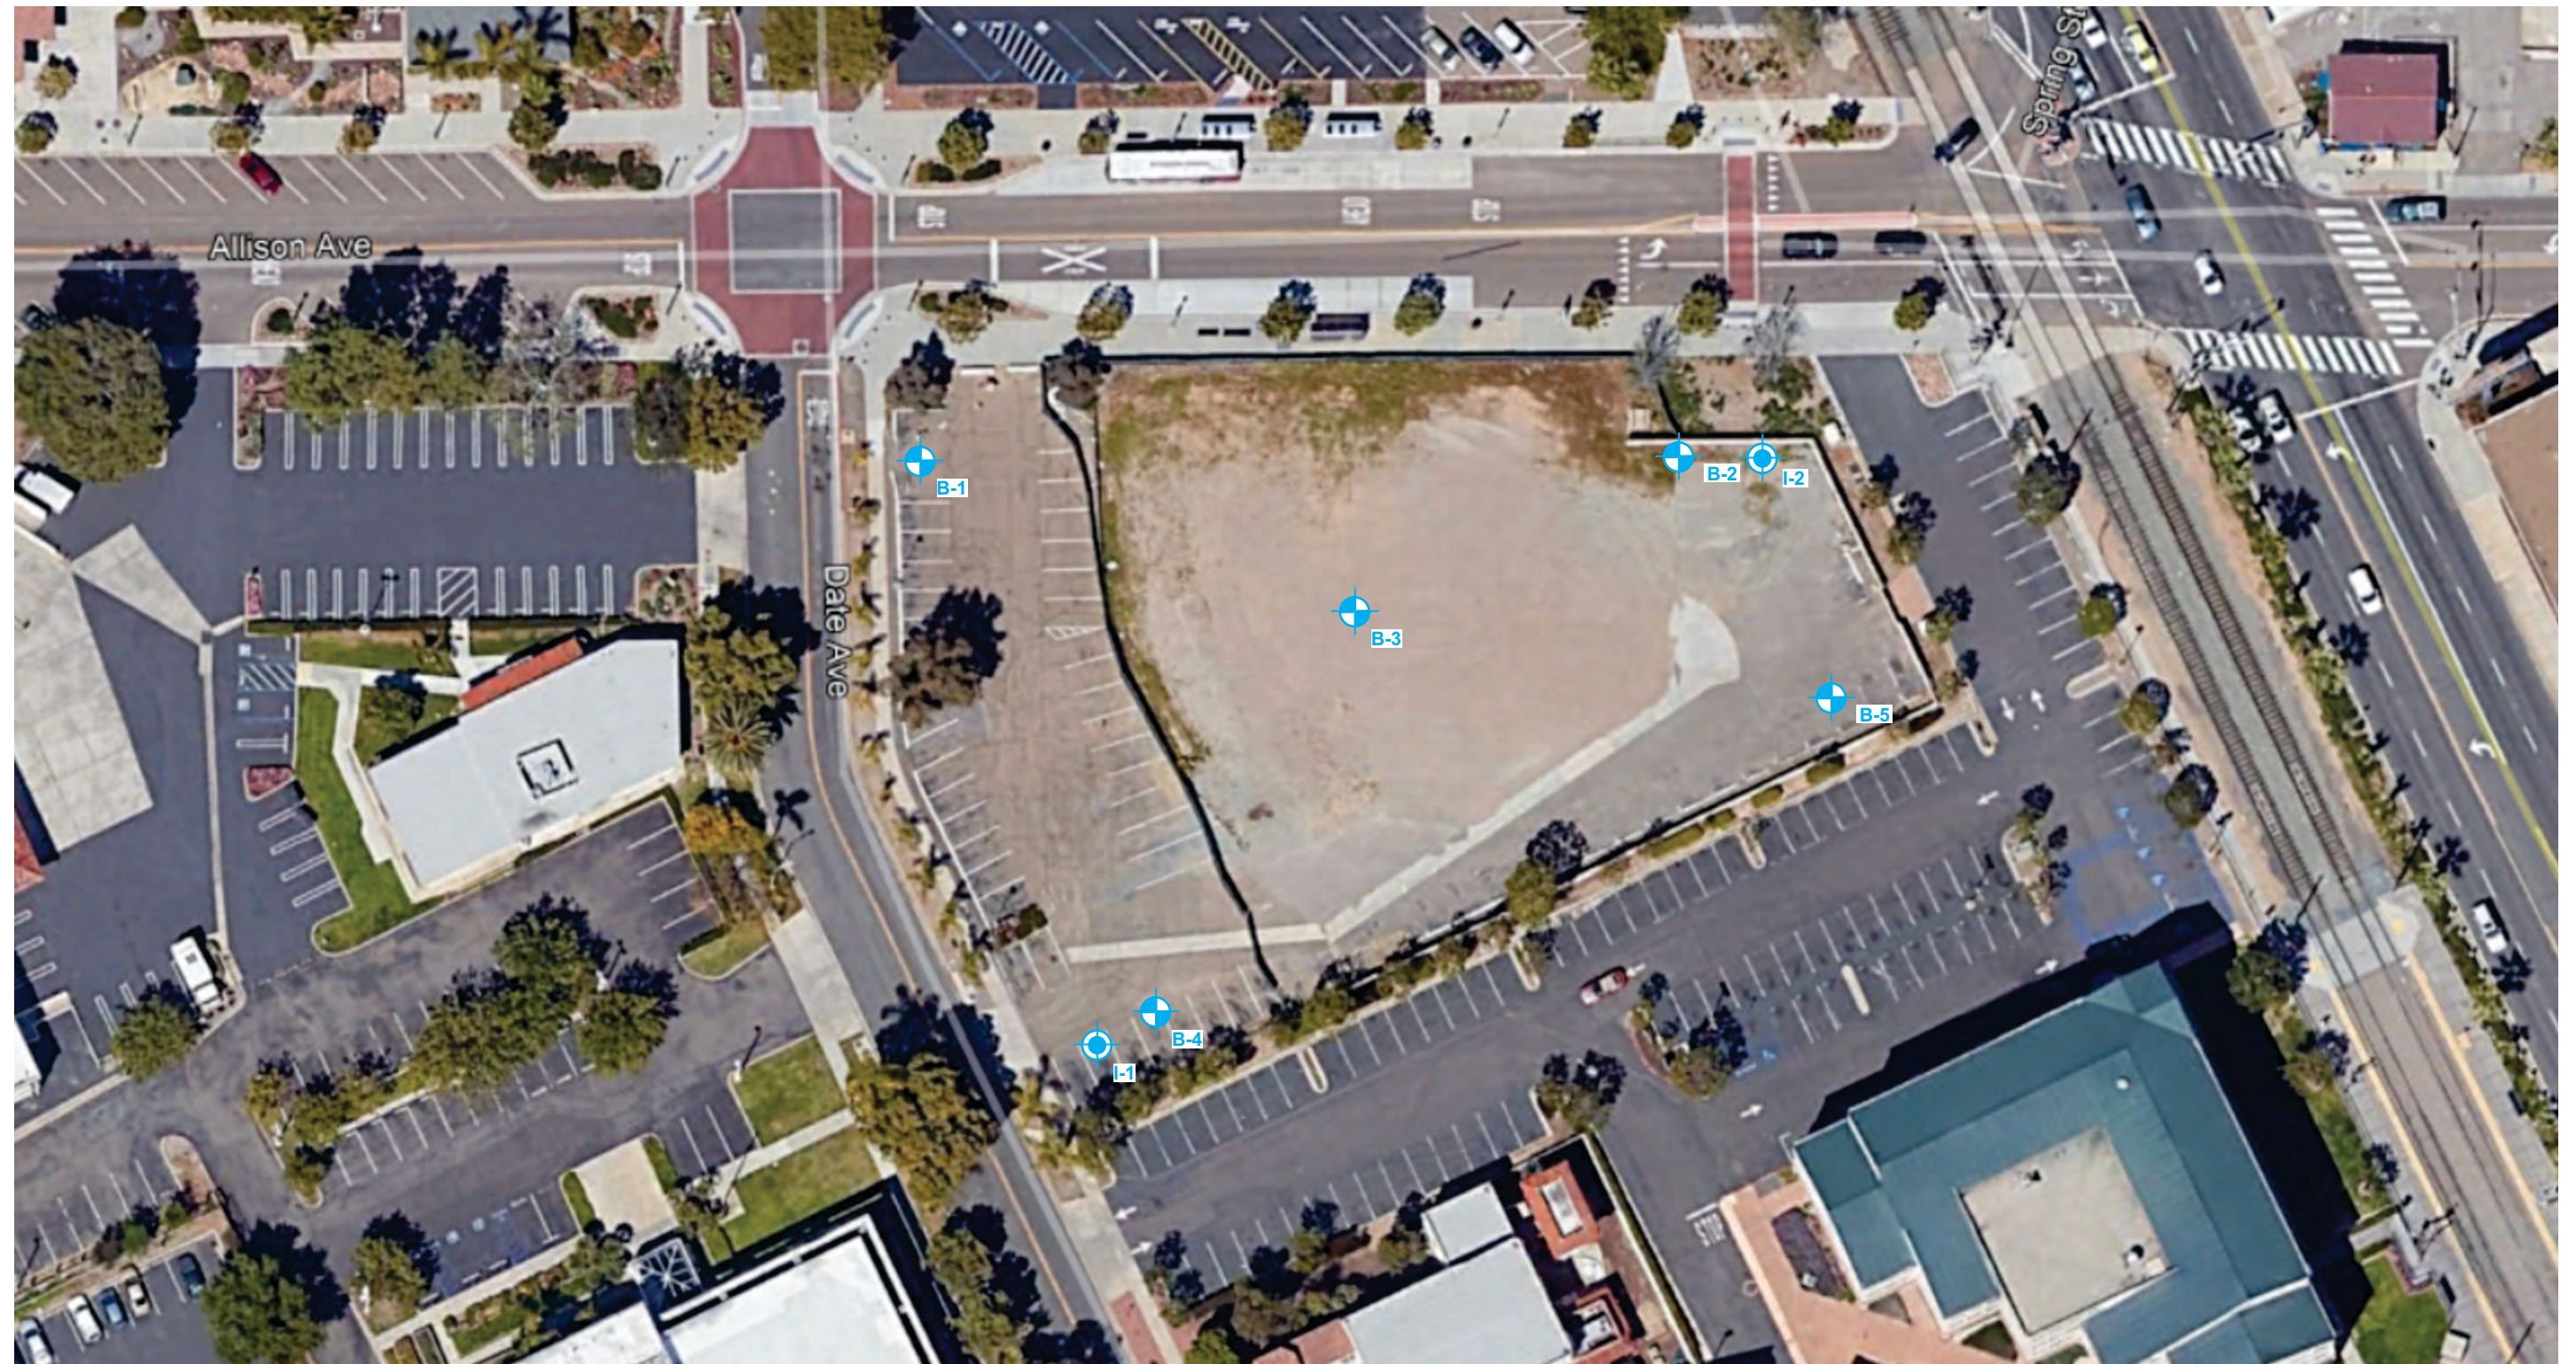
FIGURE NUMBER  
2B

**PROPOSED DEVELOPMENT**
