**SUBJECT: Preliminary Geotechnical Evaluation
505 East Bayshore Road
Redwood City, California
Langan Project No. 770655202**

This report presents a preliminary geotechnical evaluation for the proposed development at 505 East Bayshore Road in Redwood City, California. The site is bound by East Bay Shore Road to the west, a water channel to the north, a former movie theatre to the east and a car dealership to the south, as shown on Figures 1 and 2.

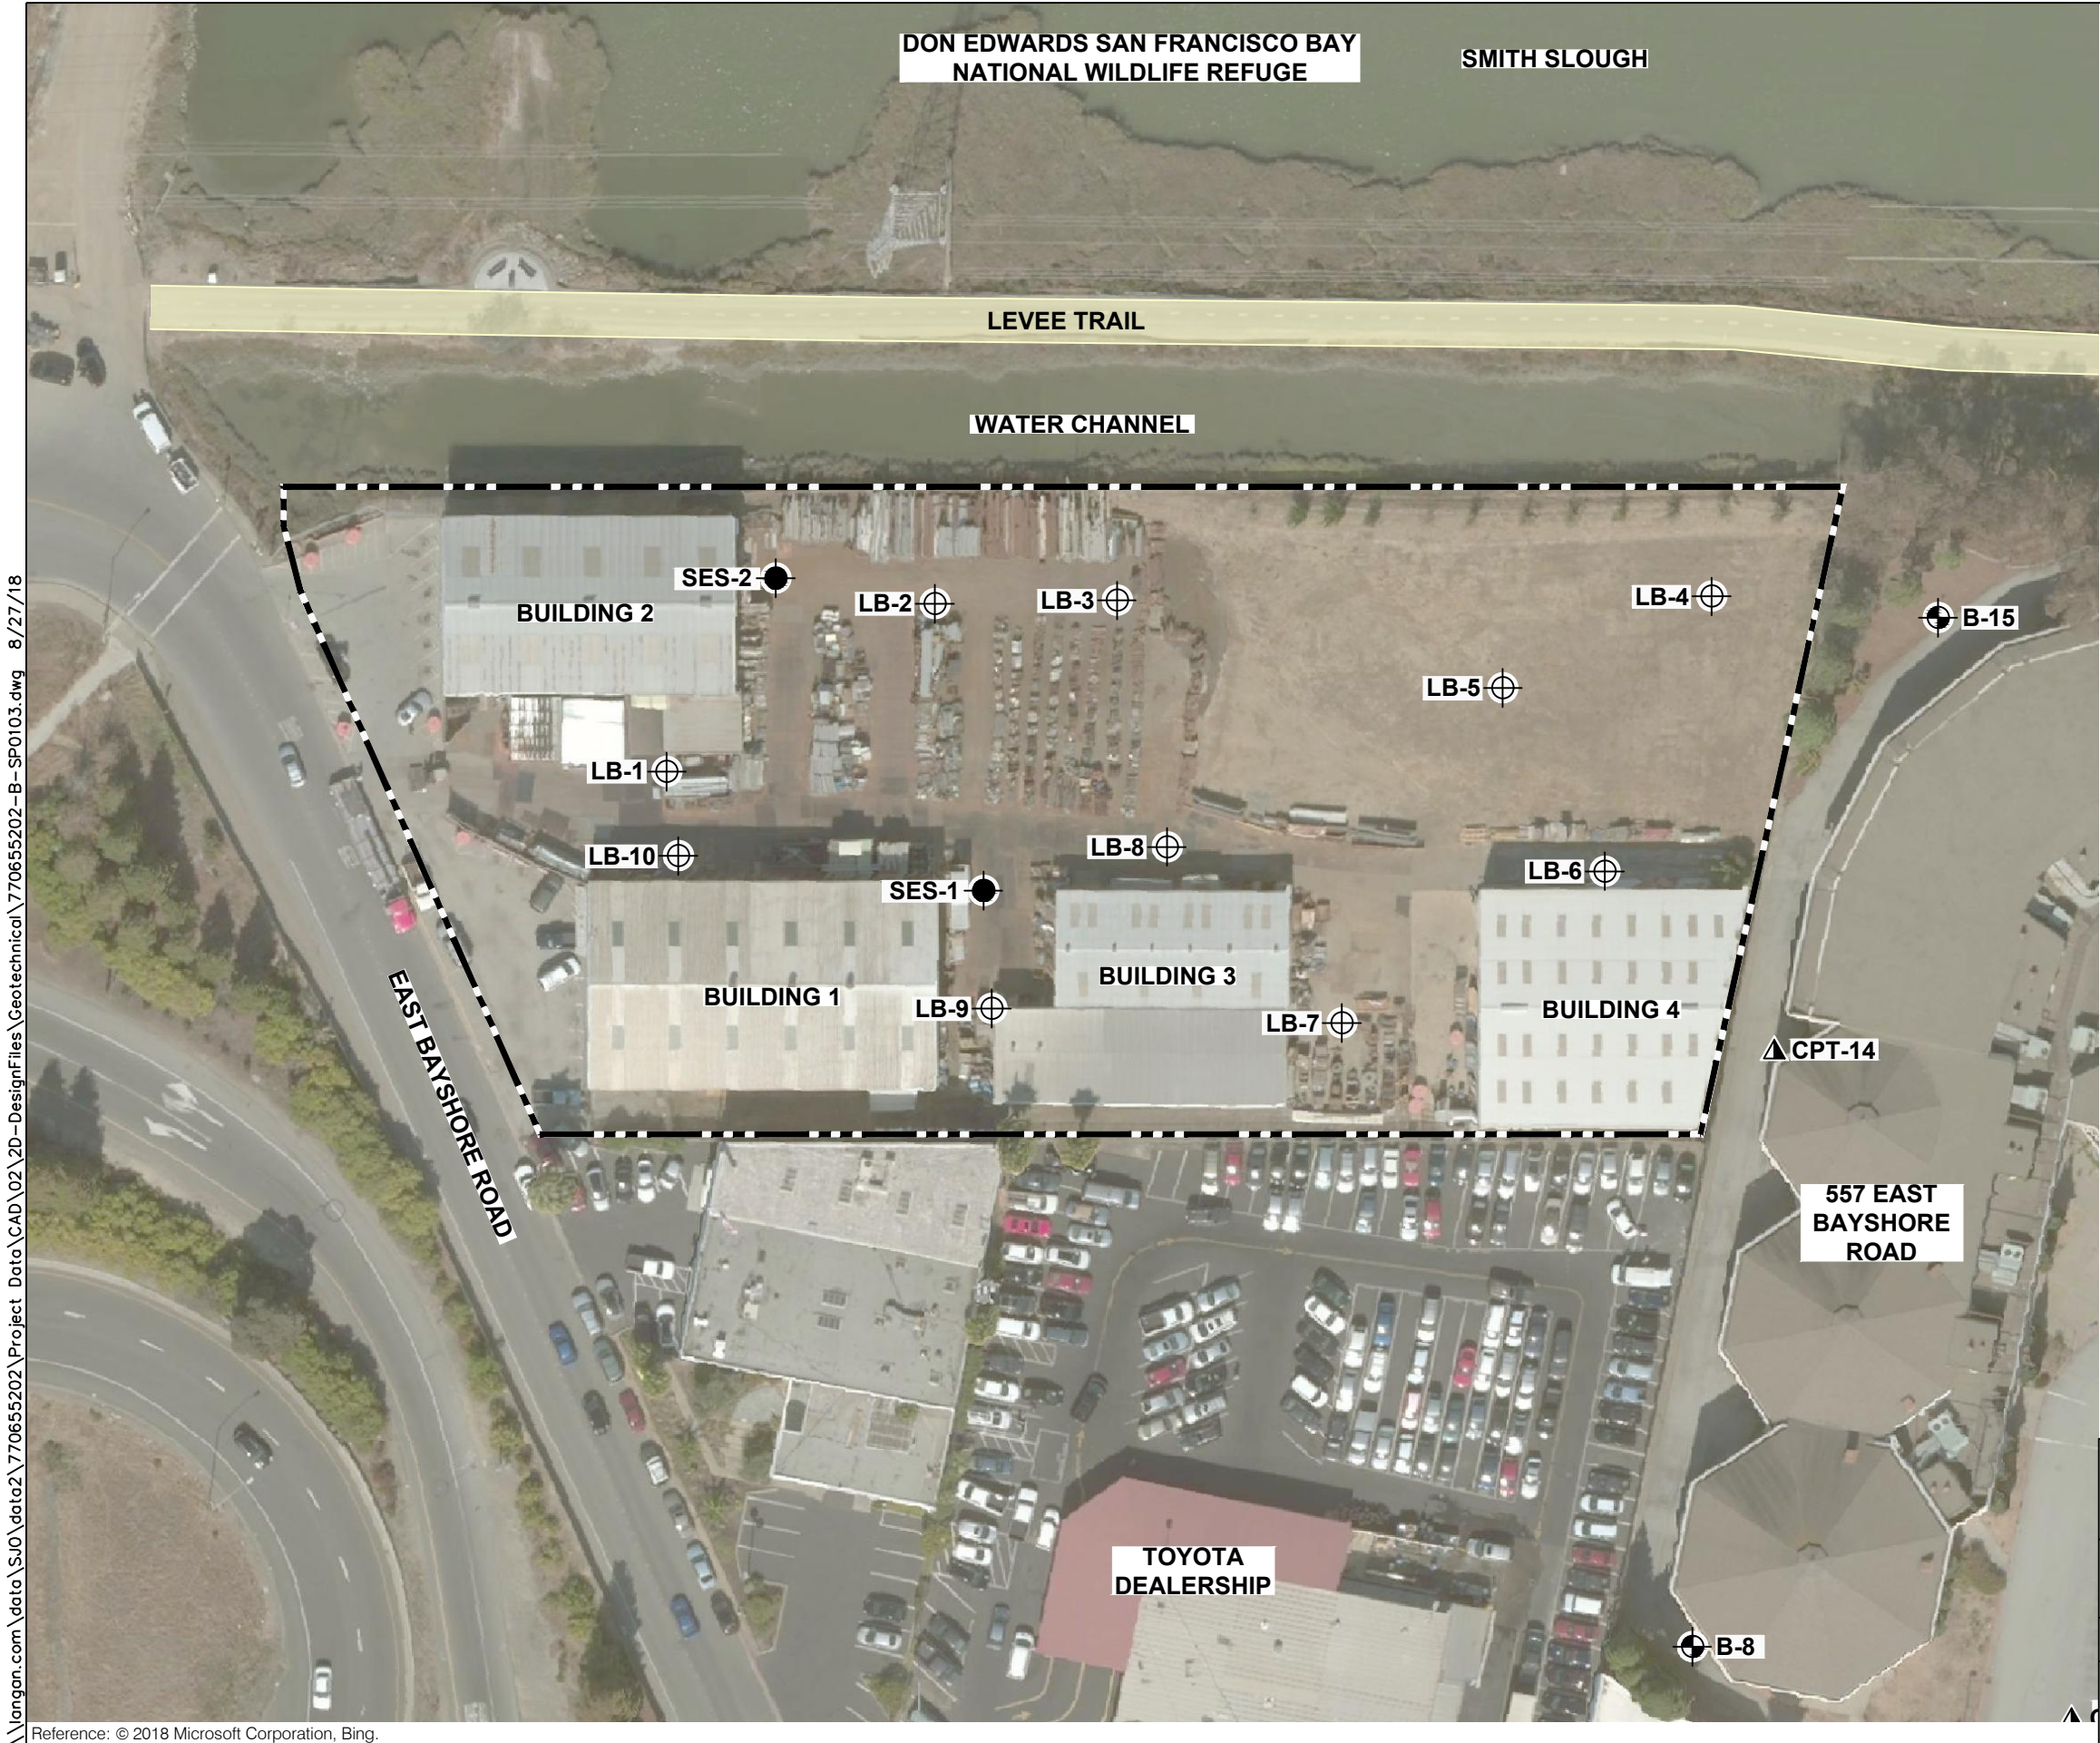
Date 08/27/18 Project No. 770655202 Figure 2

- B-15** Approximate location of boring by Langan, August and September 2017
- CPT-14** Approximate location cone penetration test by Langan, August 2017
- LB-1** Approximate location of environmental boring by Langan, August 2018
- SES-1** Approximate location of environmental boring by Stellar Environmental Solutions, Inc., December 2015
- Site boundary
- Existing 15-foot wide levee

In addition, we reviewed the environmental borings drilled for the current Phase I and Phase II investigations by Langan on 18 August 2018. The approximate locations of the borings, designated as EB-1 through EB-10, are shown on Figure 2. The environmental borings will be published under a separate cover.

four warehouse buildings (Buildings 1 through 4) along the southern and western side of the site, as shown on Figure 2. The foundation systems of the existing buildings are currently unknown. There are outdoor metal racking and storage areas between these buildings; the storage yard is covered with steel plates and asphalt. The northeastern part of the site is unpaved.
