Re: Proposed new hotel building to be located at APN 216-030-48, La Costa Avenue, La

Subject: Addendum No. 2

1.0 PURPOSE

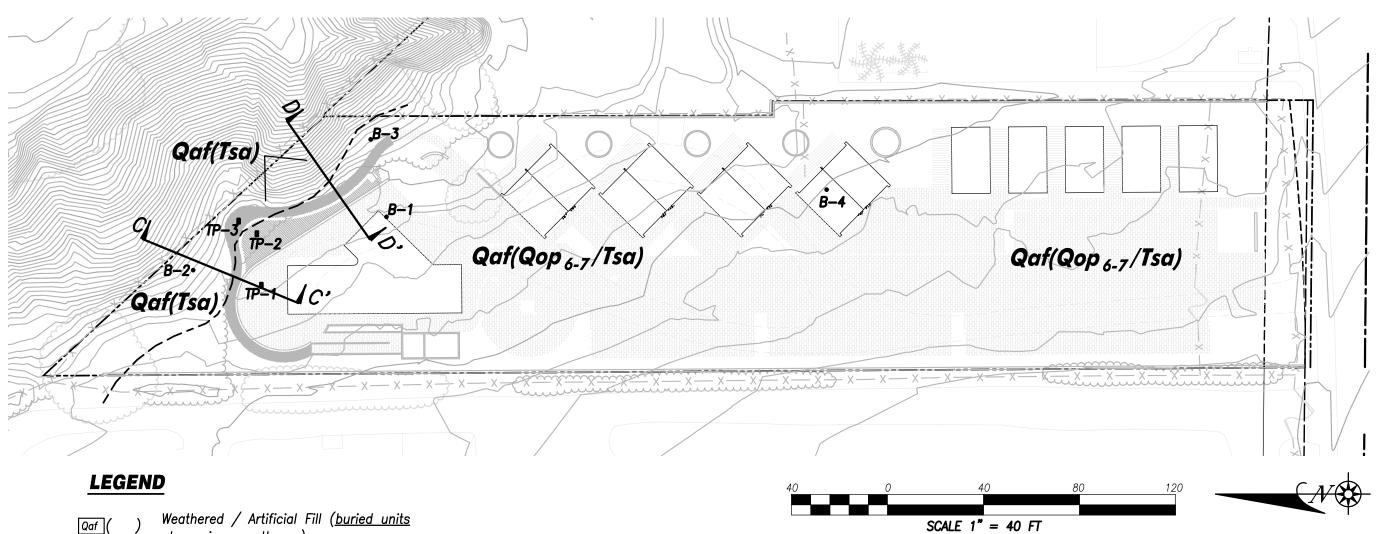
LA COSTA HOTEL GEOLOGIC / GEOTECHNICAL MAP

Old Paralic Deposits, undivided, late to Qop₆₋₇ middle Pleistocene (Kennedy, 2008)

Santiago Formation, Middle Eocene Tsa (Kennedy, 2008)

Borings (Per our original report - 2.27.18) B−2 ●

Test Pits (Per our original report - 2.27.18)

Approximate Limits of Geologic Contact

- 1.- Figure No. 1; Geologic/Geotechnical Map
- 2.- Figure No. 2; Geologic/Geotechnical Cross-Section C C'
- 3.- Figure No. 3; Geologic/Geotechnical Cross-Section D D'
- 4.- Figure No. 4; Areas of Slope Grading / Re-Grading

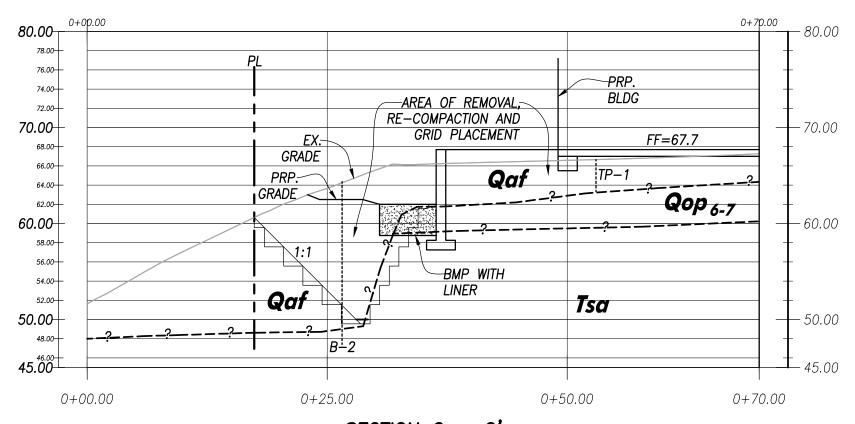
<u>LA COSTA HOTEL</u> SECTION C - C'

SECTION C - C' SCALE: 1"=10'-0"

*WHERE BORING IS NOT IN LINE WITH CROSS—SECTION, BORING IS REPRESENTED ALONG CROSS—SECTION AT 90 DEGREES FROM FIELD LOCATIONS. CONTACTS MAY BE EXTRAPOLATED.

Based on our additional slope analysis, and the grading recommendations outlined in this addendum, the new re-graded fill slope along Section C-C and the adjacent areas within the subject property, have a global minimum factor of safety against global slope stability of 1.5 for static conditions and less than 1.1 for pseudo-static conditions. Other portions of the rear slope, where fills are less deep, such as along Section D-D, have a global minimum factor of safety against global slope stability greater than 1.5 for static conditions and greater than 1.1 for pseudo-static conditions.

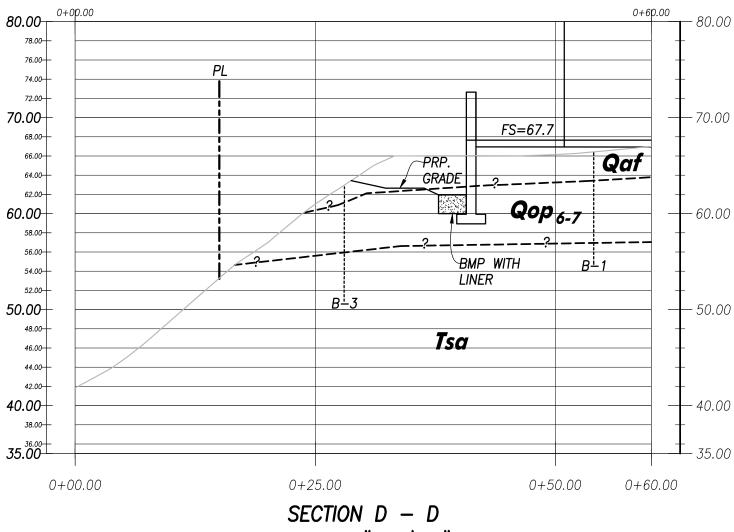
<u>LA COSTA HOTEL</u> SECTION D - D'

SCALE: 1"=10'-0"

*WHERE BORING IS NOT IN LINE WITH CROSS-SECTION, BORING IS REPRESENTED ALONG CROSS-SECTION AT 90 DEGREES FROM FIELD LOCATIONS, CONTACTS MAY BE EXTRAPOLATED.
