PRELIMINARY GEOTECHNICAL INVESTIGATION AND FOUNDATION RECOMMENDATIONS PROPOSED COMMERCIAL STRUCTURE TO BE LOCATED AT 516 LA COSTA AVENUE ENCINITAS, CALIFORNIA 92024

EDG Project No. 185881-1

February 27, 2018

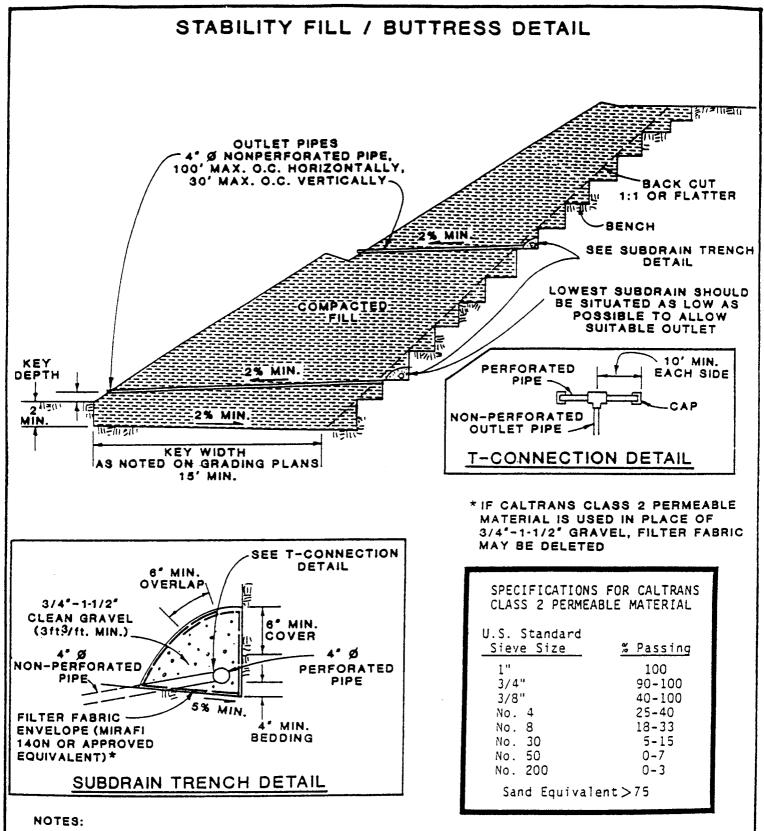
For buttress dimensions, see geotechnical report/plans. Actual dimensions of buttress and subdrain may be changed by the geotechnical consultant based on field conditions.

SUBDRAIN INSTALLATION-Subdrain pipe should be installed with perforations down as depicted. At locations recommended by the geotechnical consultant, nonperforated pipe should be installed

SUBDRAIN TYPE-Subdrain type should be Acrylon trile Butadiene Styrene (A.B.S.), Polyvinyl Chloride (PVC) or approved equivalent. Class 125,SDR 32.5 should be used for maximum fill depths of 35 feet. Class 200,SDR 21 should be used for maximum fill depths of 100 feet.

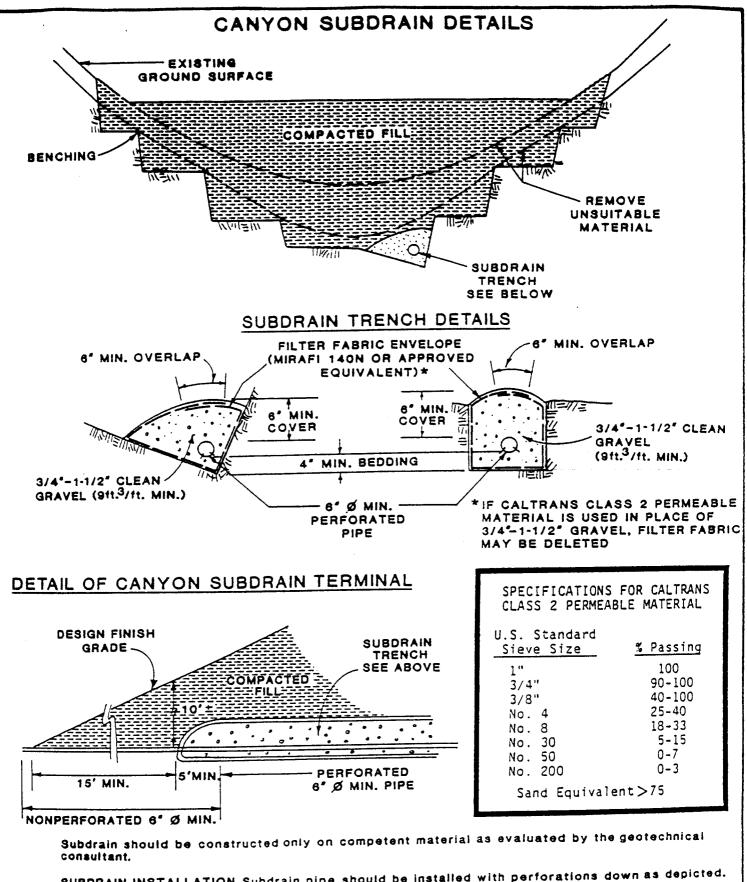
SUBDRAIN INSTALLATION Subdrain pipe should be installed with perforations down as depicted. At locations recommended by the geotechnical consultant, nonperforated pipe should be installed.

SUBDRAIN TYPE-Subdrain type should be Acrylonitrile Butadiene Styrene (A.B.S.), Polyvinyl Chloride (PVC) or approved equivalent. Class 125, SDR 32.5 should be used for maximum fill depths of 35 feet. Class 200, SDR 21 should be used for maximum fill depths of 100 feet.

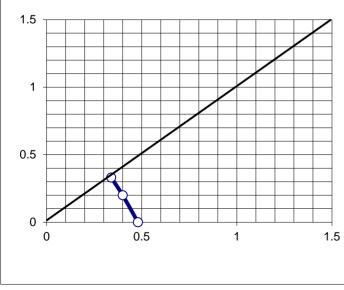
R' Value	64	58	49		
Corrected 'R' Value	64	58	49		
Exudation Pressure, lbs	6100	3310	1610		
Exudation Pressure, psi	488	265	129		
Stabilometer Thickness - ft	0.34	0.40	0.48		
Expansion Pressure	0.0010	0.0006	0.0000		
Expansion Press, Thick-ft	0.33	0.20	0.00

Cover Thickness by Expansion Pressure-Feet Expansion From Graph: 0.34

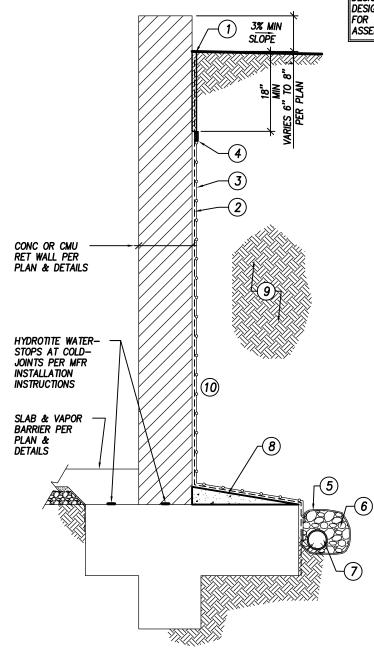
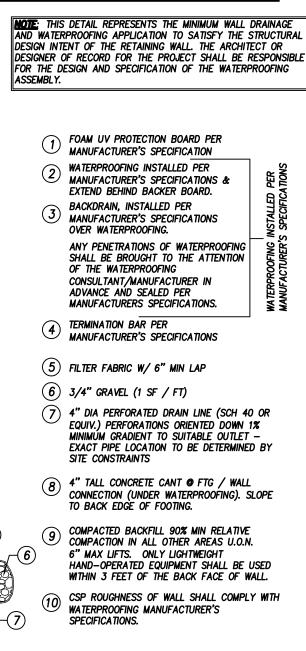
MINIMUM RETAINING WALL WATERPROOFING & DRAINAGE DETAIL

(NOT TO SCALE)
