Appendix D-1: Geological Hazard Evaluation and Design-Level Geotechnical Investigation

Type of Services	Geologic Hazard Evaluation and Design-Level Geotechnical Investigation
Project Name	455 Piercy Road
Location	455 Piercy Road San Jose, California
Client	InSite Property Group
Client Address	811 Catalina Avenue, Suite 1306 Redondo Beach, California
Project Number	1270-1-1
Date	March 22, 2021

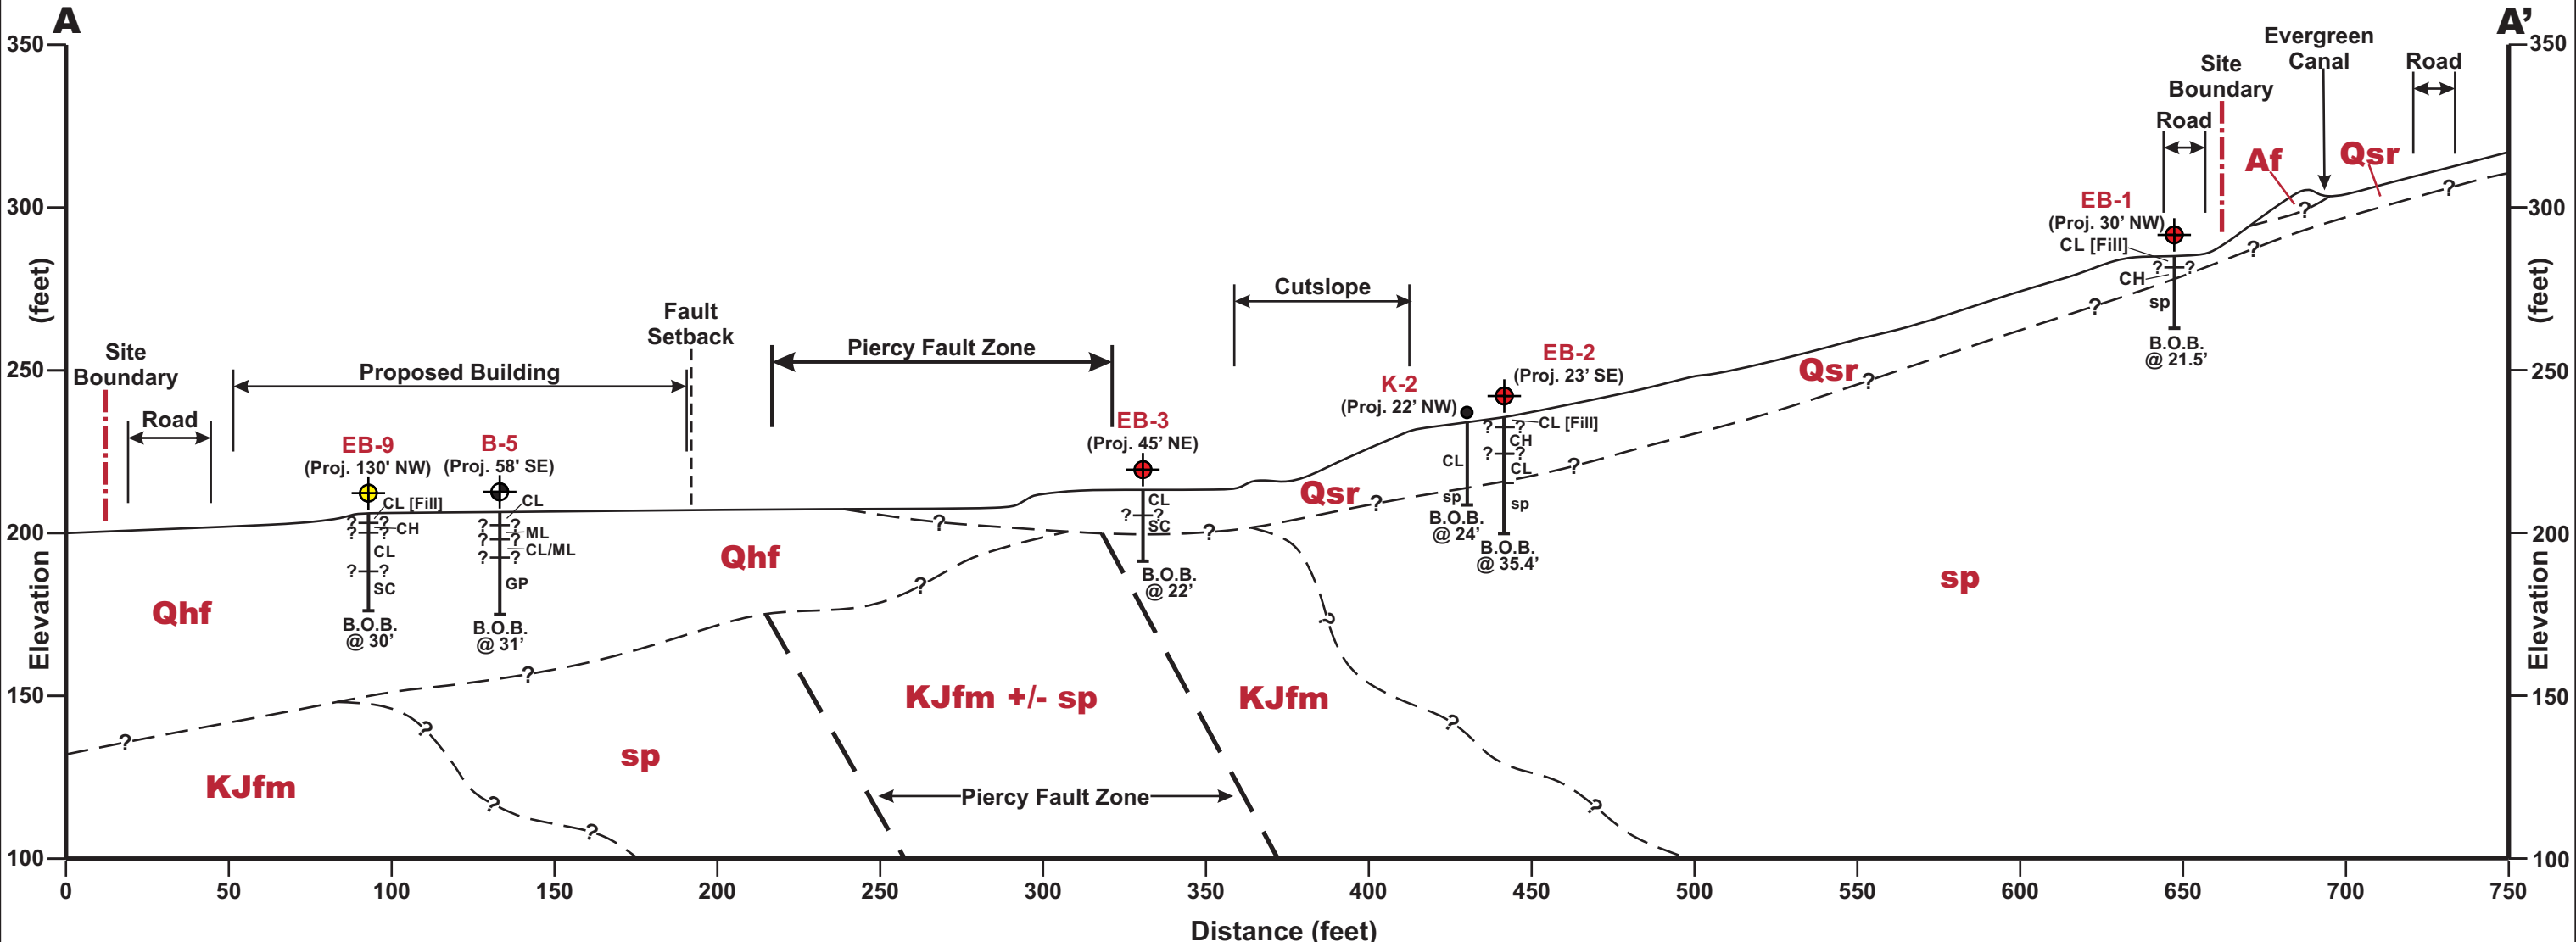
Geologic Cross Section A-A'		Project Number
455 Piercy Road San Jose, CA		1270-1-1
		Figure Number
		Figure 6
		Date
		March 2021
		Drawn By
		RRN

Section A-A'
(View Looking Northwest)
1"=50' H:V

Notes:
1) Surficial fills associated with existing pavements, landscaping or utilities are not shown.
2) The subsurface profile is conceptual and is based on limited subsurface data obtained from widely spaced borings. Actual subsurface conditions may vary significantly between borings.
3) See Figure 2 for location of cross section.

The Franciscan mélange bedrock (KJfm) consisted of fractured shale, mudstone and sandstone. This material was found to be in a weak to moderately strong condition, while the serpentinite bedrock varied considerably from weak to moderately hard. The distribution and thickness of various earth materials and subsurface structural features are depicted on our Site Geologic Map, Figure 5 and the Geologic Cross Sections A-A' and B-B', Figures 6 and 7, respectively.

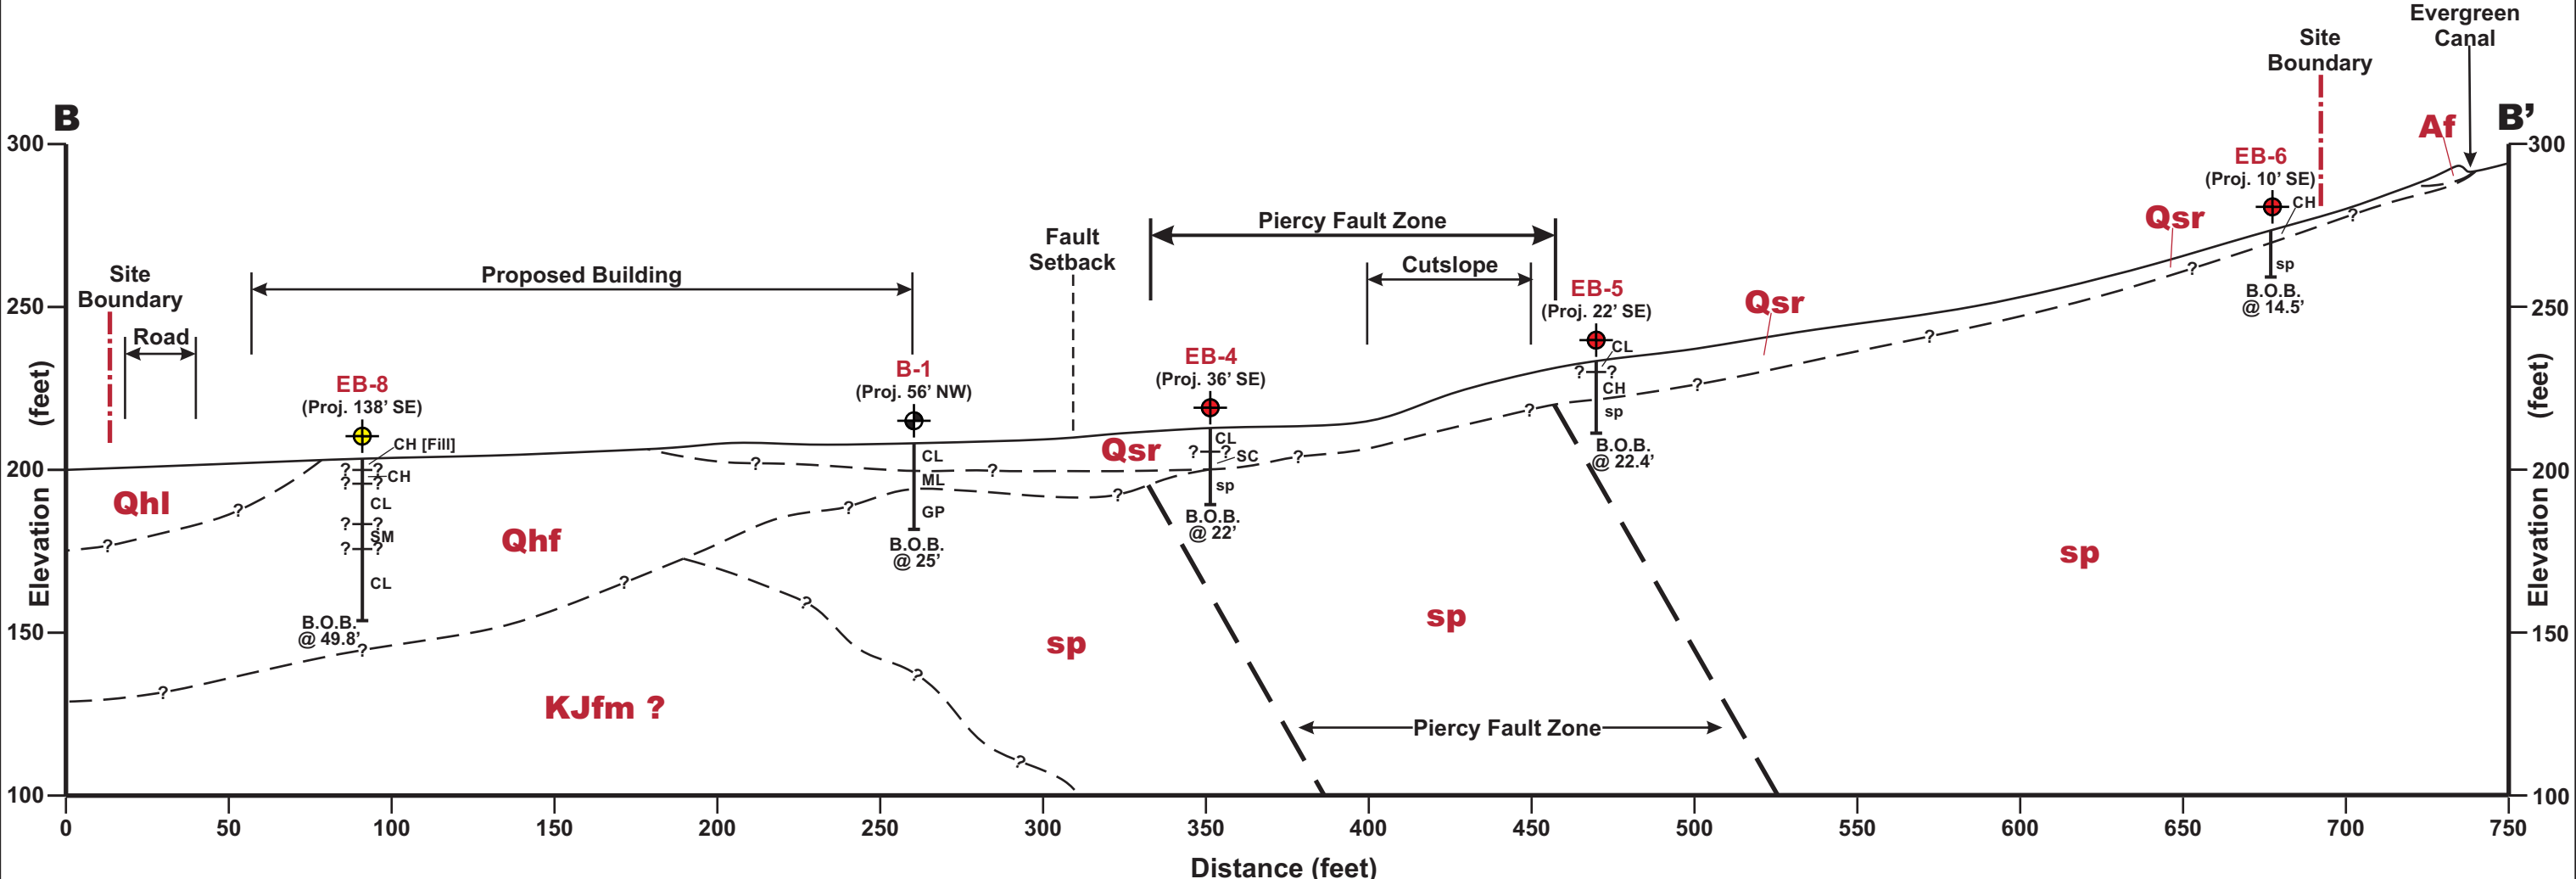
Geologic Cross Section B-B'		Project Number	
	455 Piercy Road San Jose, CA		1270-1-1	
			Figure Number	
			Figure 7	
			Date	March 2021
			Drawn By	RRN

Section B-B'
(View Looking Northwest)
1"=50' H:V

- Notes:
- 1) Surficial fills associated with existing pavements, landscaping or utilities are not shown.
 - 2) The subsurface profile is conceptual and is based on limited subsurface data obtained from widely spaced borings. Actual subsurface conditions may vary significantly between borings.
 - 3) See Figure 2 for location of cross section.

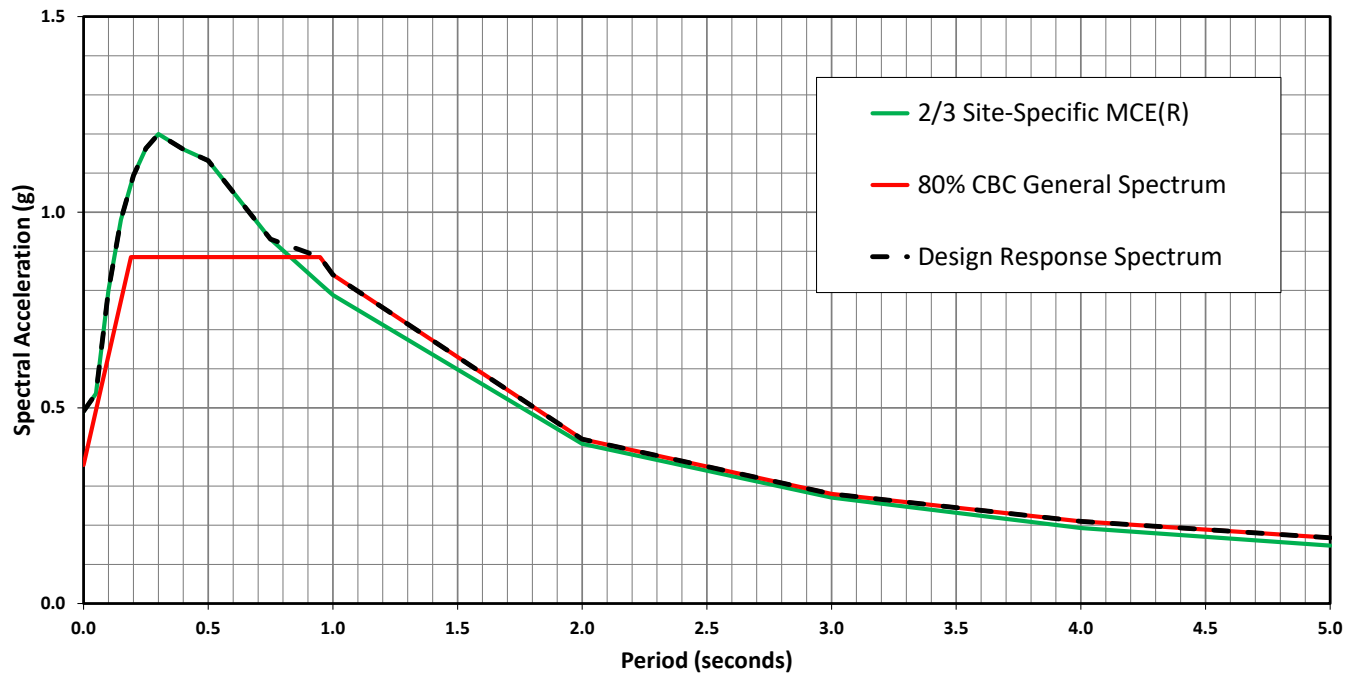
The Site-Specific Design Response Spectrum per Section 21.2, 21.3 and 21.4 of ASCE 7-16 is defined as the greater of the following at all periods:

- 2/3 of the Site-Specific MCE_R , or
- 80% of the CBC General Spectrum.
