Aquatic Resource Delineation Report
for the Los Coches Low Flow Urban Runoff
Diversion to Sewer Project
San Diego County, California
DPW Project Number 1023735

Prepared for
County of San Diego, Department of Public Works
Environmental Services Unit
5510 Overland Avenue, Suite 410
San Diego, CA 92123

Prepared by
RECON Environmental, Inc.
3111 Camino del Rio North, Suite 600
San Diego, CA 92108
P 619.308.9333

RECON Number 9009.22
July 6, 2022

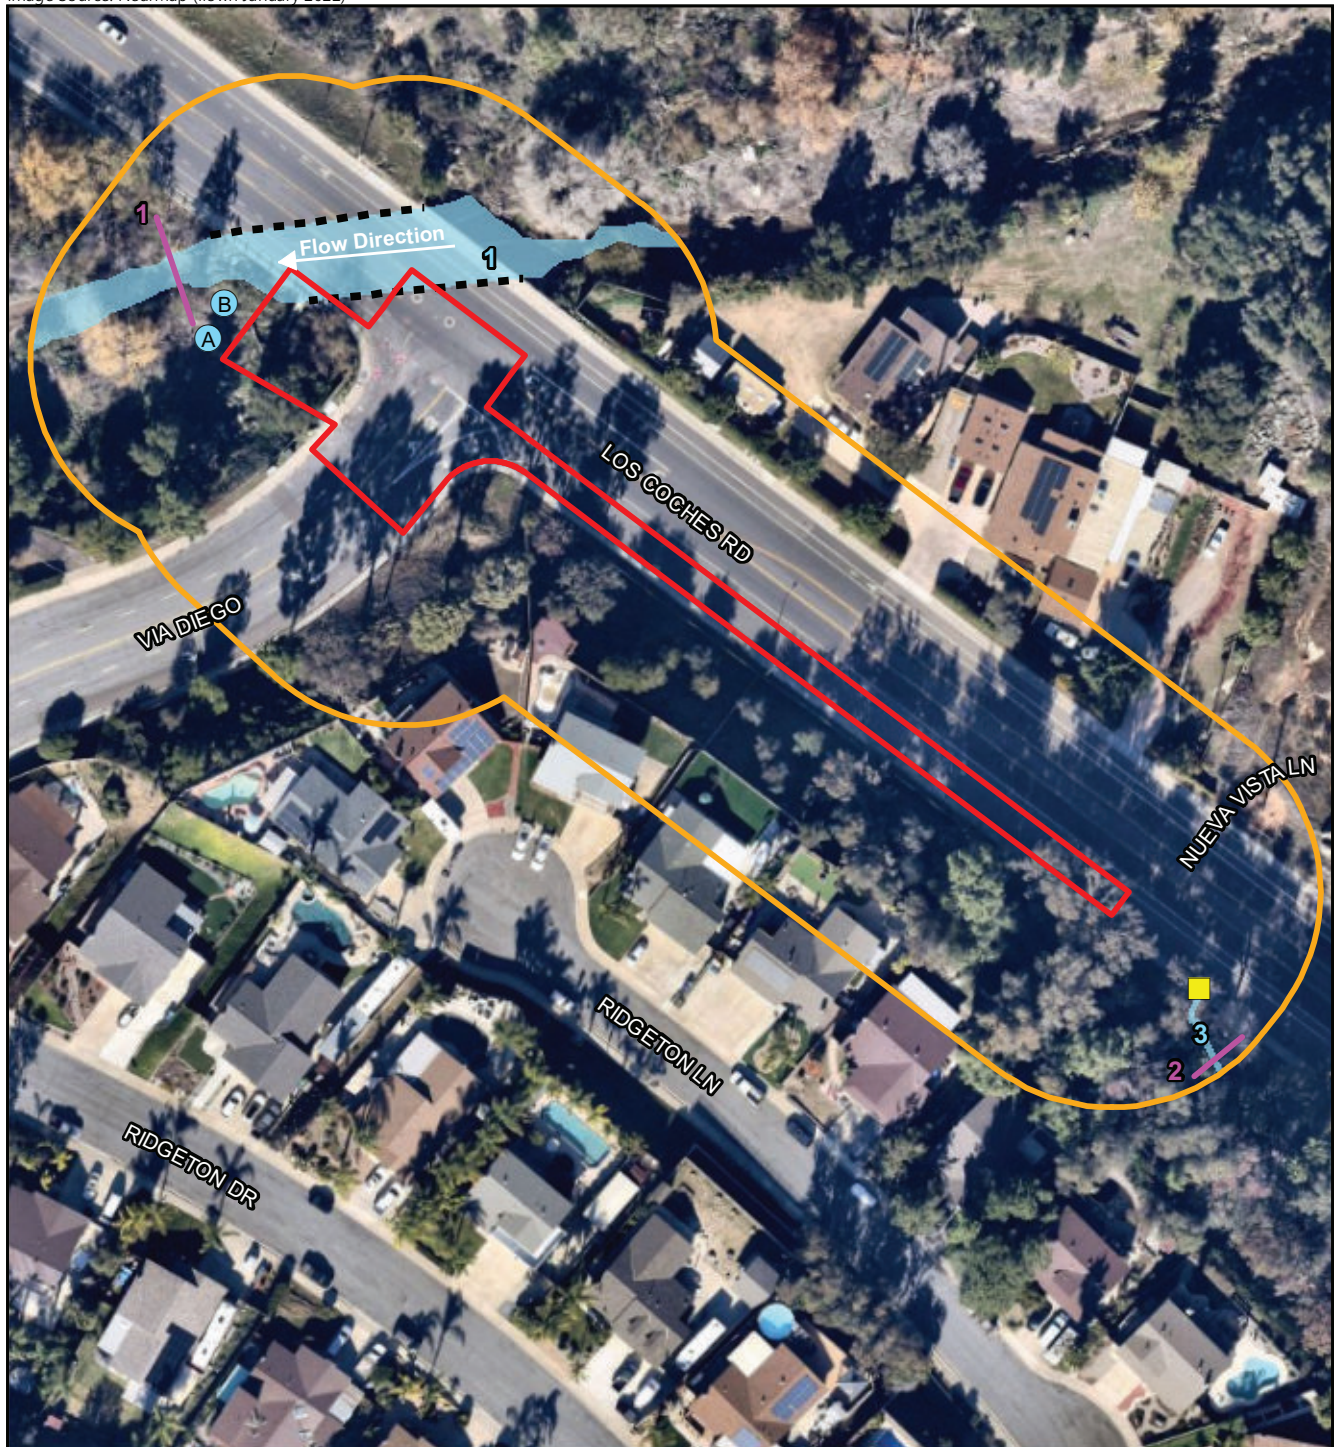
FIGURE 6

Aquatic Resources Delineated
within the Review Area

Areas mapped as riparian total 0.62 acre and include those areas mapped as southern willow scrub, disturbed southern riparian scrub, coast live oak woodland, and non-native riparian occurring outside the OHWM of the two drainages (see Figure 6). As discussed in Section 4.3, these habitats are characterized by upland herbaceous vegetation, with scattered willow trees and coast live oak trees, with varying understory composition. Since these southern riparian woodland and disturbed riparian areas all occur in the vicinity of waterway features, they have ecological connections to those features. Therefore, coast live oak woodland, southern willow scrub, disturbed southern riparian scrub, and non-native riparian patches are mapped as riparian. There is a 0.07-acre portion of coast live oak woodland that consists of planted oaks on a steep hillside that was not considered riparian due to its lack of association with a stream channel.

Non-wetland waters were delineated within the Review Area along the unvegetated portions of the Los Coches Creek active floodplain and the smaller drainage along Los Coches Road, totaling 0.21 acre and 387 linear feet (see Figure 6). These areas are comprised of the naturally occurring low flow channel that contained flowing water at the time of the survey in Los Coches Creek and the dry channel of the smaller tributary drainage. The lateral extent of the non-wetland waters areas was delineated at the OHWM. The OHWM here coincides with a break in slope, a change in vegetation and sediment composition, and other OHWM indicators mentioned in Section 4.4 above. This portion of Los Coches Creek appears to support an intermittent flow regime.

The maps of the delineated aquatic resources within the Review Areas are based on the above analysis (see Figure 6). The boundary of the majority of aquatic resource was obtained from a combination of GPS data collected in the field, aerial photography, and recent topographic survey data. Geographic information system mapping software (ArcMap) was used to produce the graphical maps contained in this report.

Under the Clean Water Act (CWA) Section 404, the USACE is authorized to regulate Waters of the U.S. including both wetland waters and non-wetland waters. The areas of potential Waters of the U.S. within the Review Area include non-wetland waters shown in Figure 6. Non-wetland waters along Los Coches Creek occur within the active floodplain delineated at the OHWM.

The different aquatic resource features have been numbered (see Figure 6) and a summary of these features is provided in Table 1. Los Coches Creek (feature 1 in Figure 6 and Table 1) appears to contain at least intermittent water flow. Los Coches Creek continues downstream from its confluence with this drainage, eventually draining into the San Diego River, a Traditional Navigable Water (TNW). In accordance with the CWA part 328.3, this moderate-sized drainage meets the definition of a relatively permanent water because it is a naturally occurring (at least) intermittent channel that contributes surface water flow to a TNW in a typical year. The unnamed smaller tributary in the south of the Review Area (feature 3 in Figure 6 and Table 1) would be considered a non-relatively permanent water of the U.S. having a significant nexus to a TNW. This nexus is the direct flow of the water into a storm drain system which empties into Los Coches Creek, then draining into the San Diego River, a TNW. The extent of these two features within the Review Area totals 0.21 acre and 387 linear feet and would likely be considered Non-wetland Waters of the U.S. under the jurisdiction of the USACE (Figure 7; Table 2).

The riparian areas (features 2 and 4 in Figure 6 and Table 1) occurring in the Review Area would likely not be USACE jurisdiction because they occur outside the OHWM and active floodplain of any drainage, and do not meet the three parameter USACE definition of a wetland.

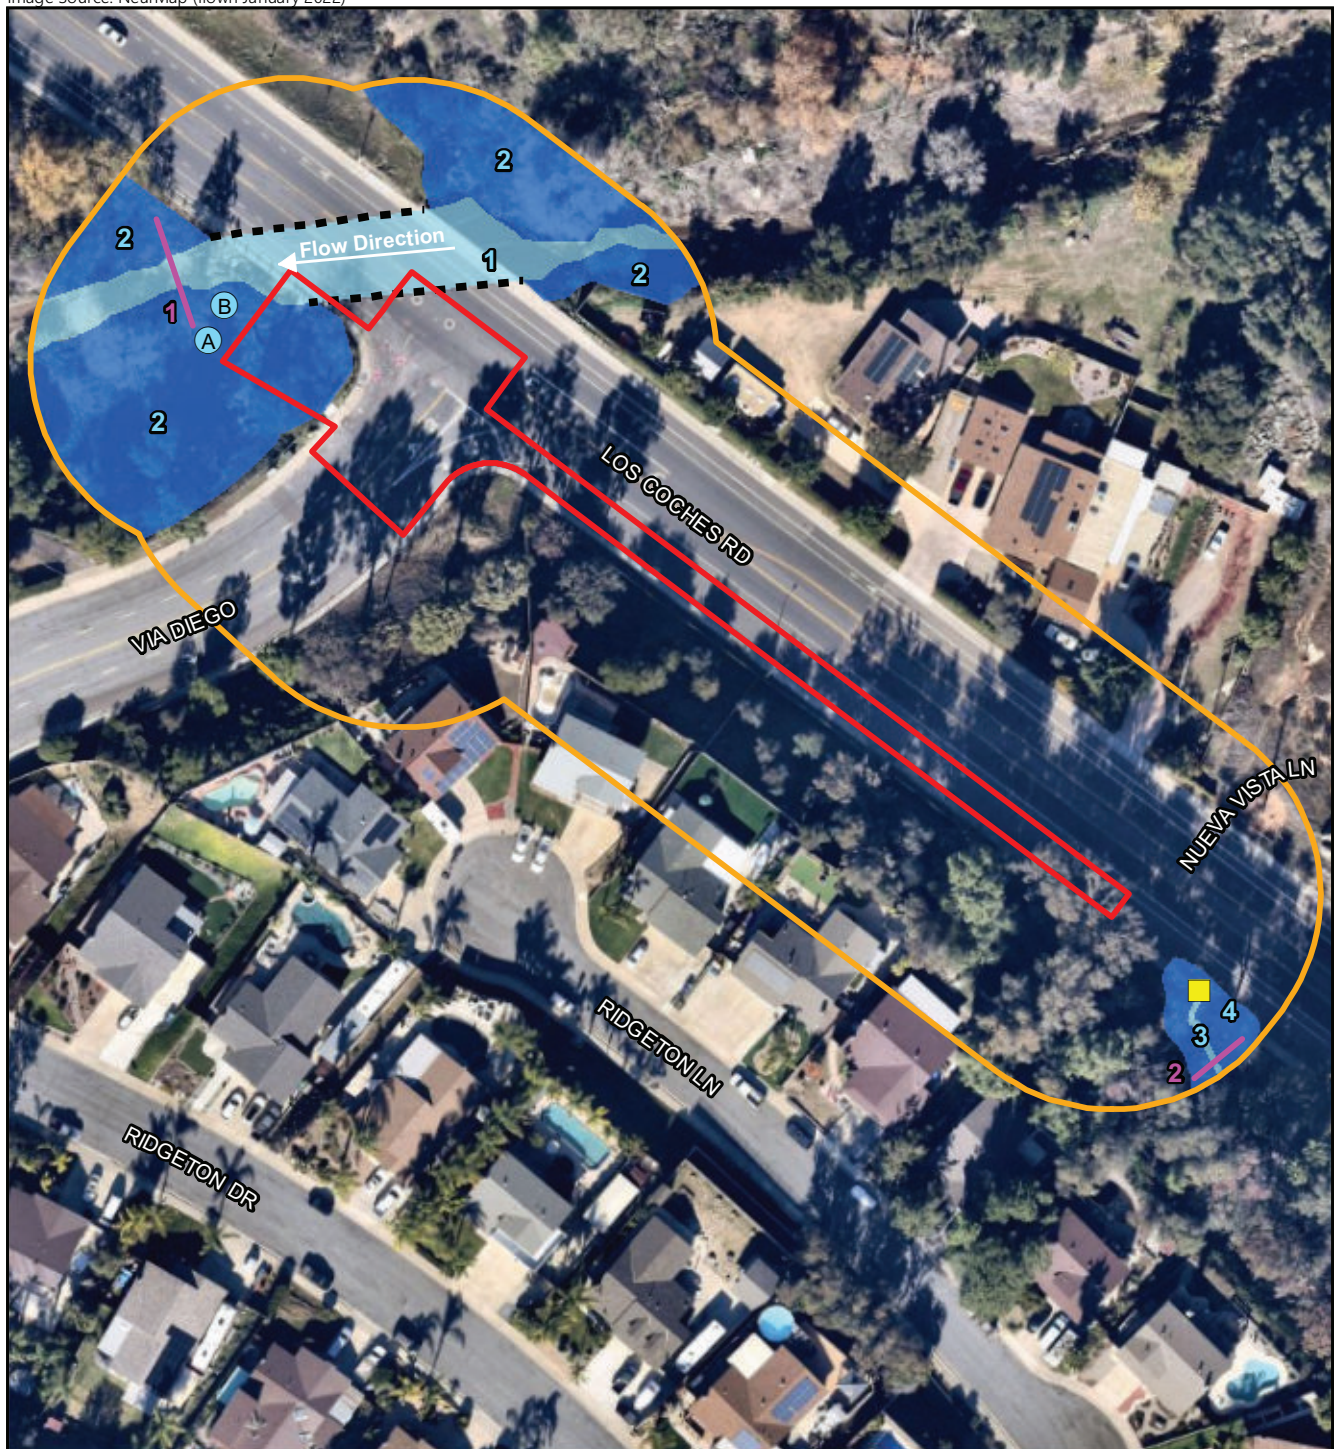
FIGURE 7

Potential USACE Waters of the U.S.
within the Review Area

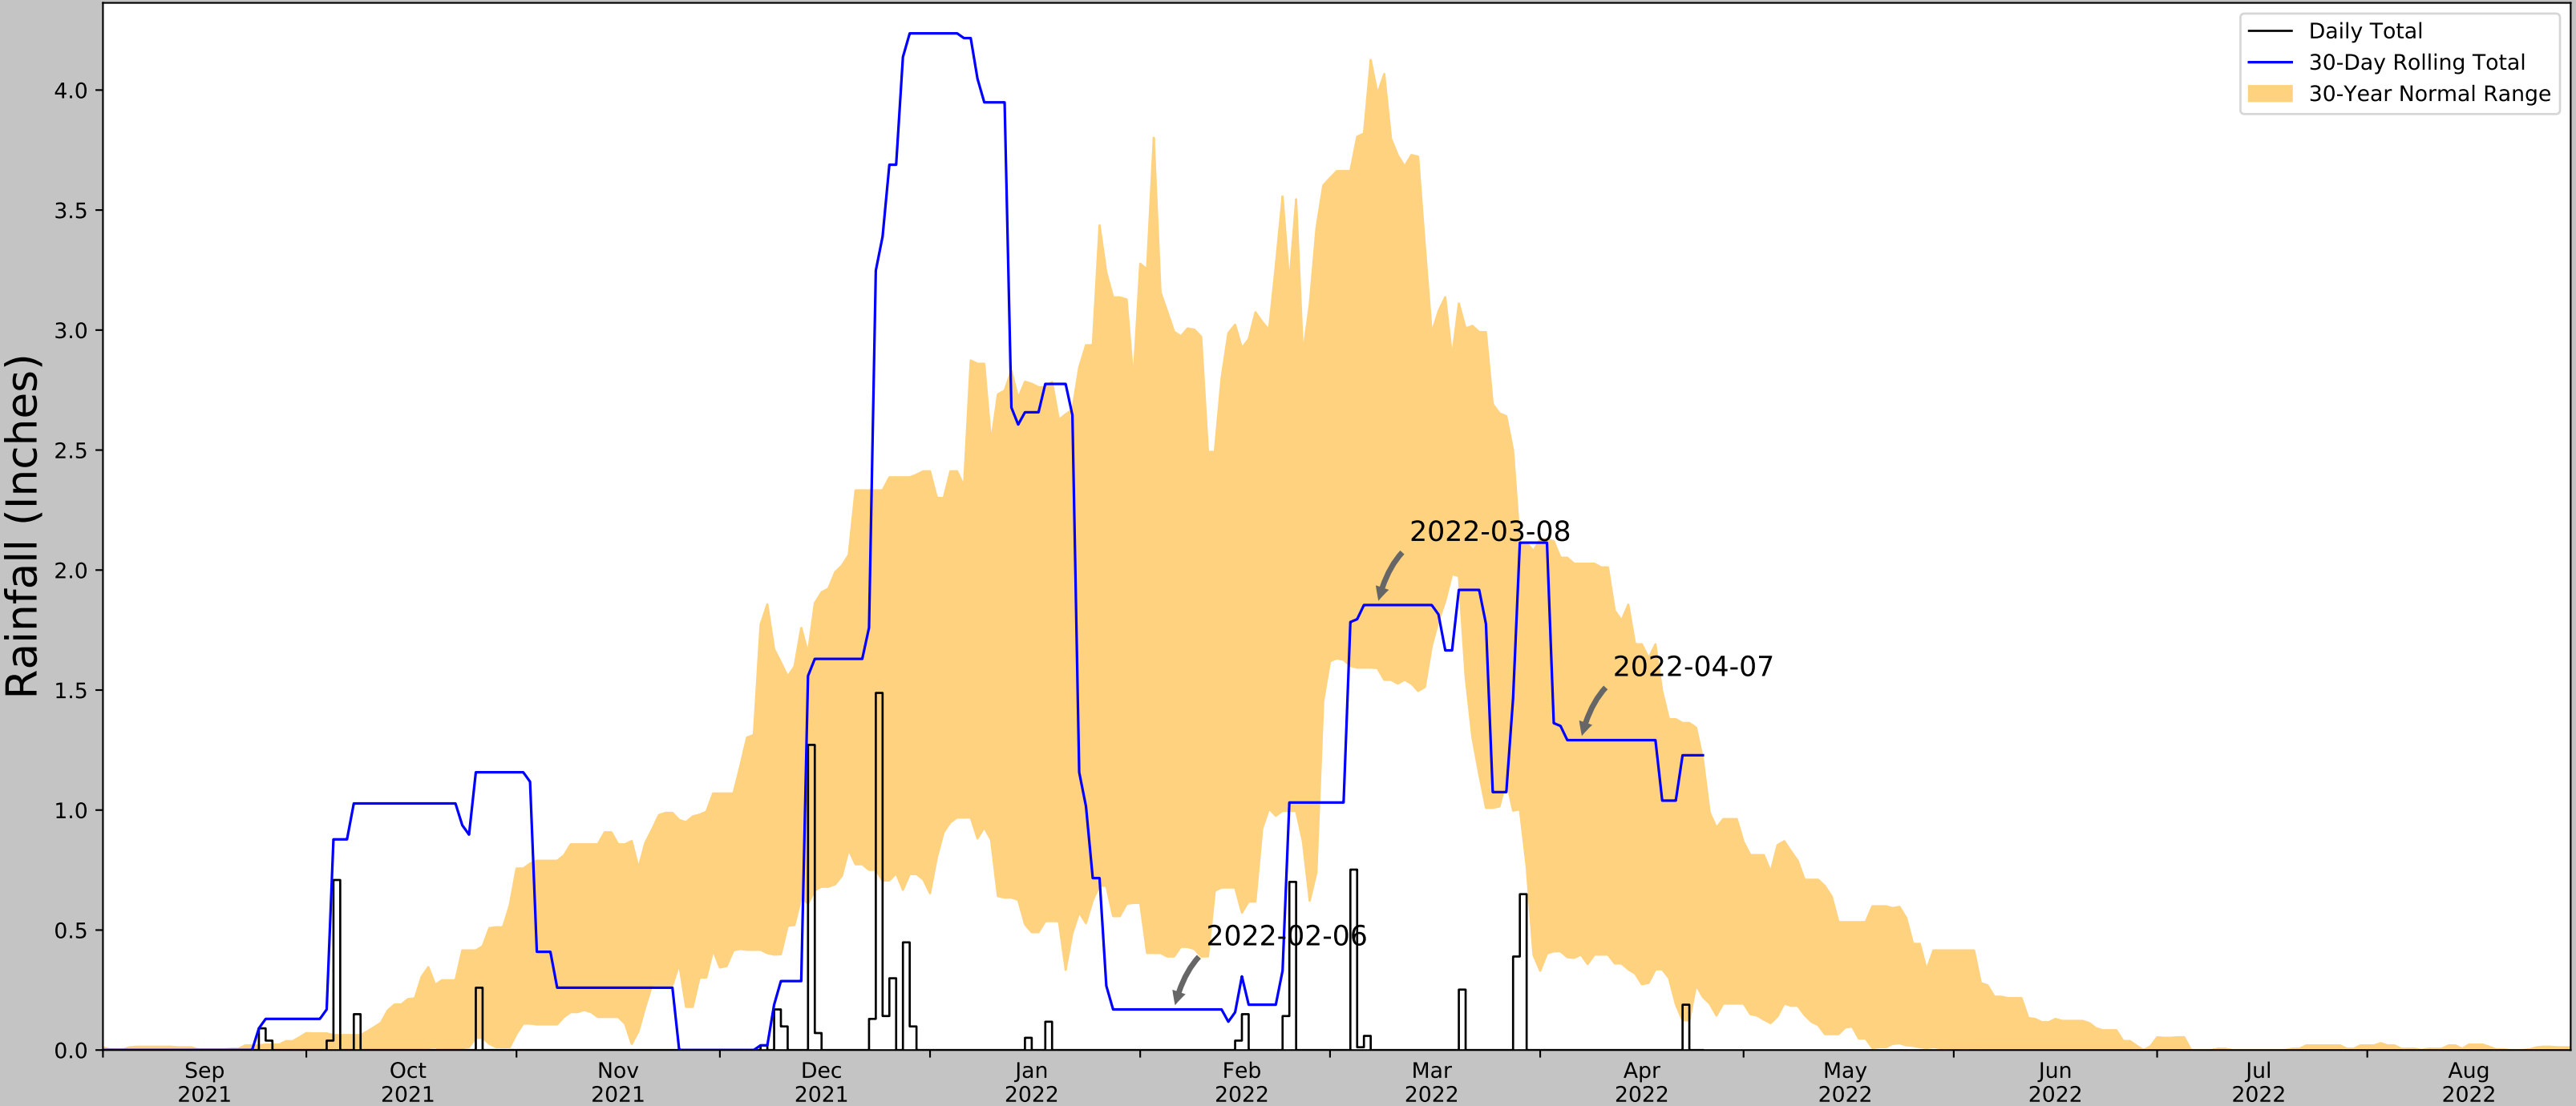
Antecedent Precipitation Tool Results

Antecedent Precipitation vs Normal Range based on NOAA's Daily Global Historical Climatology Network

Coordinates	32.83993, -116.91341
Observation Date	2022-04-07
Elevation (ft)	458.5
Drought Index (PDSI)	Not available
WebWIMP H ₂ O Balance	Dry Season

30 Days Ending	30 th %ile (in)	70 th %ile (in)	Observed (in)	Wetness Condition	Condition Value	Month Weight	Product
2022-04-07	0.397638	2.026772	1.291339	Normal	2	3	6
2022-03-08	1.591339	3.984646	1.854331	Normal	2	2	4
2022-02-06	0.389764	2.993307	0.169291	Dry	1	1	1
Result							Normal Conditions - 11

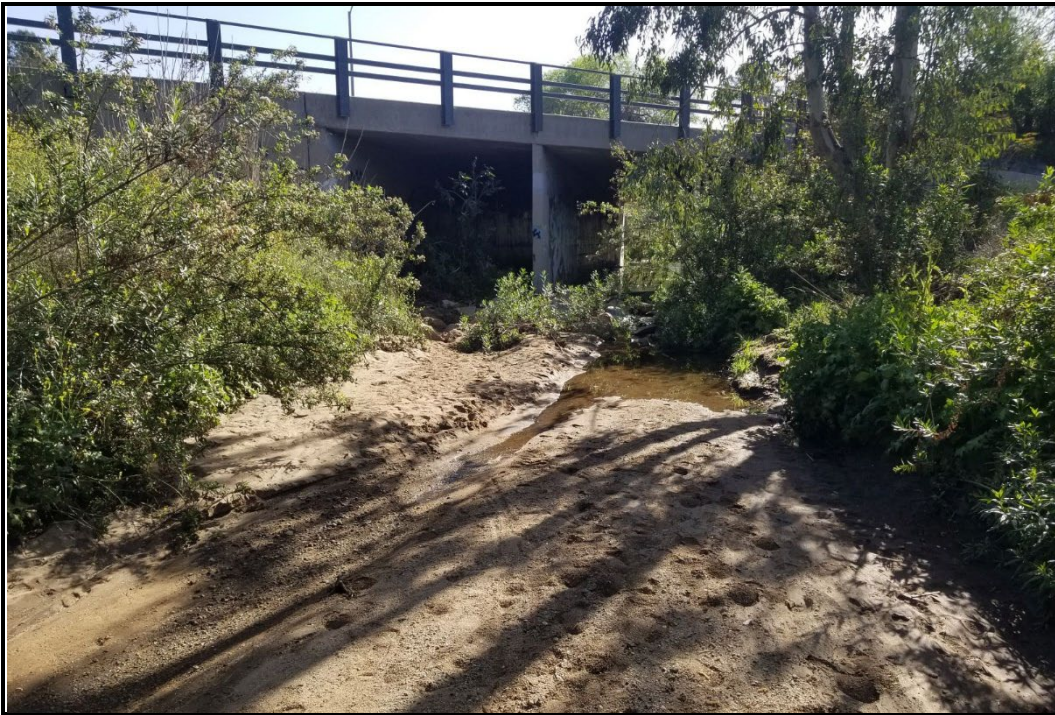
PHOTOGRAPH 1

View of Main Channel of Los Coches Creek West of the Bridge

Portions of the Review Area support coast live oak woodland, southern willow scrub, disturbed southern riparian scrub, and non-native riparian all of which were found not to meet the hydrophytic vegetation standard (Photographs 1 and 2). This habitat is characterized by mature coast live oak with scattered willow and cottonwood trees that create a discontinuous canopy cover. Shrub cover within the understory is generally low or absent but herbaceous cover can range from low to more than 50 percent. Plant species dominating the herbaceous layer can range from facultative to upland species.

The lateral extent of the ordinary high-water mark (OHWM) was delineated along the various drainages in the Review Areas using the observed hydrology indicators in accordance with *A Field Guide to the Identification of the Ordinary High Water Mark (OHWM) in the Arid West Region of the Western United States* (Lichvar and McColley 2008). The OHWM data forms are included as Attachment 5. Indicators observed and used to determine the extent of the OHWM include a change in vegetation, change in sediment texture, a break in slope, drift and sediment deposits, and ripples (see Photographs 1, 3, and 4). Los Coches Creek contained the most indicators with fewer observed

in the small drainage along the roadway. Los Coches Creek contained flowing water at the time of the survey (see Photographs 1 and 3).

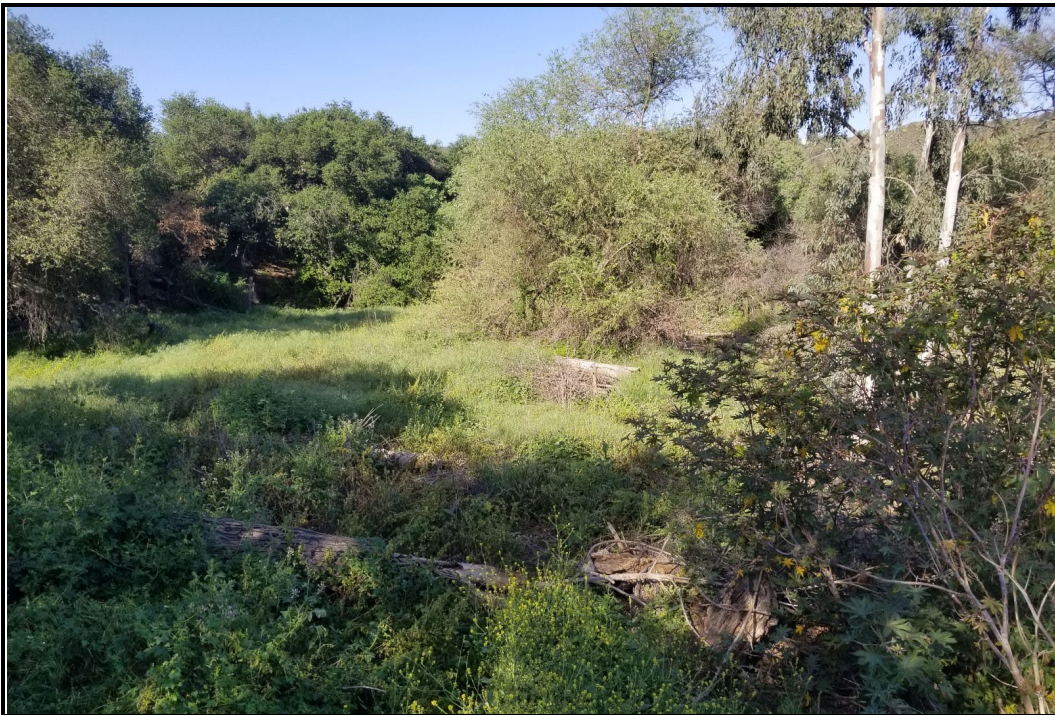
PHOTOGRAPH 2

View of Southern Riparian Woodland along Los Coches Creek

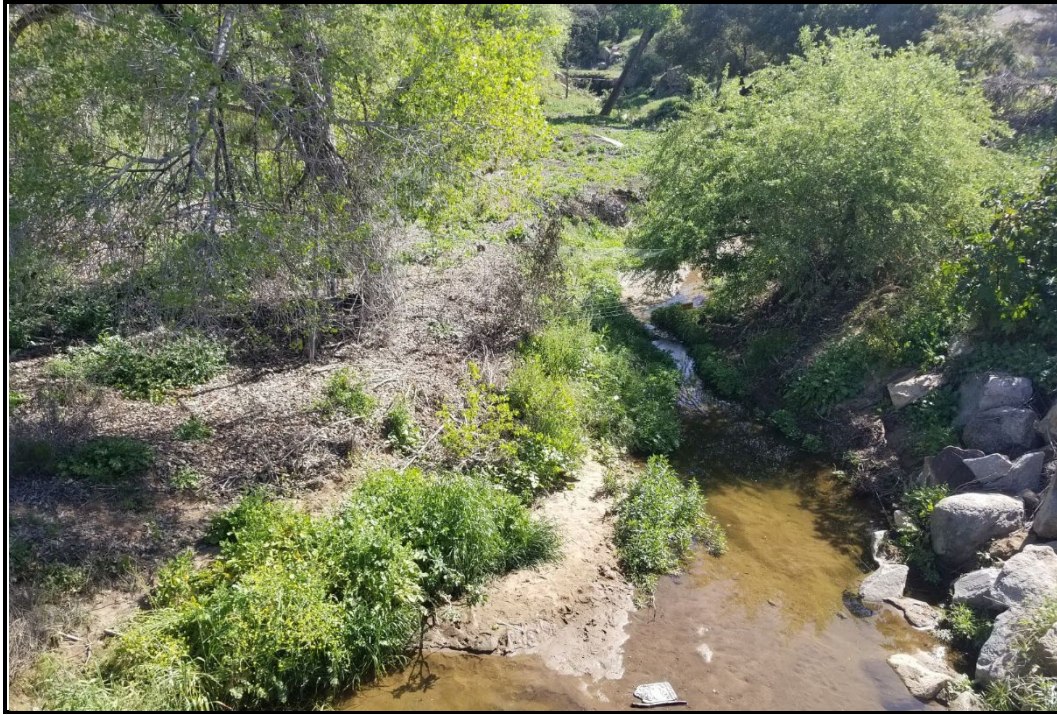
PHOTOGRAPH 3
View of Los Coches Creek East of the Bridge and
Disturbed Riparian Vegetation

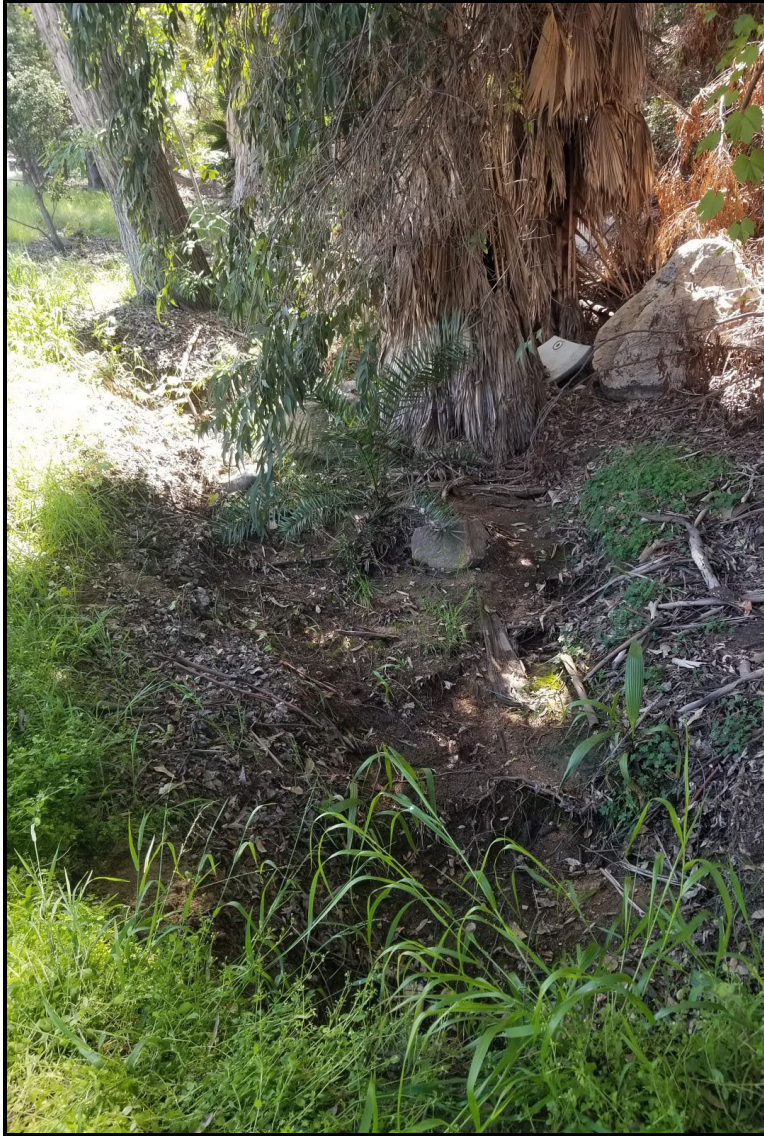
PHOTOGRAPH 4
View of Tributary Drainage along Los Coches Road,
Facing Upstream from the Culvert

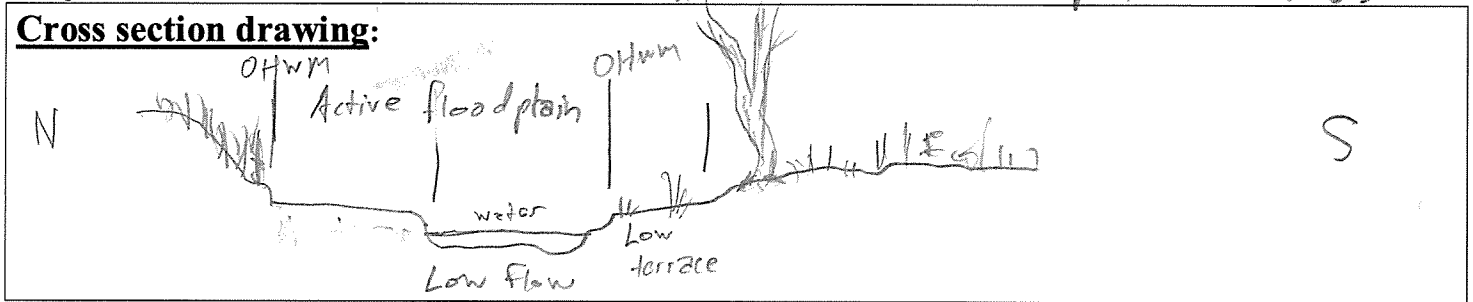
Cross section drawing:

OHWM

GPS point: 32.840053 -116.913481

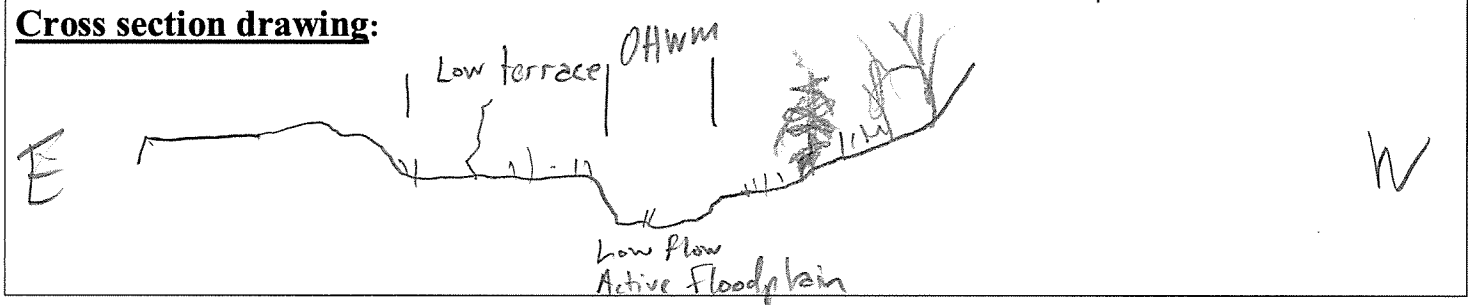
Cross section drawing:

**OHWM**

GPS point: 32.838911 -116.911691
