Converse Consultants

Subject: **PRELIMINARY GEOTECHNICAL INVESTIGATION AND WATER INFILTRATION TEST REPORT**
36 Unit Residential Development
7586 Jurupa Road
City of Jurupa Valley, Riverside County, California
Converse Project No. 20-81-168-01

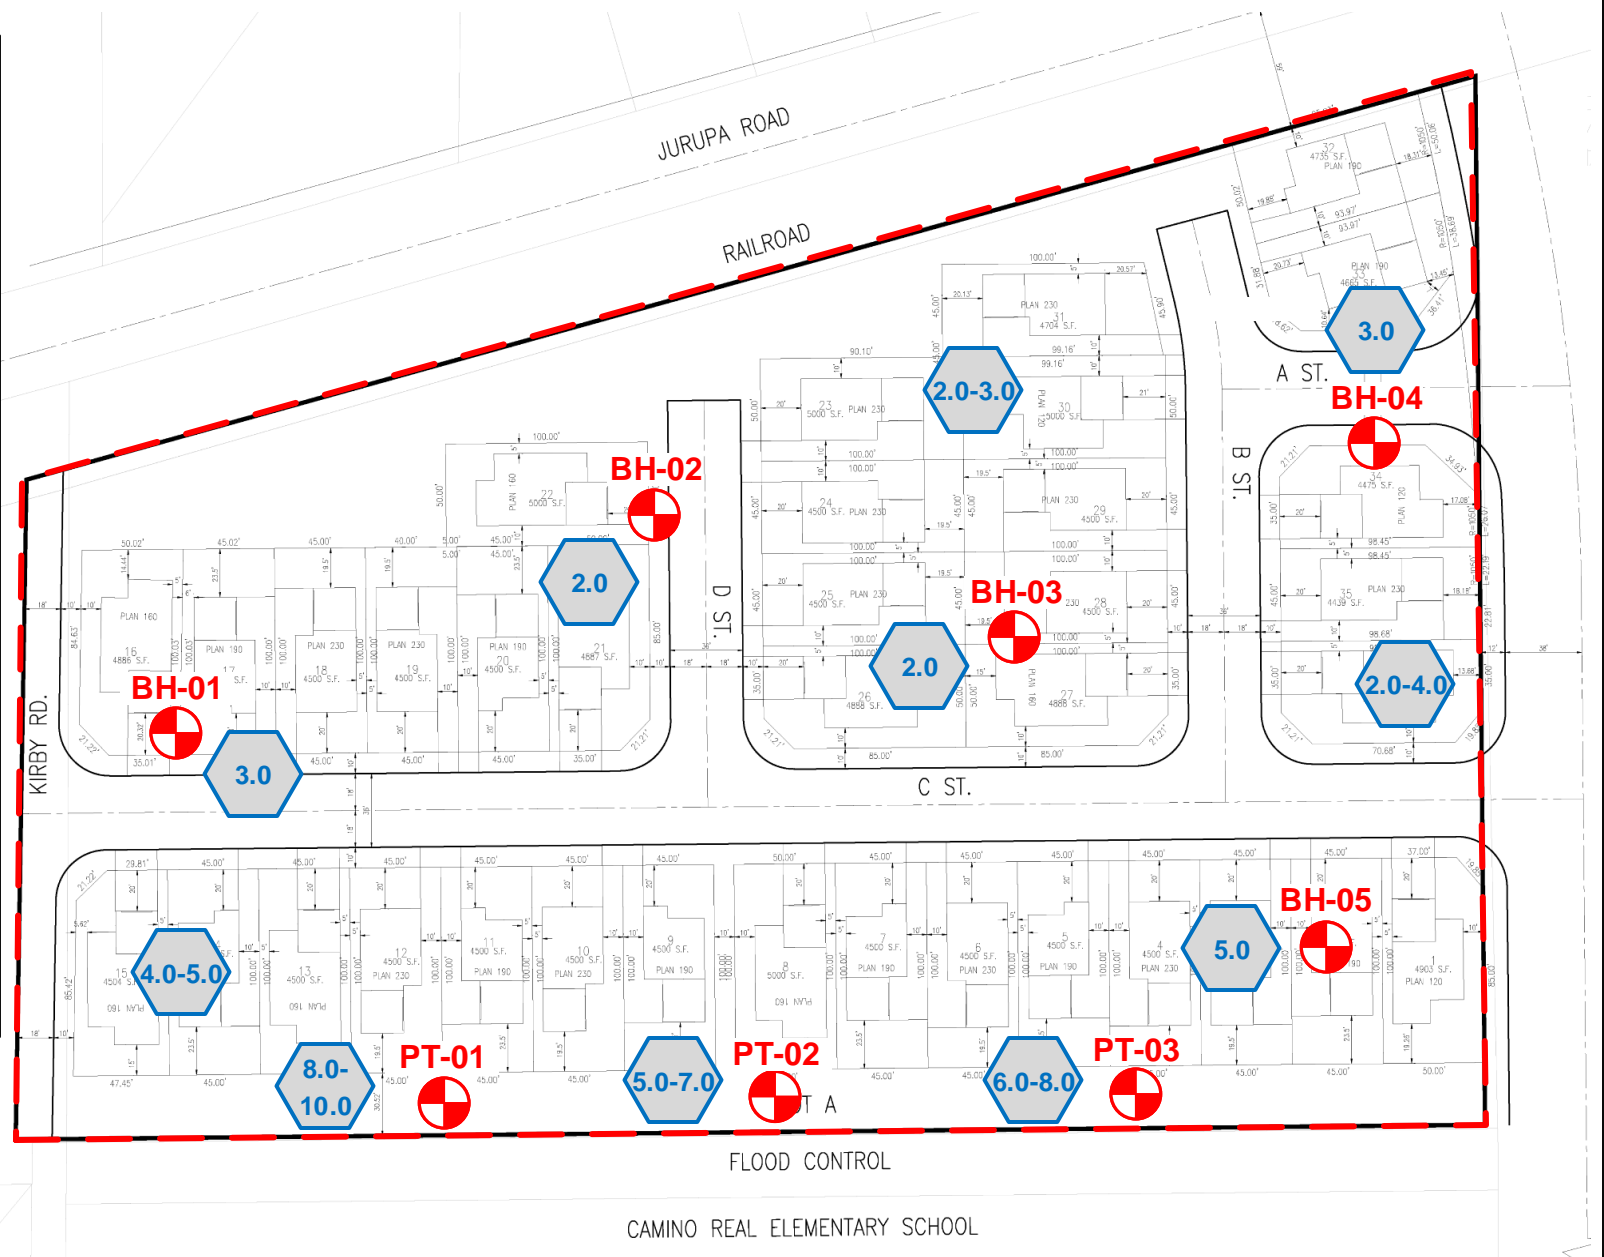
Figure No.
2

Approximate Boring, Percolation Test, and Overexcavation Locations Map

Approximate boring and percolation testing locations are indicated in Figure No. 2, *Approximate Boring, Percolation Test, and Overexcavation Locations Map*. For a description of the field exploration and sampling program, see Appendix A, *Field Exploration*.

The estimated locations and approximate depths of over-excavation of unsuitable, compressible soil materials are indicated on Figure No. 2, *Approximate Boring, Percolation Test, and Overexcavation Locations Map*.
