**ADVANCED GEOTECHNICAL SOLUTIONS, INC.**

Report No. 1310-04-B-6

**Subject:** *Response to City of Santee Review Comments and Geotechnical Third-Party Review, Tyler Street Residential Development, Southeast of Tyler Avenue and Mesa Heights Road, Santee, California*

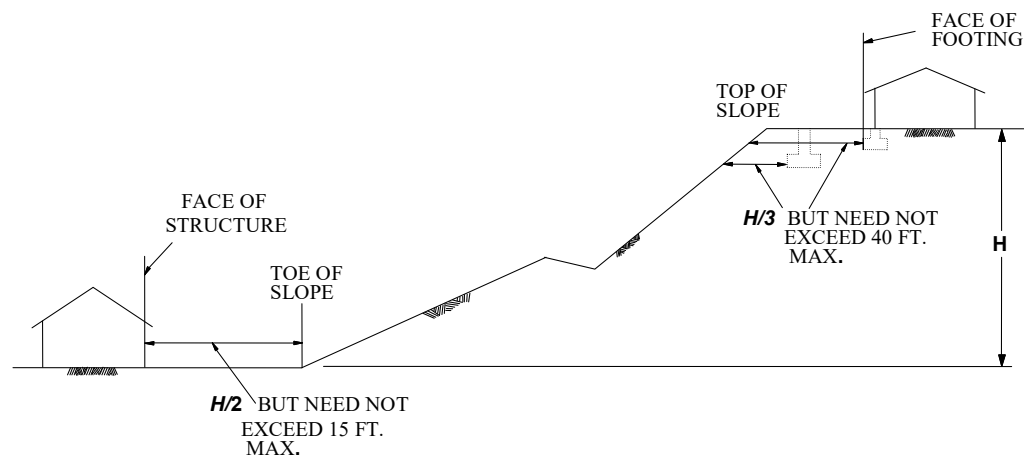
**FIGURE 7.1.4**  
**Setback Dimensions (CBC, 2013)**

For the subject site, where foundations for residential structures are to exist in proximity to slopes, the footings should be embedded to satisfy the requirements presented in the following figure.

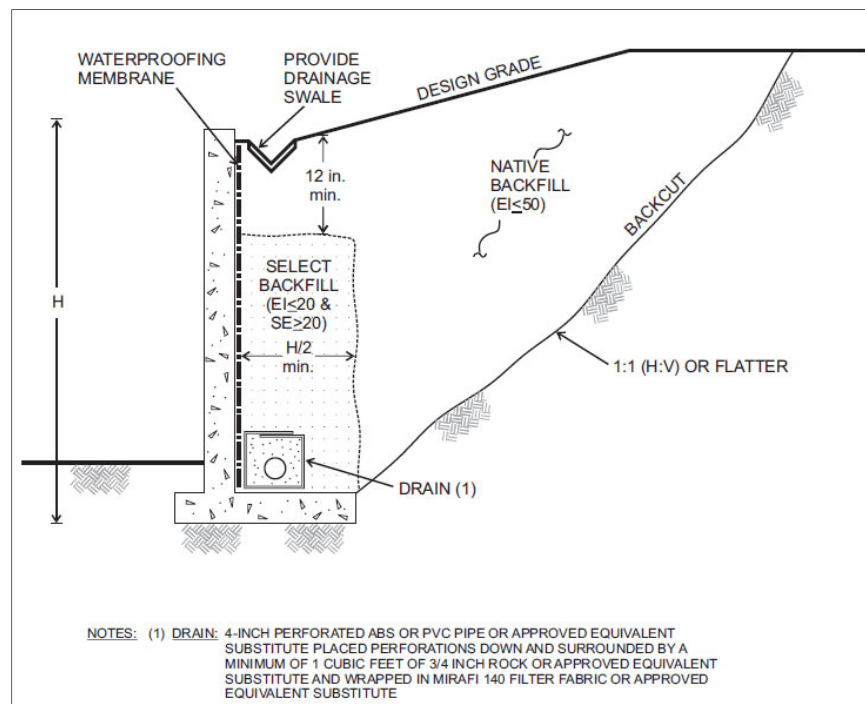
#### Detail RTW-A

Retaining walls should be provided with a drainage system adequate to prevent the buildup of hydrostatic forces as shown in Details RTW-A. Otherwise, the retaining walls should be designed to resist hydrostatic forces. Proper drainage devices should be installed along the top of the wall backfill and should be properly sloped to prevent surface water ponding adjacent to the wall. In addition to the wall drainage system, for building perimeter walls extending below the finished grade, the wall should be waterproofed and/or damp-proofed to effectively seal the wall from moisture infiltration through the wall section to the interior wall face.

The wall should be backfilled with granular soils placed in loose lifts no greater than 8-inches thick, at or near optimum moisture content, and mechanically compacted to a minimum 90 percent of the maximum dry density as determined by ASTM D1557. Flooding or jetting of backfill materials generally do not result in the required degree and uniformity of compaction and, therefore, is not recommended. No backfill should be placed against concrete until minimum design strengths are achieved as verified by compression tests of cylinders. The geotechnical consultant should observe the retaining wall footings, back drain installation, and be present during placement of the wall backfill to confirm that the walls are properly backfilled and compacted.

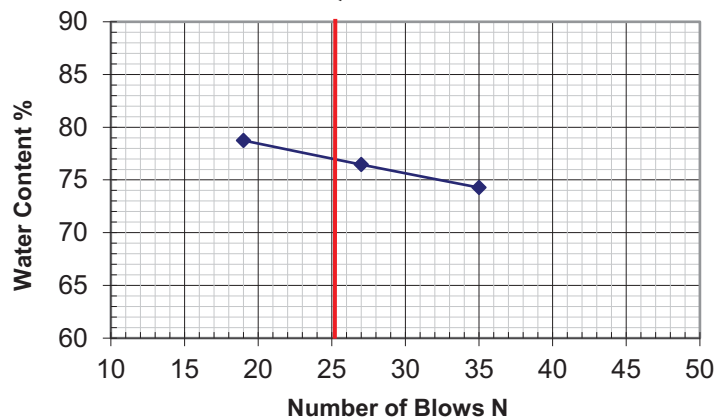
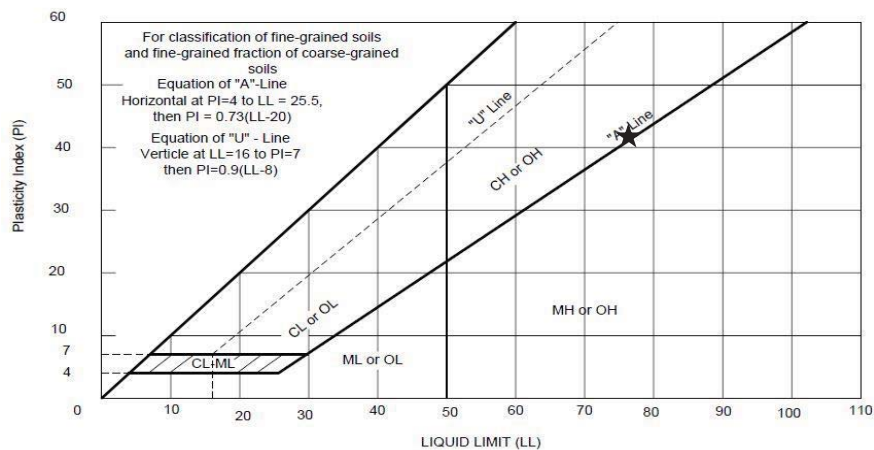
### LIQUID LIMIT

3	10
Wt. wet soil+can (g)	18.37	16.65
Wt. dry soil+can (g)	16.52	15.23
Wt. can (g)	11.23	11.15
Wt. moisture (g)	1.85	1.42
Wt. dry soil (g)	5.29	4.08
Water Content %	34.97	34.80

Liquid Limit (LL) 77 Plastic Limit (PL) 35 Plasticity Index (PI) 42

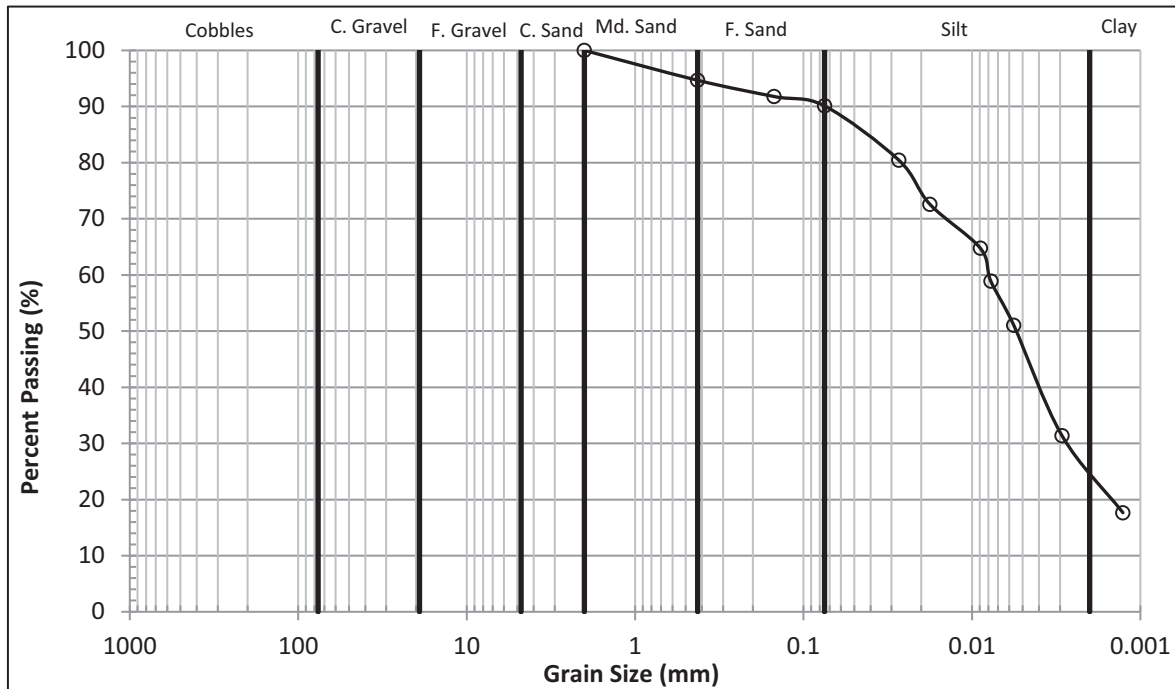
Excavation: BA-1  
 Depth: 30 '  
 By: H M

Grain Size (in/#)	Grain Size (mm)	Amount Passing (%)
3 "	75.00	
2 1/2 "	63.00	
2 "	50.00	
1 1/2 "	37.50	
1 "	25.00	
3/4 "	19.05	
1/2 "	12.70	
3/8 "	9.53	
# 4	4.75	
# 10	2.00	100.00
# 20	0.85	#N/A
# 30	0.60	#N/A
# 40	0.425	94.67
# 50	0.30	#N/A
# 60	0.212	#N/A
# 100	0.15	91.79
# 200	0.075	90.11
Hydro	0.0272	80.46
Hydro	0.0178	72.61
Hydro	0.0089	64.76
Hydro	0.0077	58.88
Hydro	0.0056	51.03
Hydro	0.0029	31.40
Hydro	0.0013	17.66

Summary	
% Gravel =	0.0
% Sand =	9.9
% Silt =	65.6
% Clay =	24.5
Sum =	100.0

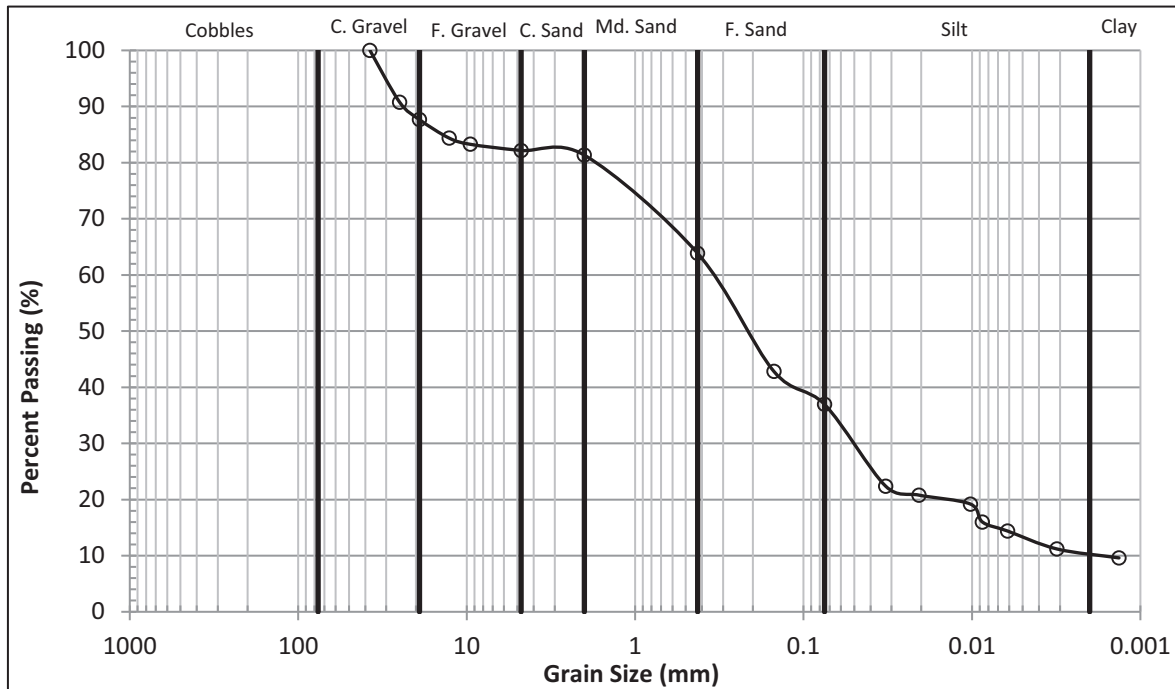
Excavation: BA-2  
 Depth: 9'  
 By: H M

Grain Size (in/#)	Grain Size (mm)	Amount Passing (%)
3 "	75.00	
2 1/2 "	63.00	
2 "	50.00	
1 1/2 "	37.50	100.00
1 "	25.00	90.77
3/4 "	19.05	87.67
1/2 "	12.70	84.38
3/8 "	9.53	83.28
# 4	4.75	82.18
# 10	2.00	81.34
# 20	0.85	#N/A
# 30	0.60	#N/A
# 40	0.425	63.84
# 50	0.30	#N/A
# 60	0.212	#N/A
# 100	0.15	42.83
# 200	0.075	36.95
Hydro	0.0326	22.39
Hydro	0.0207	20.79
Hydro	0.0102	19.19
Hydro	0.0087	15.99
Hydro	0.0061	14.39
Hydro	0.0031	11.19
Hydro	0.0013	9.60

Summary		
% Gravel =		17.8
% Sand =		51.7
% Silt =		20.1
% Clay =		10.4
Sum =		100.0

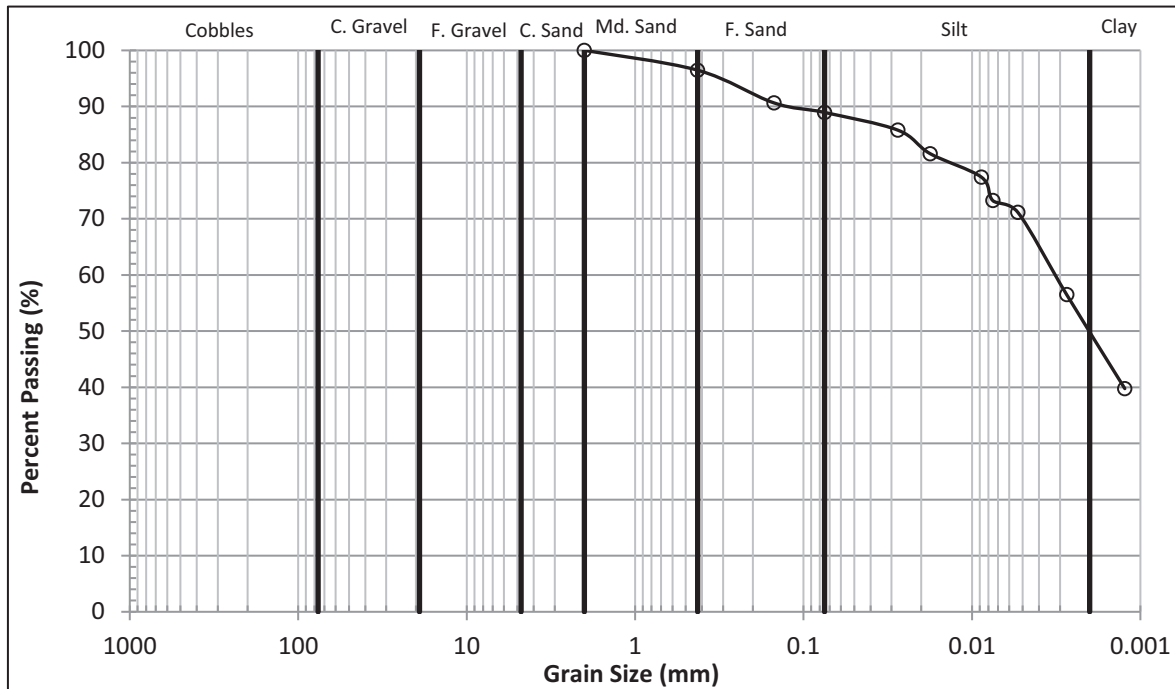
Excavation: BA-2  
 Depth: 40 '  
 By: H M

Grain Size (in/#)	Grain Size (mm)	Amount Passing (%)
3 "	75.00	
2 1/2 "	63.00	
2 "	50.00	
1 1/2 "	37.50	
1 "	25.00	
3/4 "	19.05	
1/2 "	12.70	
3/8 "	9.53	
# 4	4.75	
# 10	2.00	100.00
# 20	0.85	#N/A
# 30	0.60	#N/A
# 40	0.425	96.47
# 50	0.30	#N/A
# 60	0.212	#N/A
# 100	0.15	90.66
# 200	0.075	88.95
Hydro	0.0275	85.79
Hydro	0.0177	81.61
Hydro	0.0088	77.42
Hydro	0.0075	73.24
Hydro	0.0053	71.15
Hydro	0.0027	56.50
Hydro	0.0012	39.76

Summary	
% Gravel =	0.0
% Sand =	11.1
% Silt =	40.8
% Clay =	48.1
Sum =	100.0

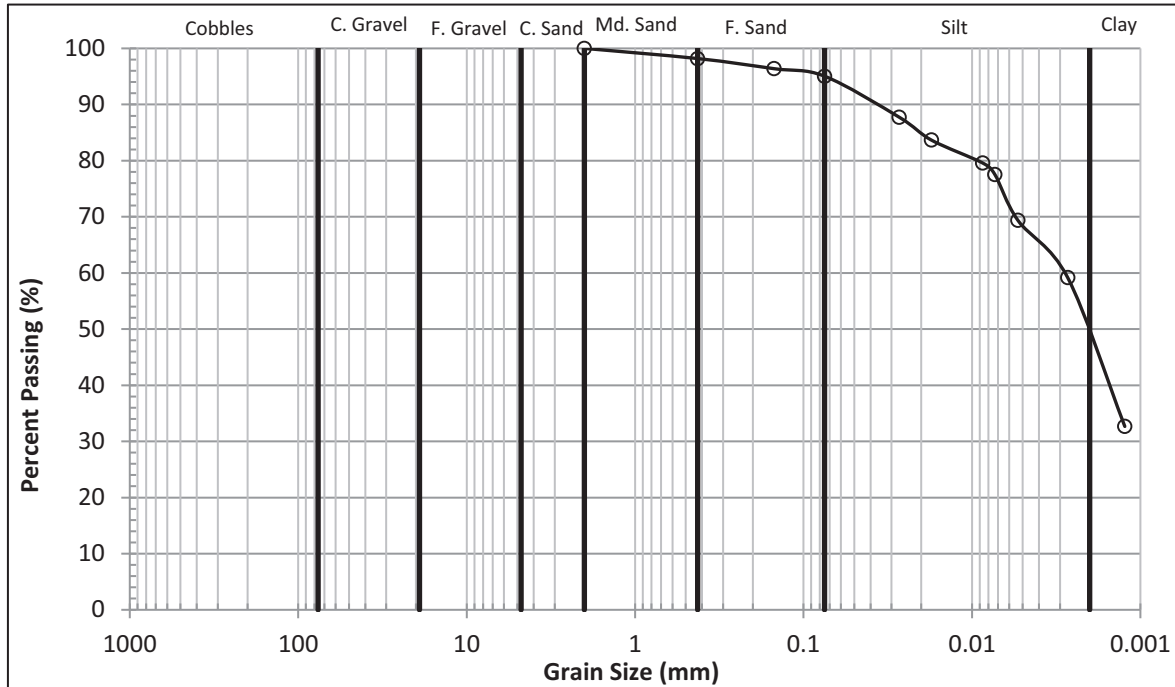
Excavation: BA-2  
 Depth: 50 '  
 By: H M

Grain Size (in/#)	Grain Size (mm)	Amount Passing (%)
3 "	75.00	
2 1/2 "	63.00	
2 "	50.00	
1 1/2 "	37.50	
1 "	25.00	
3/4 "	19.05	
1/2 "	12.70	
3/8 "	9.53	
# 4	4.75	
# 10	2.00	100.00
# 20	0.85	#N/A
# 30	0.60	#N/A
# 40	0.425	98.19
# 50	0.30	#N/A
# 60	0.212	#N/A
# 100	0.15	96.39
# 200	0.075	95.05
Hydro	0.0271	87.75
Hydro	0.0174	83.67
Hydro	0.0086	79.59
Hydro	0.0073	77.55
Hydro	0.0053	69.38
Hydro	0.0027	59.18
Hydro	0.0012	32.66

Summary	
% Gravel =	0.0
% Sand =	5.0
% Silt =	49.1
% Clay =	45.9
Sum =	100.0

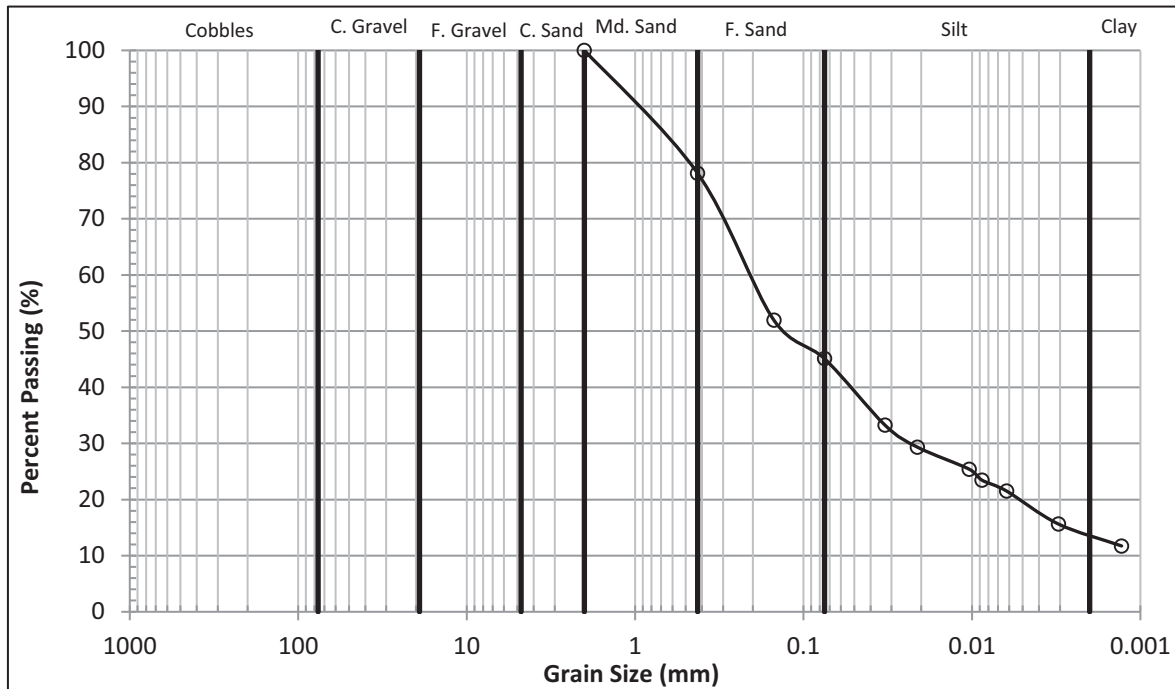
Excavation: T-5  
 Depth: 1'  
 By: H M

Grain Size (in/#)	Grain Size (mm)	Amount Passing (%)
3 "	75.00	
2 1/2 "	63.00	
2 "	50.00	
1 1/2 "	37.50	
1 "	25.00	
3/4 "	19.05	
1/2 "	12.70	
3/8 "	9.53	
# 4	4.75	
# 10	2.00	100.00
# 20	0.85	#N/A
# 30	0.60	#N/A
# 40	0.425	78.10
# 50	0.30	#N/A
# 60	0.212	#N/A
# 100	0.15	51.95
# 200	0.075	45.08
Hydro	0.0328	33.24
Hydro	0.0211	29.33
Hydro	0.0104	25.42
Hydro	0.0087	23.46
Hydro	0.0062	21.51
Hydro	0.0031	15.64
Hydro	0.0013	11.73

Summary	
% Gravel =	0.0
% Sand =	54.9
% Silt =	31.4
% Clay =	13.7
Sum =	100.0

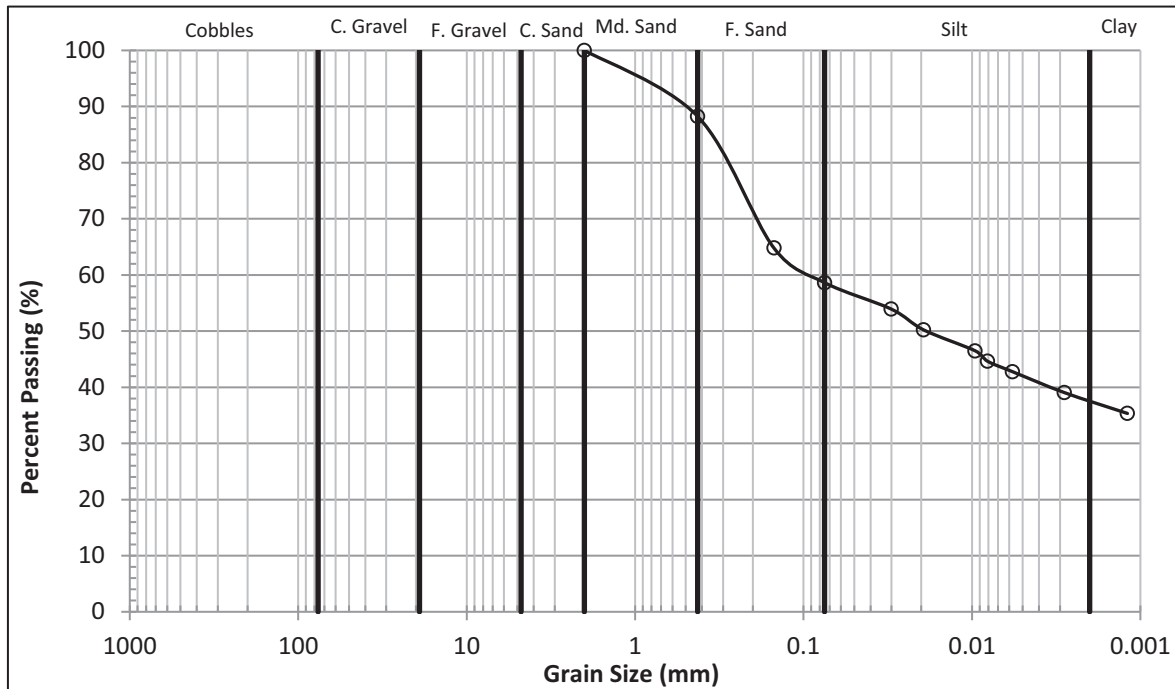
Excavation: T-8  
 Depth: 8'  
 By: H M

Grain Size (in/#)	Grain Size (mm)	Amount Passing (%)
3 "	75.00	
2 1/2 "	63.00	
2 "	50.00	
1 1/2 "	37.50	
1 "	25.00	
3/4 "	19.05	
1/2 "	12.70	
3/8 "	9.53	
# 4	4.75	
# 10	2.00	100.00
# 20	0.85	#N/A
# 30	0.60	#N/A
# 40	0.425	88.24
# 50	0.30	#N/A
# 60	0.212	#N/A
# 100	0.15	64.81
# 200	0.075	58.63
Hydro	0.0302	53.93
Hydro	0.0194	50.21
Hydro	0.0096	46.49
Hydro	0.0081	44.63
Hydro	0.0057	42.77
Hydro	0.0028	39.05
Hydro	0.0012	35.34

Summary	
% Gravel =	0.0
% Sand =	41.4
% Silt =	21.4
% Clay =	37.2
Sum =	100.0

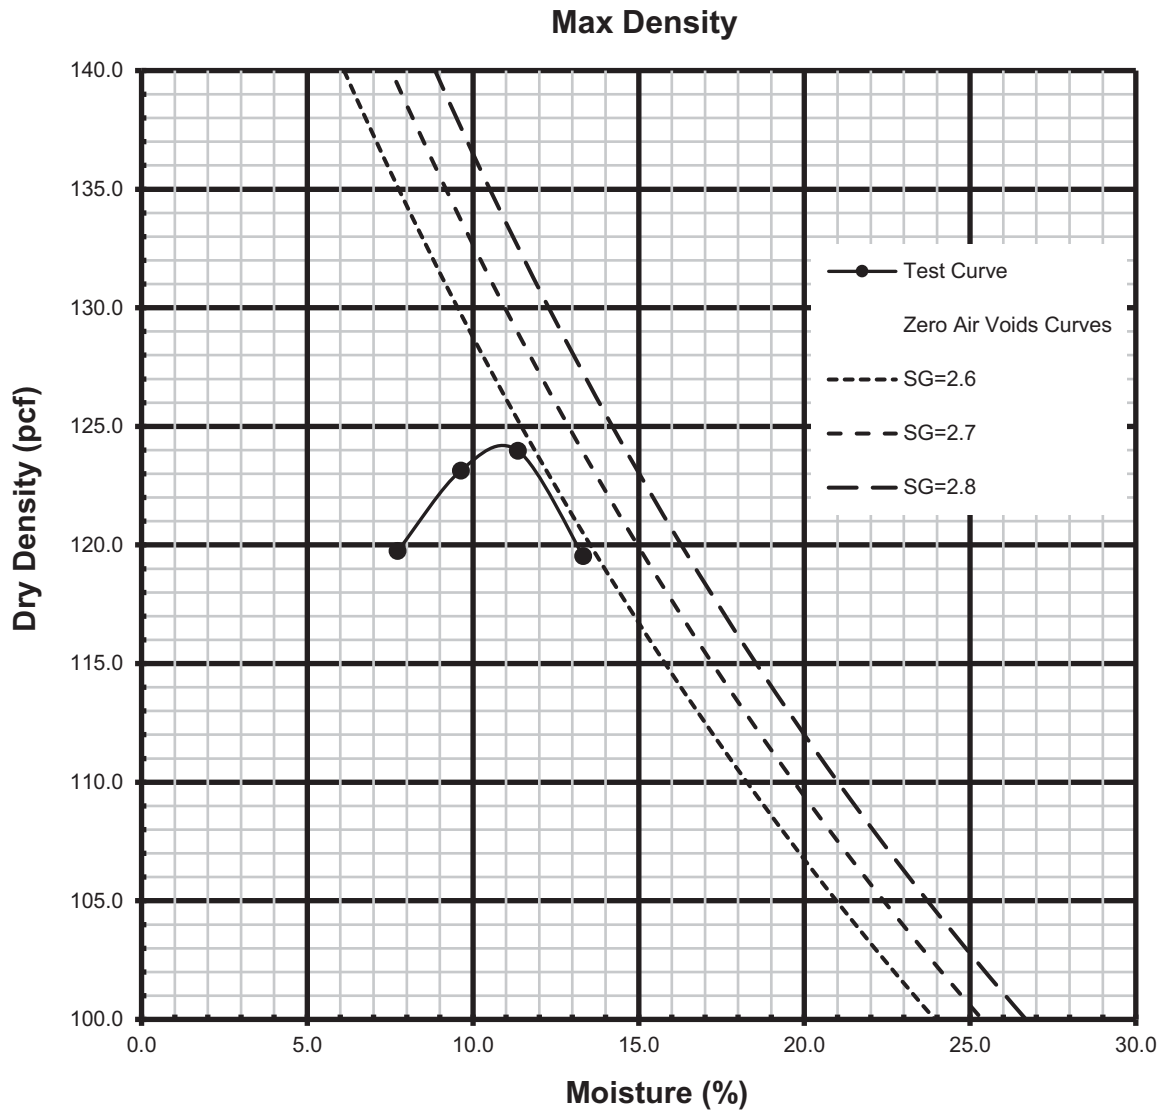
Method A			
Test Number	1	2	3	4
Dry Density (pcf)	119.8	123.1	124.0	119.5
Moisture Content (%)	7.7	9.6	11.4	13.3

Maximum Density 124.0 pcf

Optimum Moisture 11.0 %

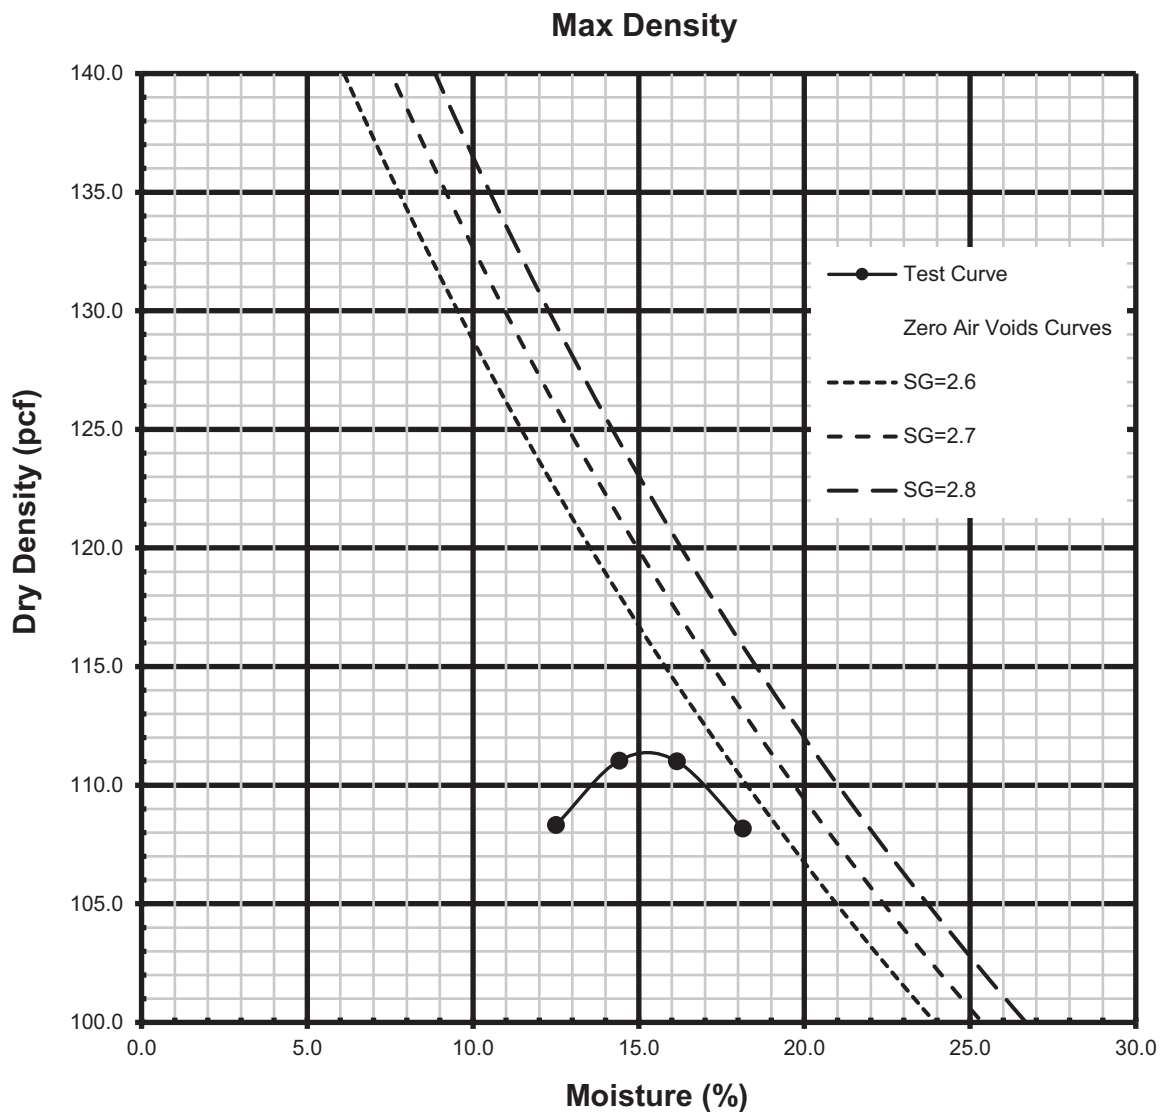
Excavation: T-8  
Depth: 8'  
Description: Brown Sandy Clay  
By: H-M

Method	A			
Test Number	1	2	3	4
Dry Density (pcf)	108.3	111.0	111.0	108.2
Moisture Content (%)	12.5	14.4	16.1	18.1

Maximum Density 111.0 pcf

Optimum Moisture 15.5 %

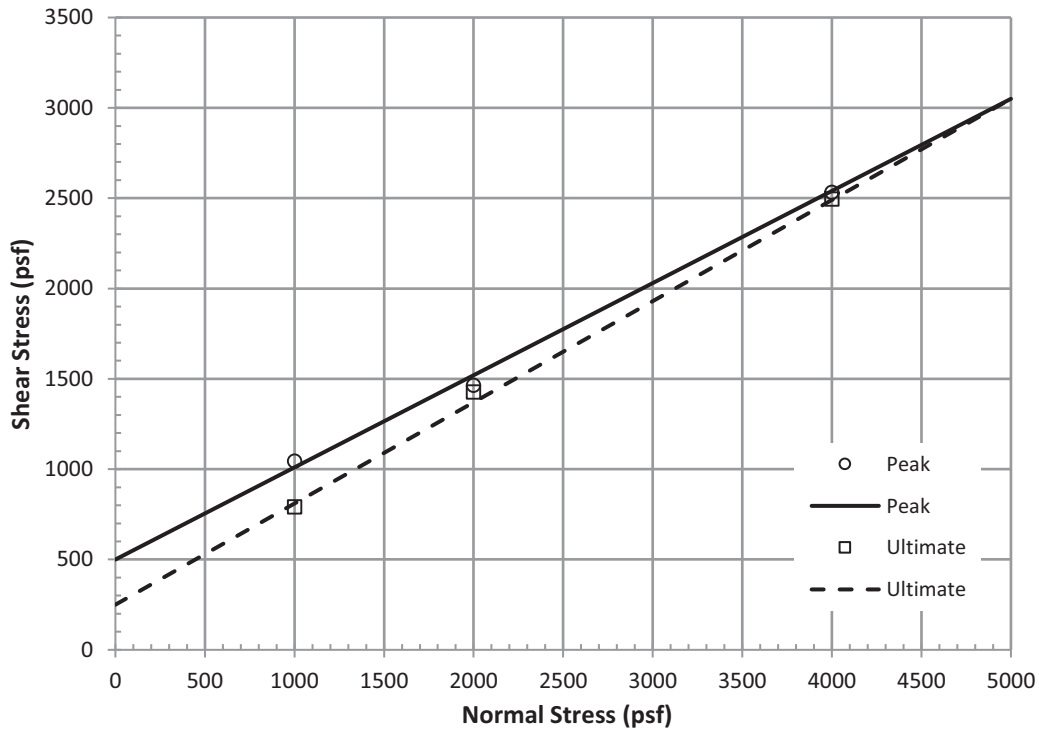
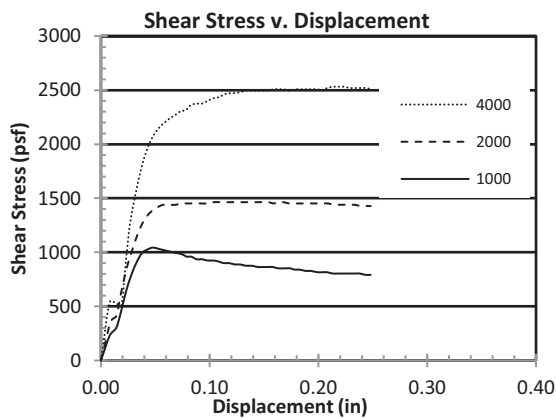
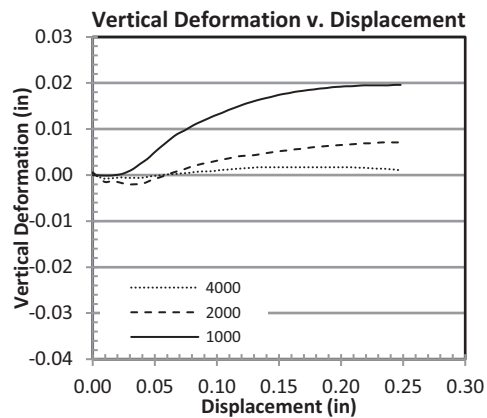
Method: Drained  
 Consolidation: Yes  
 Saturation: Yes  
 Shearing Rate (in/min): 0.04

Peak	Ultimate
Friction Angle, phi (deg)	27	29
Cohesion (psf)	500	250

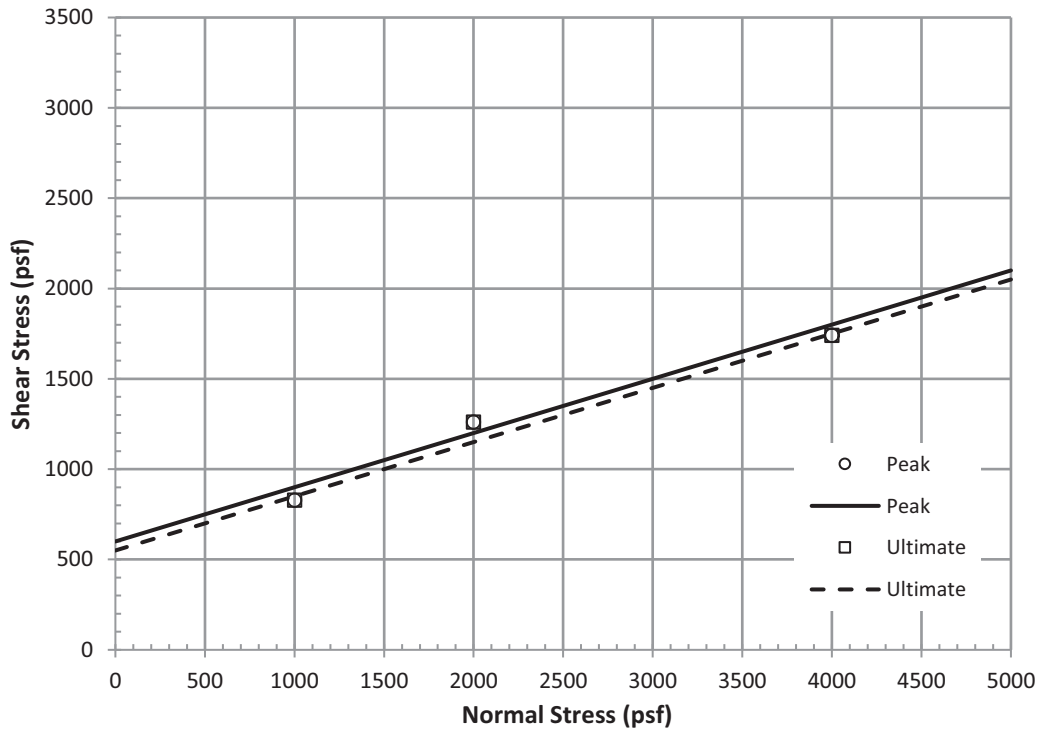
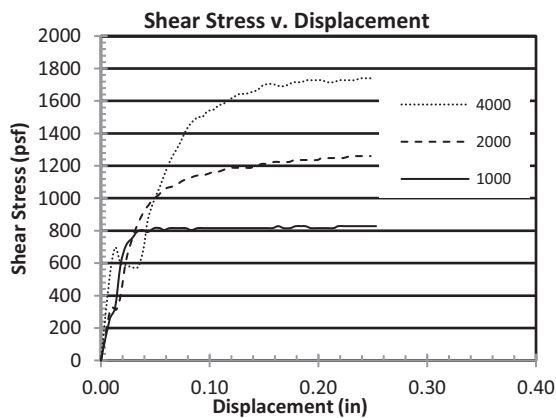
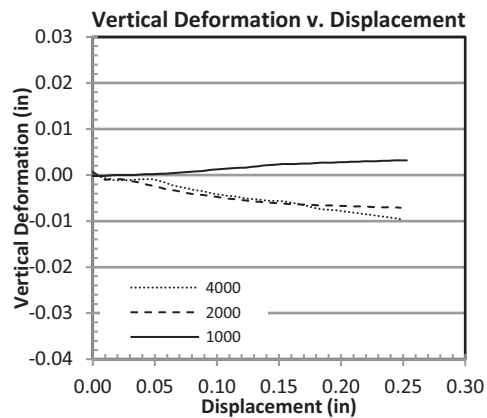
Method: Drained  
 Consolidation: Yes  
 Saturation: Yes  
 Shearing Rate (in/min): 0.04

Peak	Ultimate
Friction Angle, phi (deg)	17	17
Cohesion (psf)	600	550

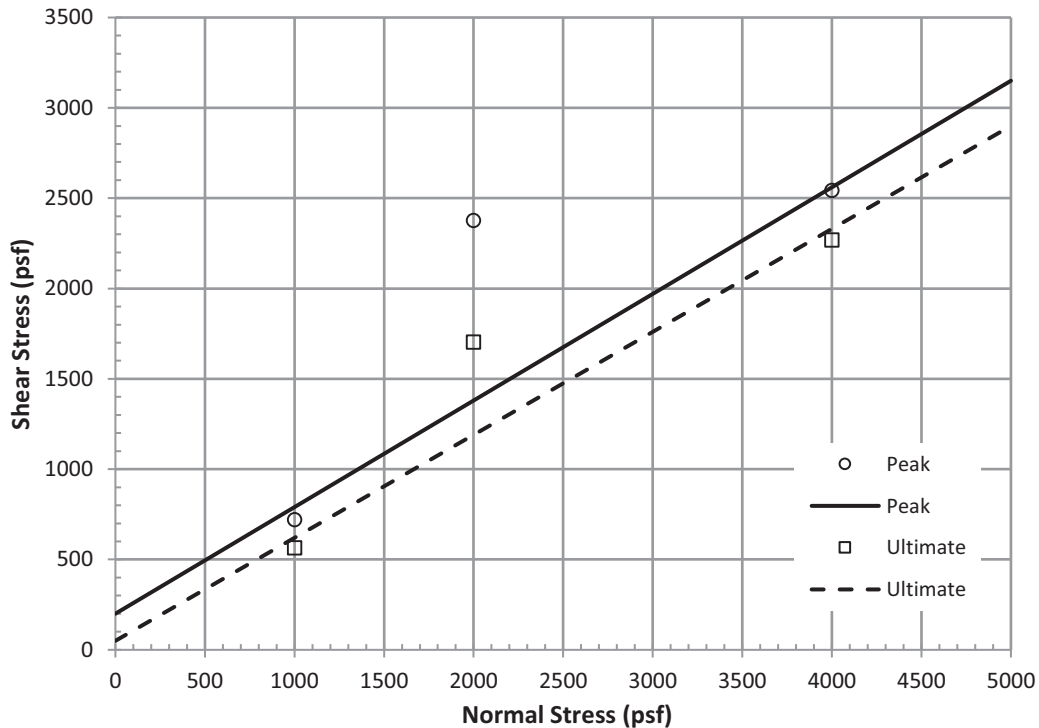
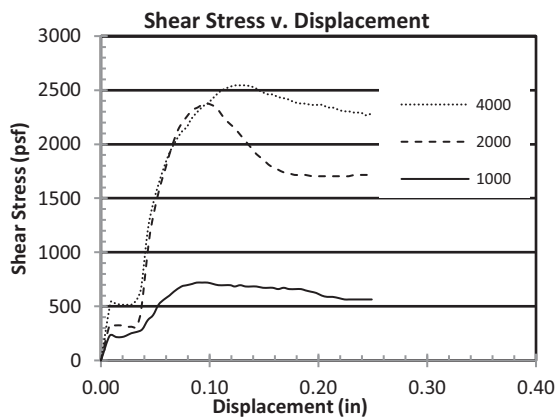
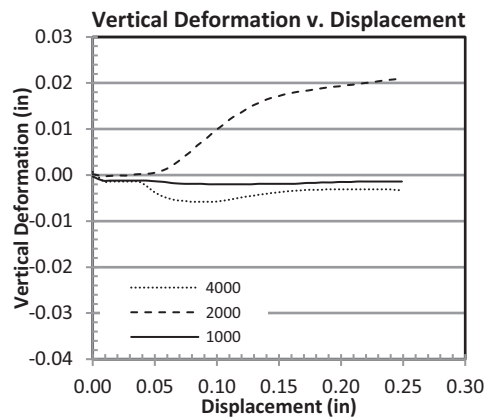
Method: Drained  
 Consolidation: Yes  
 Saturation: Yes  
 Shearing Rate (in/min): 0.04

Peak	Ultimate
Friction Angle, phi (deg)	31	30
Cohesion (psf)	200	50

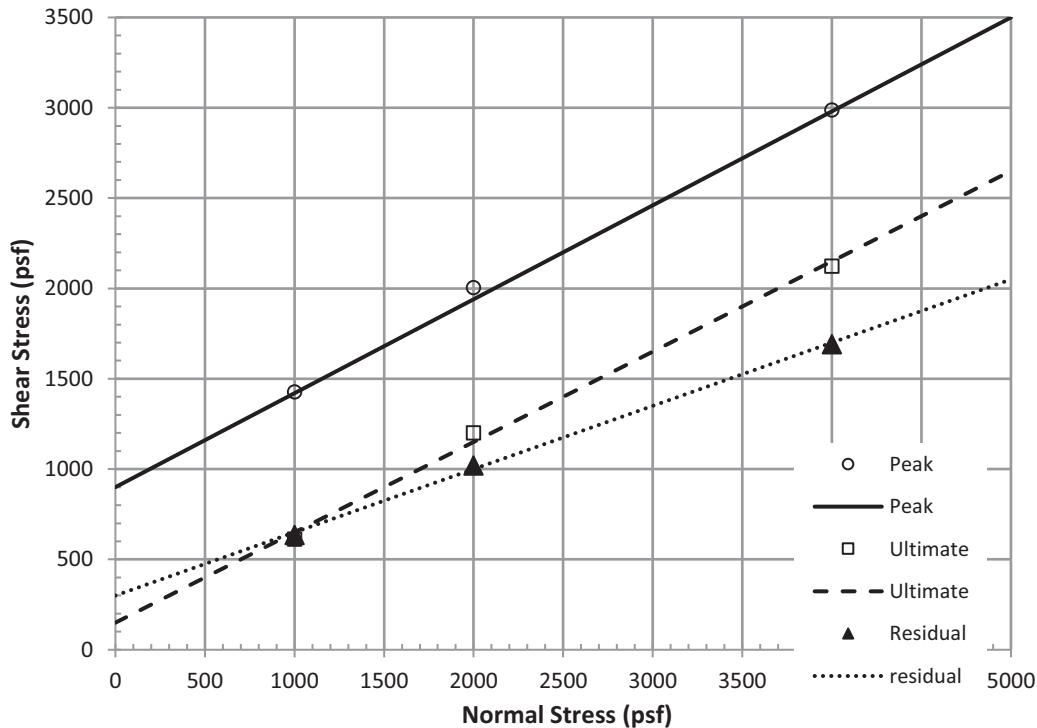
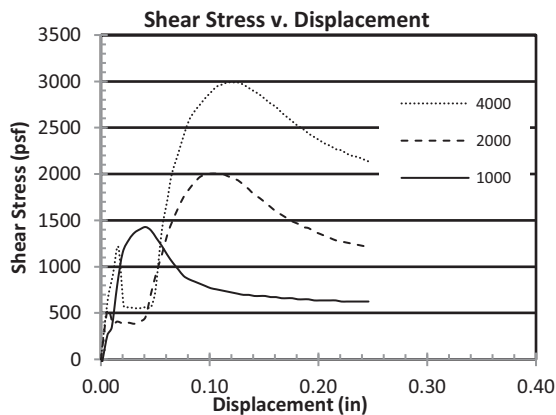
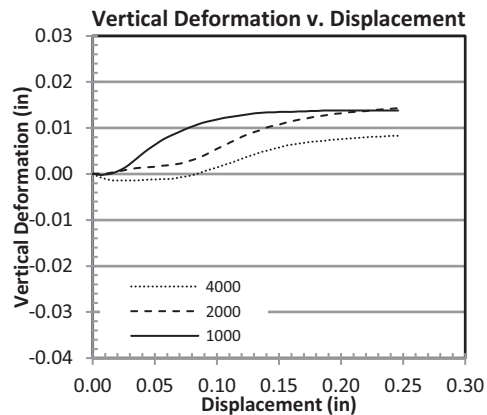
Method: Drained  
 Consolidation: Yes  
 Saturation: Yes  
 Shearing Rate (in/min): 0.04

Peak	Ultimate	Residual
Friction Angle, phi (deg)	27	27	19
Cohesion (psf)	900	150	300

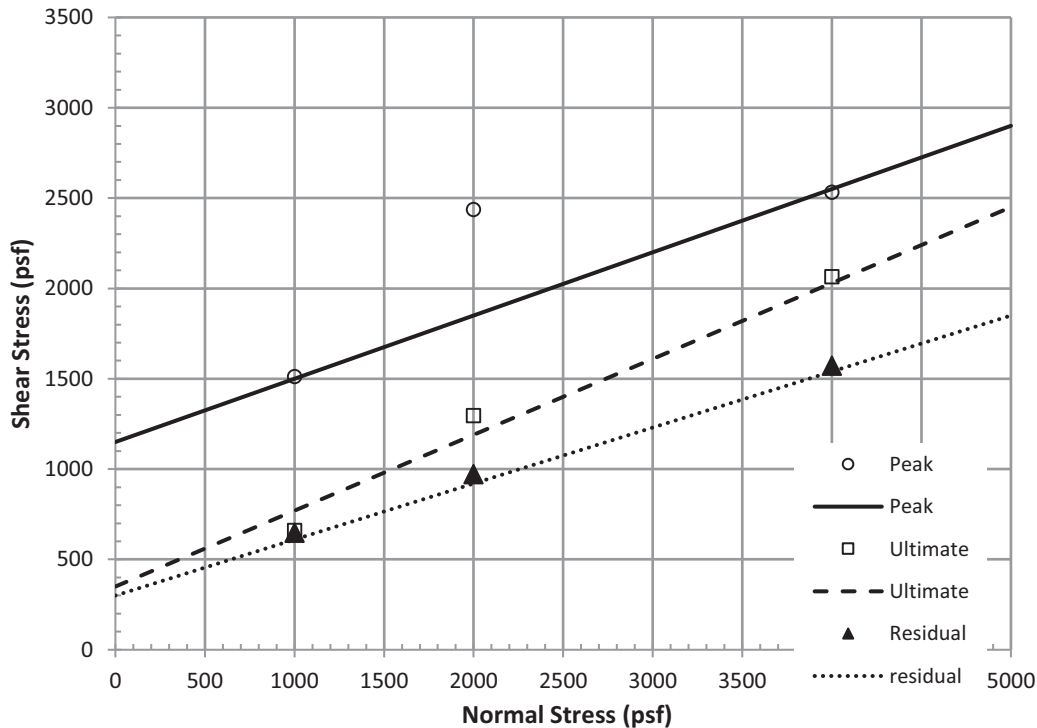
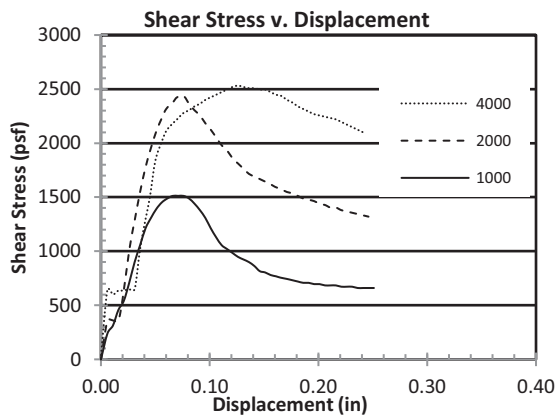
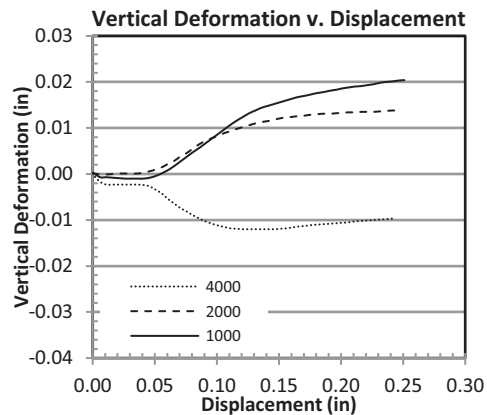
## DIRECT SHEAR - ASTM D3080

Samples Tested	1	2	3
Normal Stress (psf)	1000	2000	4000
Maximum Shear Stress (psf)	1512	2436	2532
Ultimate Shear Stress (psf)	660	1296	2064
Initial Moisture Content (%)	23.3	23.3	23.3
Initial Dry Density (pcf)	102.9	102.2	93.1

Method: Drained  
 Consolidation: Yes  
 Saturation: Yes  
 Shearing Rate (in/min): 0.04

Peak	Ultimate	Residual
Friction Angle, phi (deg)	19	23	17
Cohesion (psf)	1150	350	300

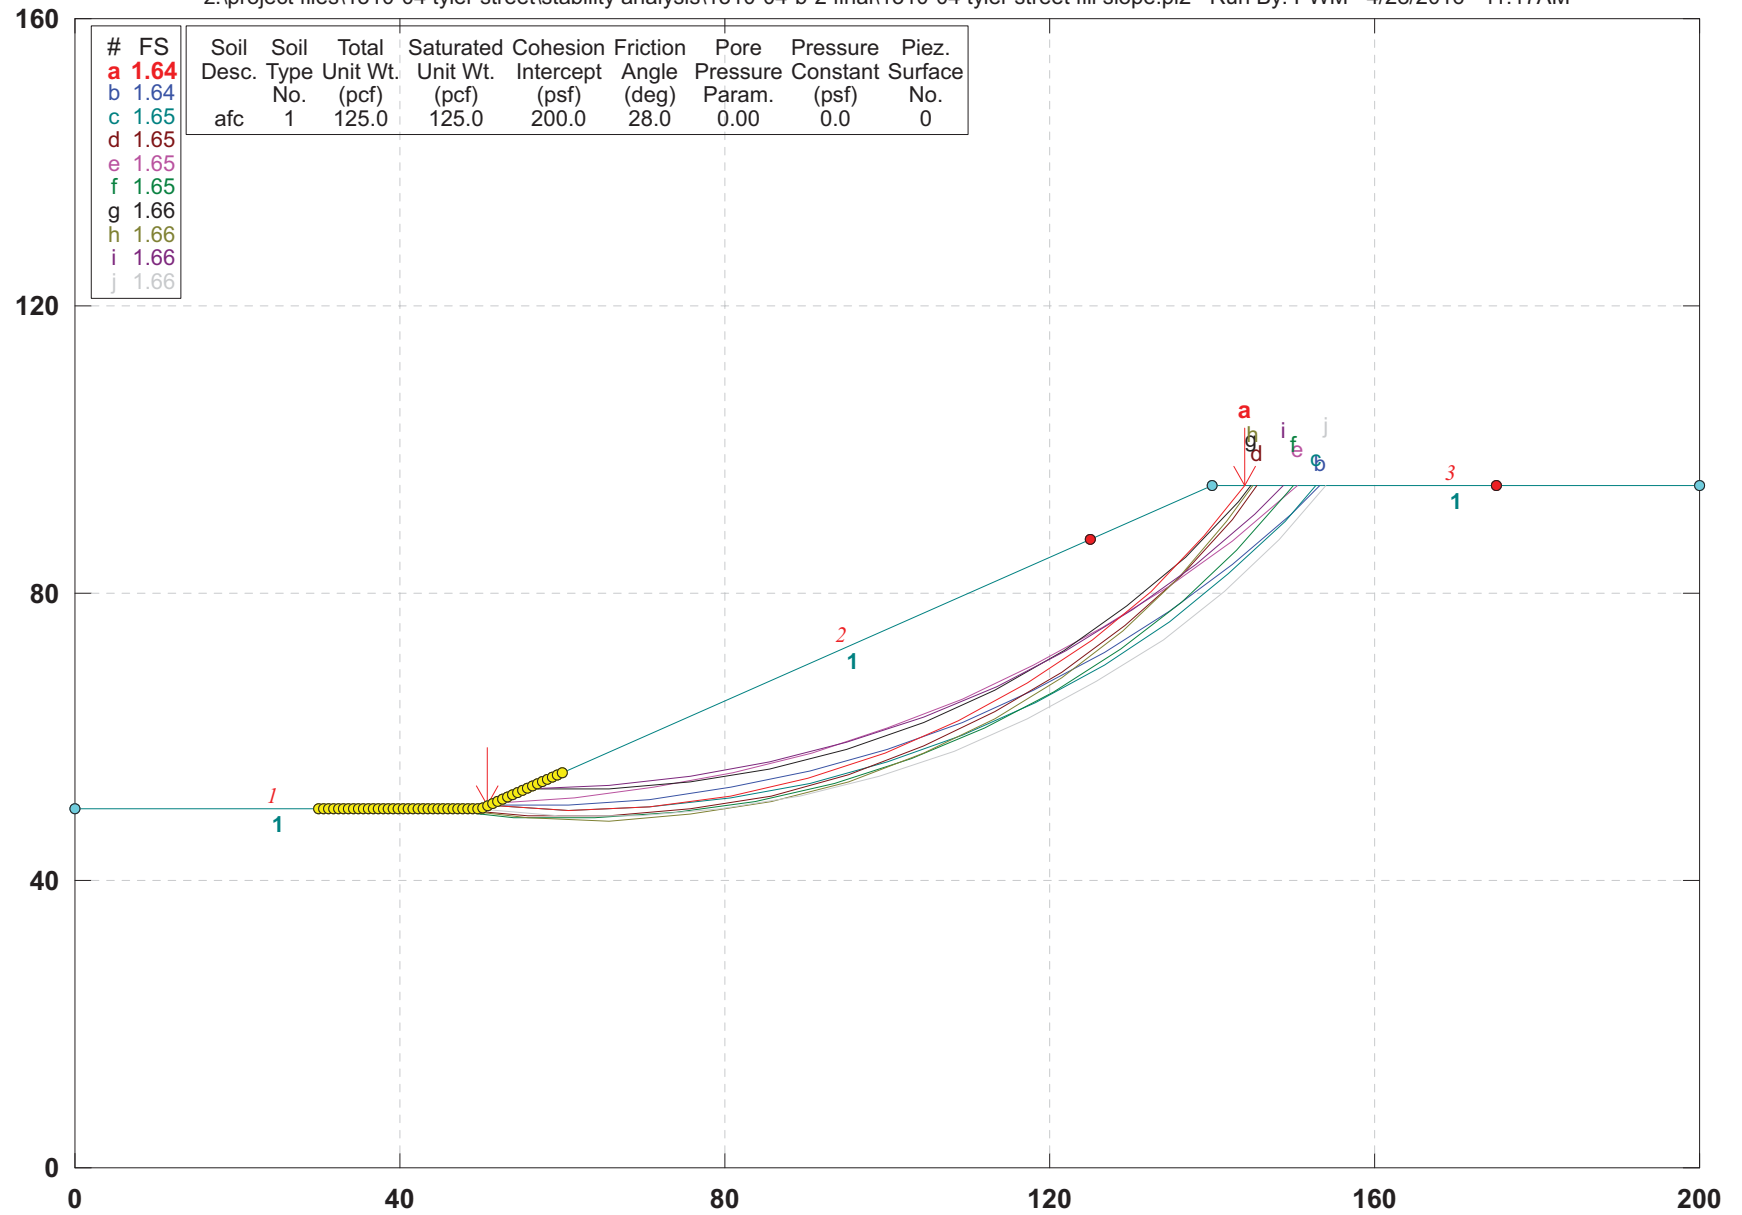
# 1310-04 Tyler Street 45 ft Fill Slope

GSTABL7 v.2 FSmin=1.64  
Safety Factors Are Calculated By The Modified Bishop Method

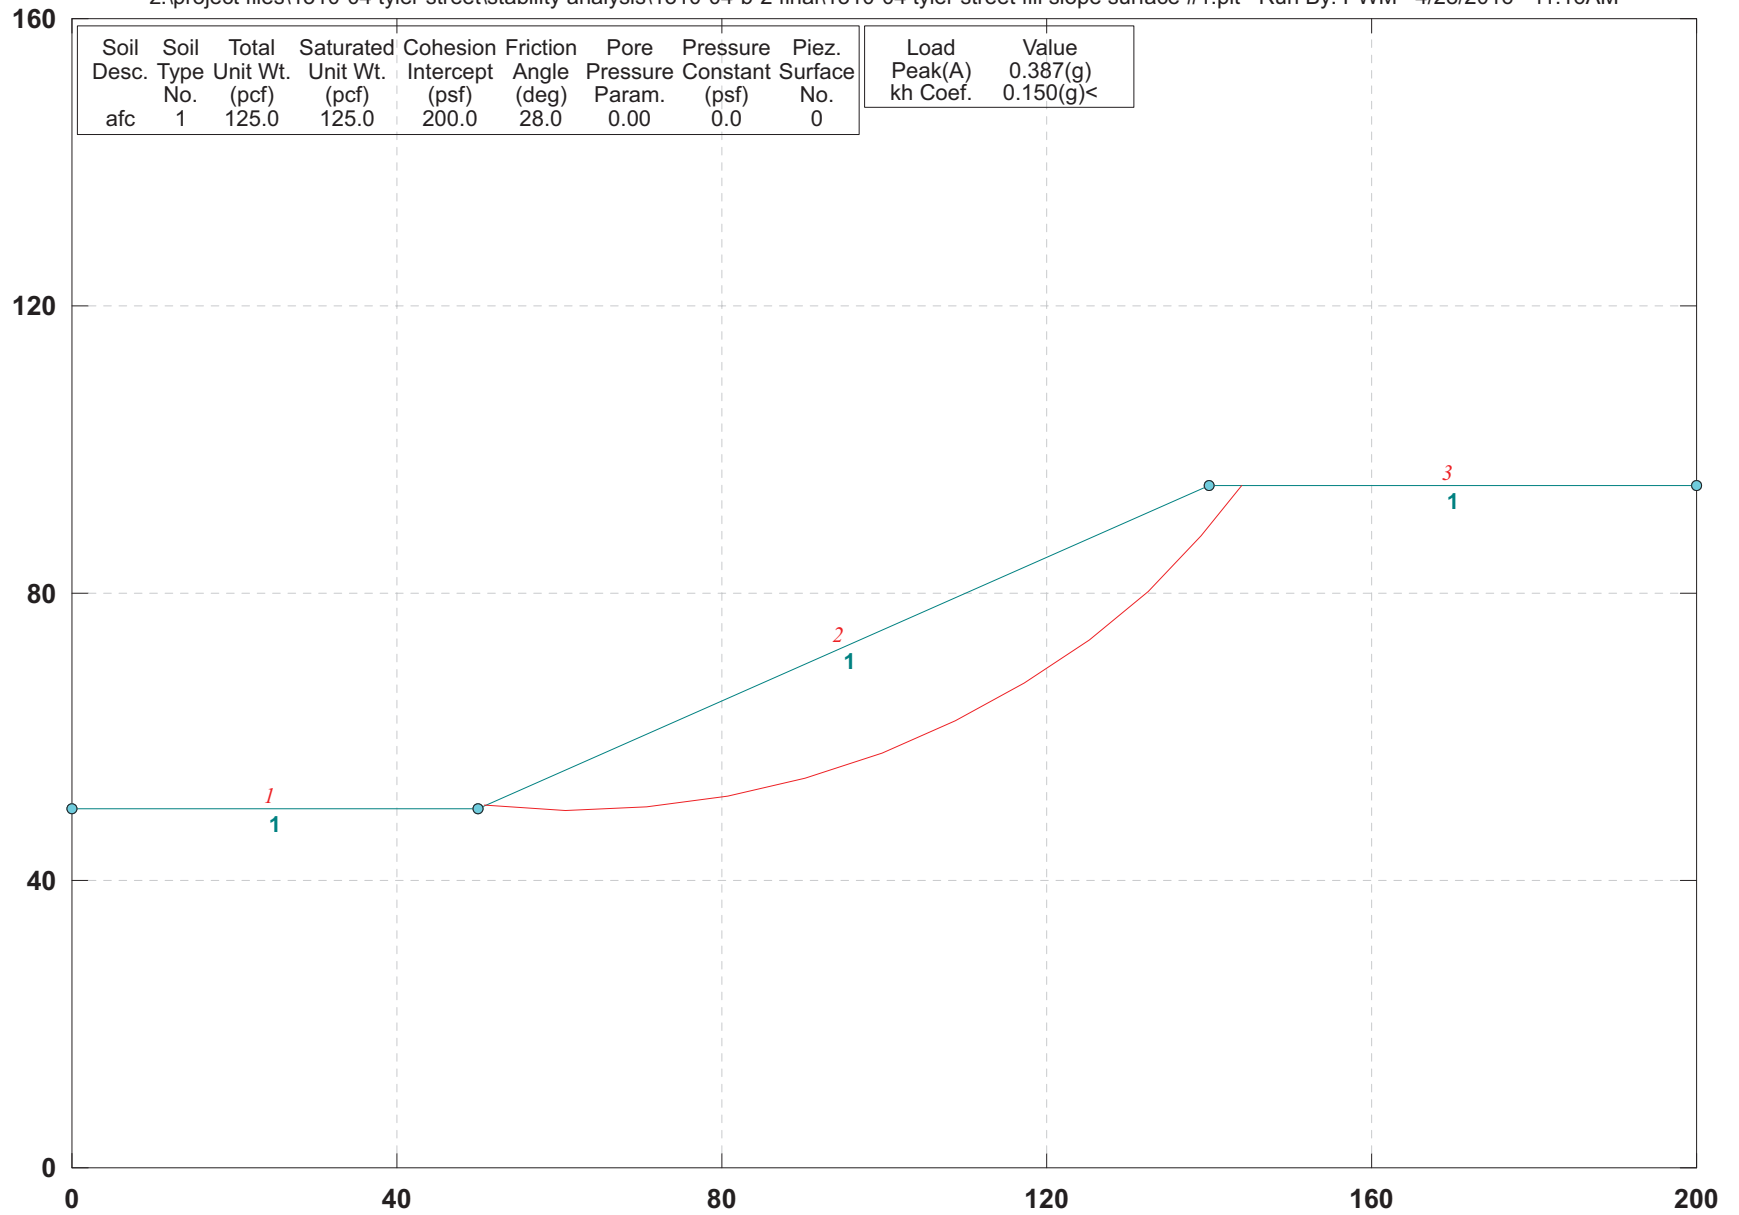
# 1310-04 Tyler Street 45 ft Fill Slope Pseudostatic

GSTABL7 v.2 FSmin=1.21  
Factor Of Safety Is Calculated By The Modified Bishop Method

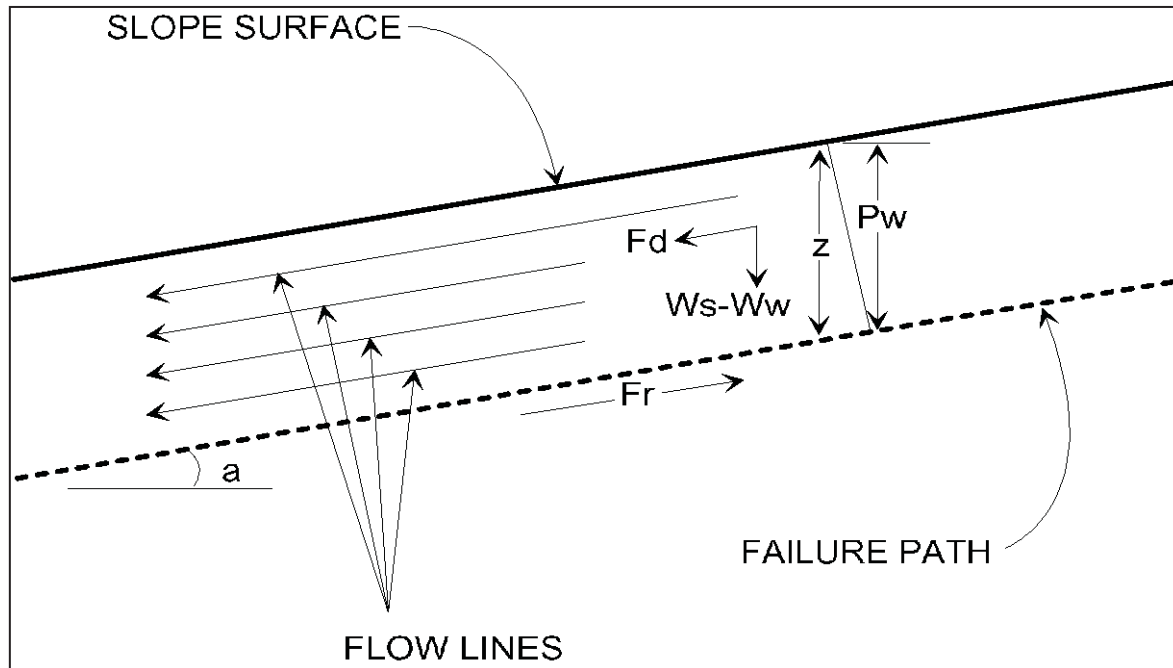
## SURFICIAL SLOPE STABILITY - 2:1 FILL

Assume: (1) Saturation To Slope Surface  
(2) Sufficient Permeability To Establish Water Flow

$$P_w = \text{Water Pressure Head} = (z)(\cos^2(a))$$
