**ADVANCED GEOTECHNICAL SOLUTIONS, INC.**

Report No. 1310-04-B-6

**Subject:** *Response to City of Santee Review Comments and Geotechnical Third-Party Review, Tyler Street Residential Development, Southeast of Tyler Avenue and Mesa Heights Road, Santee, California*

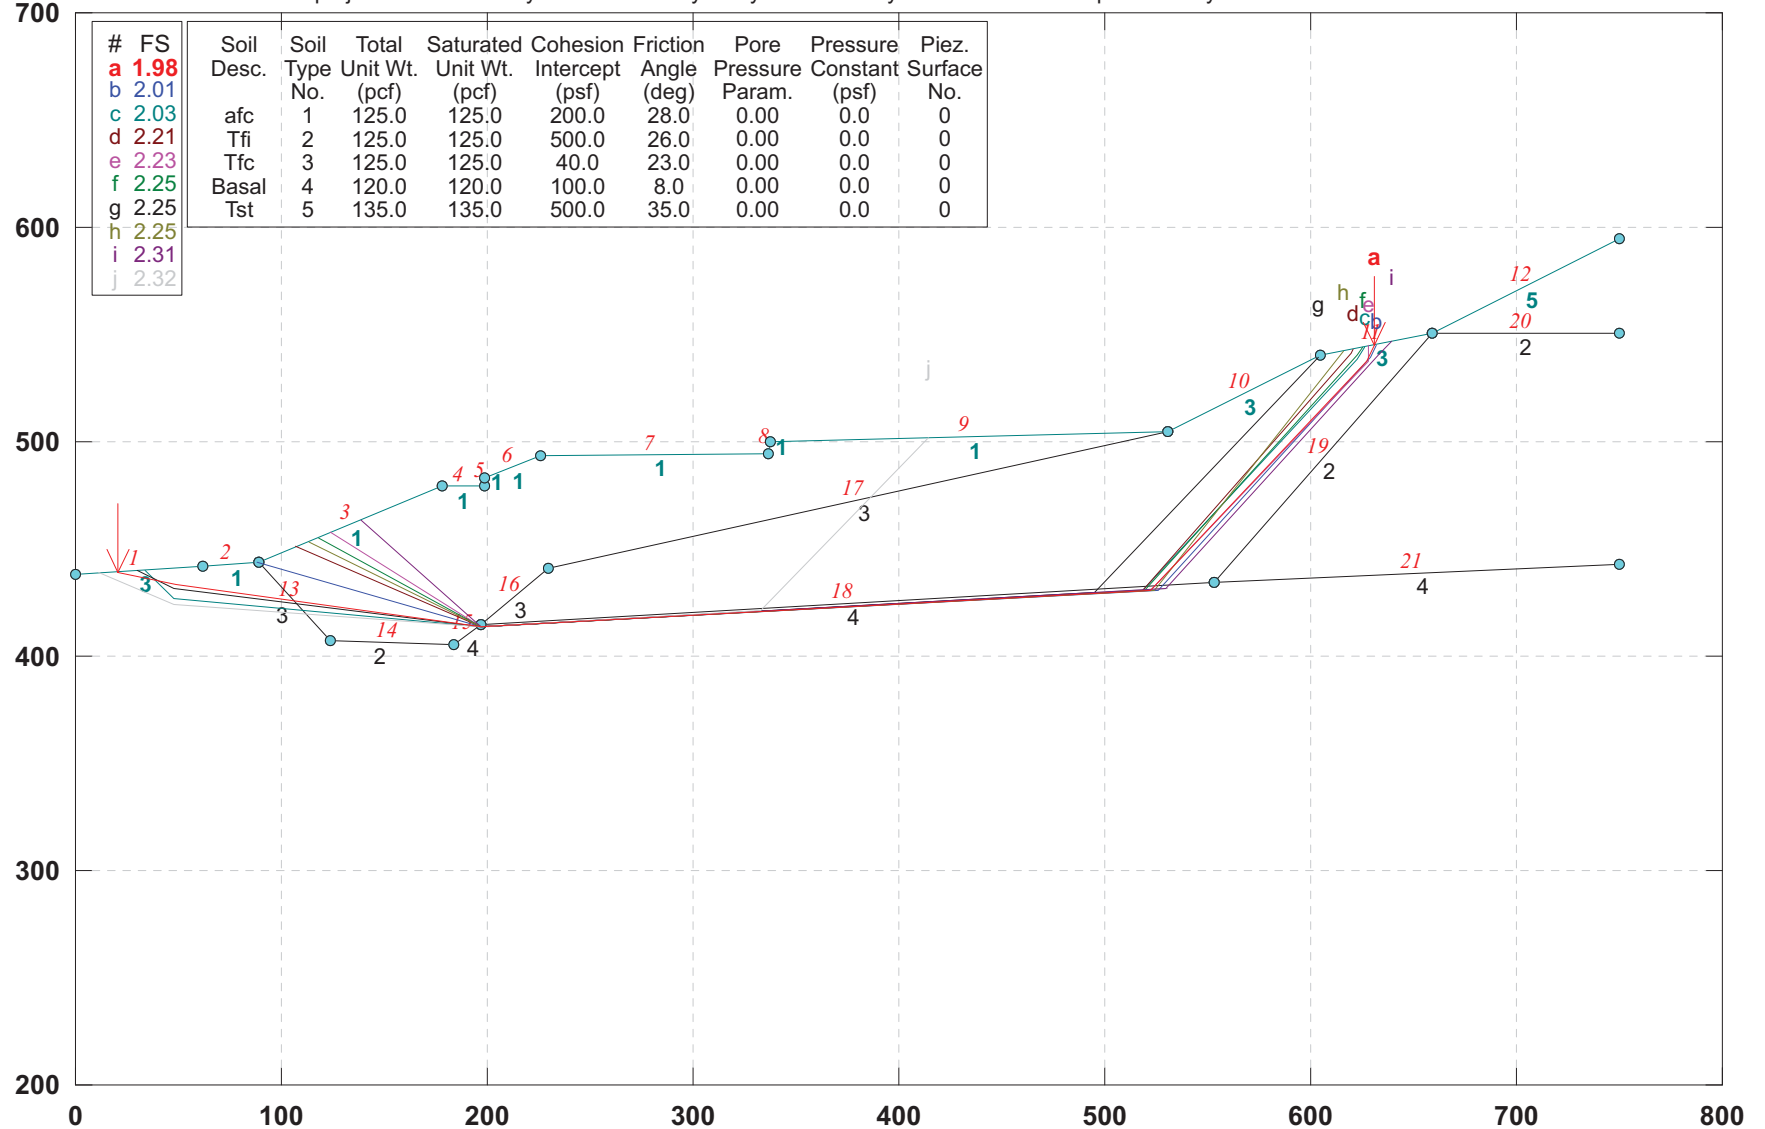
# 1310-04 Tyler Street AA 60 ft shear key

GSTABL7 v.2 FSmin=1.98

Safety Factors Are Calculated By The Simplified Janbu Method

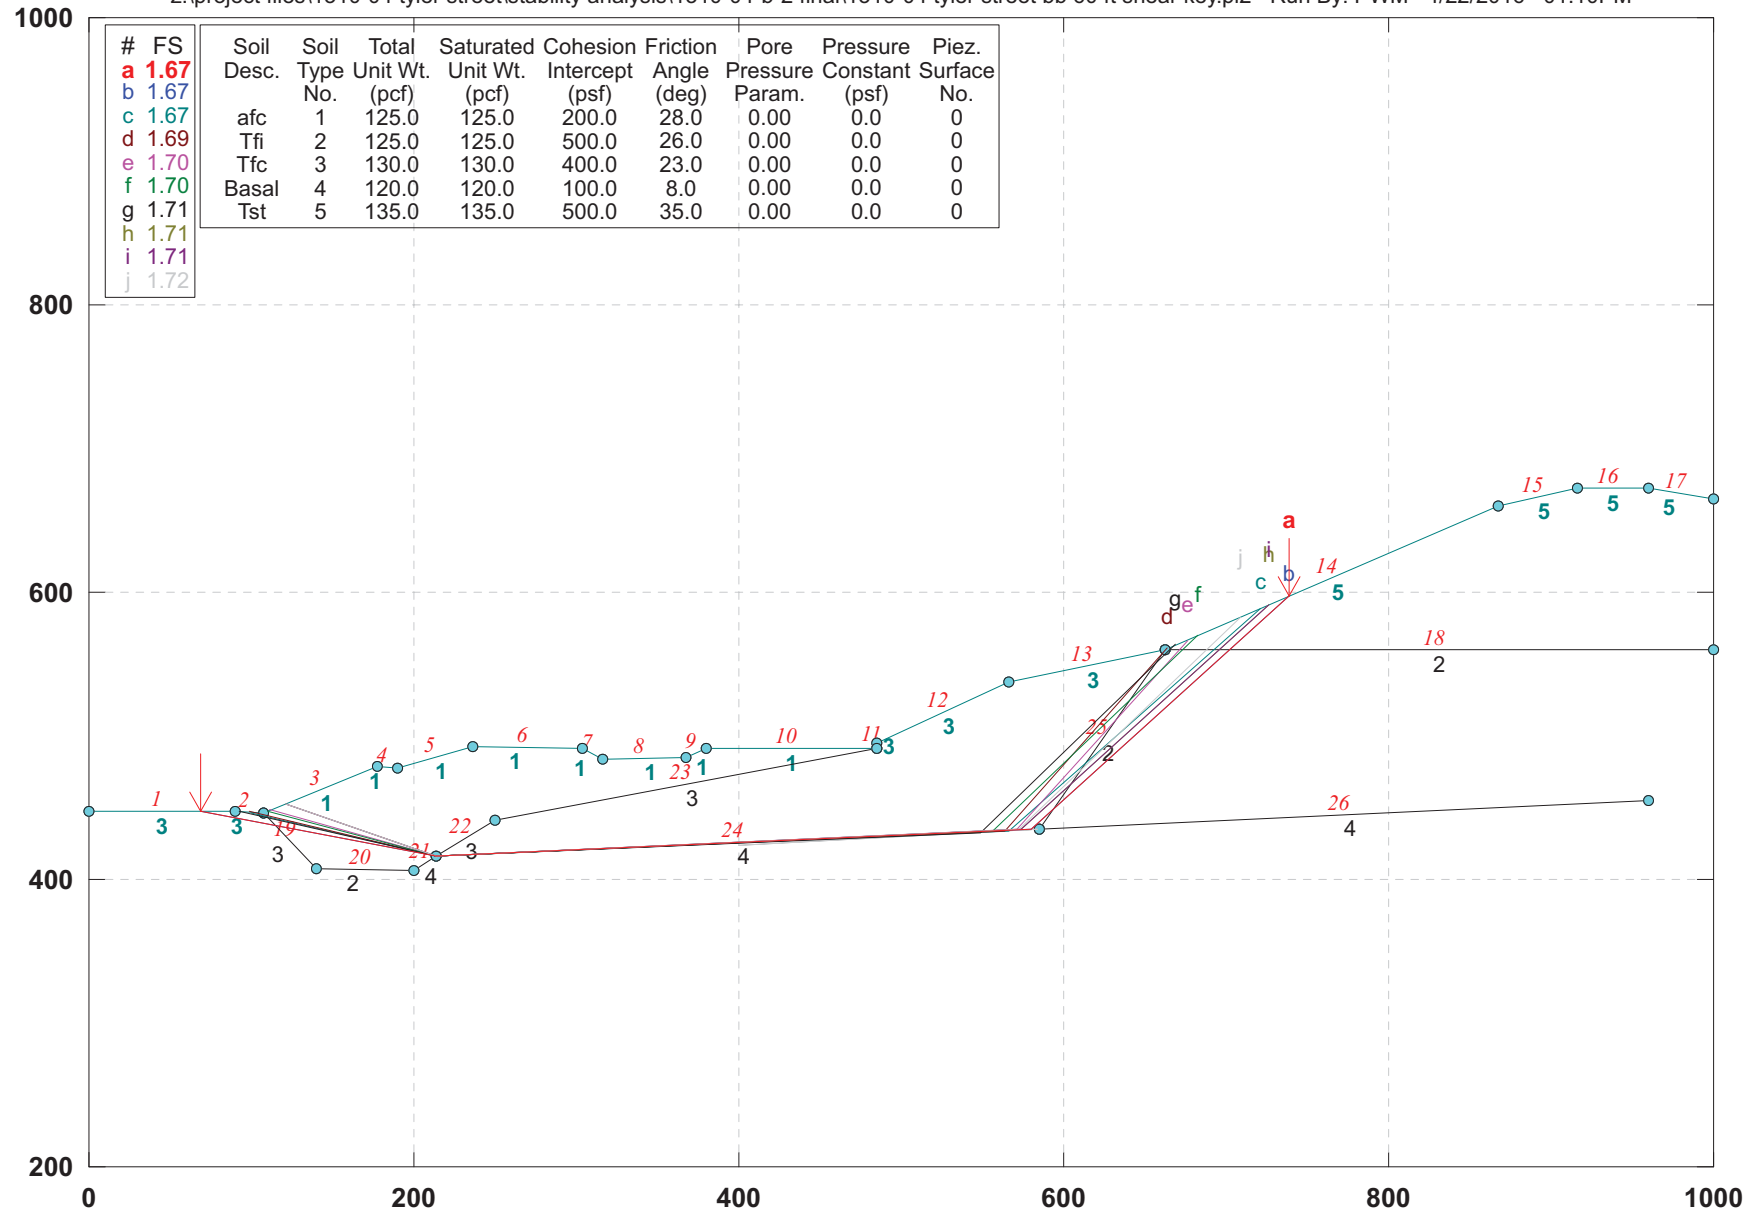
# 1310-04 Tyler Street BB 60 ft shear key

GSTABL7 v.2 FSmin=1.67  
Safety Factors Are Calculated By The Simplified Janbu Method
