Preliminary Infiltration Testing Investigation for the Proposed Single-Family Residential Development, Located at 800 N. Girard Street, City of Hemet, Riverside County, California

Dated: October 14, 2019 Project No. G18-1647-20

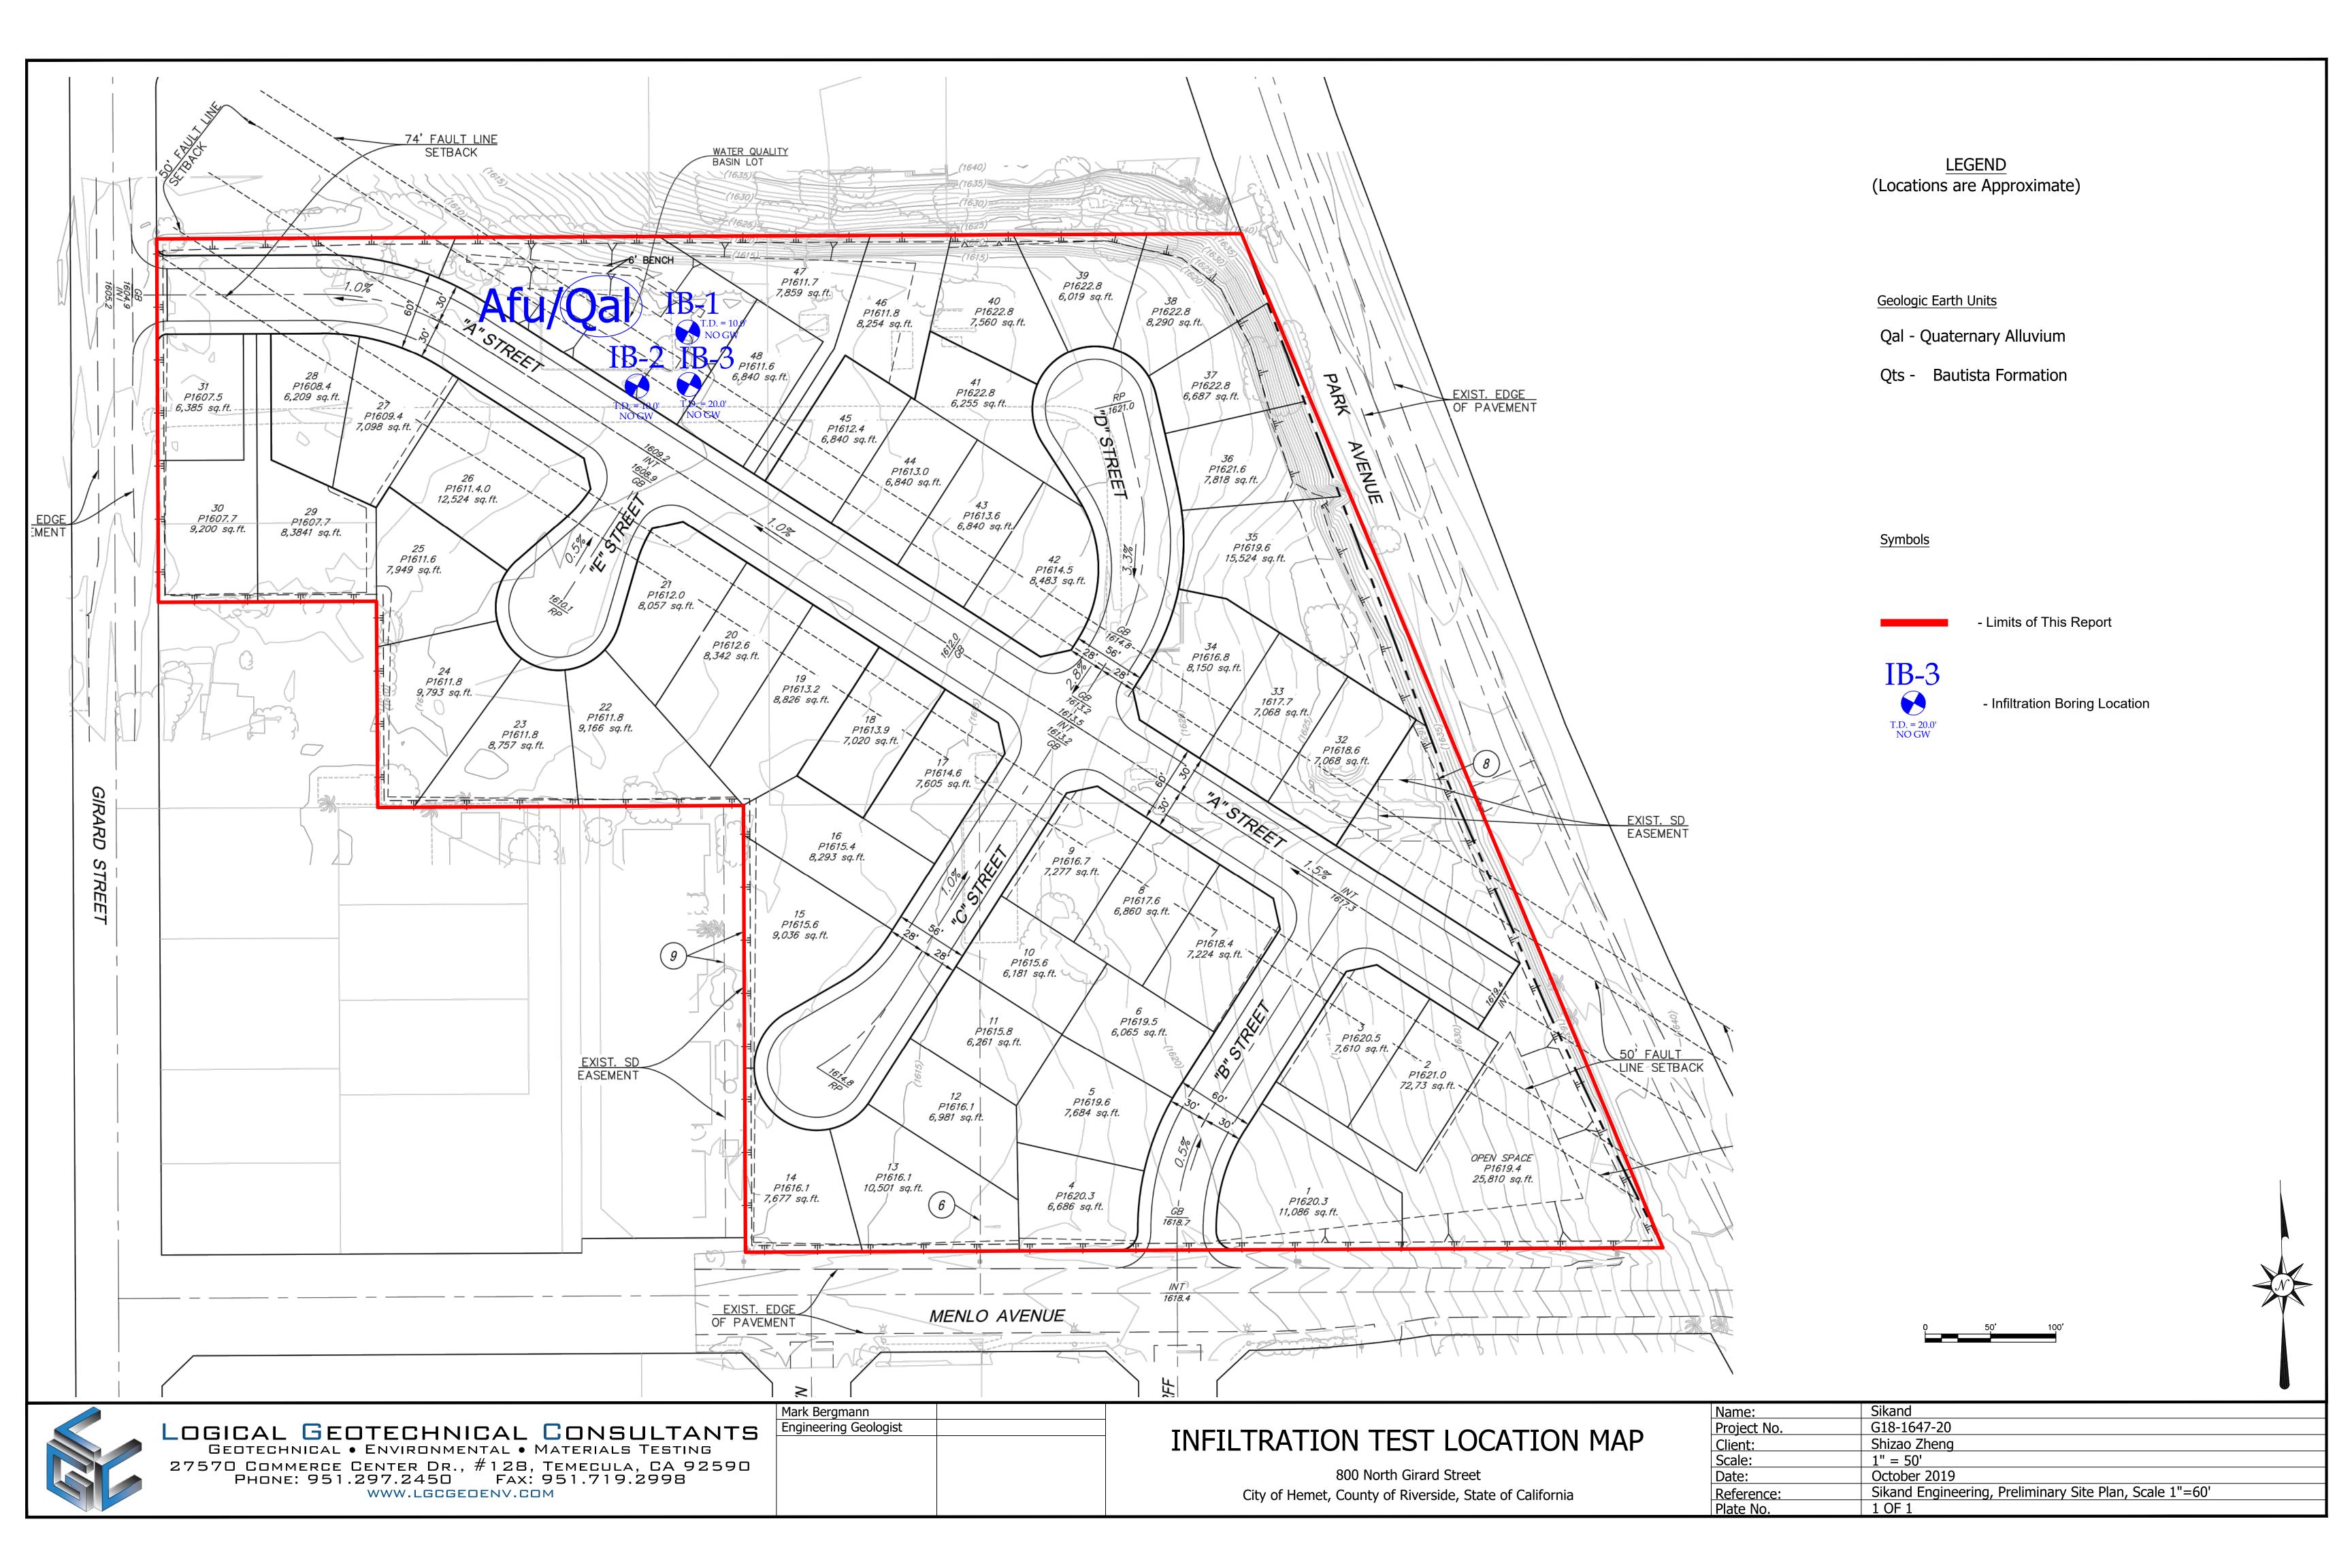
Plate 1 – Infiltration Test Location Map (Pocket Enclosure)

On October 11, 2019, two (2) infiltration tests were conducted within the proposed area of the infiltration system. The infiltration test borings were labeled IB-1 through IB-2; and are depicted on the Infiltration Test Location Map (Plate 1). The tests were performed as per the referenced Riverside County Technical Guidance Manual for Onsite Wastewater Treatment Systems.

Subsurface exploration of the subject site was performed on October 10, 2019 and consisted of advancing two (2) infiltration test borings. The borings were excavated within the proposed infiltration system location utilizing a hollow stem drill rig to a depth of 10 feet below existing grade. A third boring was excavated to a depth of 20 feet, to observe the depth to groundwater. These logs are presented in Appendix A. Earth materials encountered within the locations were classified in general accordance with the visual manual procedures of the Unified Soil Classification System (USCS). Logs of the infiltration borings are presented in Appendix A, and their approximate locations are depicted on the Infiltration Test Location Map (Plate 1).
