**HYDRAULIC ANALYSIS, CONCEPTUAL DESIGN, AND
PRELIMINARY COST ESTIMATE FOR THE KOPTA SLOUGH
FLOOD DAMAGE REDUCTION AND HABITAT RESTORATION
STUDY ON THE SACRAMENTO RIVER, RM 216 TO RM 224
TEHAMA COUNTY, CALIFORNIA**

December 28, 2009

Ayres Associates Project Number: 33-0581.00

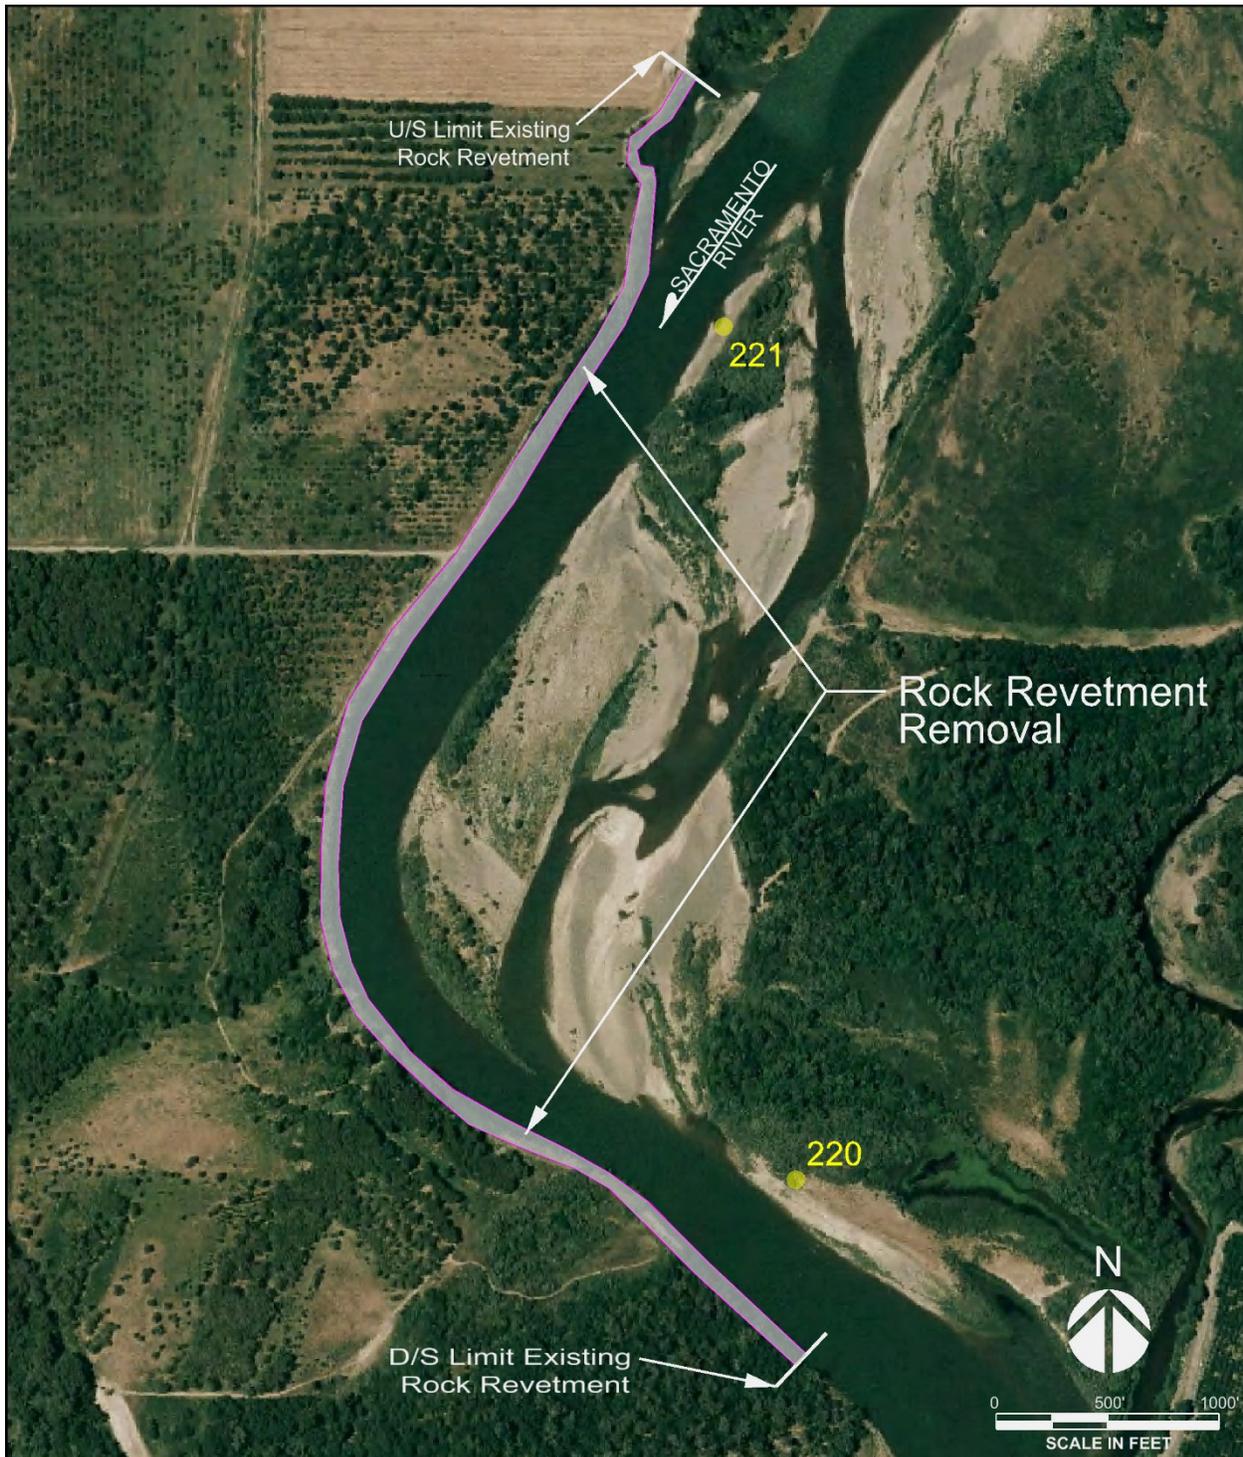
Figure 4. Full Length Rock Revetment Removal

For the rock revetment removal, the element was split into two options, removal of the full length of rock (about 7,300 ft) or removal of the downstream half of the rock (4,000 ft), as shown in **Figures 4 and 5**, respectively. Within these 2 options there were additional options; for the lateral removal of the rock, the options were to either remove as one large section or remove it in a notching pattern. The notching pattern would remove sections of rock and leave other sections, as shown in **Figures 6 and 7** for the full length (2,800 ft) and half length (1,400 ft), respectively. For the vertical bank, either rock would be removed for the entire bank height (26 ft) or only removed from the top portion of the bank (12 ft), as shown in **Figures 8 and 9**, respectively. The existing berm behind the rock would also be excavated to match the existing floodplain elevation.

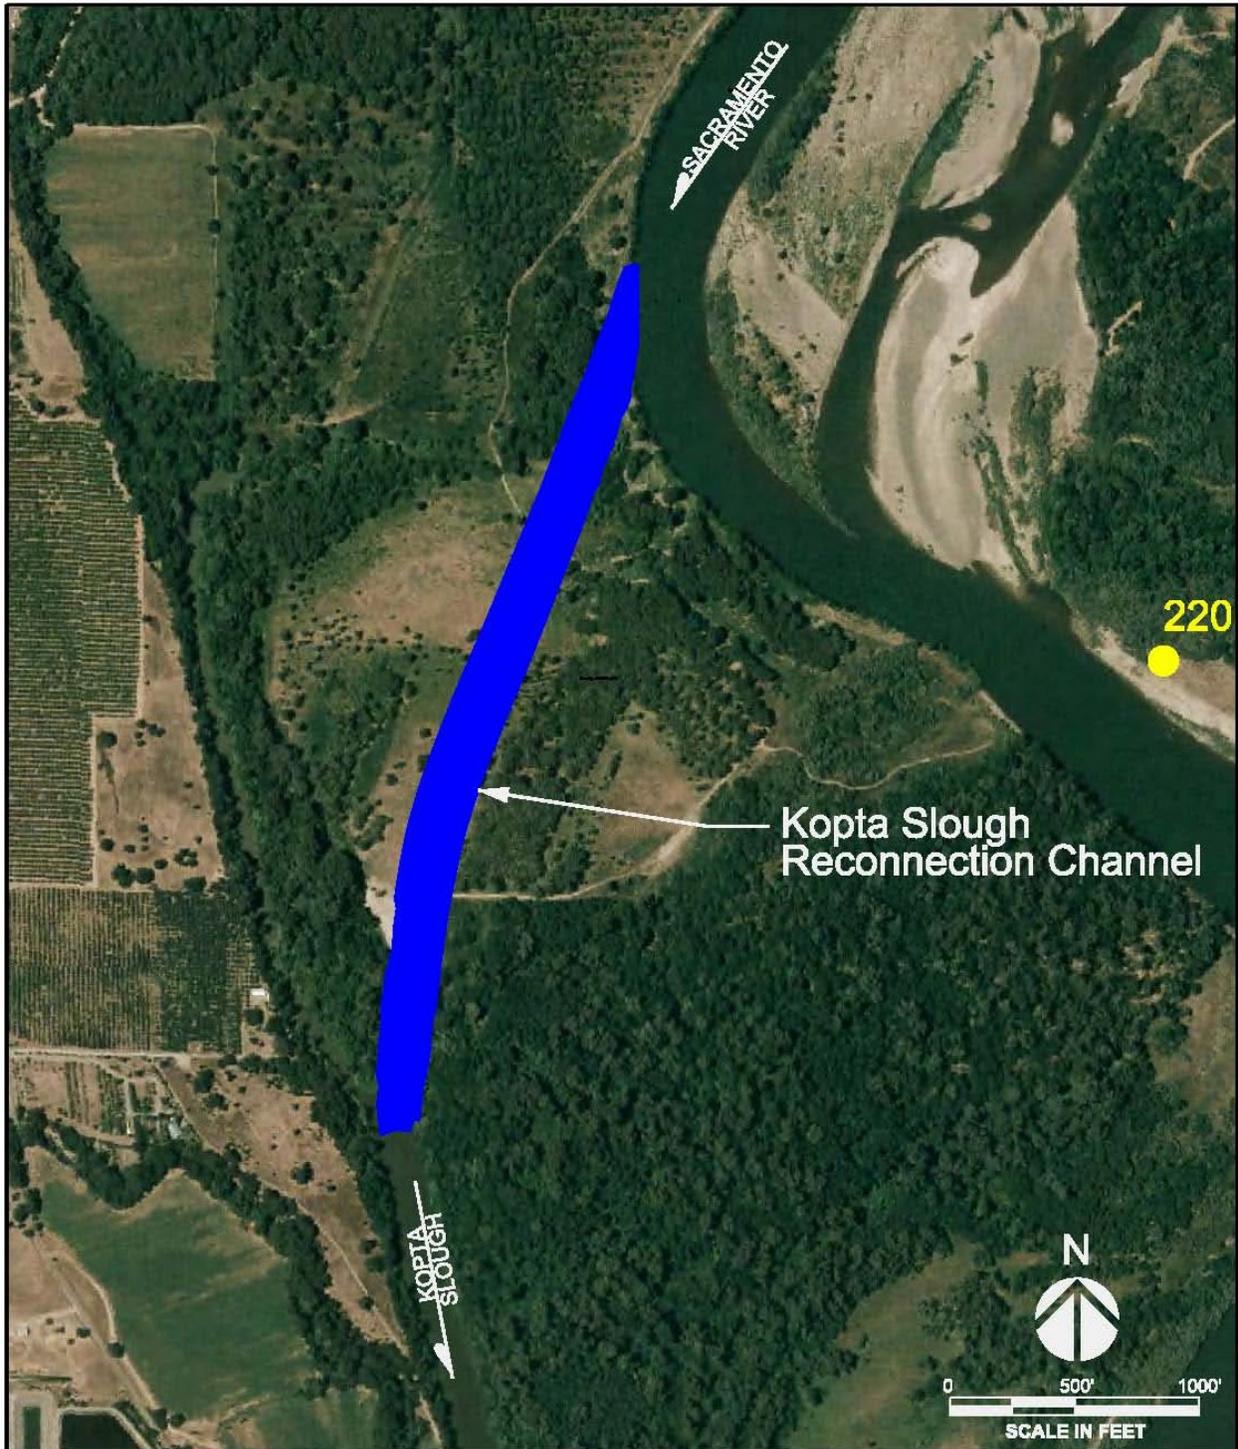
Figure 10. Location of Kopta Slough Connection

The location of the channel reconnection is shown in **Figure 10**. This location was based on a low spot in the bank and the river’s natural tendency to flow through this location at high flows. The reconnection would be either through a pilot channel or a fully excavated channel. The pilot channel provides an initial start for the Sacramento River to re-connect with Kopta Slough. It would be approximately 8 ft wide and connect the Sacramento River to entrance of the existing Kopta Slough. The full Kopta Slough reconnection involves creating a new channel to force the water into Kopta Slough. The reconnection channel would be approximately 110 ft wide on the bottom (based on present bottom width of existing Kopta Slough), extend from the Sacramento River channel invert to the Kopta Slough channel invert, and have 2:1 side slopes.

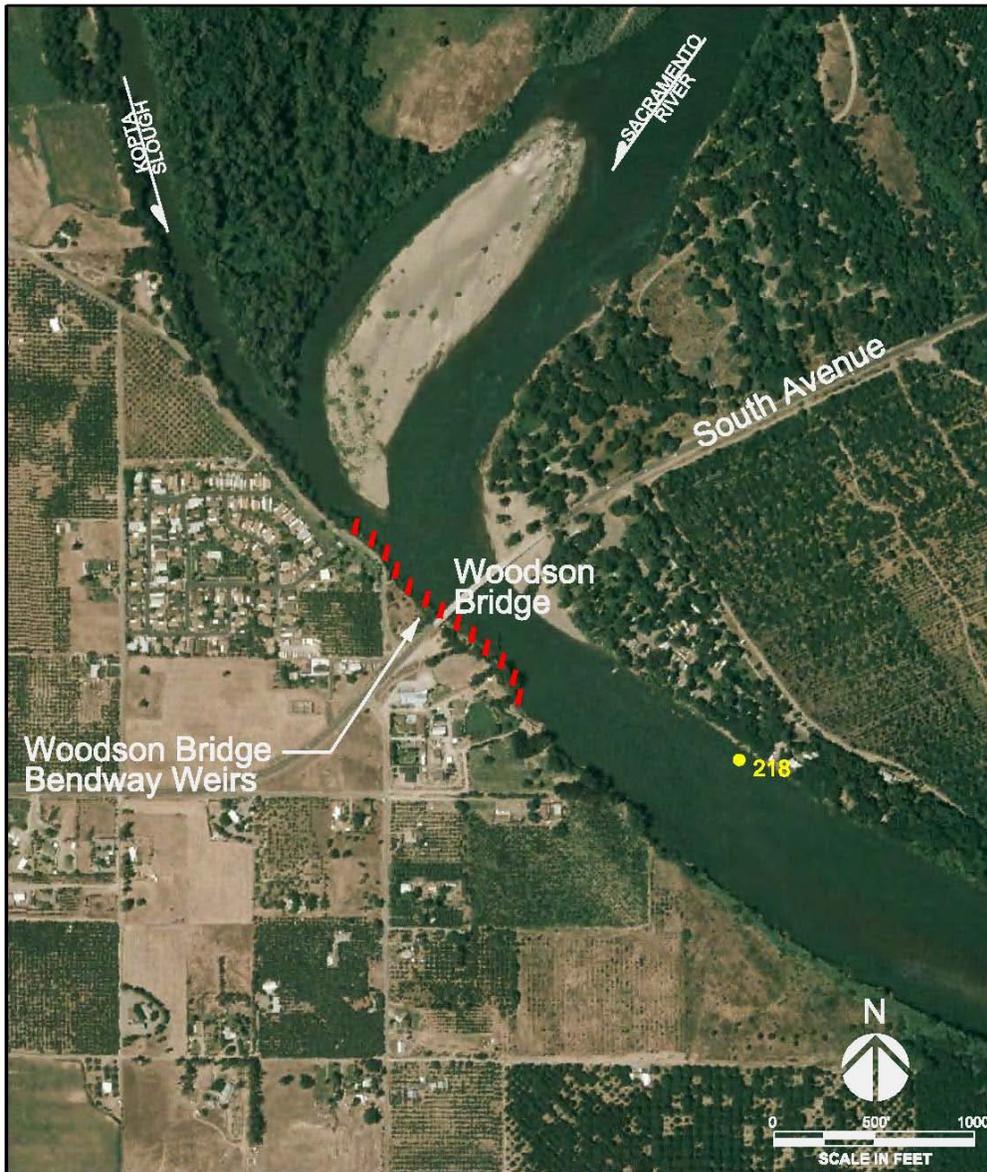
Figure 11. Plan View of Bendway Weirs at Woodson Bridge

Bendway weirs act to redirect the flow away from the bank and into the channel. The weirs would extend into the channel and be placed at an angle to ensure the redirection of flow. The design for this study includes 13 weirs, spaced 100 ft apart, protecting 1,200 ft of bank, as shown in **Figure 11**. The weirs would be approximately 6 ft high, with 1.5:1 side slopes, and a crest width of 2 ft. The top of the weir would be at about the summer low flow water level and may require the use of buoys to prevent them from becoming a navigational hazard. The configuration of these weirs is shown in **Figure 12**. Vegetation would be placed on the existing bank where the velocities are lower than 5 ft/s to protect the bank from erosion. In addition, the vegetation would have environmental benefits and be aesthetically pleasing.

The bendway weirs would redirect the flow more towards the opposite bank. However, the redirection of flow could affect the boat launch and the Woodson Bridge footings, located on the opposite bank. Since the location is considered boating recreation area there is a concern that the spur dikes could be a hazard to boaters and would therefore be unlikely to be selected. Because of the pinch point at the bridge crossing, the low berm could slightly reduce the cross sectional area and likely increase the water surface or velocity through the bridge. The bank armor with upper bank vegetation was the chosen option for hydraulic modeling.

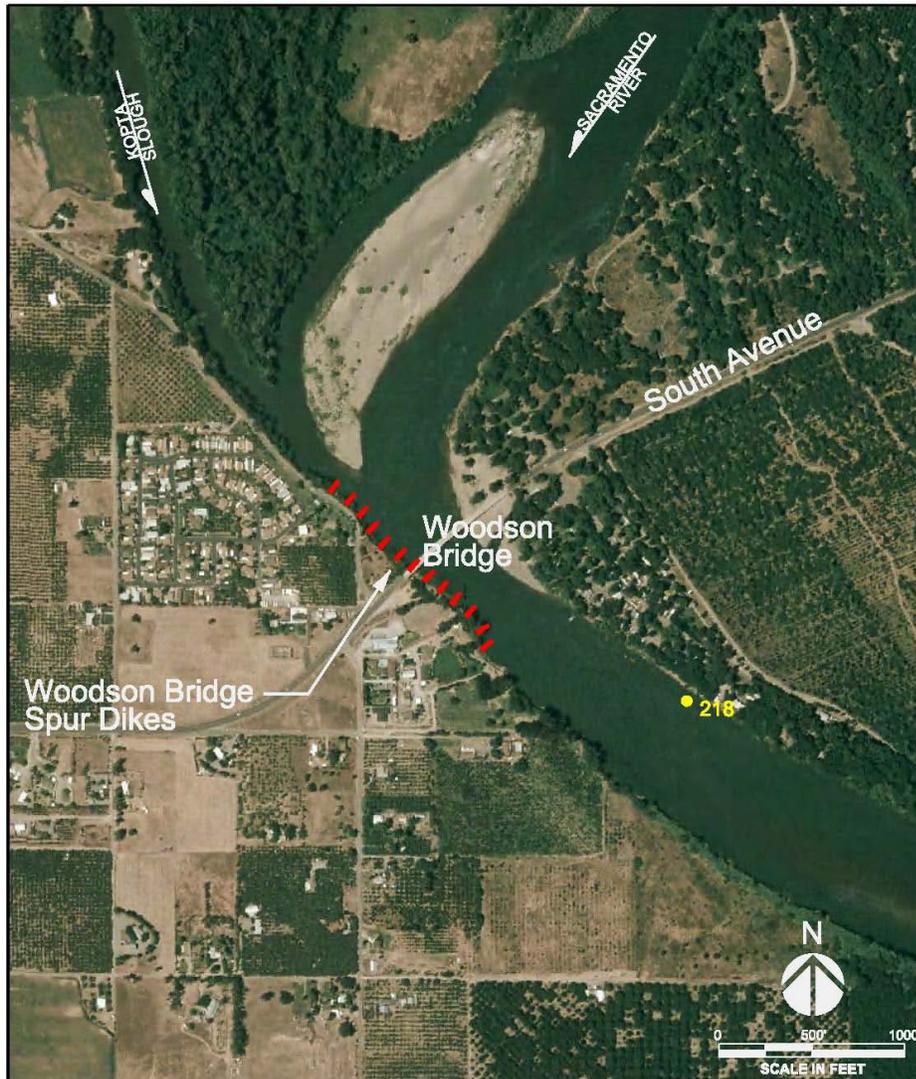
Figure 13. Plan View of Spur Dikes at Woodson Bridge

Another erosion protection option for Woodson Bridge was the use of spur dikes with bank vegetation. Spur dikes are similar to bendway weirs; however, they are designed differently and their goal is to produce deposition on the banks rather than redirect flow. For this design 13 dikes would extend perpendicular to the banks into the channel, spaced approximately 100 ft apart for 1,200 ft, as shown in **Figure 13**. The configuration of the dikes is shown in **Figure 14**.

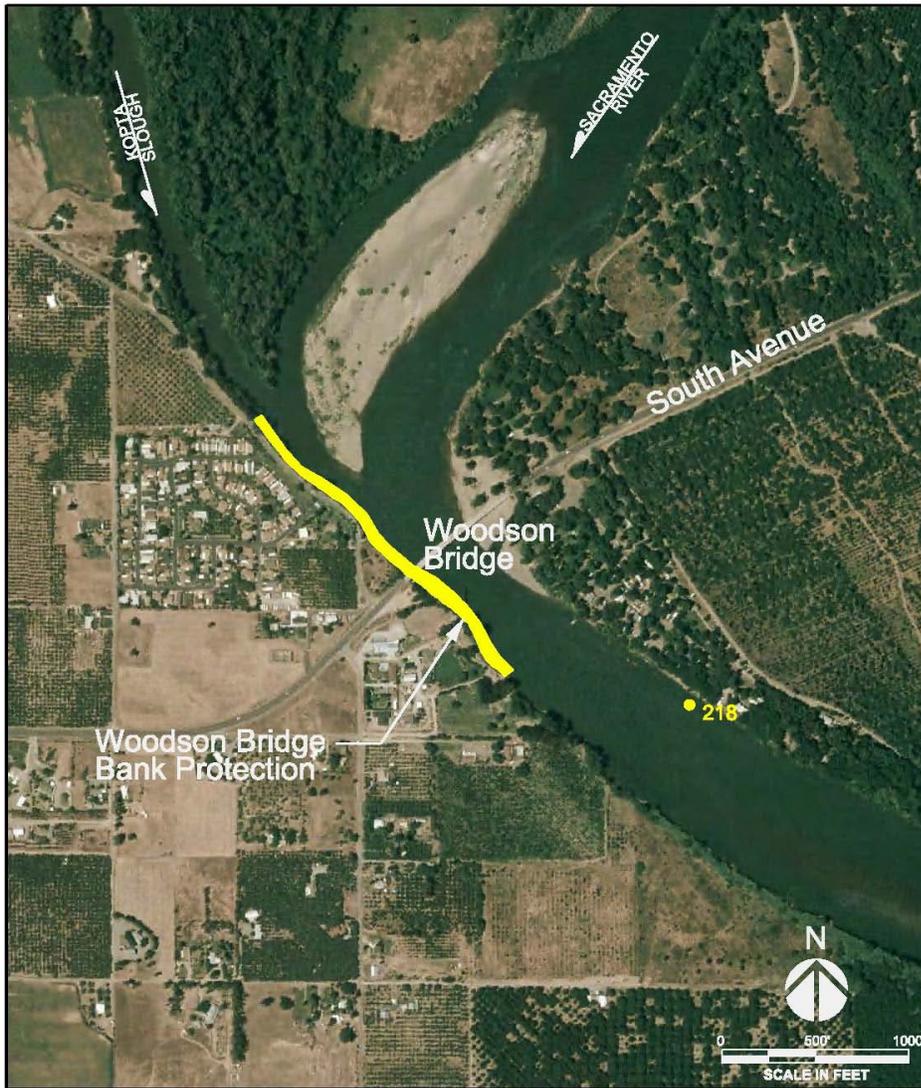
Figure 15. Plan View of Bank Armor/Low Berm Location at Woodson Bridge

Another option for protecting Woodson Bridge is building a low berm. The low berm would extend approximately 1,900 ft, in the vicinity of high velocities, as shown in **Figure 15**. The berm would extend approximately 20 ft into the main channel at the summer low flow water surface elevation with a 2:1 slope to the bottom of the channel. Some rock will need to be placed up the slope where the velocities exceed 5 ft/s. The remaining upper slope will be protected with bank vegetation. The configuration of this design is shown in **Figure 16**.

For the bank armor option, the rock would be placed in the same location as the low berm (Figure 15). The rock would extend past the mean summer water level until the velocity is below 5 ft/s, as shown in **Figure 17**. The remaining upper slope will be protected with vegetation.

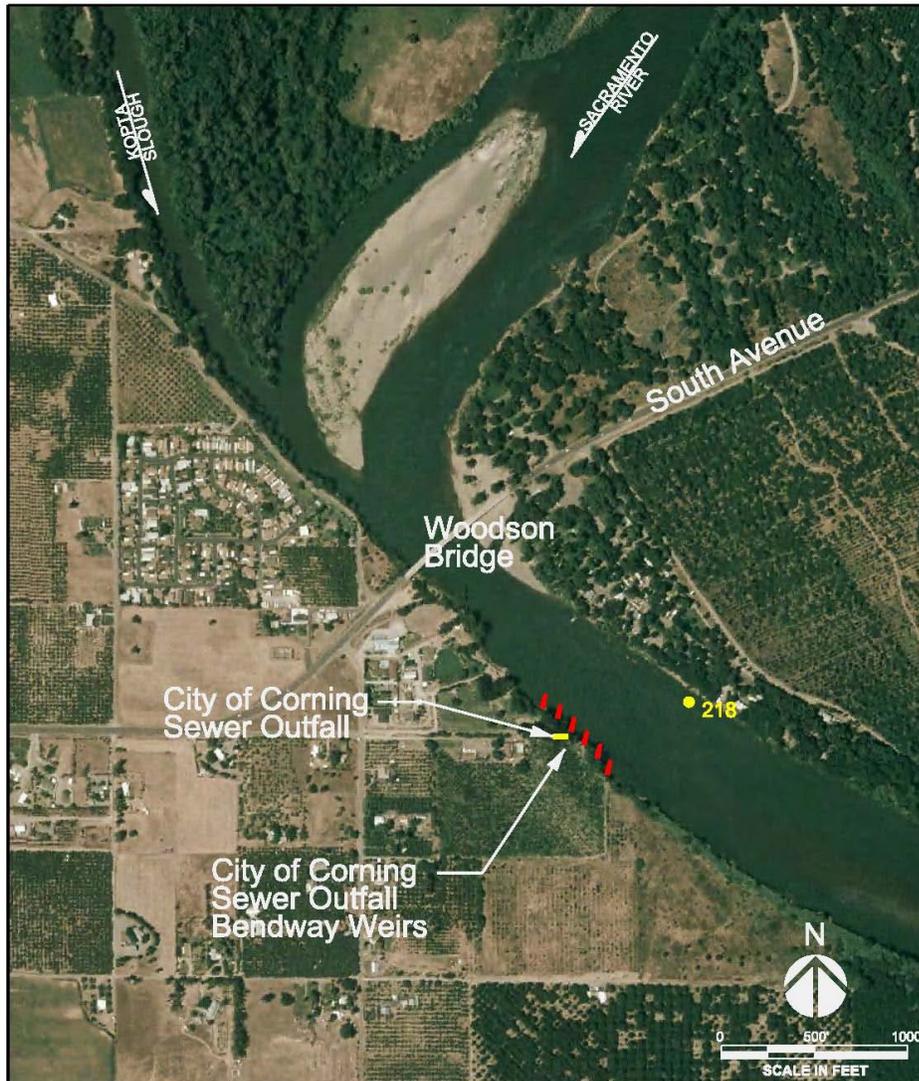
Figure 18. Plan View of Bendway Weirs at the City of Corning Sewer Outfall

City of Corning sewer outfall. The weirs are placed at an angle to ensure the redirection of flow and extend to the middle of the channel. The design for this study includes 6 weirs, spaced 100 ft apart, protecting 500 ft of bank, as shown in **Figure 18**. The top of the weir would be at the summer low flow water level and may require the use of buoys to prevent them from becoming a navigational hazard. The configuration of these weirs is shown in **Figure 19**. Vegetation would be placed along the existing bank to provide additional erosion protection, environmental features, and for aesthetics.

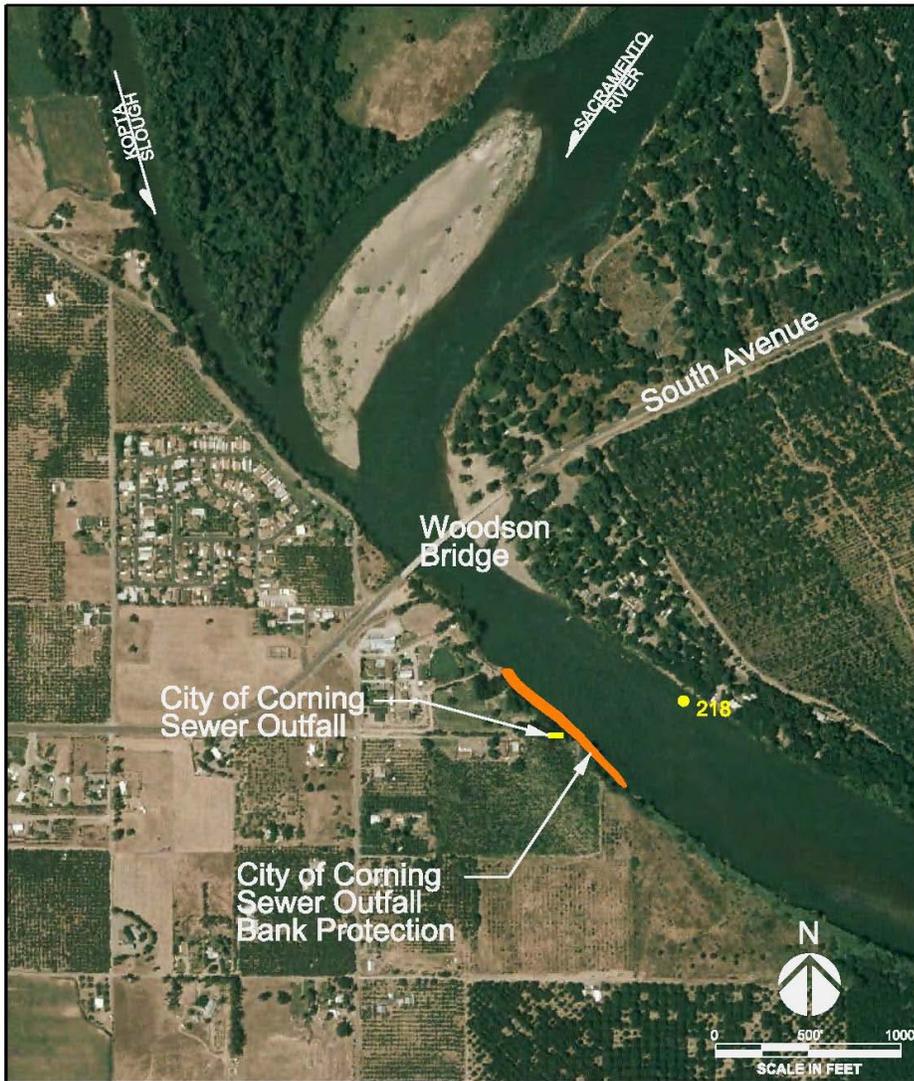
Figure 22. Plan View of Bank Armor/Low Berm at the City of Corning Sewer Outfall

Another option for protecting the City of Corning sewer outfall is building a low berm. The low berm would cover the same area as the bank armor, as shown in **Figure 22**. The berm would extend out approximately 20 ft at the summer low flow water surface elevation with a 2:1 slope to the bottom of the channel. Rock will need to be placed half way up the bank slope where the velocities are greater than 5 ft/s. The upper slope will also be protected with bank vegetation. The configuration of this design is shown in **Figure 24**.

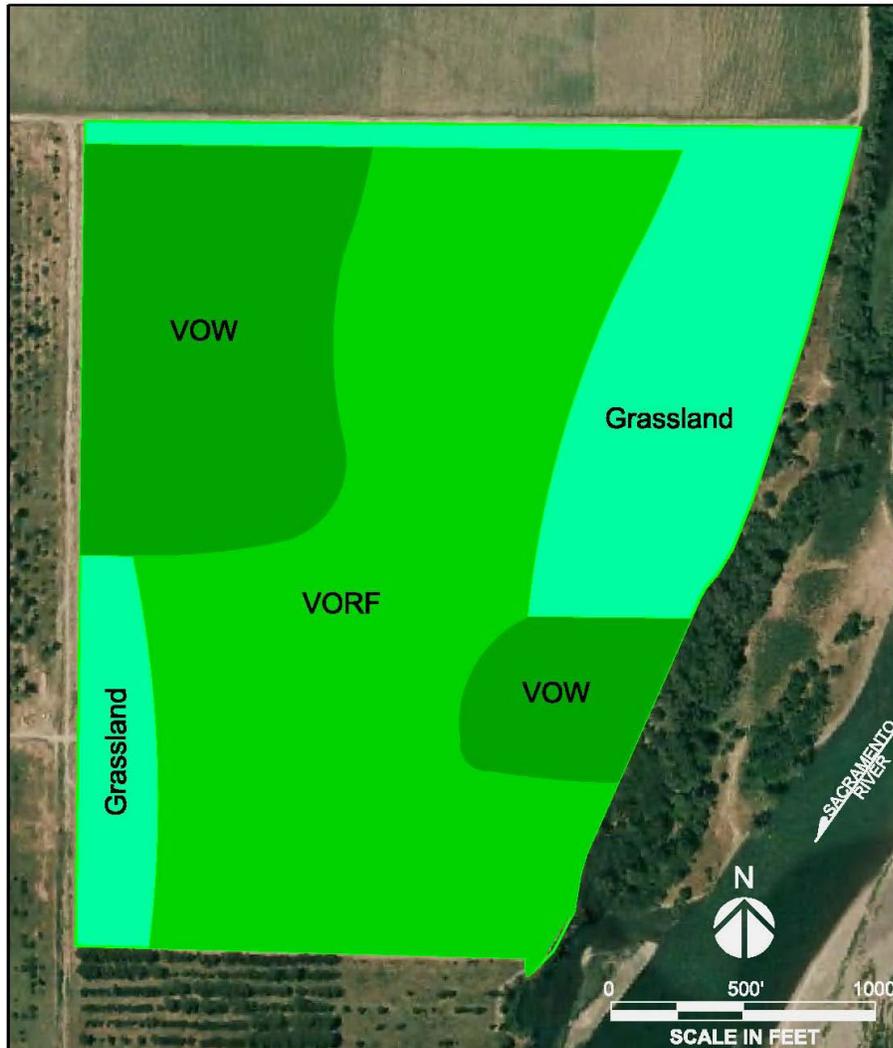
Figure 27. Habitat Restoration Plan for the Kopta Slough Property

Scenario 1 simulates the 100-year flow in combination with the restoration condition for the Kopta Slough Property. The model represents a restoration condition to the Kopta Slough property. The area of proposed restoration is used for crops, which is alfalfa in the existing condition. The restoration habitat consists of a mixture of Valley Oak Riparian Forest (VORF), Valley Oak Woodland (VOW) and Grassland, as shown in **Figure 27**.
