Appendix D: Geotechnical Supporting Information

Type of Services	Preliminary Geotechnical Investigation
Project Name	Moorpark Residential Development
Location	2323 Moorpark Avenue San Jose, California
Client	TTL Management, Inc.
Client Address	12647 Alcosta Blvd., Suite 470 San Ramon, CA
Project Number	648-20-2
Date	December 2, 2019

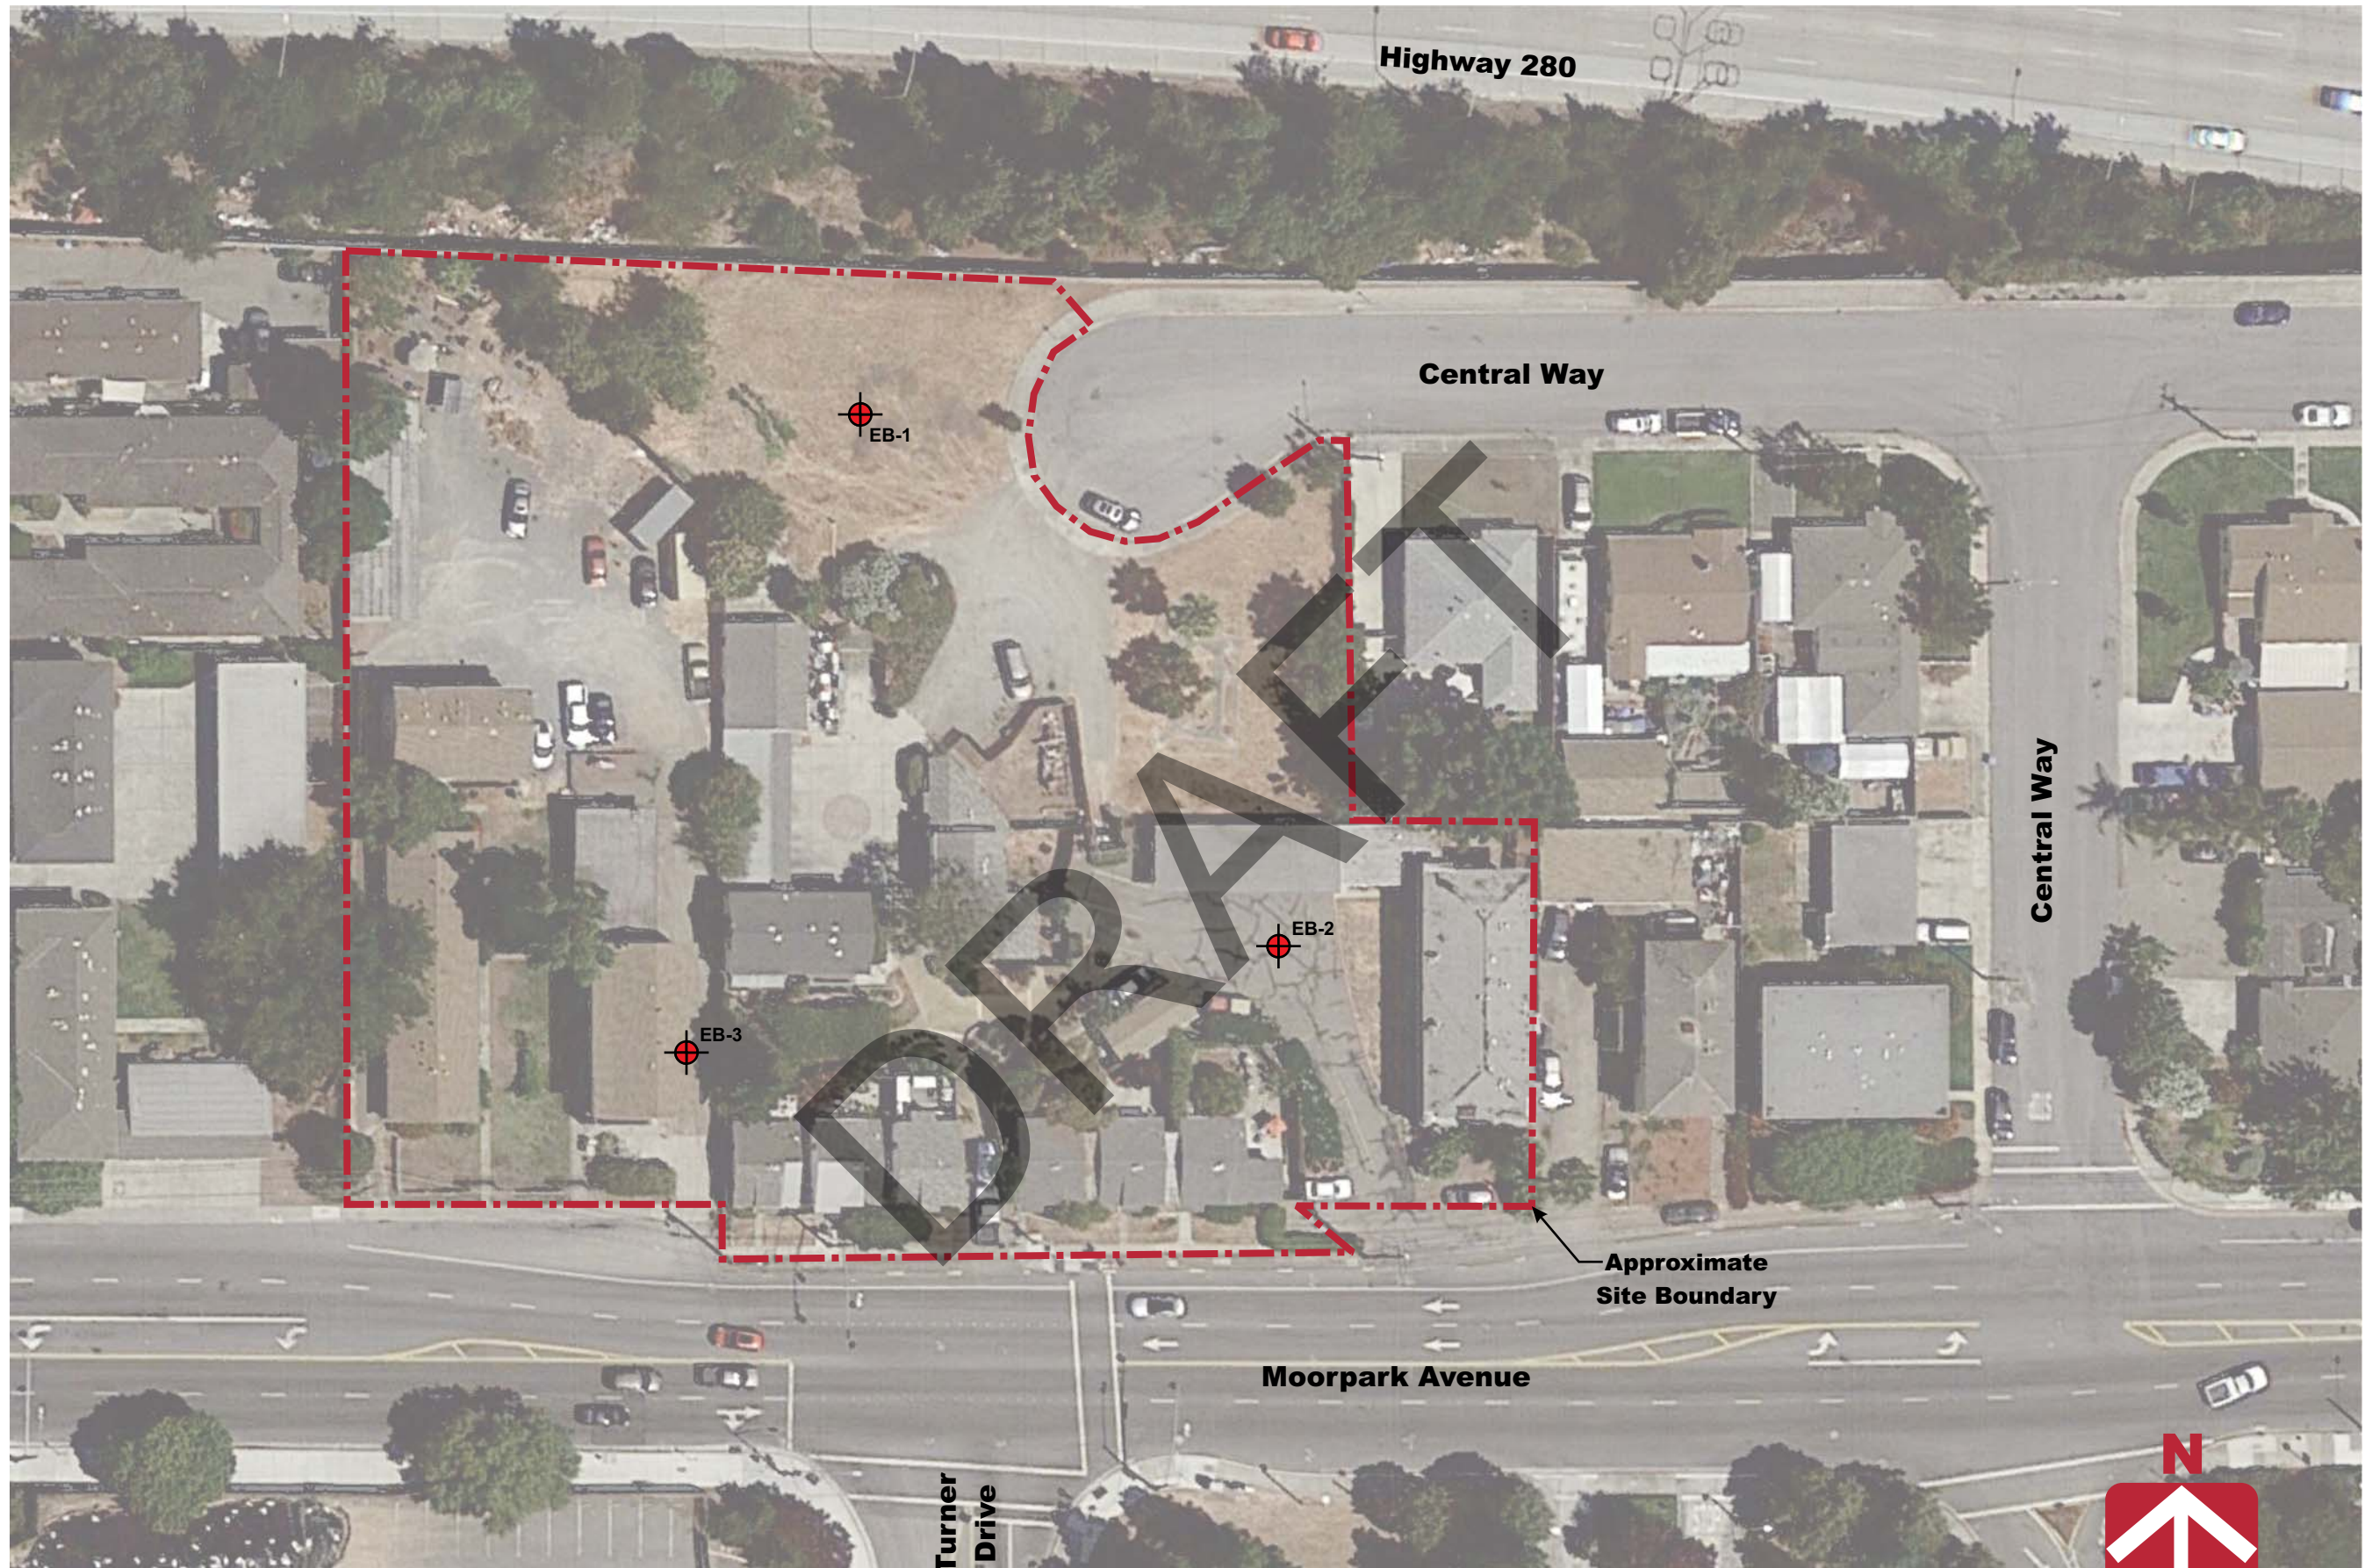
Site Plan		Project Number	648-20-2
		Figure Number	Figure 2
CORNERSTONE EARTH GROUP		Moorpark Avenue San Jose, CA	
		Date	November 2019
		Drawn By	RRN

Approximate location of exploratory boring (EB)

The approximate locations of our exploratory borings are shown on the Site Plan, Figure 2. Details regarding our field program are included in Appendix A.

The field investigation consisted of a surface reconnaissance and a subsurface exploration program using truck-mounted, hollow-stem, auger drilling equipment. Three 8-inch-diameter exploratory borings were drilled on October 25, 2019 to depths of approximately 20 feet. The approximate locations of exploratory borings are shown on the Site Plan, Figure 2. The soils encountered were continuously logged in the field by our representative and described in accordance with the Unified Soil Classification System (ASTM D2488). Boring logs, as well as a key to the classification of the soil, are included as part of this appendix.
