430-18 September 24, 2018

SUBJECT: Dignity Health Project—Tree Survey Report (Candidate Trees)

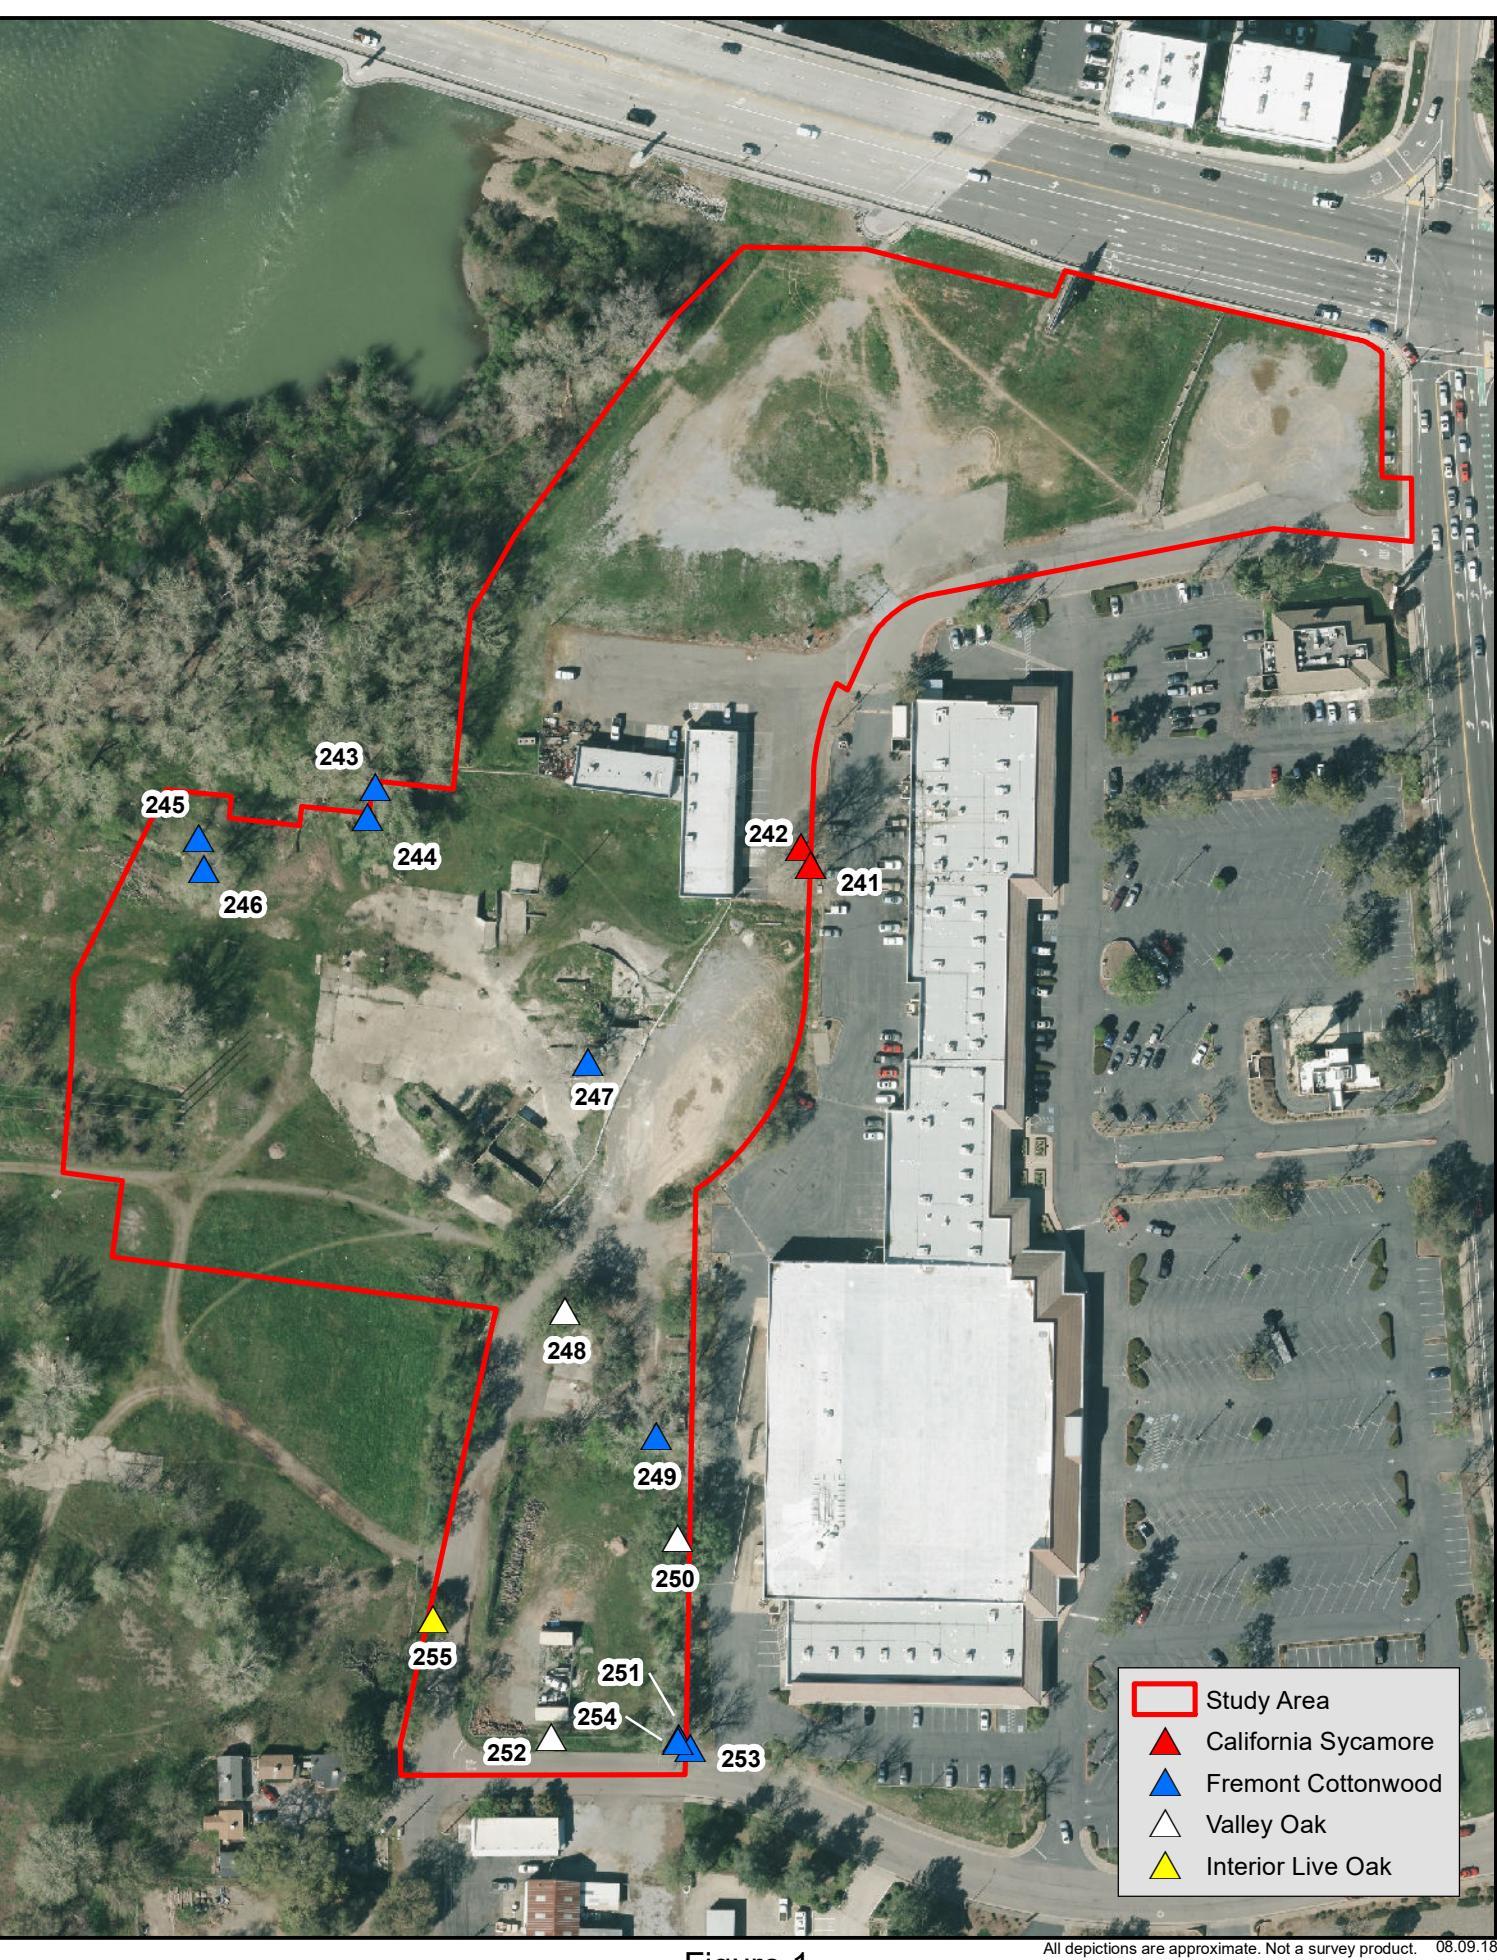
# Figure 1 Tree Survey Results

The site was surveyed on July 23, 2018, to identify the presence of candidate trees and candidate tree groupings, as defined above. The survey was conducted by Rico Montenegro, Certified Arborist #WE-6734A. A total of 15 candidate trees were recorded on the site; no candidate tree groupings were observed (Figure 1). Candidate trees, including their identification number, species, size, and health rating, are shown in Table 1. Non-candidate trees identified on the site exhibit smaller diameters and, generally speaking, are structurally sound. However, the arborist did not consider the remaining trees as meeting the criteria necessary for candidate status.
