# Appendix D: Biological Resources Technical Report

July 27, 2017	7 Project # 3328-15	
То:	Caitlin Chase, Project Manager Circlepoint	
From:	Kelly Hardwicke, Principal Plant Ecologist H. T. Harvey & Associates	
Subject:	Half Moon Bay Hyatt Place Project Biological Resources Technical Repo Peer Review	rt

## **Executive Summary**

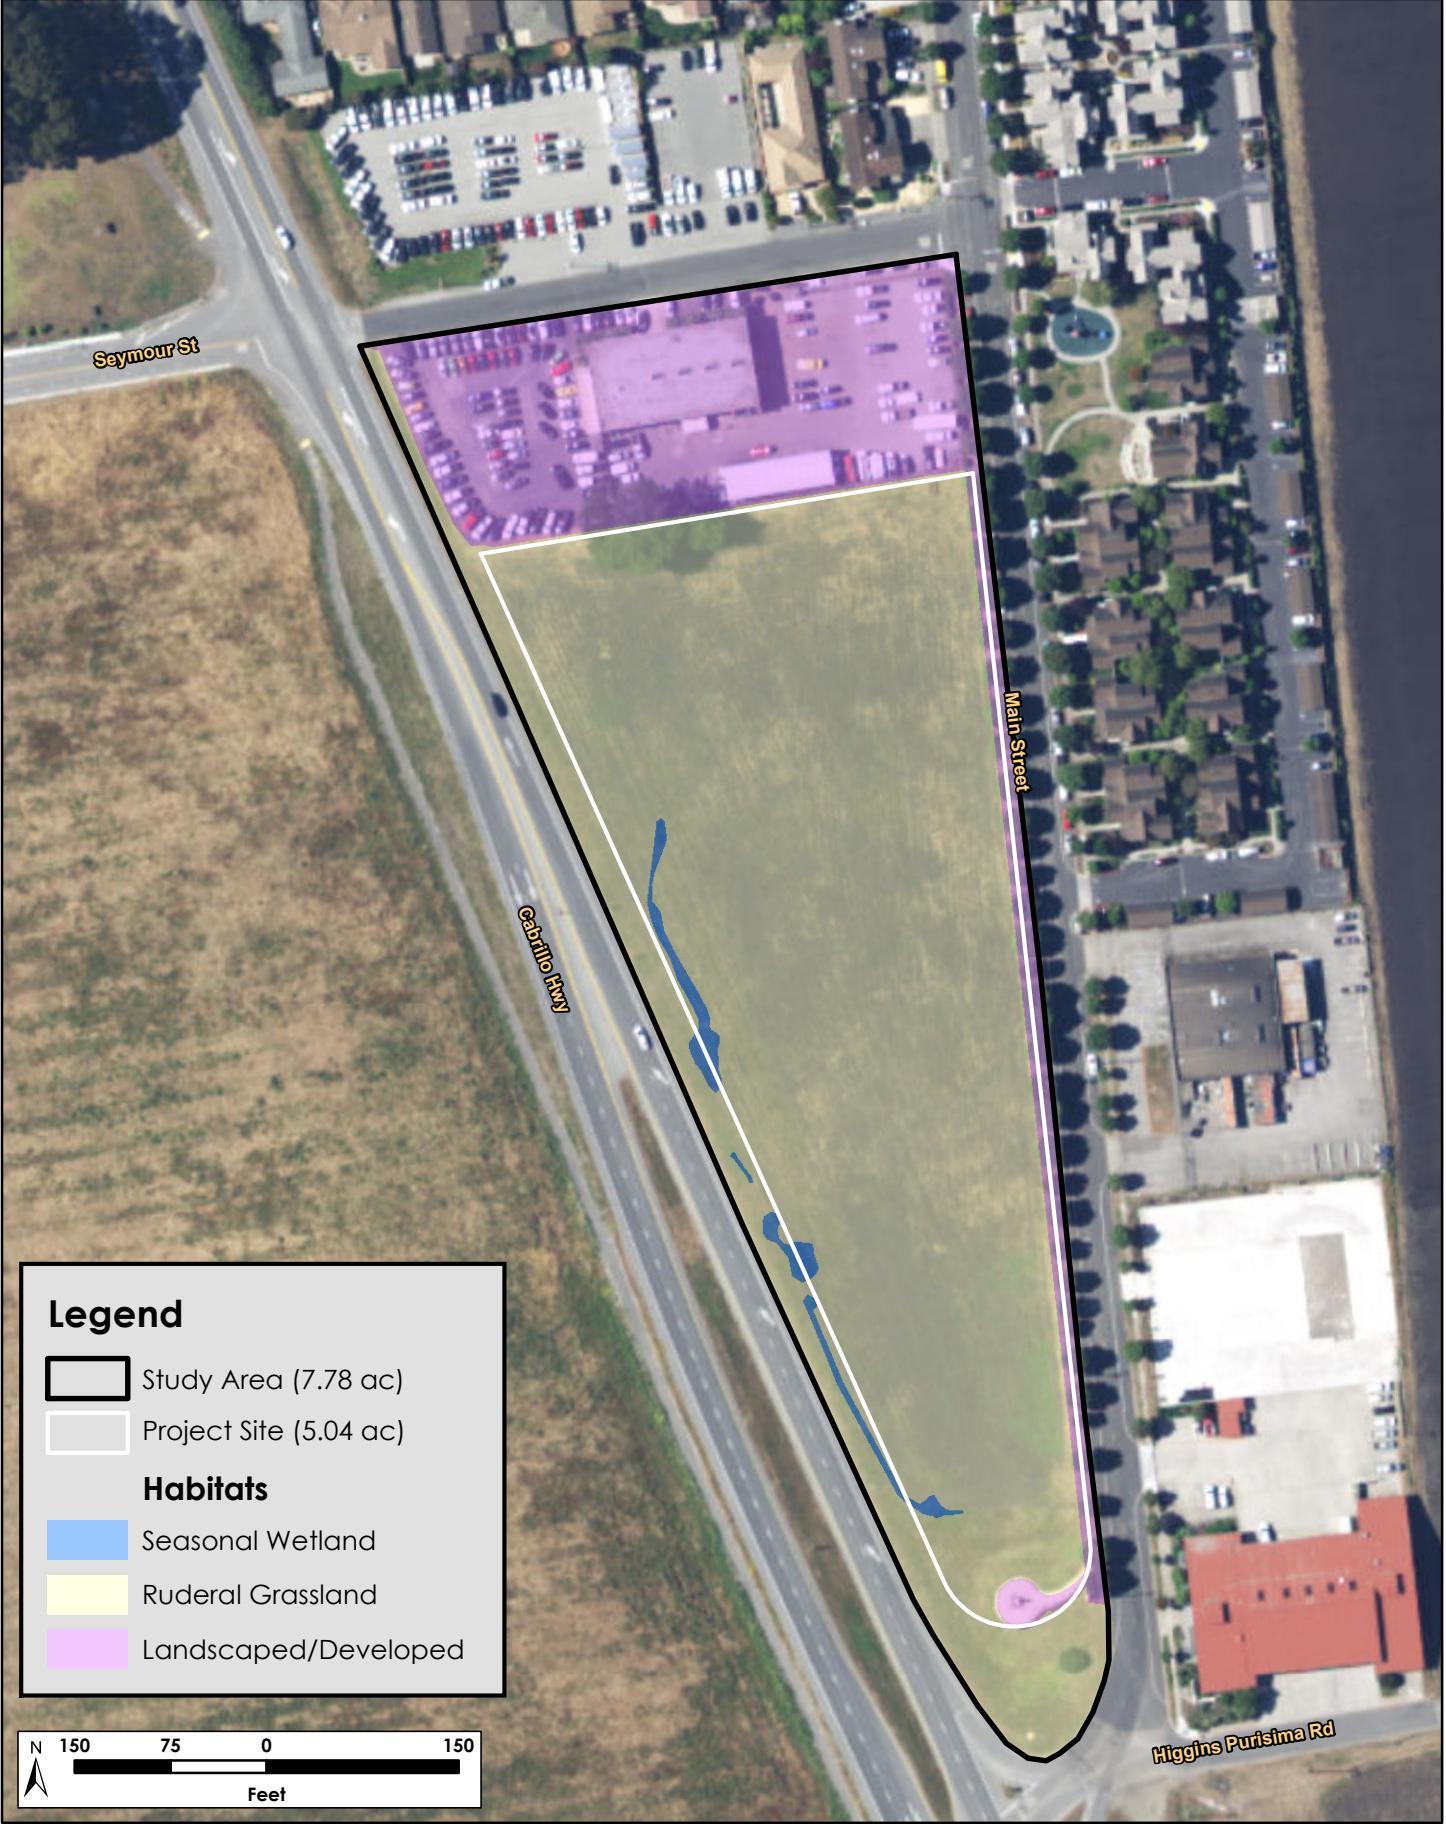
Figure 4. Habitat Map Half Moon Bay Hyatt House Hotel Project Biological Resources Technical Report Peer Review (3328-15) August 2017 discounted in these depressional areas, but as mentioned above, the Botella soil map unit is considered hydric when occurring in depressions.

During the 2017 field surveys, H. T. Harvey & Associates observed three biotic habitats in the study area: (1) landscaped/developed, (2) ruderal grassland, and (3) seasonal wetlands (Figure 4). These results differed from the vegetation mapping provided by CRB and Biosearch Associates (2013) and SWCA (2016) for the portion of the study area located south of the existing car dealership. Detailed descriptions are provided below<sup>1</sup>.

Four seasonal wetland features located on the western boundary of the study area were determined to meet the USACE three-parameter criteria for wetlands under Section 404 of the Clean Water Act (Figure 4). Each feature supported strongly hydrophytic (water-loving) vegetation, occurred in depressions, and exhibited wetland hydrology indicators. Soils were determined to be problematic across the study area as a result of intermittent disking, and thus hydric soil indicators such as soil color mottling were not observed nor

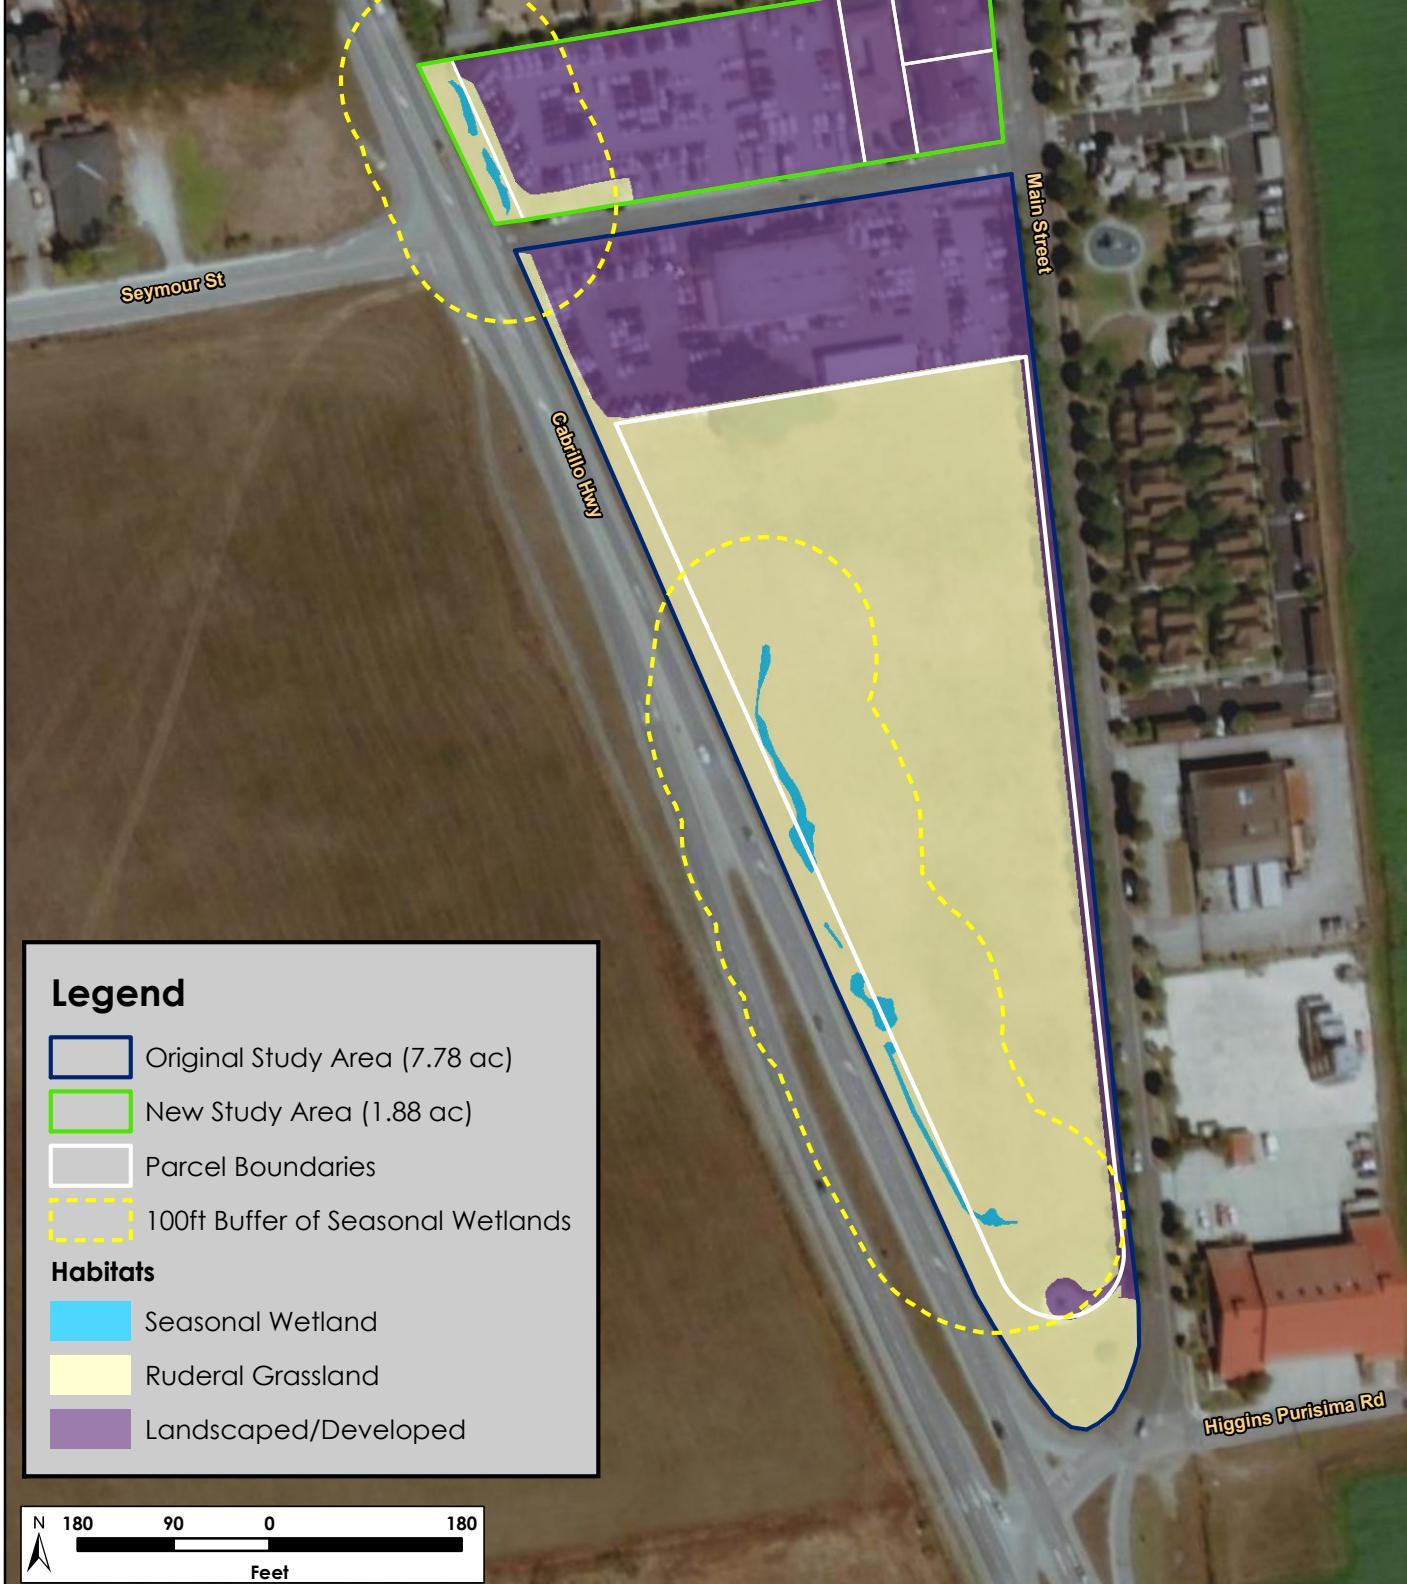
H. T. HARVEY & ASSOCIATES Ecological Consultants Figure 4. Habitat and Wetland Buffer Map Half Moon Bay Hyatt Hotel Project Biological Resources Technical Report Update (3328-15) January 2022 disking, and thus hydric soil indicators such as soil color mottling were not observed nor discounted in these depressional areas, but as mentioned above, the Botella soil map unit is considered hydric when occurring in depressions, as seen in both study areas.

During the 2017 and 2021 field surveys, H. T. Harvey & Associates observed three biotic habitats in the study area: (1) landscaped/developed, (2) ruderal grassland, and (3) seasonal wetlands (Figure 4). These results differed from the vegetation mapping provided by CRB and Biosearch Associates (2013) and SWCA (2016) for the portion of the original study area located south of the existing car dealership. Detailed descriptions are provided below.

Four seasonal wetland features located on the western boundary of the original study area, and two seasonal wetland features along the western boundary of the new study area, totaling 0.12 ac, were determined to meet the USACE three-parameter criteria for wetlands under Section 404 of the Clean Water Act (Figure 4). Each feature supported hydrophytic (water-loving) vegetation, occurred in depressions, and exhibited wetland hydrology indicators. Soils were determined to be problematic across the study area as a result of intermittent

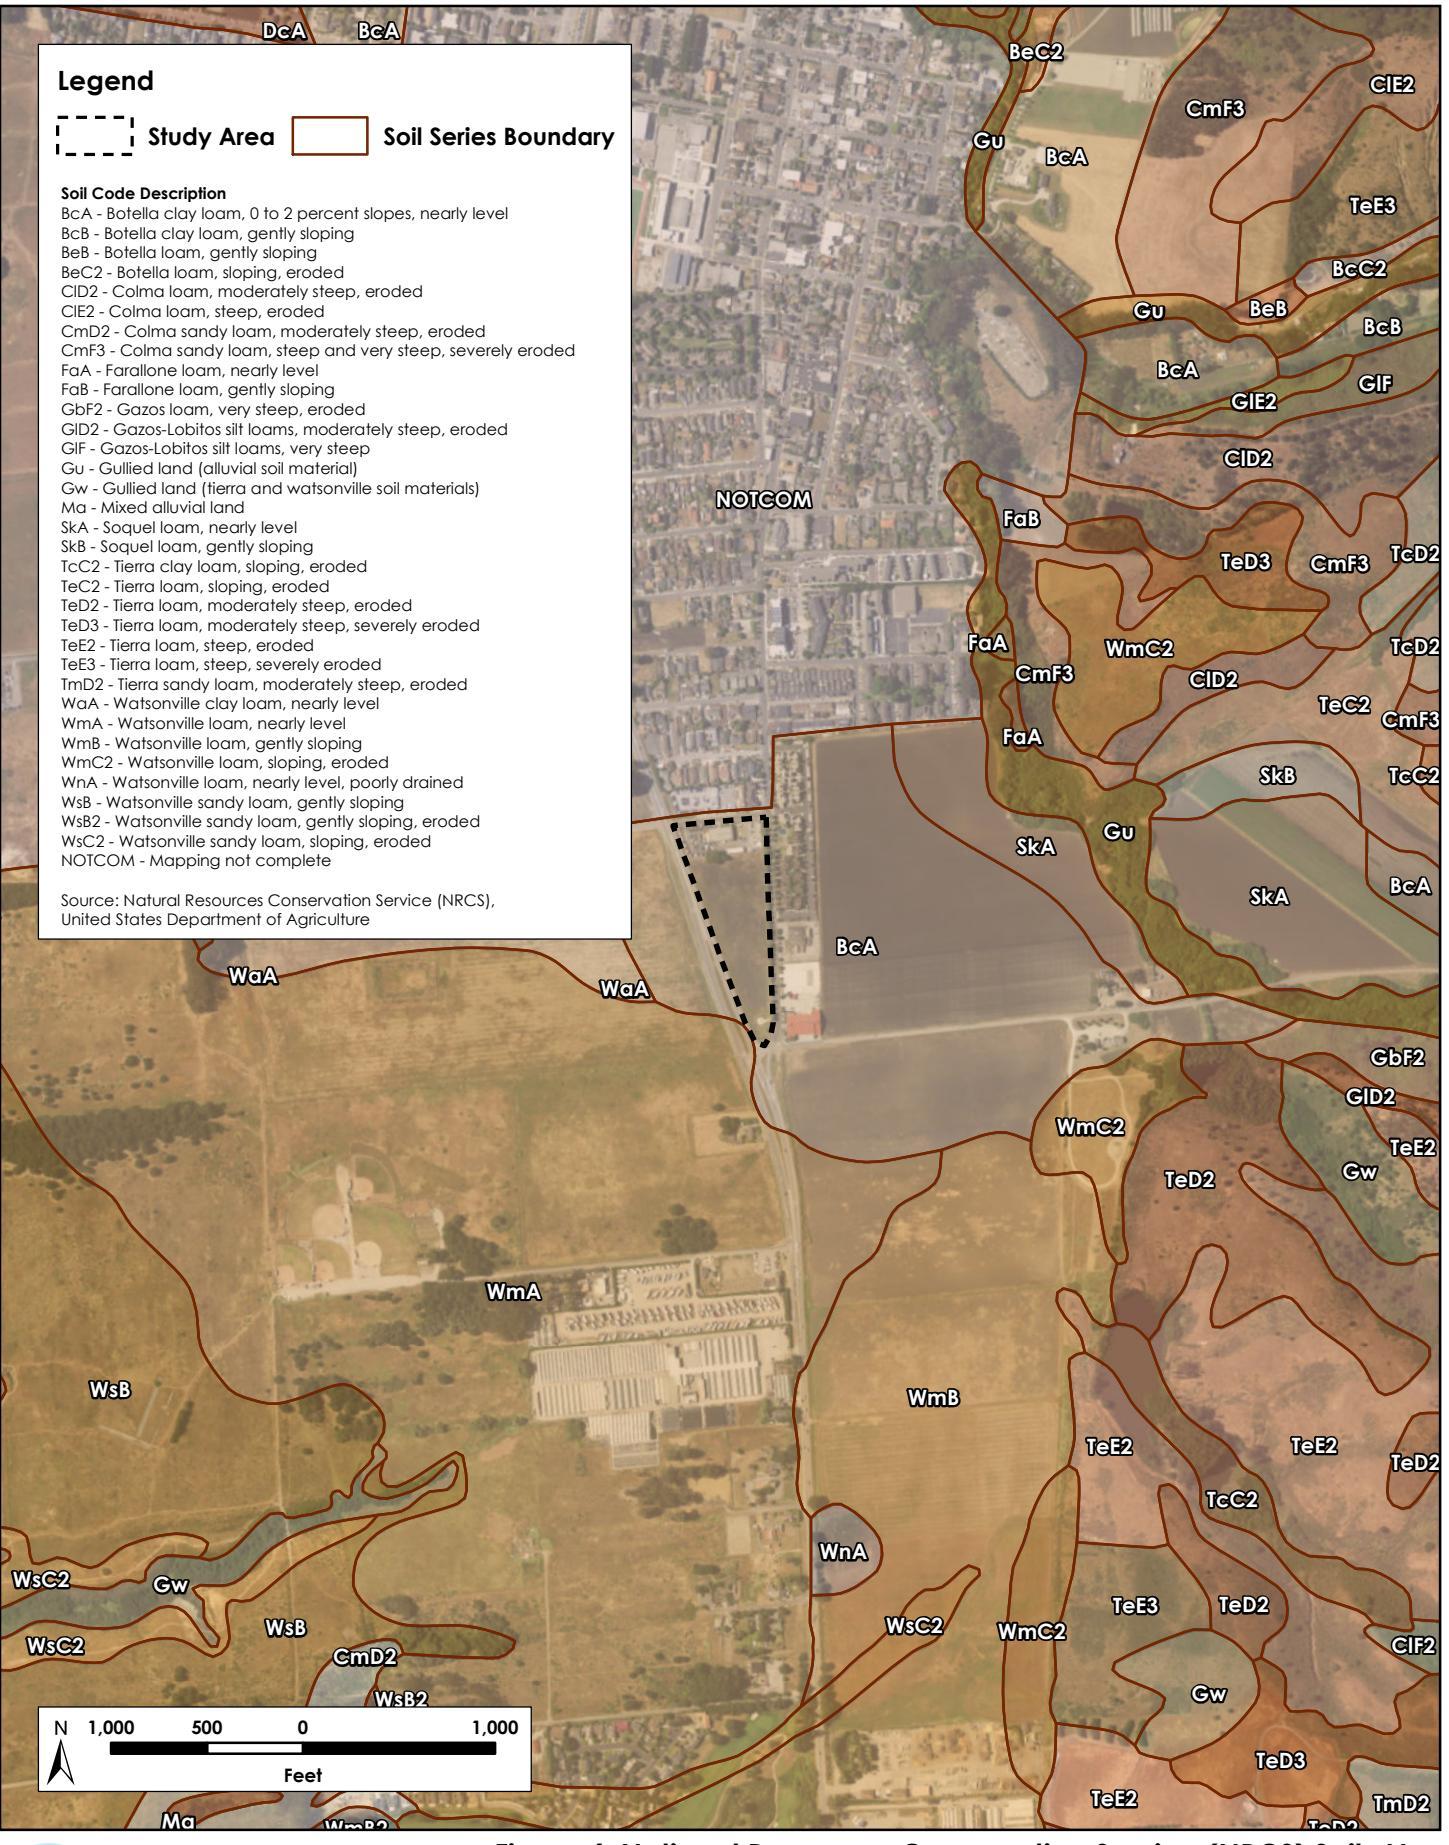
H. T. HARVEY & ASSOCIATES Ecological Consultants Figure 4. National Resources Conservation Service (NRCS) Soils Map Half Moon Bay Hyatt Preliminary Identification of Waters of the U.S. and State (3328-15) August 2017

Soil Symbo	Soil Name	Soil Texture	Drainage Classification	Hydric?
BcA	Botella clay loam, 0 to 2 percent slopes, nearly level	Clay loam	Well-drained	Yes, when found in depressions

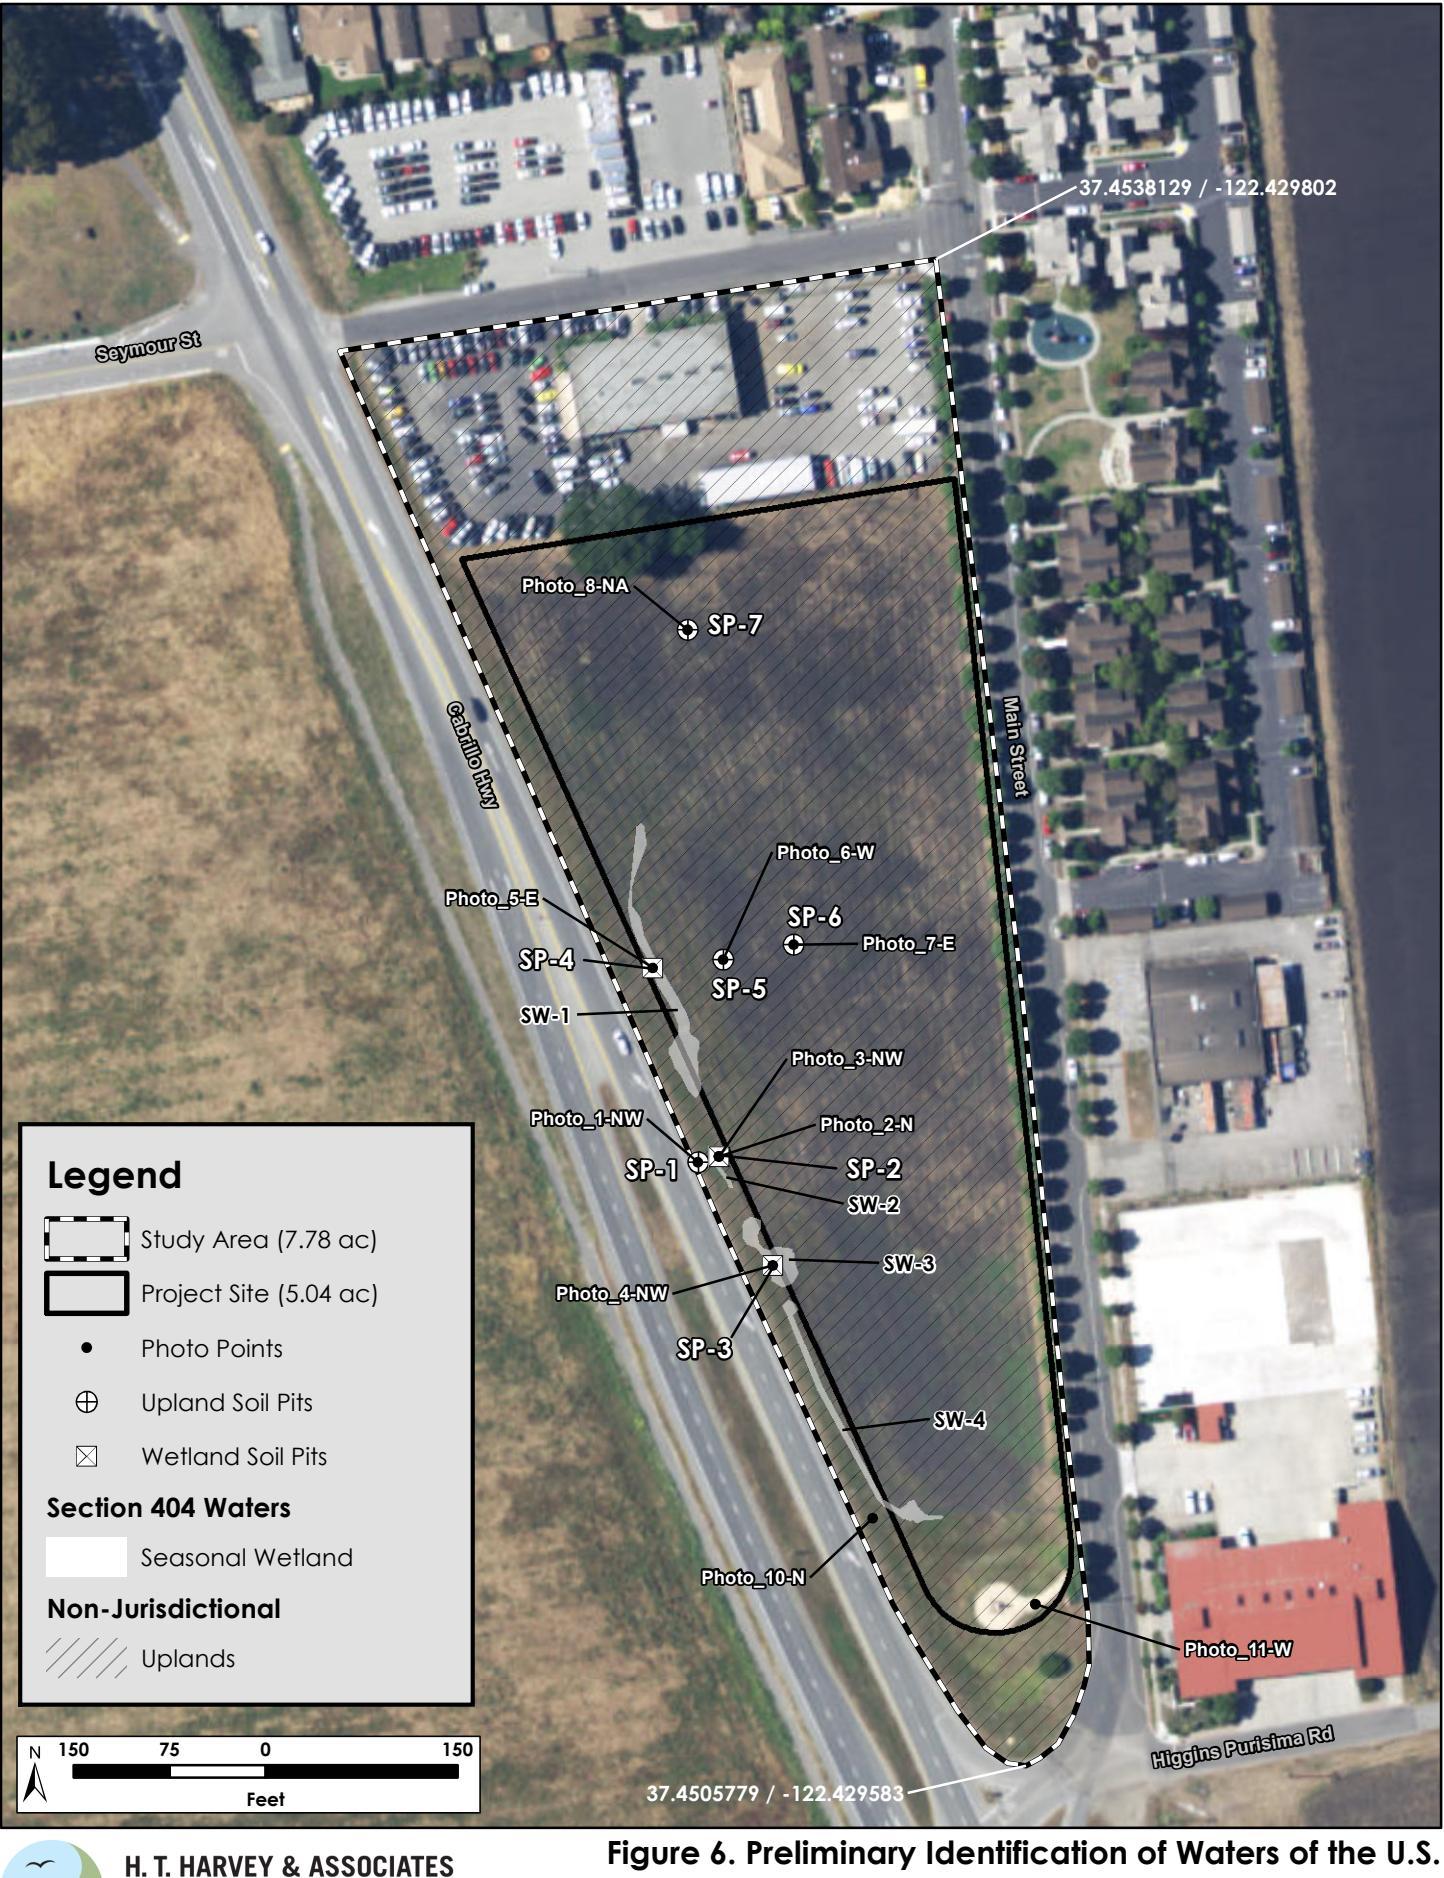
Figure 6. Preliminary Identification of Waters of the U.S. Half Moon Bay Hyatt Preliminary Identification of Waters of the U.S. and State (3328-15) August 2017

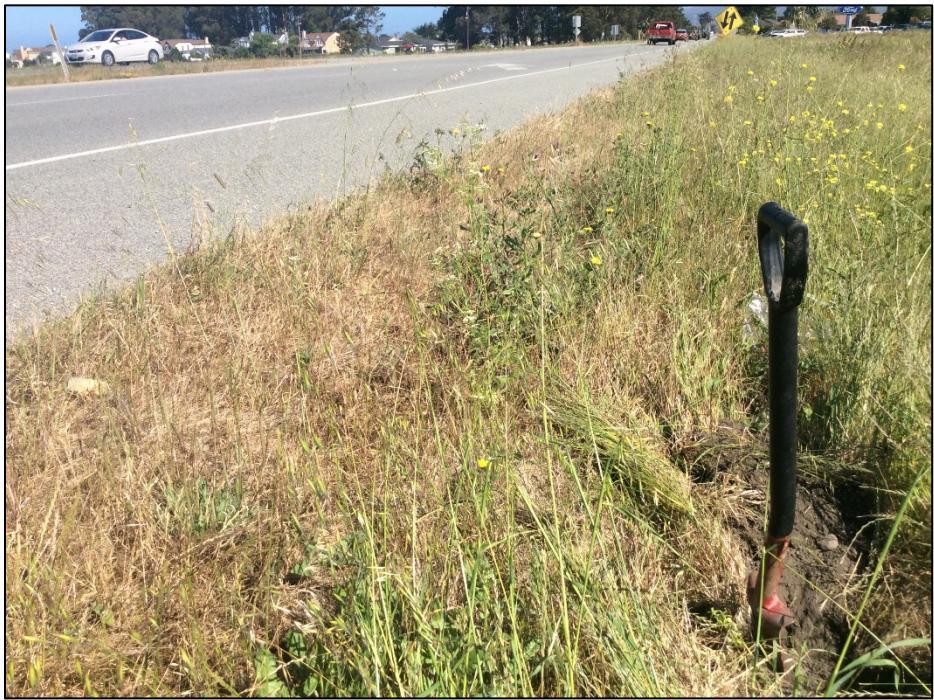
Photo 1. Upland sample location SP1. Photo was taken facing NW on June 13, 2017 (Photo\_1-NW, Figure 6).

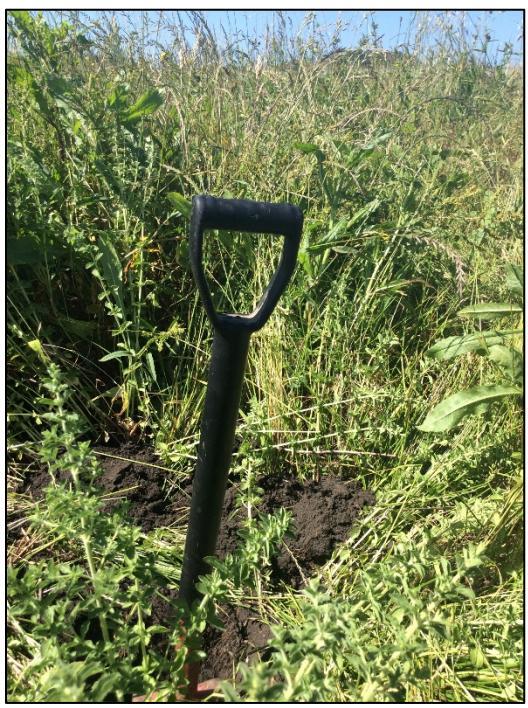
Photo 2. Wetland sampling location SP2. Photo was taken facing N on June 13, 2017 (Photo\_2-N, Figure 6).

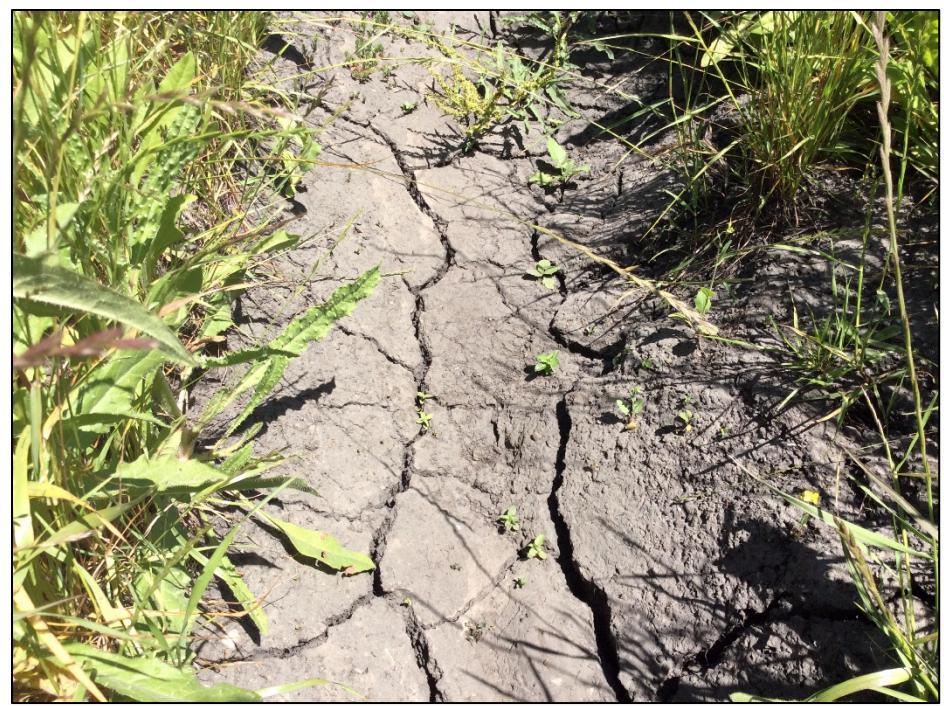
Photo 3. Near wetland sample location SP2 (within the boundaries of wetland SW-2) to illustrate surface soil cracks (wetland hydrology indicator B6). Photo was taken facing N on June 27, 2017 (Photo\_3-N, Figure 6).

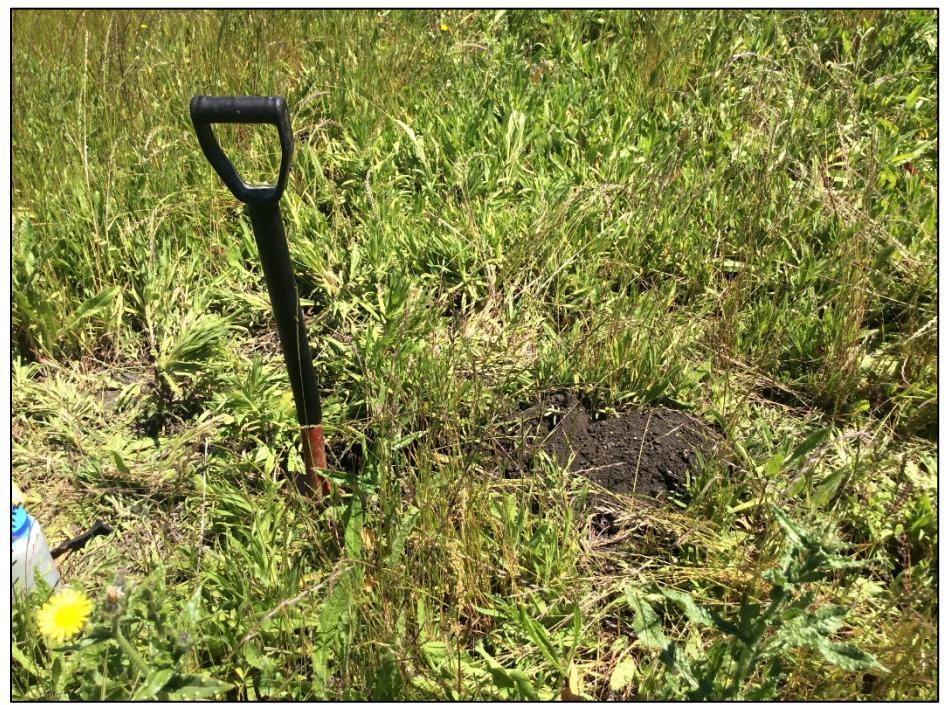
Photo 4. Wetland sampling location SP3. Photo was taken facing NW on June 13, 2017 (Photo\_4-NW, Figure 6).

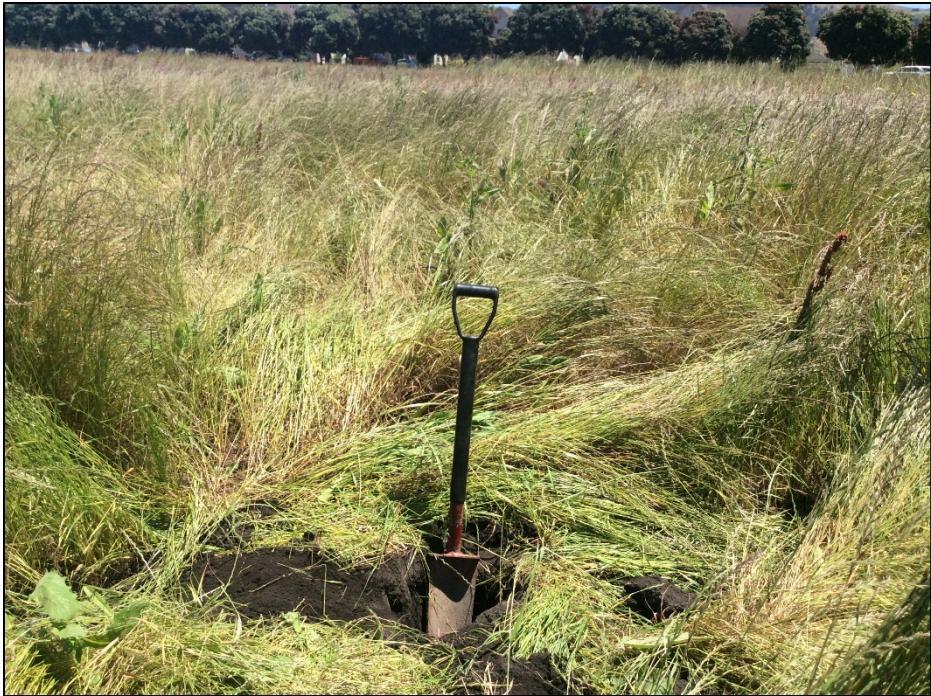
Photo 5. Wetland sample location SP4. Photo was taken facing E on June 13, 2017 (Photo\_5-E, Figure 6).

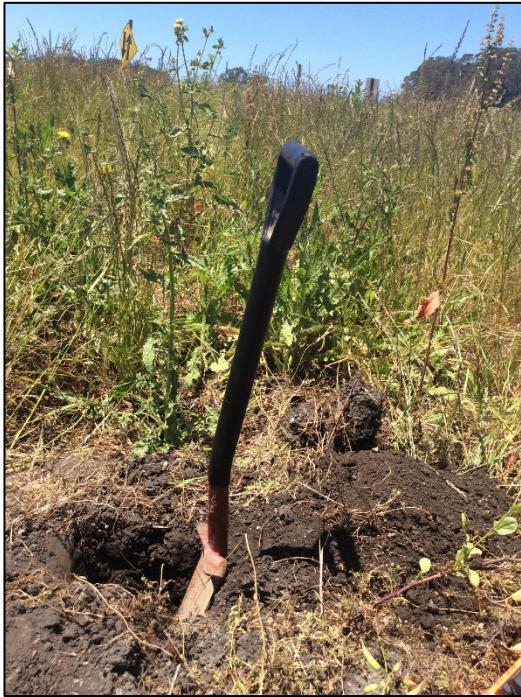
Photo 6. Upland sample location (SP5). Photo was taken facing W on June 13, 2017 (Photo\_6-W, Figure 6).

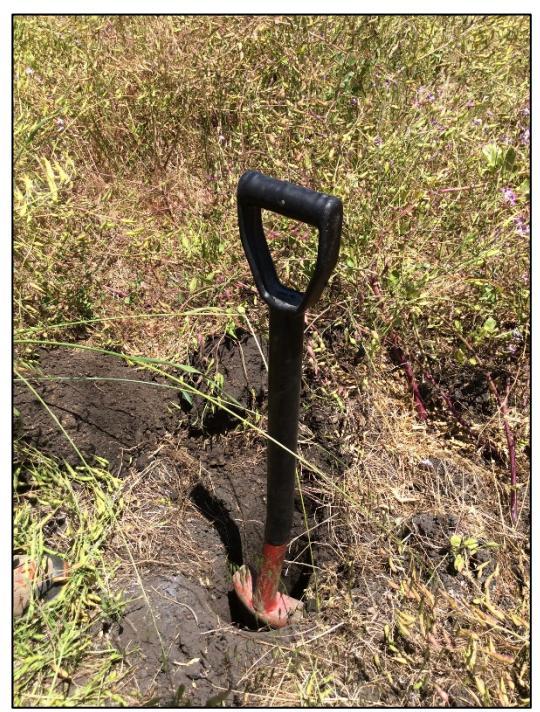
Photo 7. Upland sample location (SP6). Photo was taken facing W on June 13, 2017 (Photo\_7-W, Figure 6).

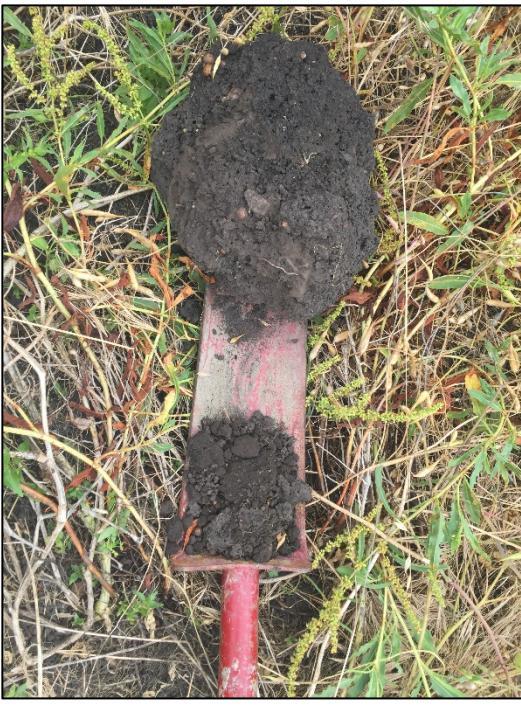
Photo 8. Soil on the top of the shovel is from SP7, whereas the soil on the lower portion of the shovel was taken from the wetland SW-1. (Photo\_8-NA, Figure 6).

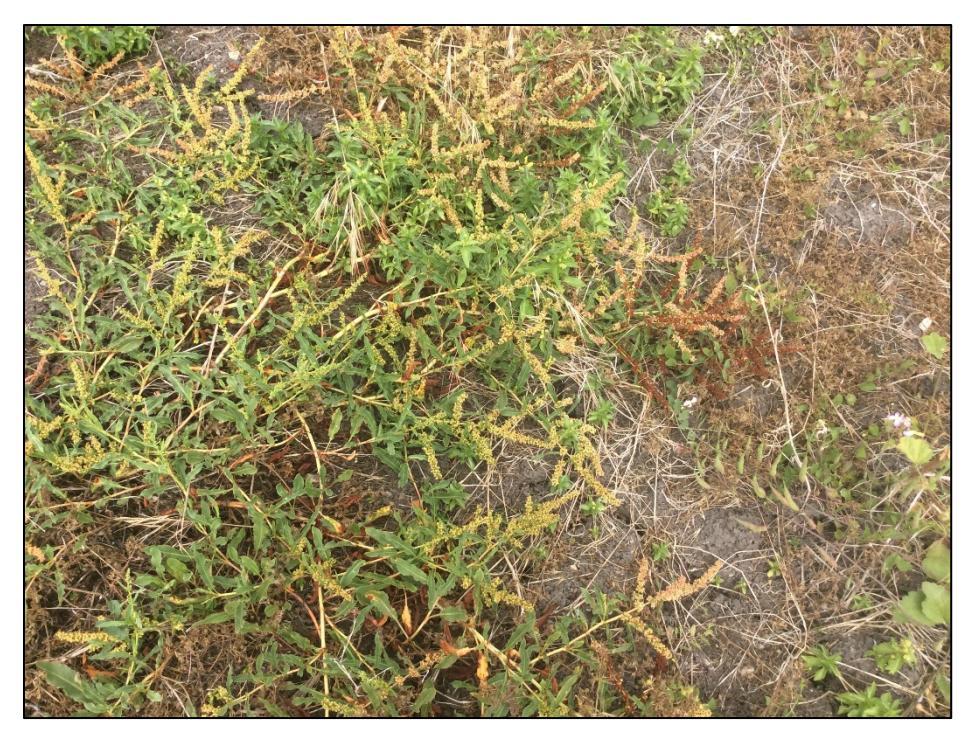
Photo 9. Upland sample location SP7 with willow dock. Photo was taken facing the ground surface on June 27, 2017 (Photo\_9-NA, Figure 6).

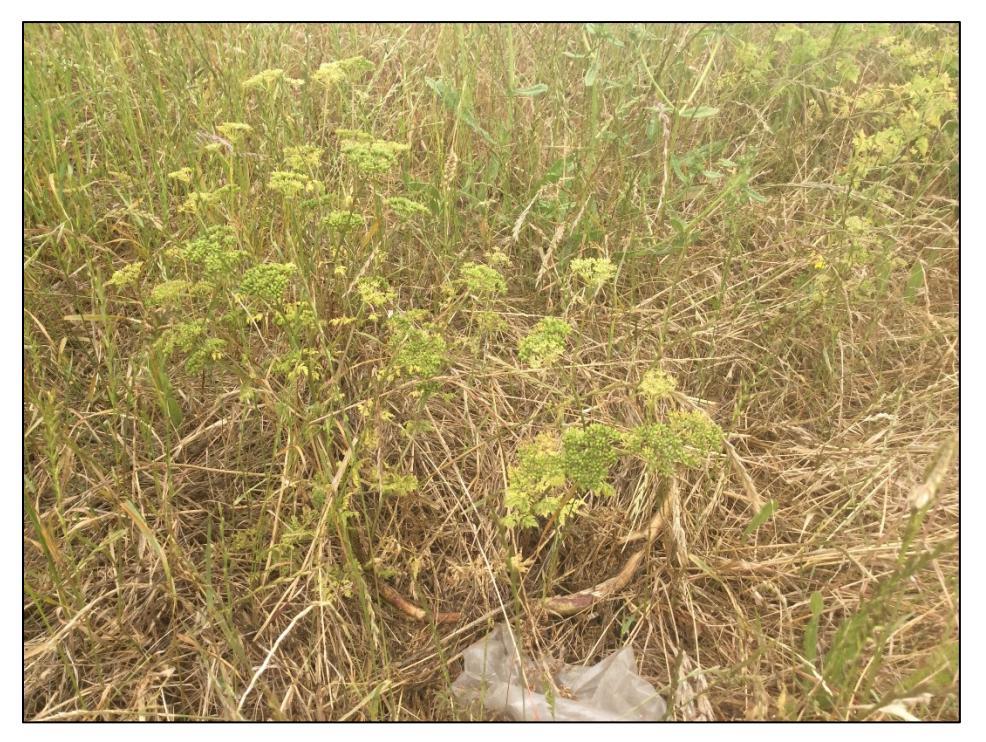
Photo 10. Uplands with poison hemlock. Photo was taken facing N on June 27, 2017 (Photo\_10-N, Figure 6).

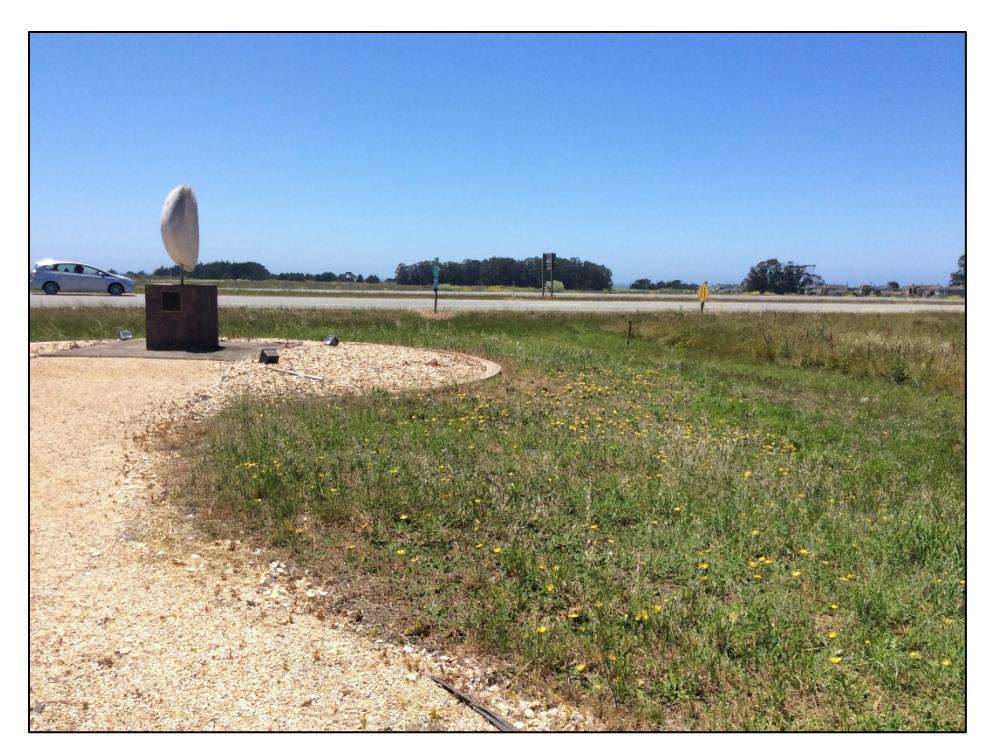
Photo 11. Uplands with a mowed area and developed trail. Photo was taken facing W on June 13, 2017 (Photo\_11-W, Figure 6).
