Cultural Resources Survey and Test Excavations Report for the Ashwood Street Corridor Improvements Project San Diego, California

RECON Number 8661 October 15, 2019

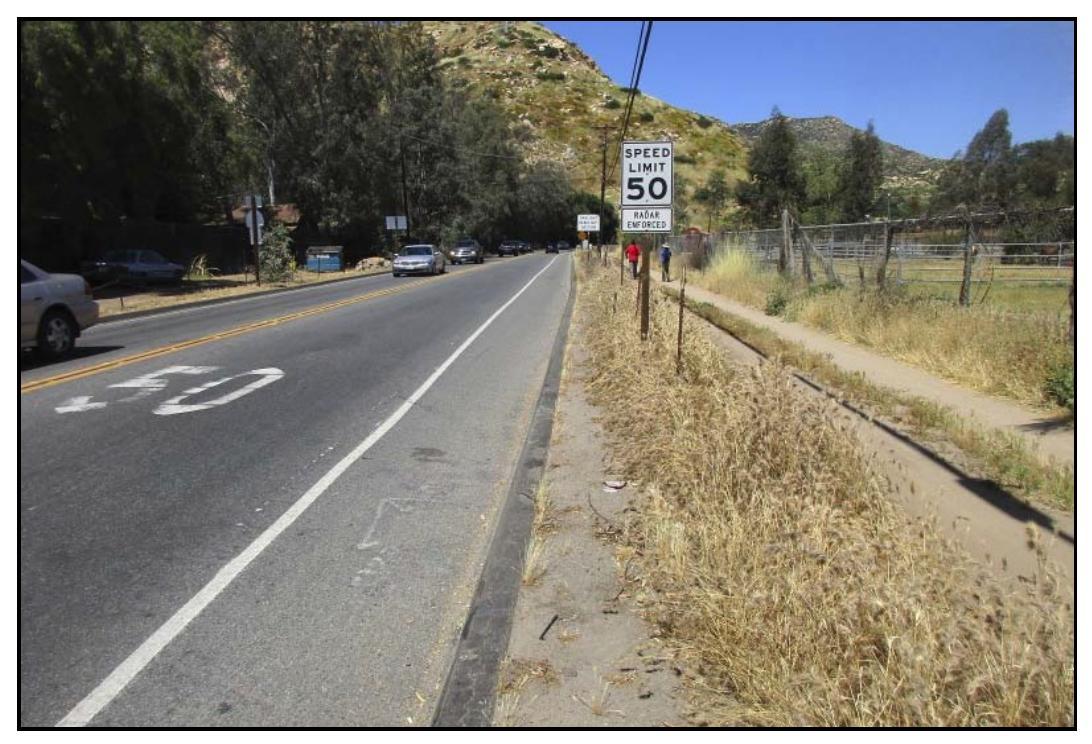
PHOTOGRAPH 1 Survey Area along East Side of Wildcat Canyon, Looking North

RECON surveyed only along the roadsides in the northern portion of the APE due to private property fencing (Photograph 1). Additionally, only a portion of the roadside of the northernmost segment was surveyed because access was denied by the landowner. The APE in the northern portion has been impacted by rural residences, horse corrals and structures, ball fields, and a County of San Diego maintenance yard. As noted above, one prehistoric (CA-SDI-4901) and one historic site (CA-SDI-12870H) have been recorded in this portion of the APE.

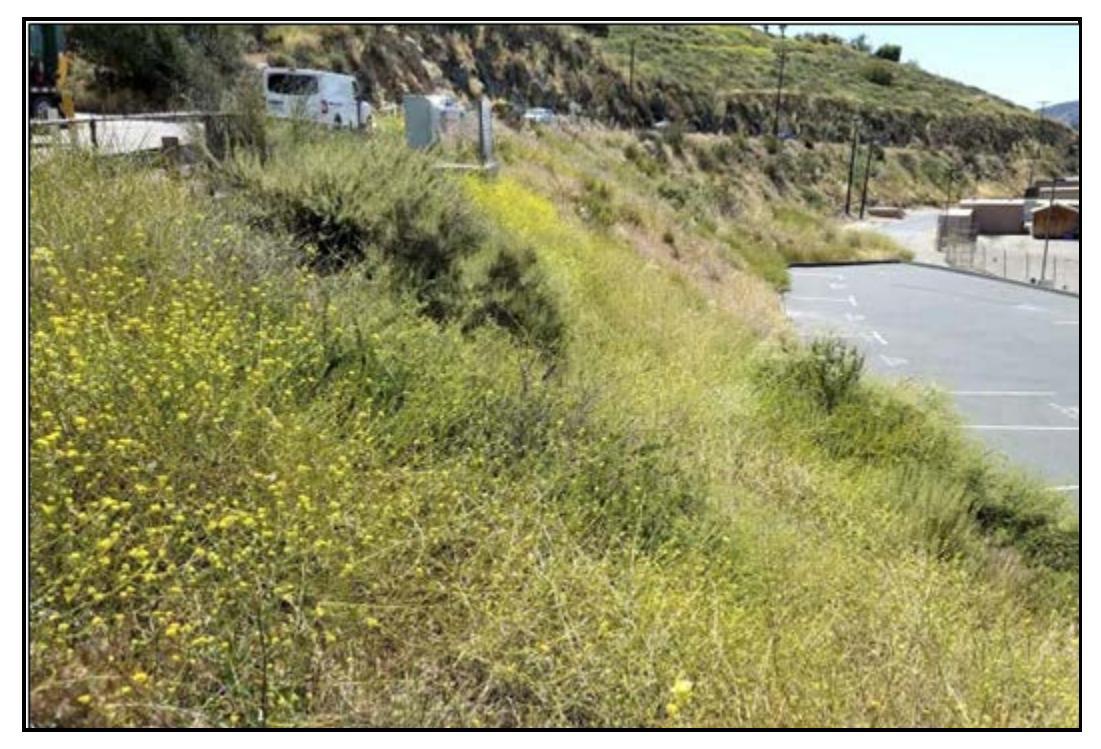
PHOTOGRAPH 2 West Side of Ashwood Street at El Capitan High School, Note Cut Slope on East Side of the Street

The central portion of the APE consisted of developed lands on the west side of Ashwood Street and some development on the ridgeline on the east side. Developed lands include El Capitan High School, Cactus County Park, and a BMX course (Photograph 2). To the east of Ashwood Street is a north-south trending ridgeline that has been cut on the west side for the Ashwood Street right-of-way. Ashwood Street, in a slightly different alignment, is noted in the 1893 topographic map and on the 1953 aerial photograph; in the 1964 aerial photograph the current alignment of Ashwood Street is in place. A series of dirt roads, four mobile homes, and terraced areas are located along the ridgeline. In the 1980 aerial photograph, the top of the ridgeline has some disturbance and by the time of the 2002 aerial photograph the entire top of the ridgeline has been graded to an extent and the mobile homes are in place. At the far north end of the central APE across the street from the BMX course is the remnant of a past quarrying or sand and gravel mining. This depression was noted on the 1953 aerial photograph. Ball fields and equestrian exercise arenas first appear in the 1964 aerial photograph. Terracing is also noted on the east side of Ashwood Street in the 1964 aerial photograph along with El Capitan High School on the west side (Nationwide Environmental Title Research LLC 2017).

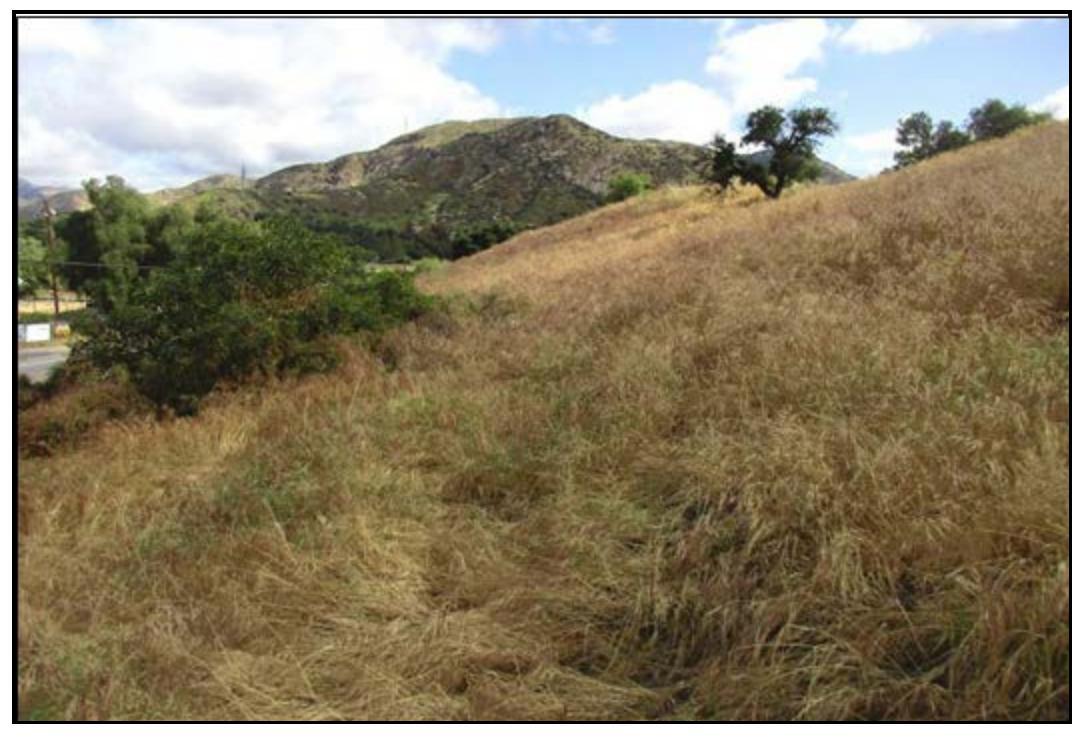
PHOTOGRAPH 3 Steep Slope Covered with Non-Native Grasses

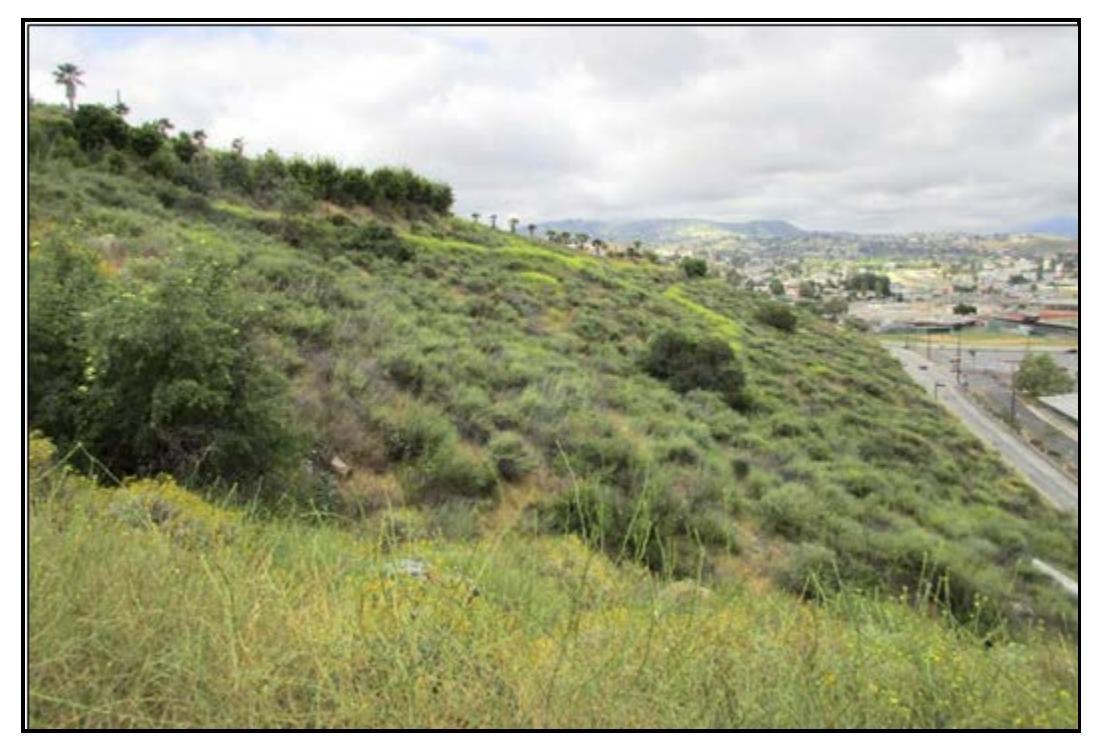
PHOTOGRAPH 4 Steep West-Facing Slope, on East Side of Ashwood Street

Visibility in the central portion of the APE varied from 0 to 50 percent. A large portion was covered in non-native grasses and disturbed Diegan coastal sage scrub with some Diegan coastal sage scrub (Photograph 3). Piles of construction debris, dirt push piles, and moved boulders were evidence of the disturbances noted on the aerial photographs. The steep west-facing slope of the ridgeline was not surveyed (Photograph 4).

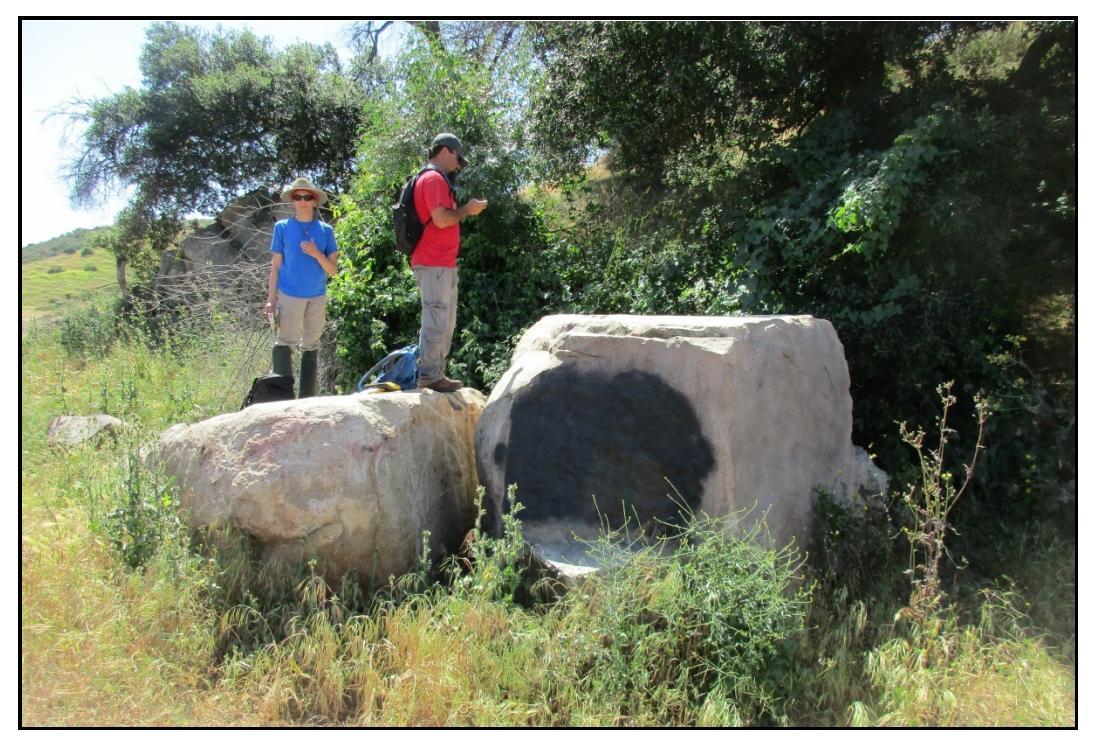
CA-SDI-22117/P-37-036609 (8661-CZH-2) is a bedrock milling feature with 19 milling elements including 9 slicks, 8 basins, and 2 mortars. It is a boulder showing evidence of drilled holes and blasting, and as such may have been moved in the past (Photograph 5). A portion of one of the slicks was broken during blasting and likely was larger than its present extent. The boulder next to the milling feature has heavy machinery scrapes, suggesting it has been moved. Vegetation was dense around the feature and may have hidden surface artifacts. No artifacts were noted. Surrounding vegetation consisted of Coast Live Oak woodland with non-native grasses and disturbed habitat at the base of the feature boulder.

PHOTOGRAPH 5 Looking South at CA-SDI-22117

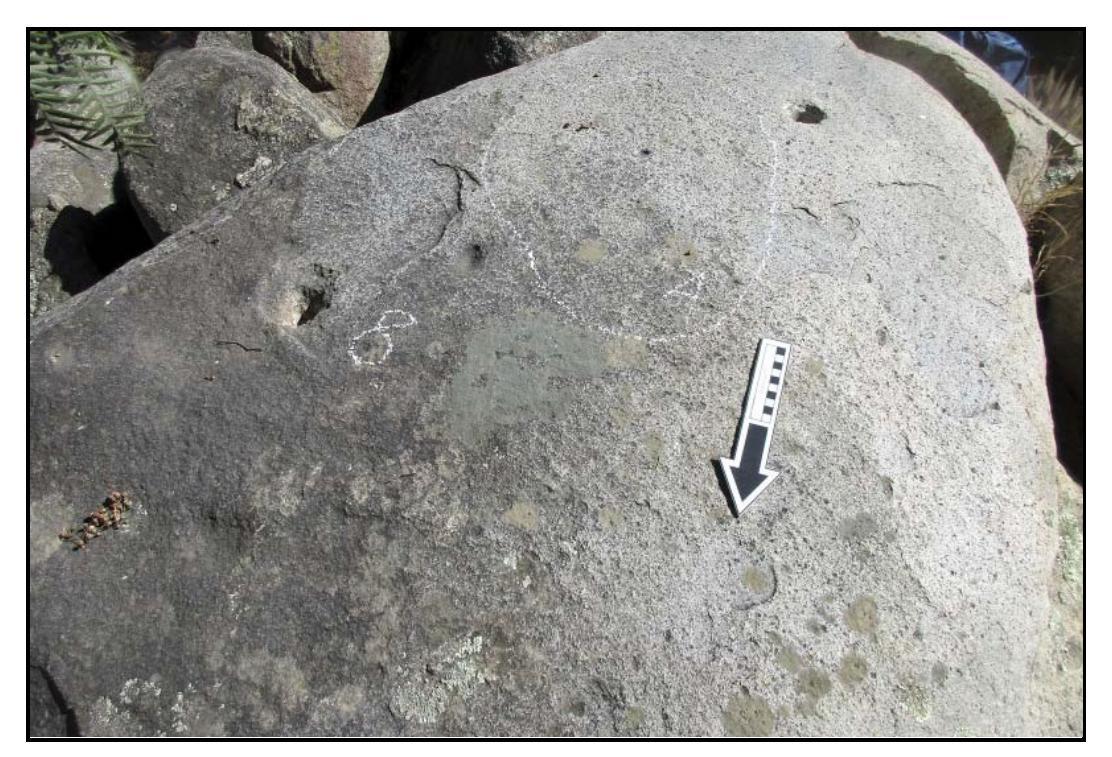
8661-HJP-3 is a bedrock milling site identified close to the mapped SCIC boundary for CA-SDI-8128. Based on the site form sketch map for CA-SDI-8128, HJP-3 is assumed to be CA-SDI-8128. The current survey identified nine bedrock milling features among bedrock outcrops with many drill holes for blasting (Photograph 6). Some of the boulders have been moved and pushed to the main bedrock concentration from locations on its perimeter. Feature 1 contained one possible slick. Feature 2 contained a basin and slick. Feature 3 contained a slick. Feature 4 contained three slicks. Feature 5 contained one slick and two basins. Feature 6 contained two slicks. Feature 7 contained one slick. Feature 8 contained one slick. Feature 9 was a split boulder with three slicks and two basins. Artifacts included three FGM flakes with the possibility of more artifacts covered by leaf duff and other vegetation. Surrounding vegetation included pepper trees and non-native grasses.

PHOTOGRAPH 6 CA-SDI-8128 Feature 8 with One Slick and Two Drill Holes

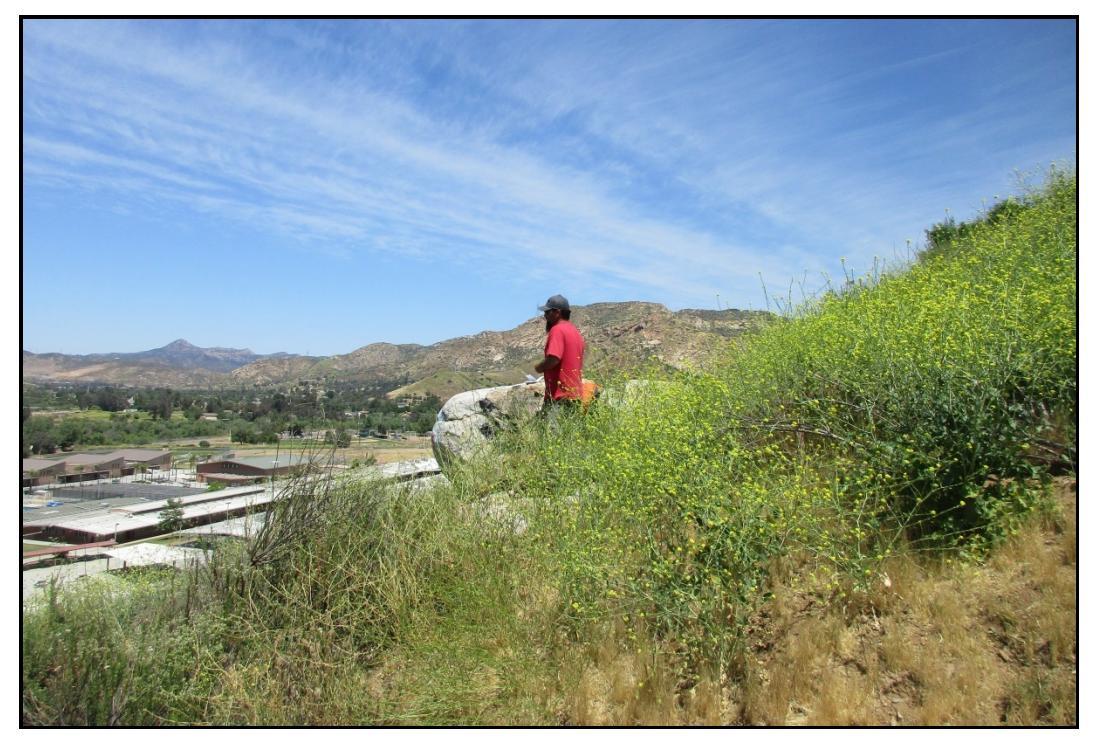
CA-SDI-22119/P-37-036612 (8661-JL-4) is a bedrock milling site with three features (Photograph 7). Feature A contained two slicks and Features B and C each contained one slick. The west-facing, downslope end of the Feature A had modern graffiti. No artifacts were noted. Surrounding vegetation included Diegan coastal sage scrub and disturbed habitat.

PHOTOGRAPH 7 Overview of CA-SDI-22119 Showing Site Location on Slope

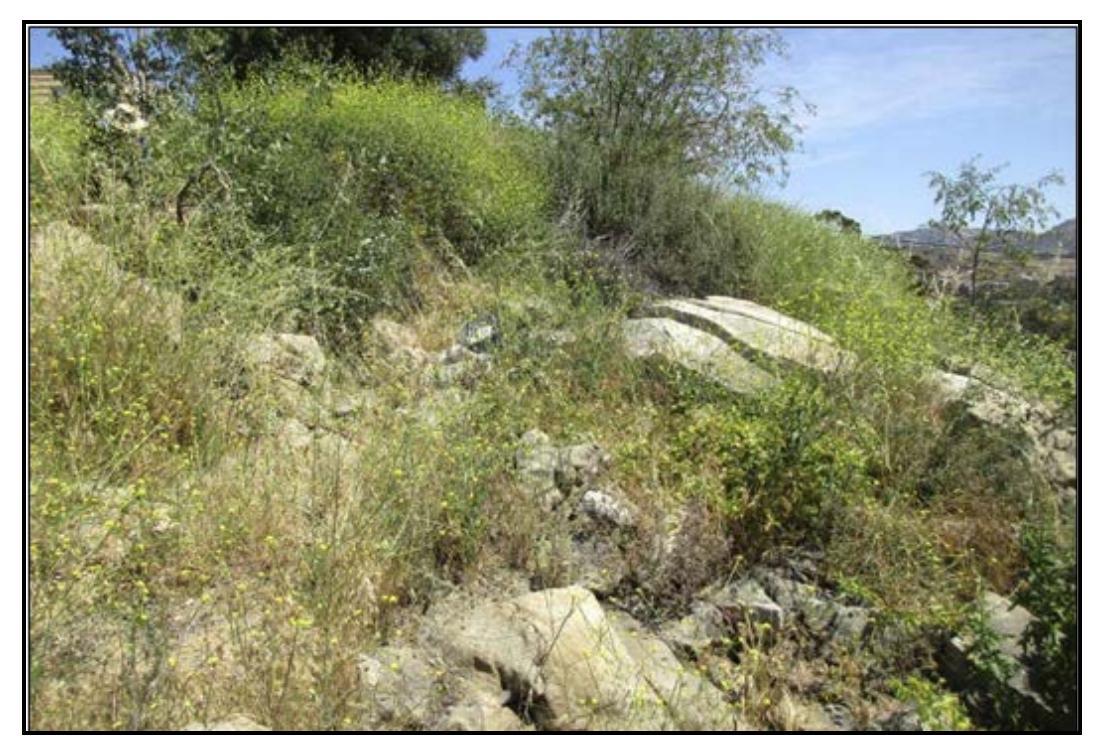
PHOTOGRAPH 8 Overview of CA-SDI-22118, Looking Northeast, Note Non-Native Vegetation Cover

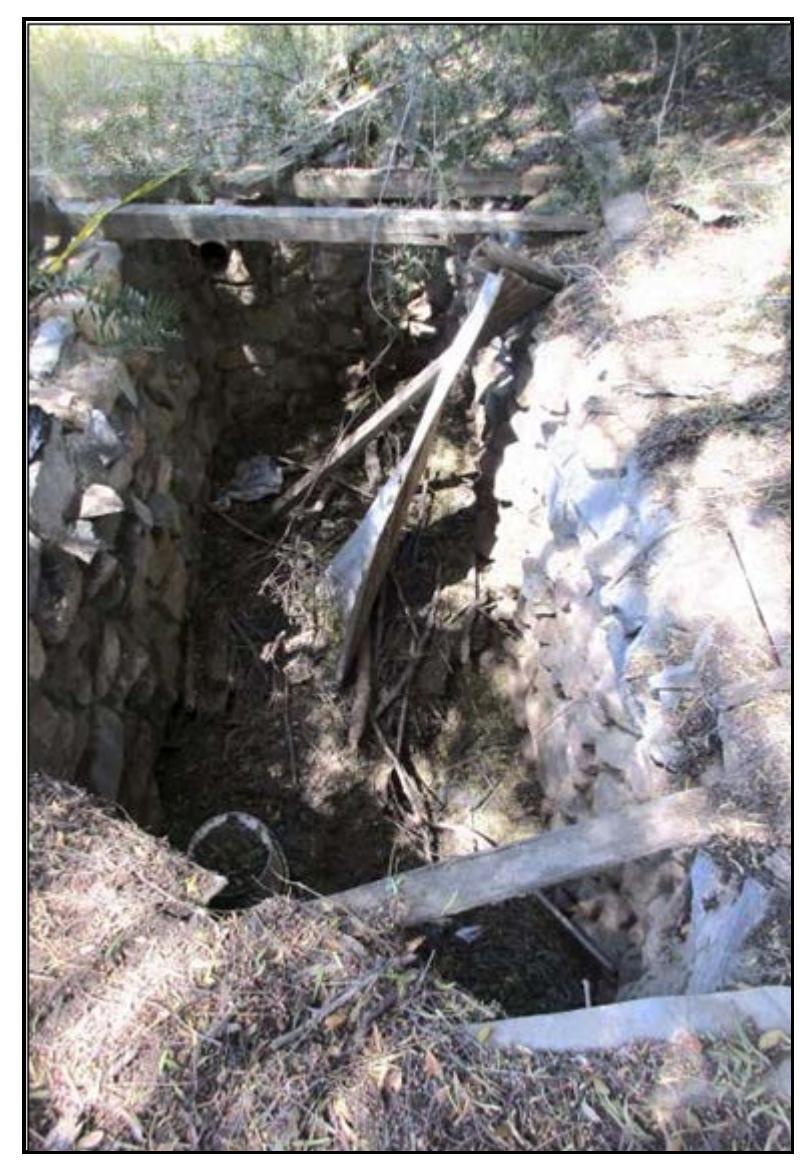
PHOTOGRAPH 9 Overview of P-37-036611 with Corrugated Metal and Wood Slats at the Bottom of Photograph

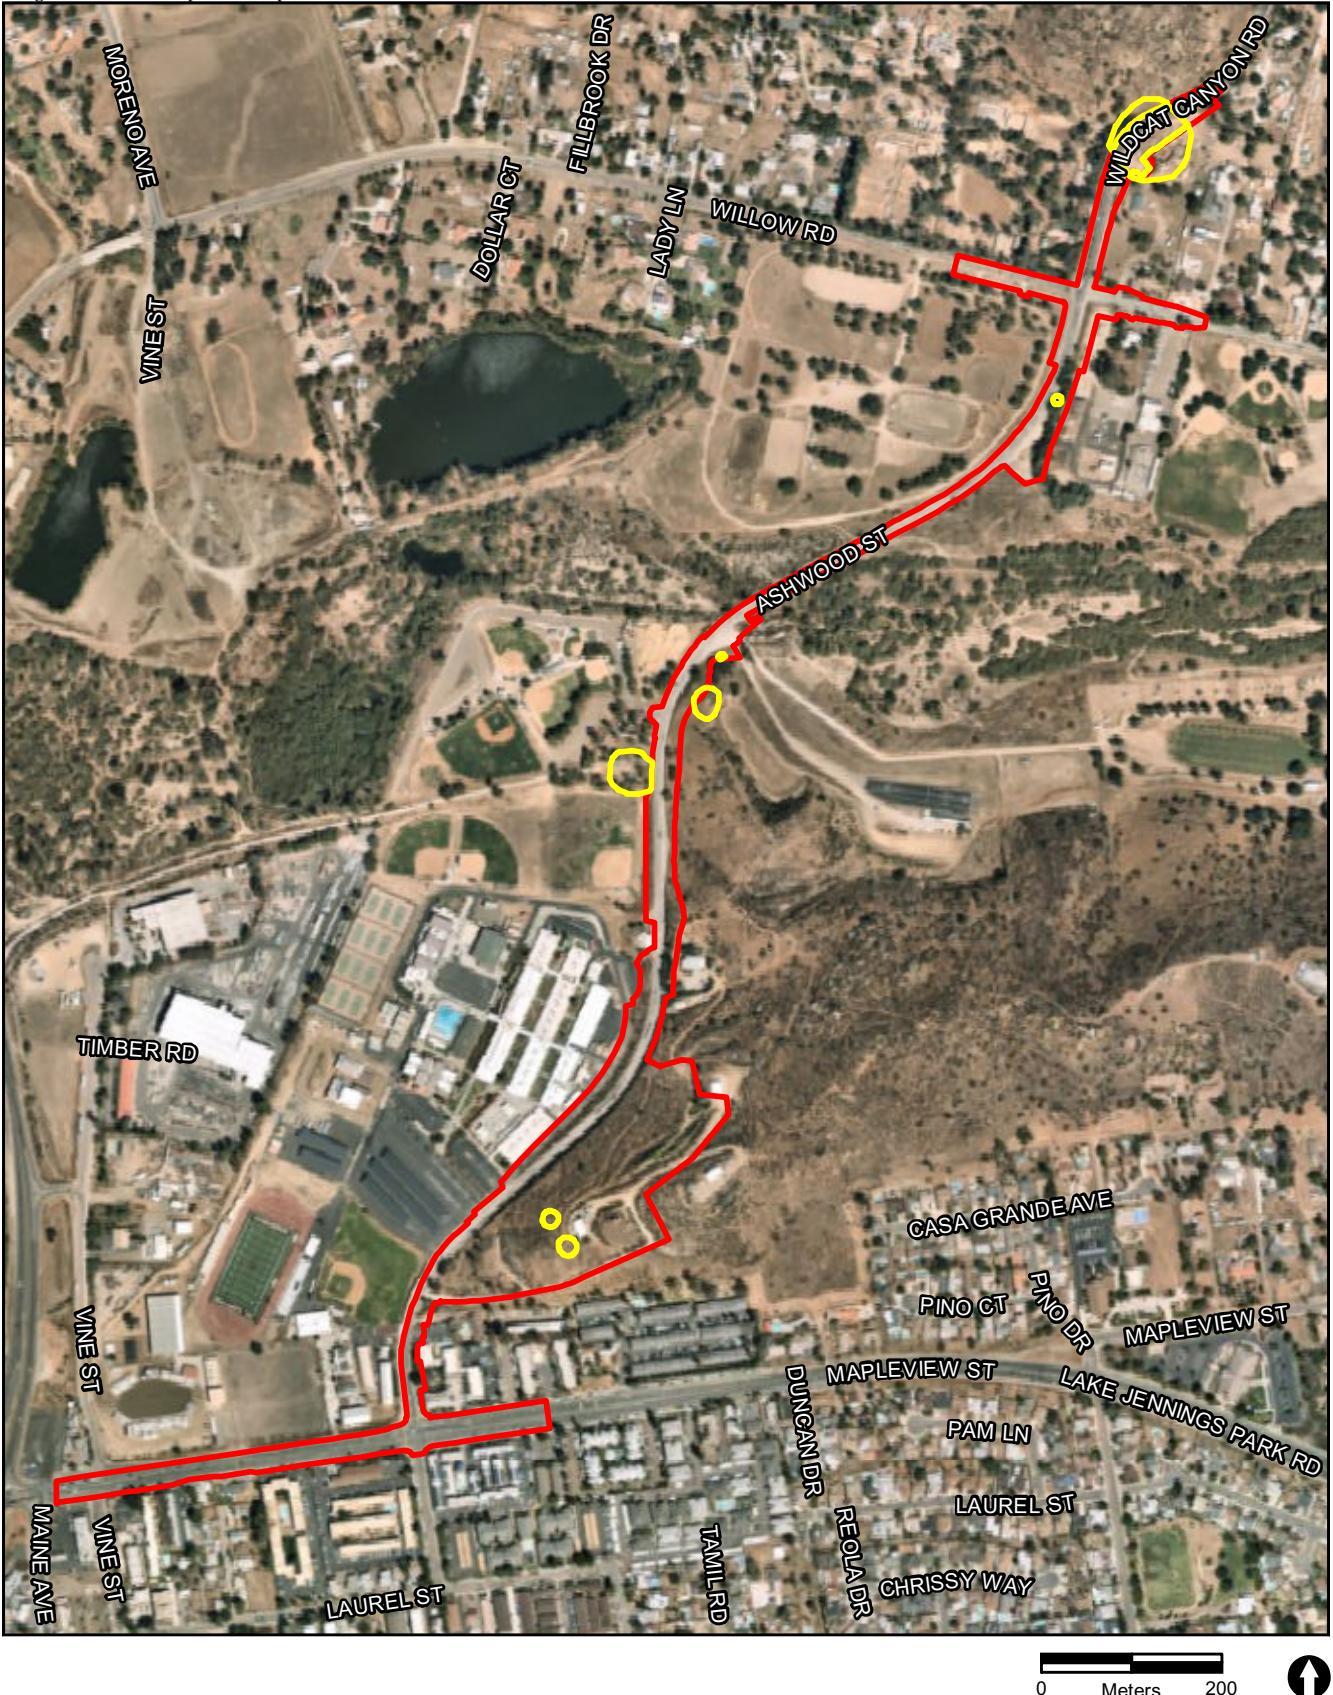
Environmentally Sensitive / Monitoring Area Project Boundary / Area of Potential Effect

Prior to vegetation clearing and grading, a qualified archaeologist and a Native American representative will verify the location of temporary Environmentally Sensitive Area (ESA) fencing installed by the contractor along the APE near CA-SDI-4901. No construction activity or equipment would be allowed in the areas behind the ESA fencing. Archaeological and Native American monitors would attend a preconstruction meeting and be present during ground-disturbing activities, including installation of ESA fencing and grading near ESA fencing near CA-SDI-4901. If previously unidentified potentially significant cultural resources are discovered, construction activities should be diverted away from the discovery and the resources should be evaluated for significance. The Principal Investigator would inform the County Archaeologist of the discovery and, together, determine its significance. To mitigate potential impacts to significant cultural resources identified during monitoring, a data recovery program should be prepared by the Principal Investigator and approved by the County Archaeologist. All cultural material collected during the monitoring and data recovery program shall be processed and curated at a San Diego facility that meets federal standards. If human remains are discovered, work shall halt in that area and the procedures set forth in the California Public Resources Code (Section 5097.98) and State Health and Safety Code (Section 7050.5) would be followed. After the completion of the monitoring, an appropriate report shall be prepared.
