Geophysical Investigation Report, Proposed Commercial Development, SEC Central Avenue and Cambern Avenue, Lake Elsinore, California

Salem Engineering Group

Project No. 3-421-0165

Subject: REVISED GEOPHYSICAL INVESTIGATION REPORT Proposed Commercial Development SEC Central Avenue and Cambern Avenue Lake Elsinore, California

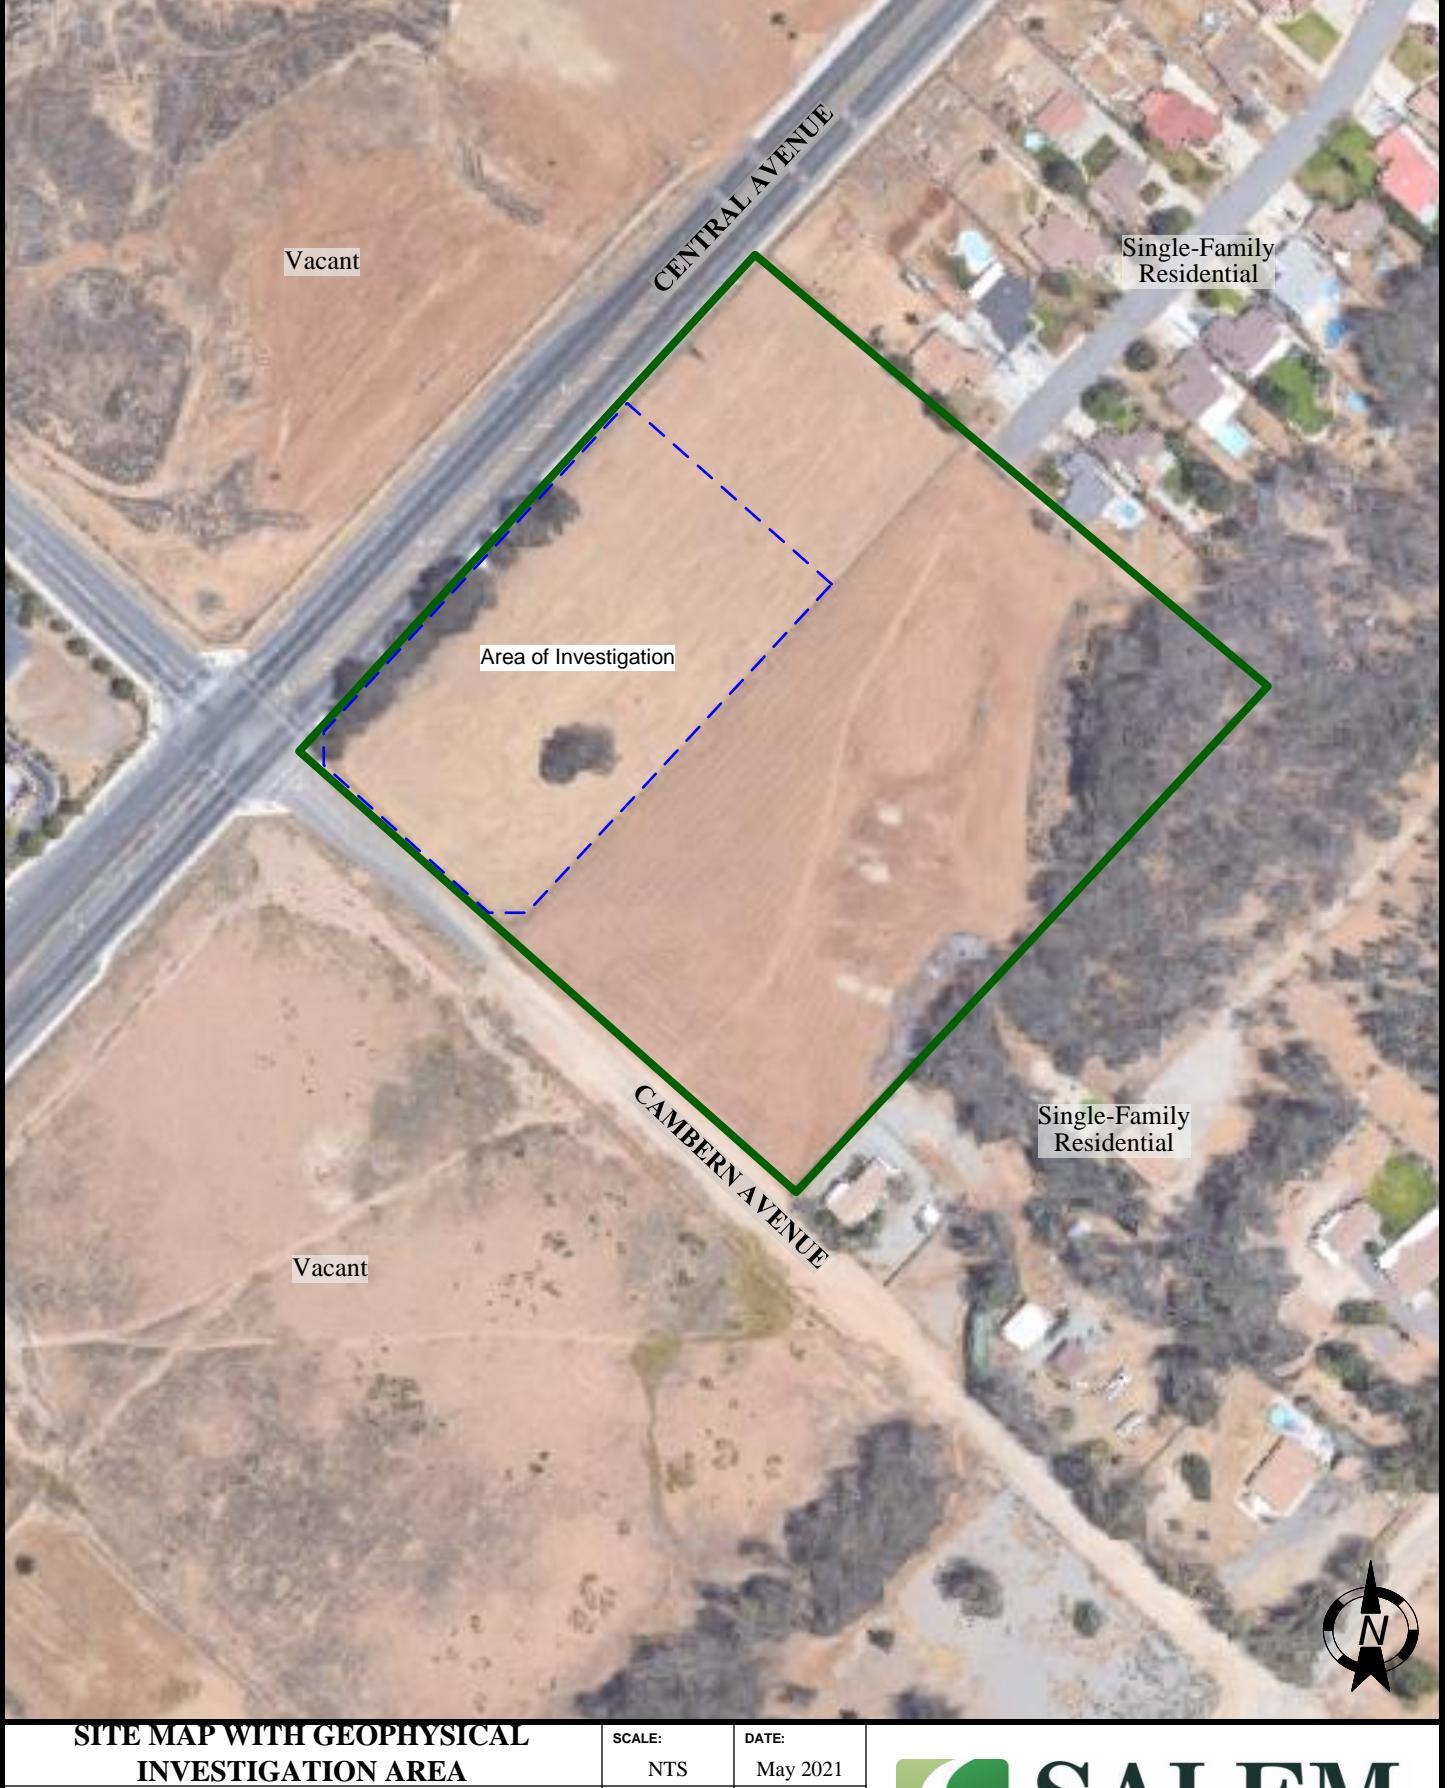
OUALL.	DATE.				
NTS	May 2021				
DRAWN BY:	APPROVED BY:				
BR	RR				
PROJECT NO .:	FIGURE NO.:				
3-421-0165	2

Consequently, SALEM recommended conducting a geophysical survey of the northwestern portion of the subject property (approximately 2 acres) to evaluate whether waste materials or other debris were placed into the former pit, and the excavation of test pits in areas of potential environmental concern identified during the geophysical survey. A site plan showing the area of investigation is included as Figure 2.

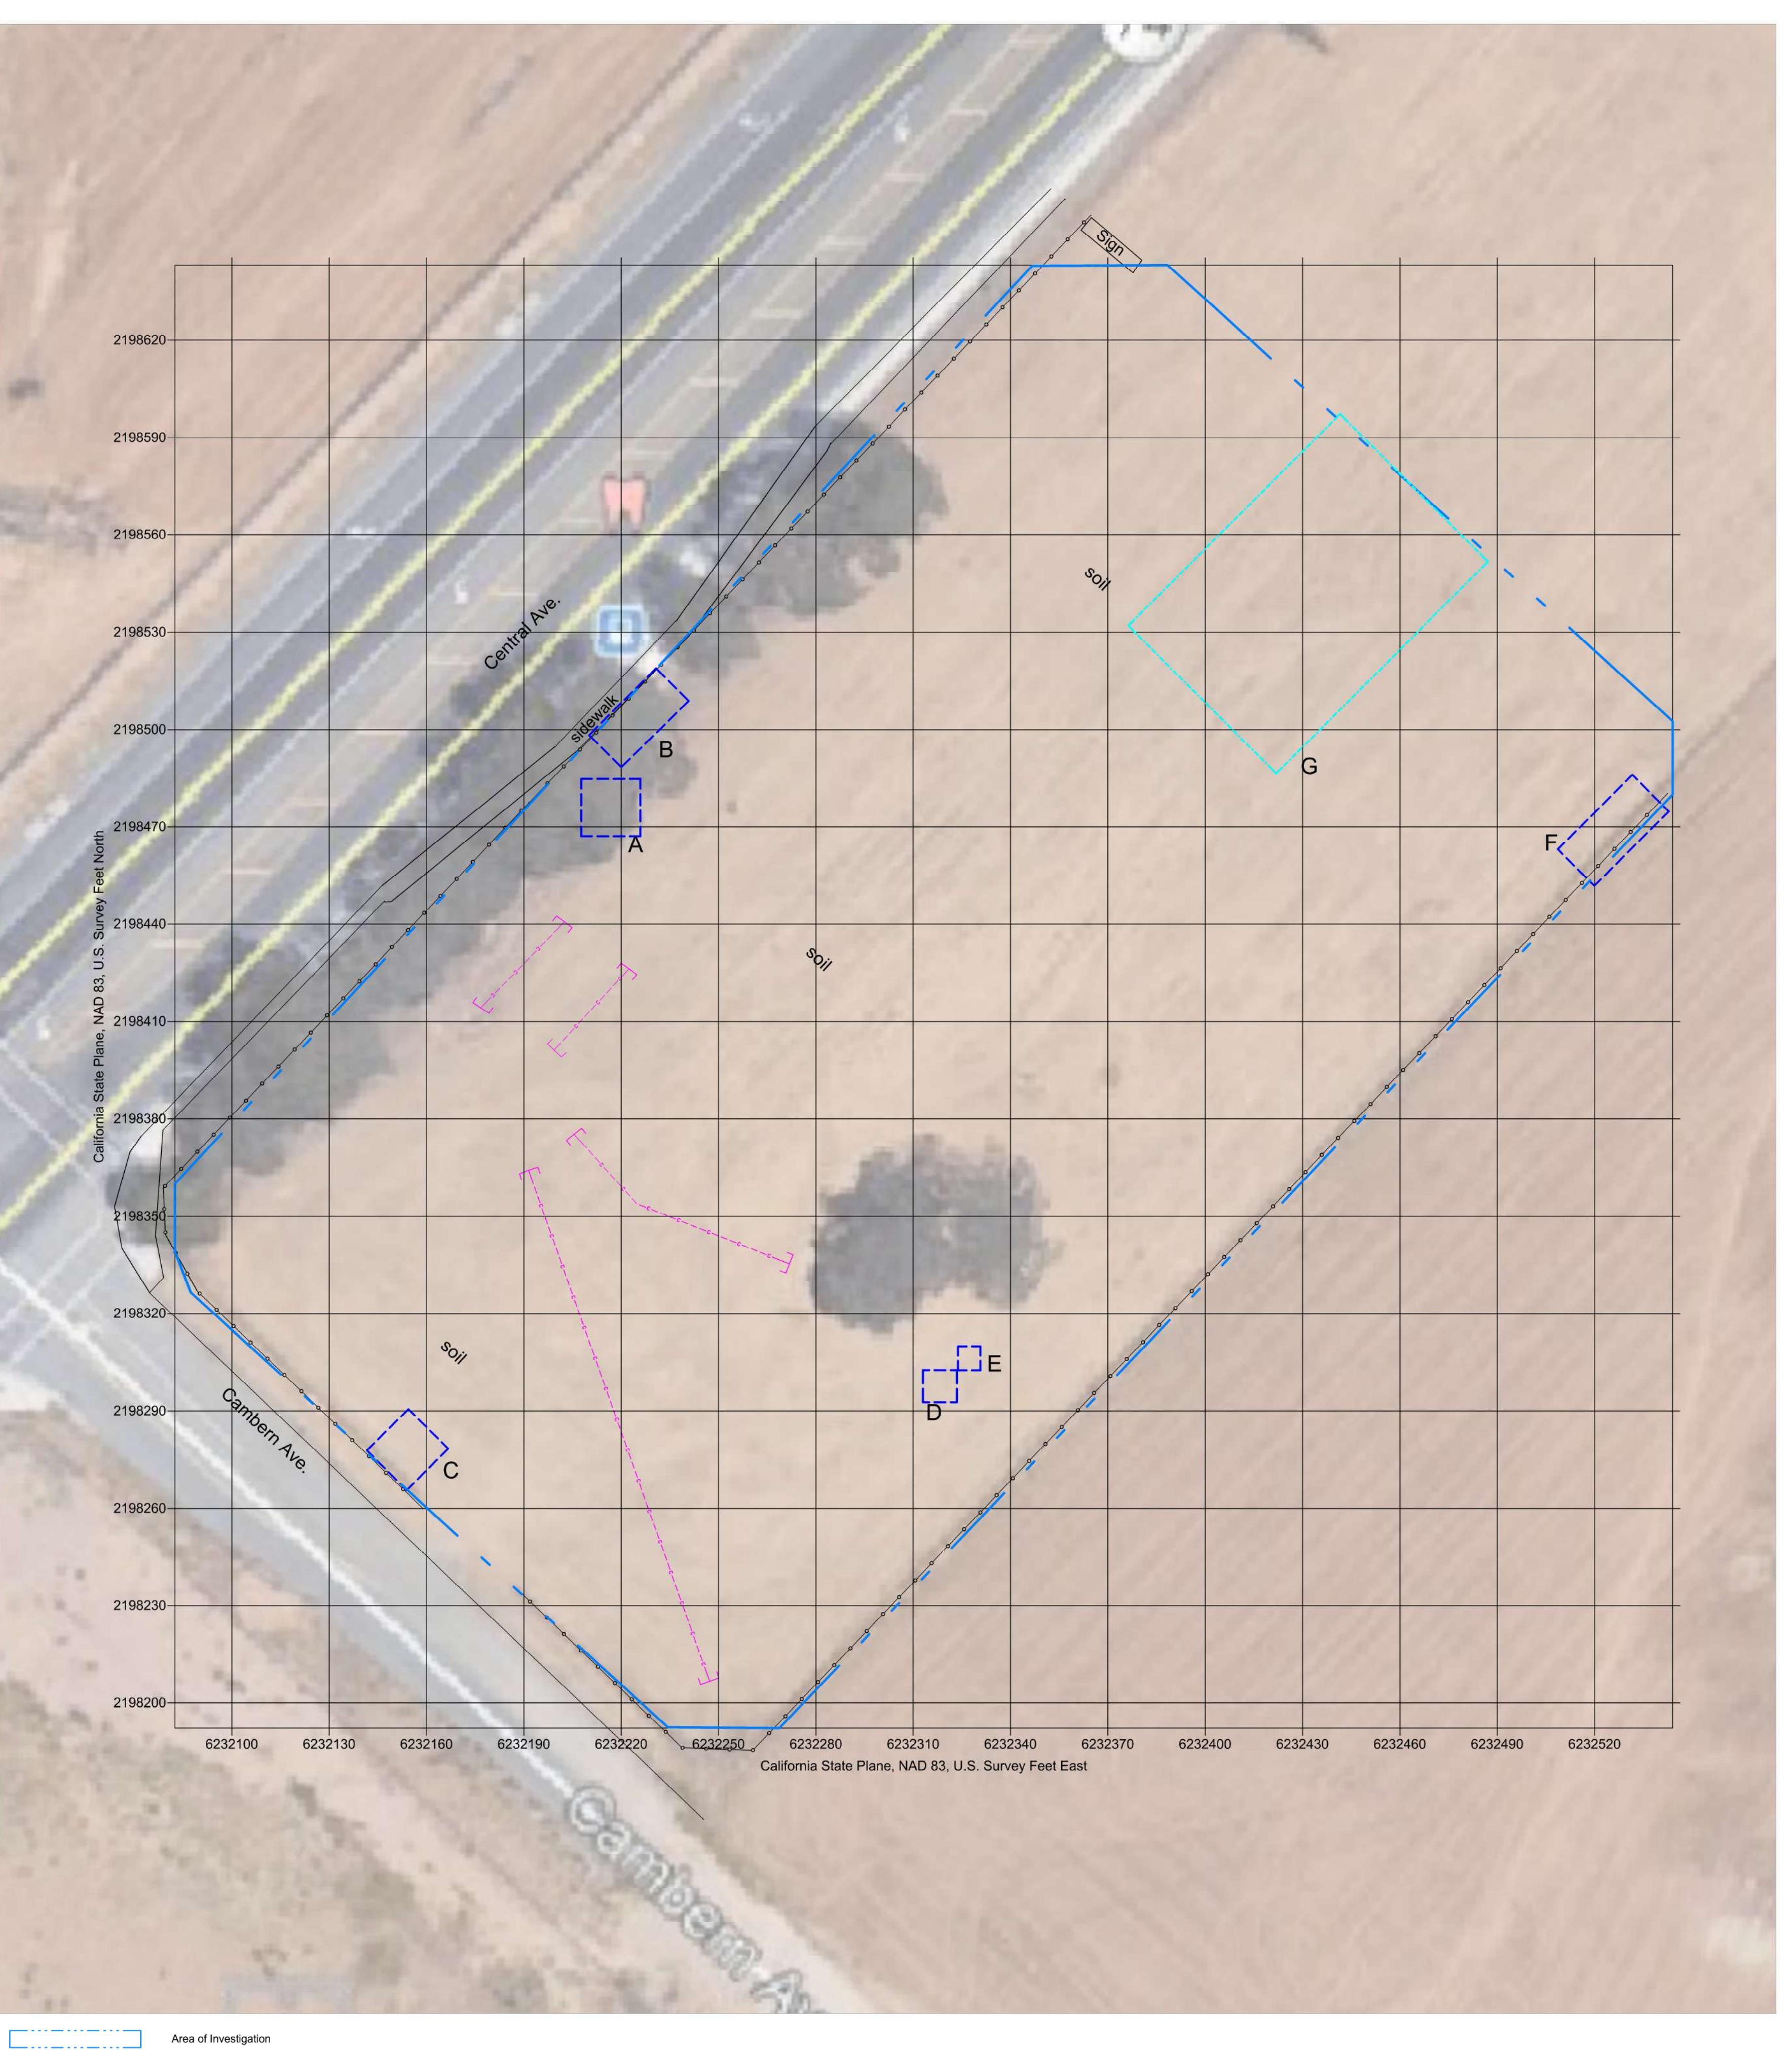
A site plan showing an interpretive map of the geophysical survey and color-enhanced contour maps of the EM-61 and EM-31 differential data collected within the survey area are included as Figures 1 through 3, respectively, in Appendix A.

The largest anomalies detected in the survey area were Anomalies G and H. Both are soil density anomalies of unknown origin. Anomaly G is a high conductivity anomaly located in the northeastern portion of the

survey area. Anomaly H is a low conductivity anomaly located in the central portion of the survey area close to the area where the former pit was likely located. Low conductivity anomalies are commonly associated with areas of a coarser-grained material. Both anomalies could be associated with a backfilled excavation, different soil types (i.e., sand in one area and silt or clay in the other area), or it could simply be that the area has a lower compaction percentage than the surrounding soils. In addition to these two anomalies, several utility conduits were identified, along with six rectangular-shaped metallic anomalies. No USTs, septic tanks, clarifiers, sumps, or suspected septic piping were identified during the performance of the geophysical survey.

The geophysical survey did not identify any subsurface anomalies of potential environmental concern such as waste materials or other debris that may have been placed in the former pit on the northwestern portion of the subject property. No further investigation is warranted, and the REC identified in SALEM's March 18, 2021 Phase I ESA has been adequately investigated and is no longer considered an REC.
