GEOTECHNICAL REPORT

KAISER PERMANENTE

MORENO VALLEY MEDICAL CENTER
CENTRAL UTILITY PLANT (CUP)
27300 IRIS AVENUE
MORENO VALLEY, CALIFORNIA

Project No. C.314.82.00

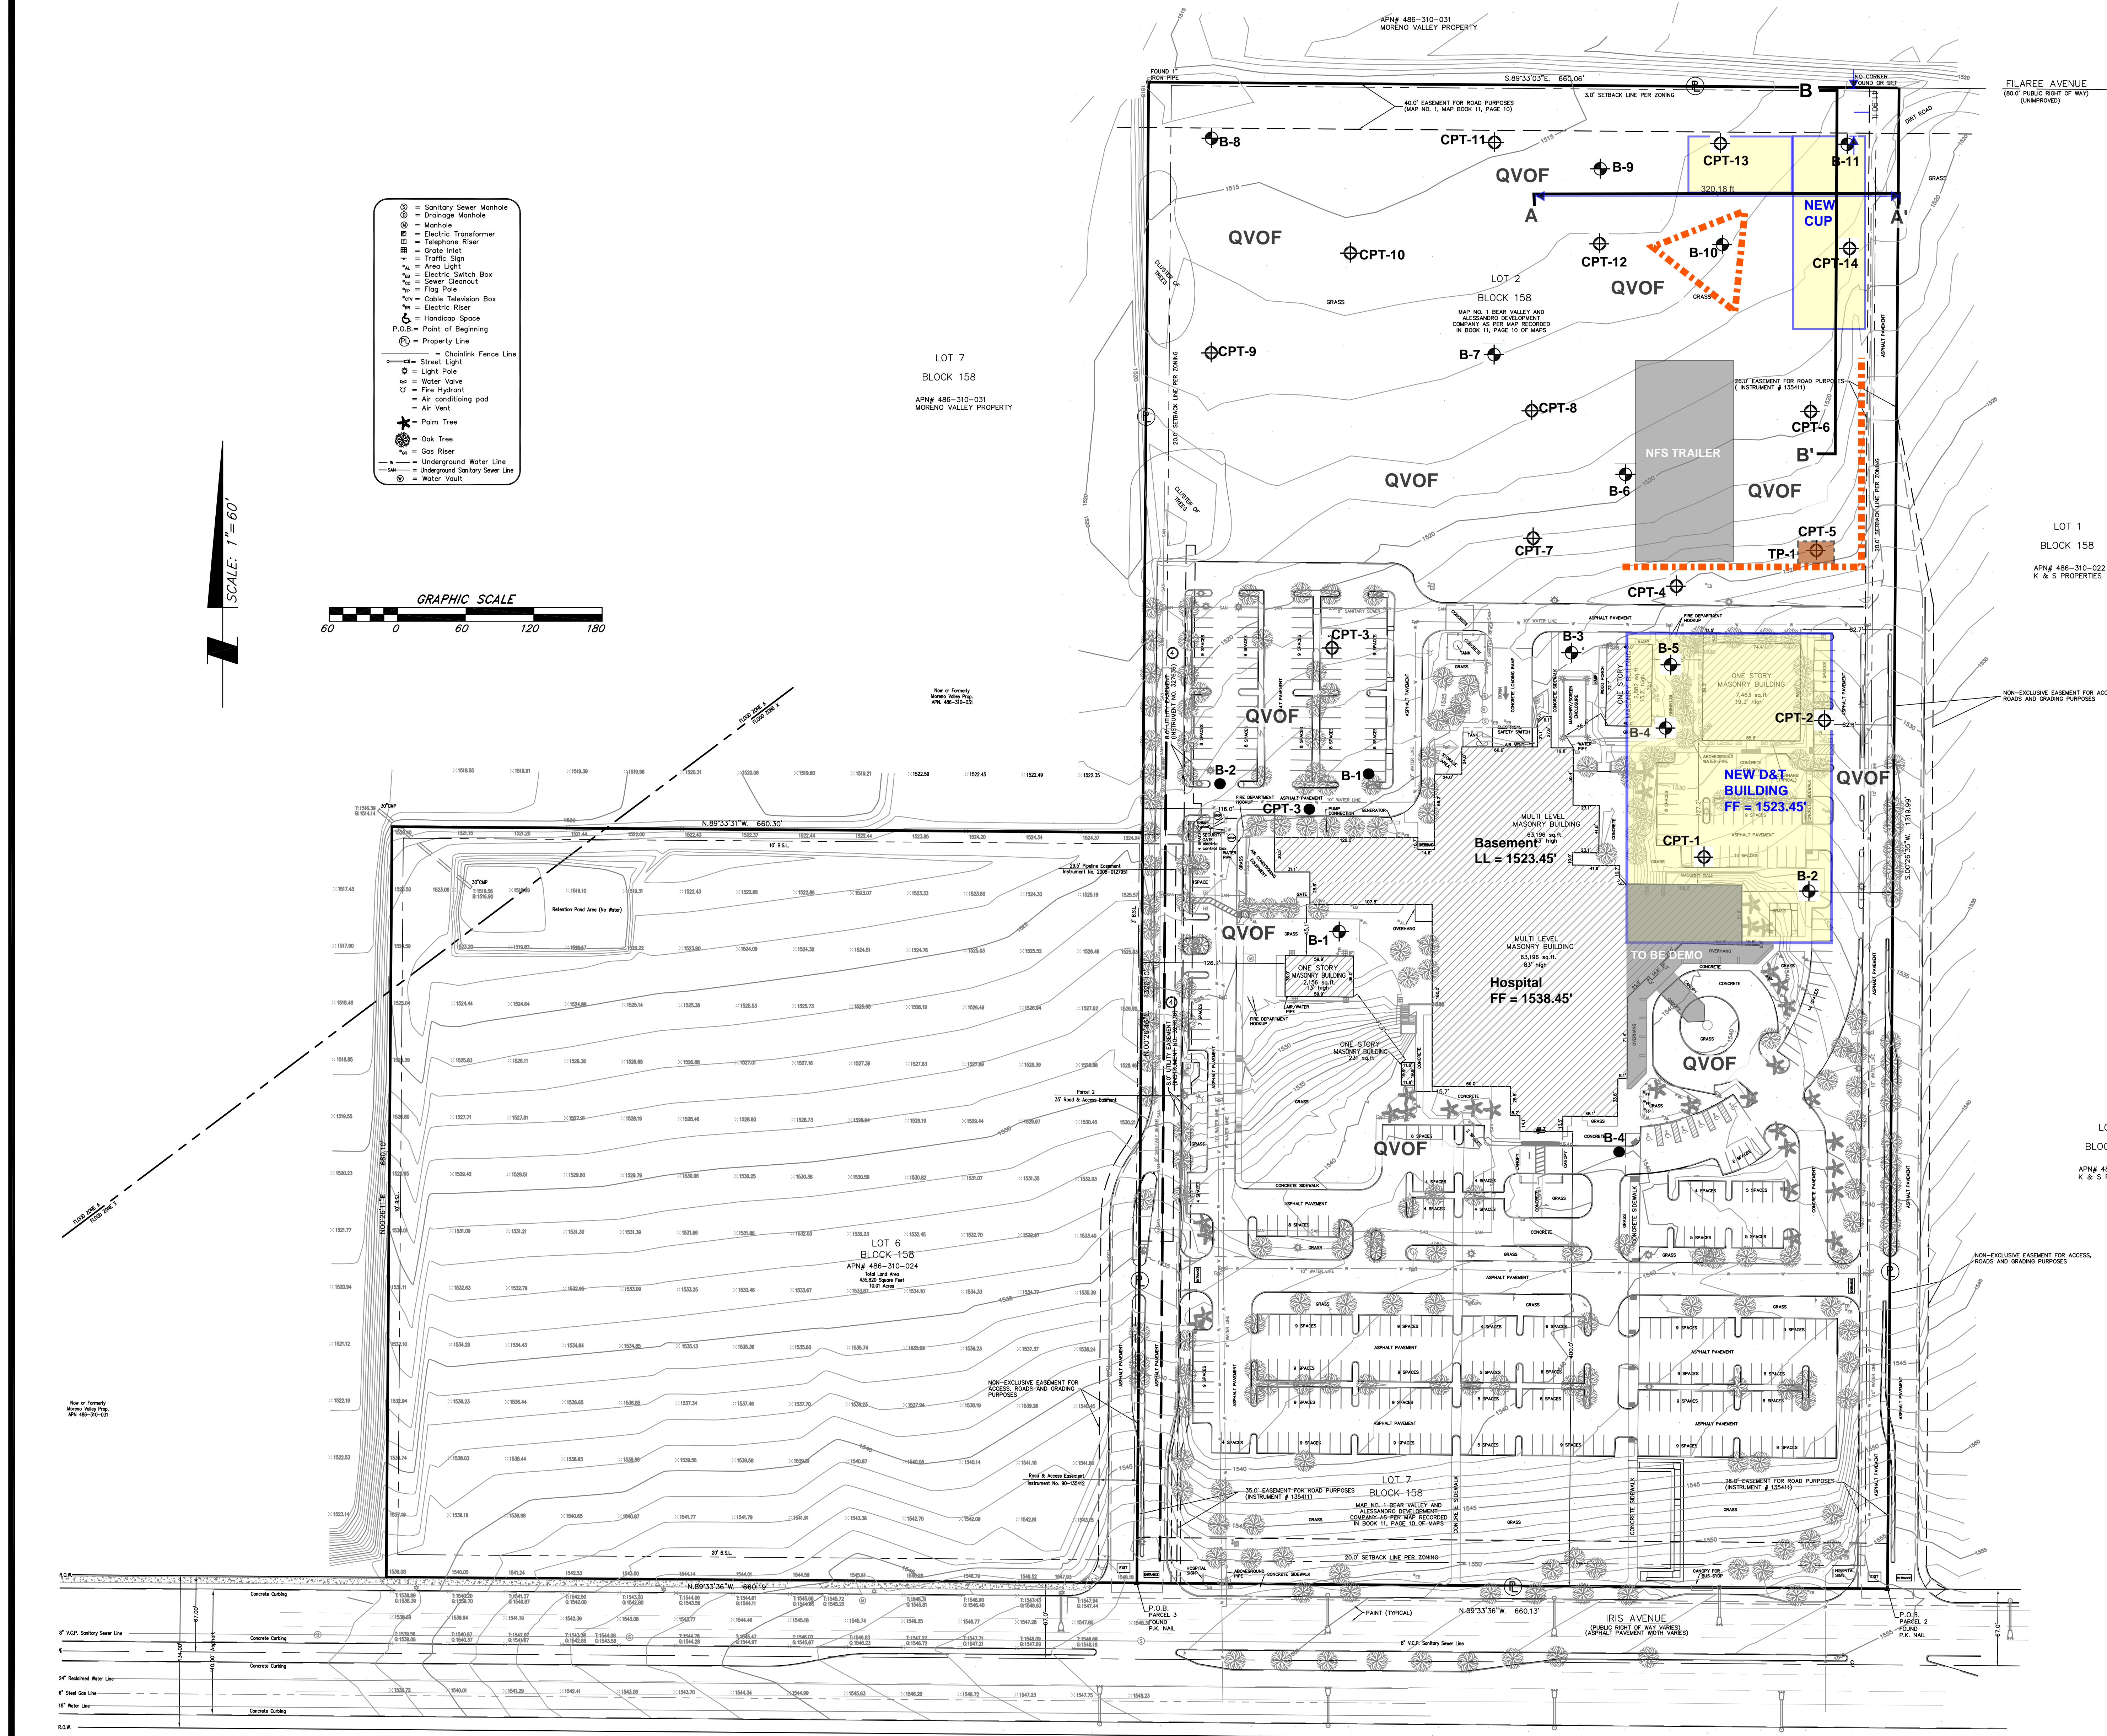
FIGURE A-3

- EXPLANATIONS:**
- Approximate Location of Boring (GEOBASE 2017)
 - Approximate Location of CPTs (GEOBASE 2017)
 - Approximate Location of Test Pit (GEOBASE 2017)
 - Geophysical Survey Lines (GEOBASE 2017)
 - Approximate Location of Boring/CPTs (GEOBASE 2010)

A--A' Geological cross-section
 LL -- Lower Level (Basement)
 FF -- Finish Floor
 Qvof -- Quaternary Very Old Alluvium

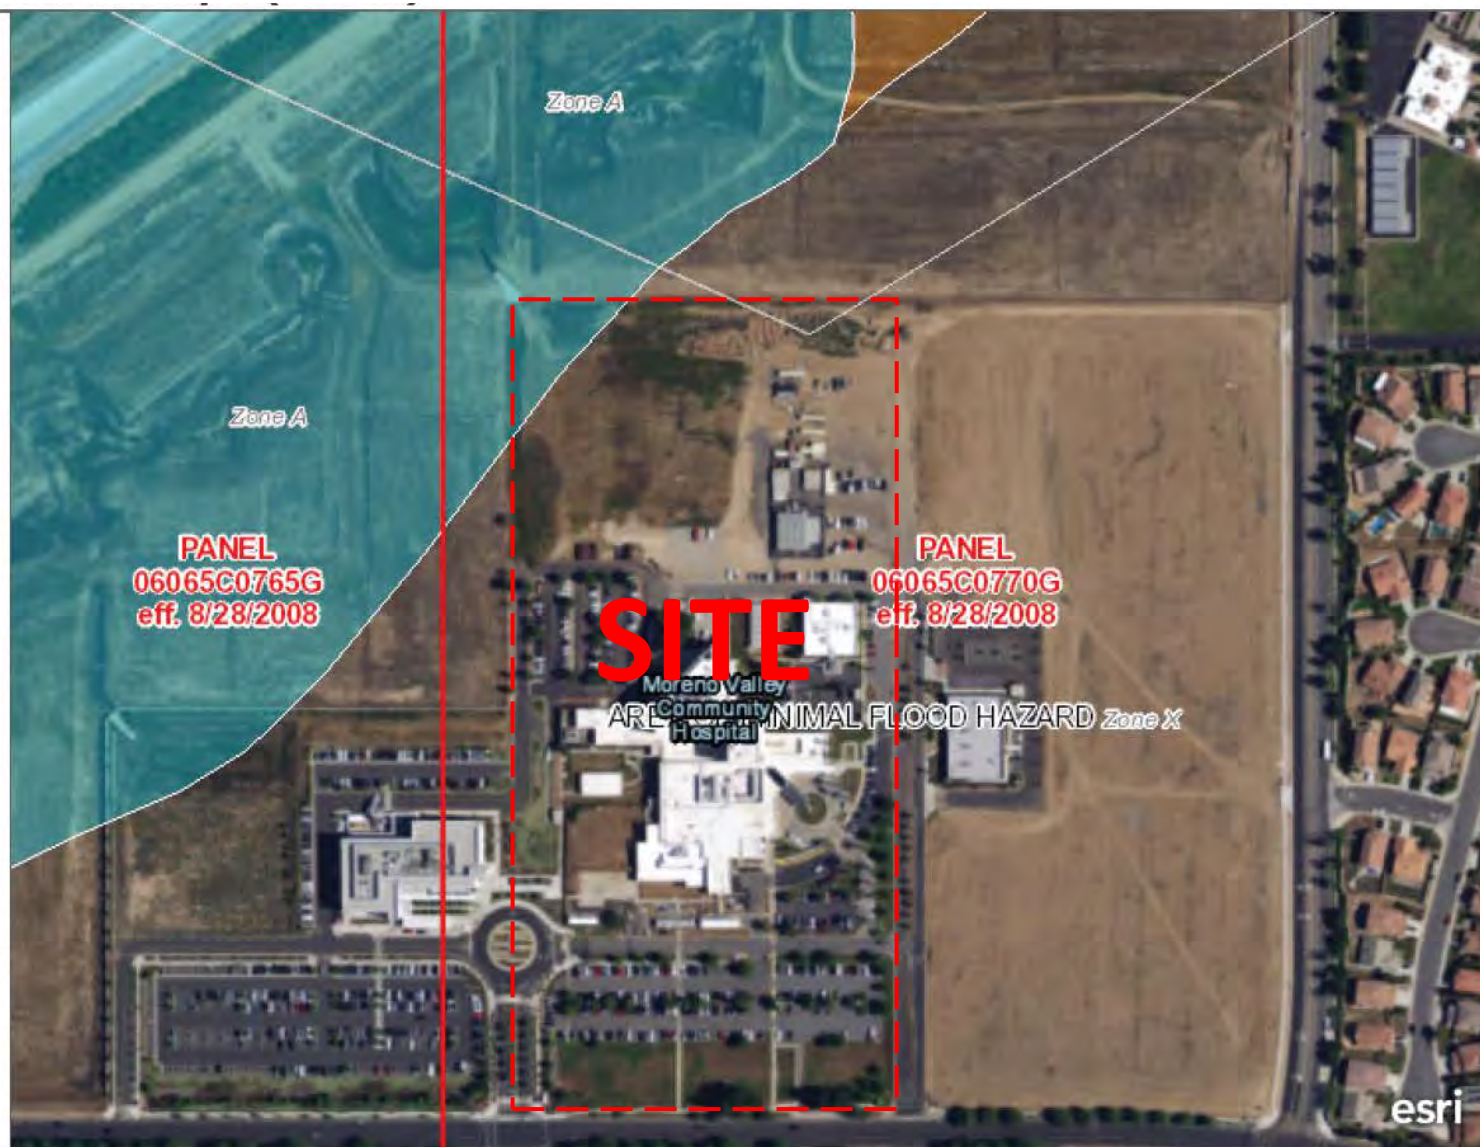
The **SITE** is in Zone X – Area determined to be outside of 0.2% annual chance of floodplain.

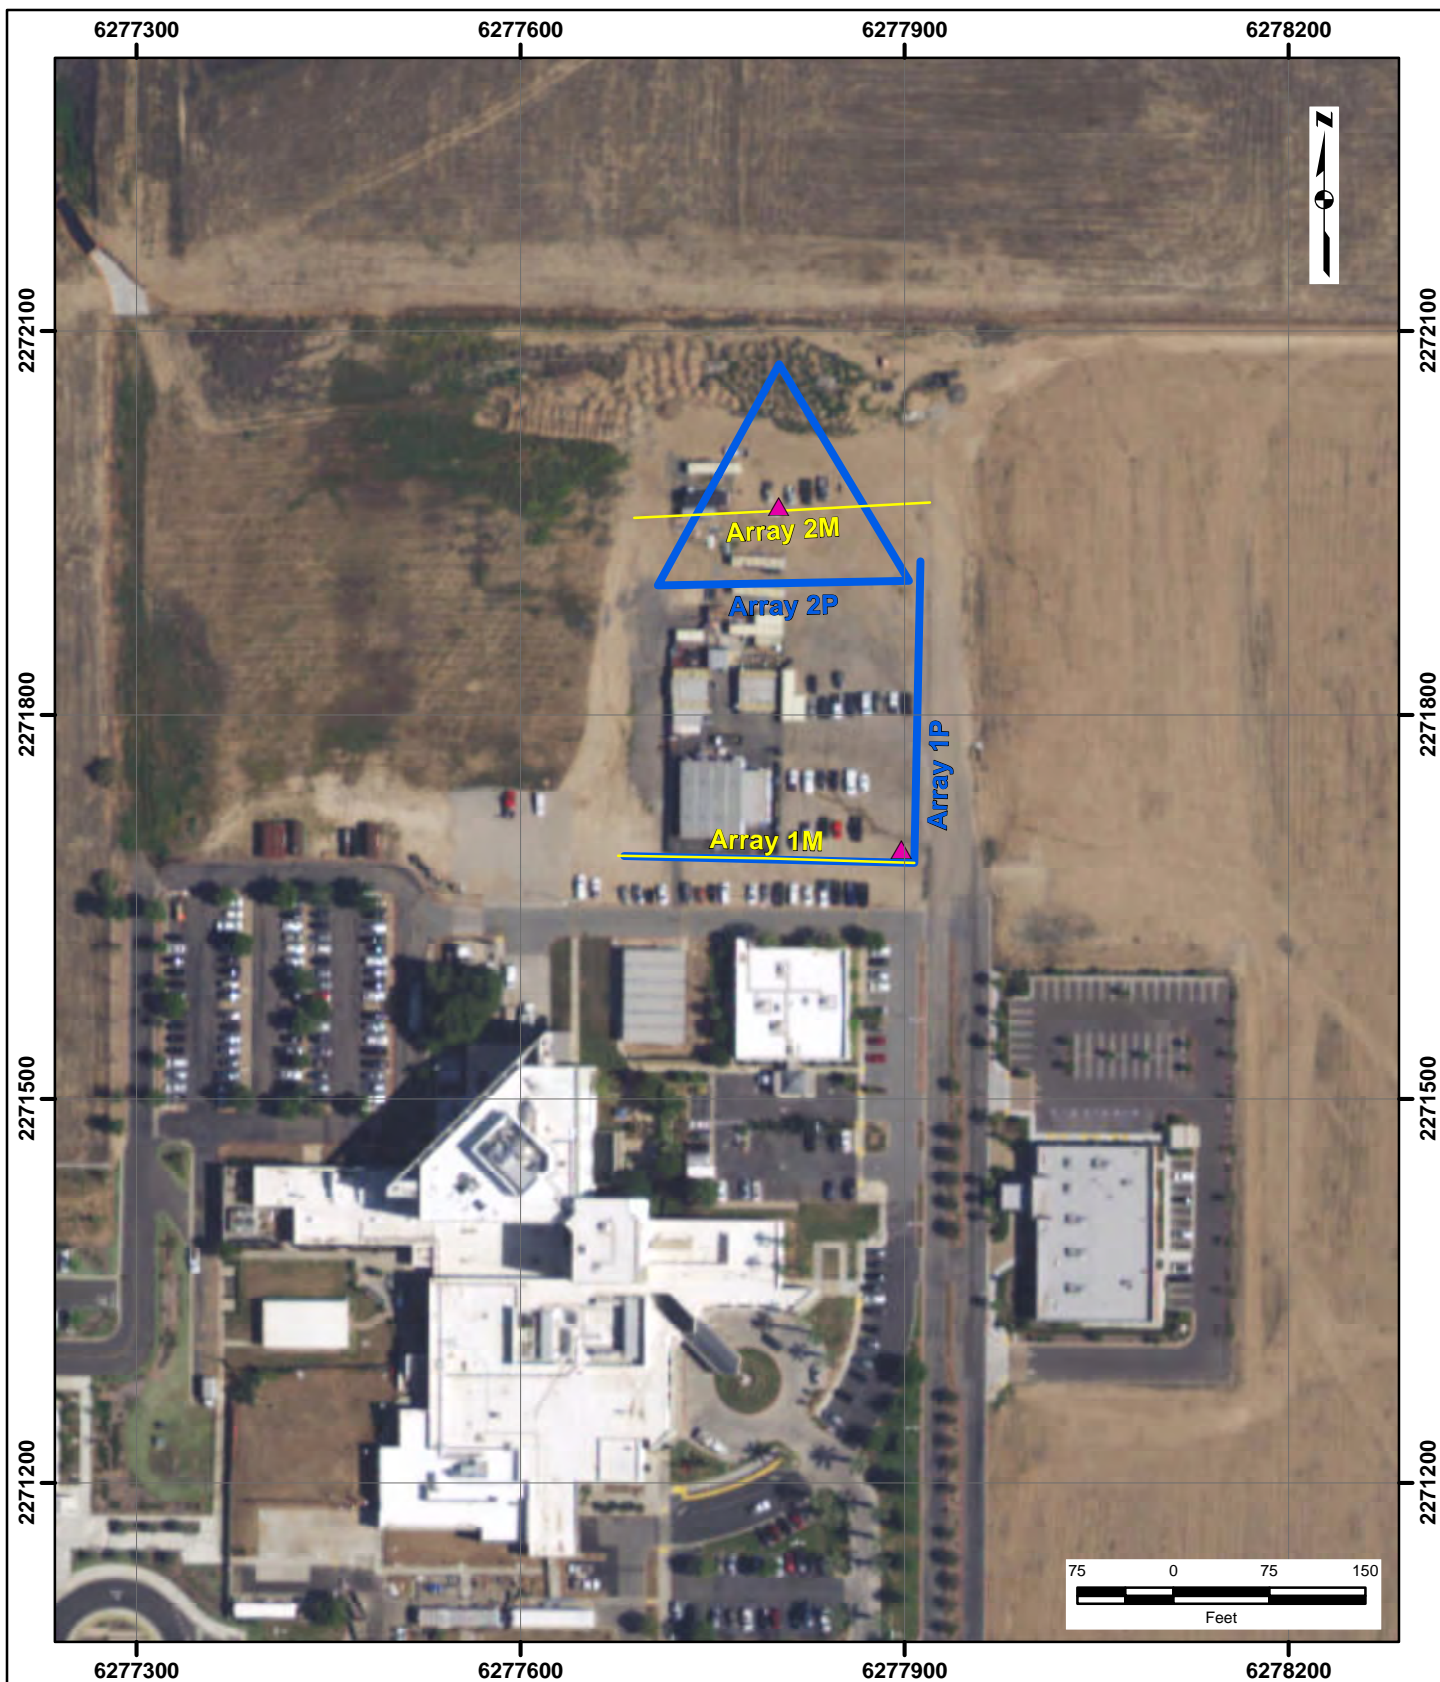
Legend

- Active Surface Wave Array (MASW)
- Passive Surface Wave Array
- ▲ H/V Spectral Ratio Measurement Location

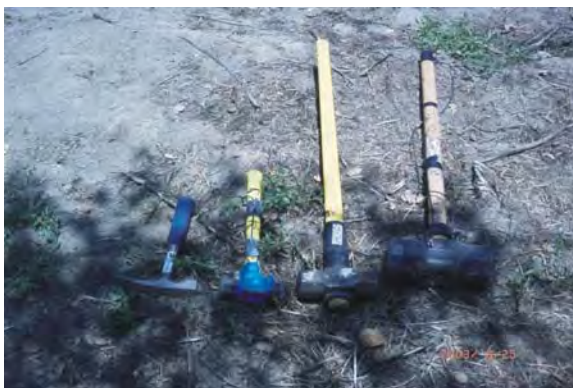
Hammer Energy Sources

Active surface wave techniques measure surface waves generated by dynamic sources such as hammers, weight drops, electromechanical shakers, vibroseis and bulldozers. These techniques include the spectral analysis of surface waves (SASW) and multi-channel array surface wave (MASW) methods.

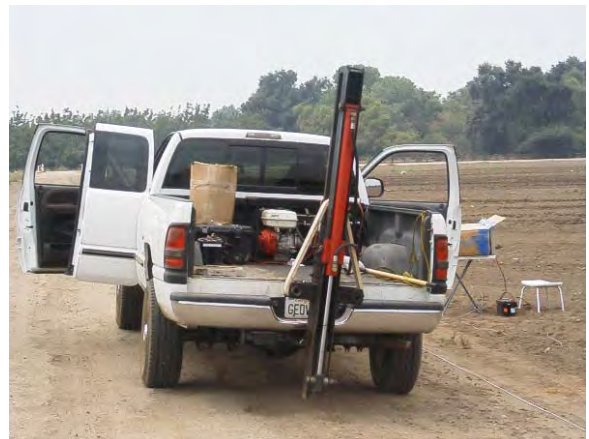
Accelerated Weight Drop

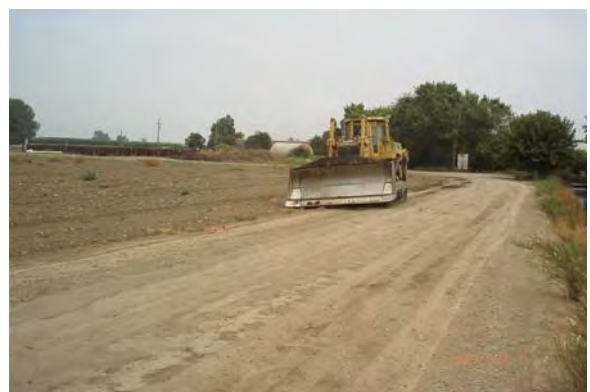
Bulldozer Energy Source

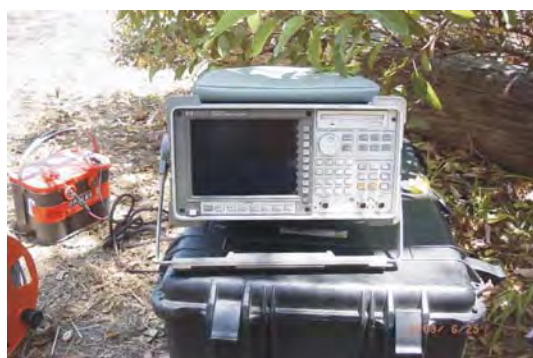
HP Dynamic Signal Analyzer

The SASW method is optimized for conducting V_s depth soundings. A dynamic source is used to generate surface waves of different wavelengths (or frequencies) which are monitored by two or more receivers at known offsets. An expanding receiver spread and optimized source-receiver geometry are used to minimize near field effects, body wave signal and attenuation. A dynamic signal analyzer is typically used to calculate the phase and coherence of the cross spectrum of the time history data collected at a pair of receivers. During data analysis, an interactive masking process is used to discard low quality data and to unwrap the phase spectrum, as shown in the figure below. The dispersion curve (Rayleigh wave phase velocity versus frequency or alternatively wavelength) is calculated from the unwrapped phase spectrum.

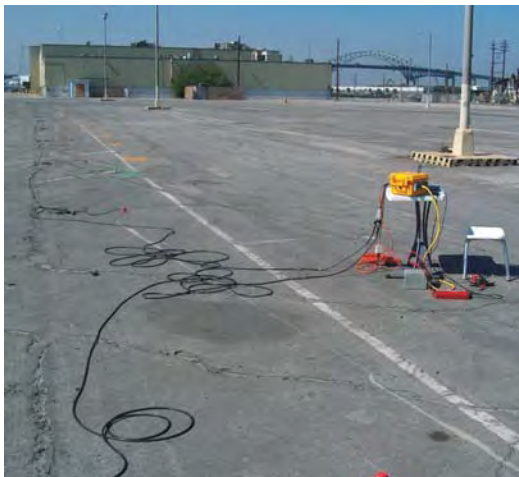
Refraction Microtremor Array Layout

The refraction microtremor (REMI) technique uses a field layout similar to the seismic refraction method (hence its name). Twenty-four, 4.5 Hz geophones are laid out in a linear array with a spacing of 6 to 8m and fifteen to twenty 30-second noise records are acquired. A slowness-frequency (p-f) wavefield transform is used to separate Rayleigh wave energy from that of other waves. Because the noise field can originate from any direction, the wavefield transform is conducted for multiple vectors through the geophone array, all of which are summed. The dispersion curve is defined as the lower envelope of the Rayleigh wave energy in p-f space. Because the lower envelope is picked rather than the energy peak (energy traveling along the profile is slower than that approaching from an angle), this technique may be somewhat more subjective than the others, particularly at low frequencies. The SPAC technique can also be used to extract the surface wave dispersion curve from linear array microtremor data providing there are omni-directional noise sources.

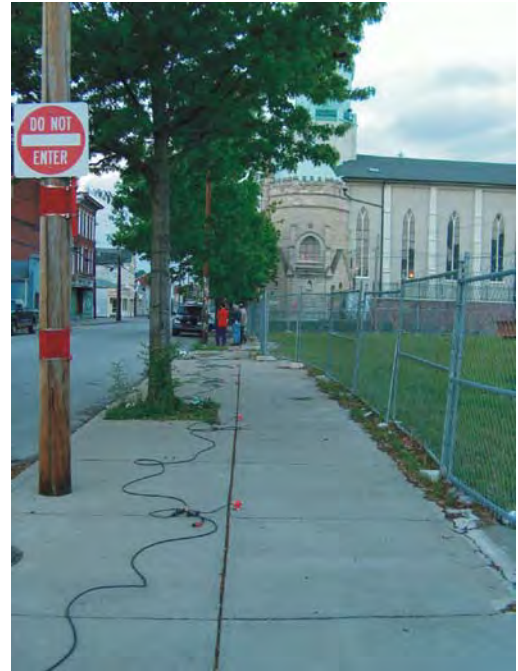
The combined use of active and passive techniques may offer significant advantages on many investigations. It can be very costly to mobilize large energy sources for 30m/100ft active surface wave soundings. In urban environments, the combined use of active and passive surface wave techniques can image to these depths without the need for large energy sources. We have found that dispersion curves from active and passive surface wave techniques are generally in good agreement, making the combined use of the two techniques viable. It is not recommended that passive surface wave techniques be applied alone for UBC/IBC site classification investigations. Microtremor techniques do not generally characterize near surface velocity, which may have a significant impact of the average shear wave velocity of the upper 30m or 100ft and so should always be used in conjunction with SASW or MASW. An SASW sounding to a depth of 30m requires at least a 60m linear array. If sufficient space is not available for this, it may be possible to use a 45m triangle array on the site or place a 100-200m long REMI array along an adjacent sidewalk or an "L" array at an adjacent street intersection.

Microtremor Measurements along Sidewalk

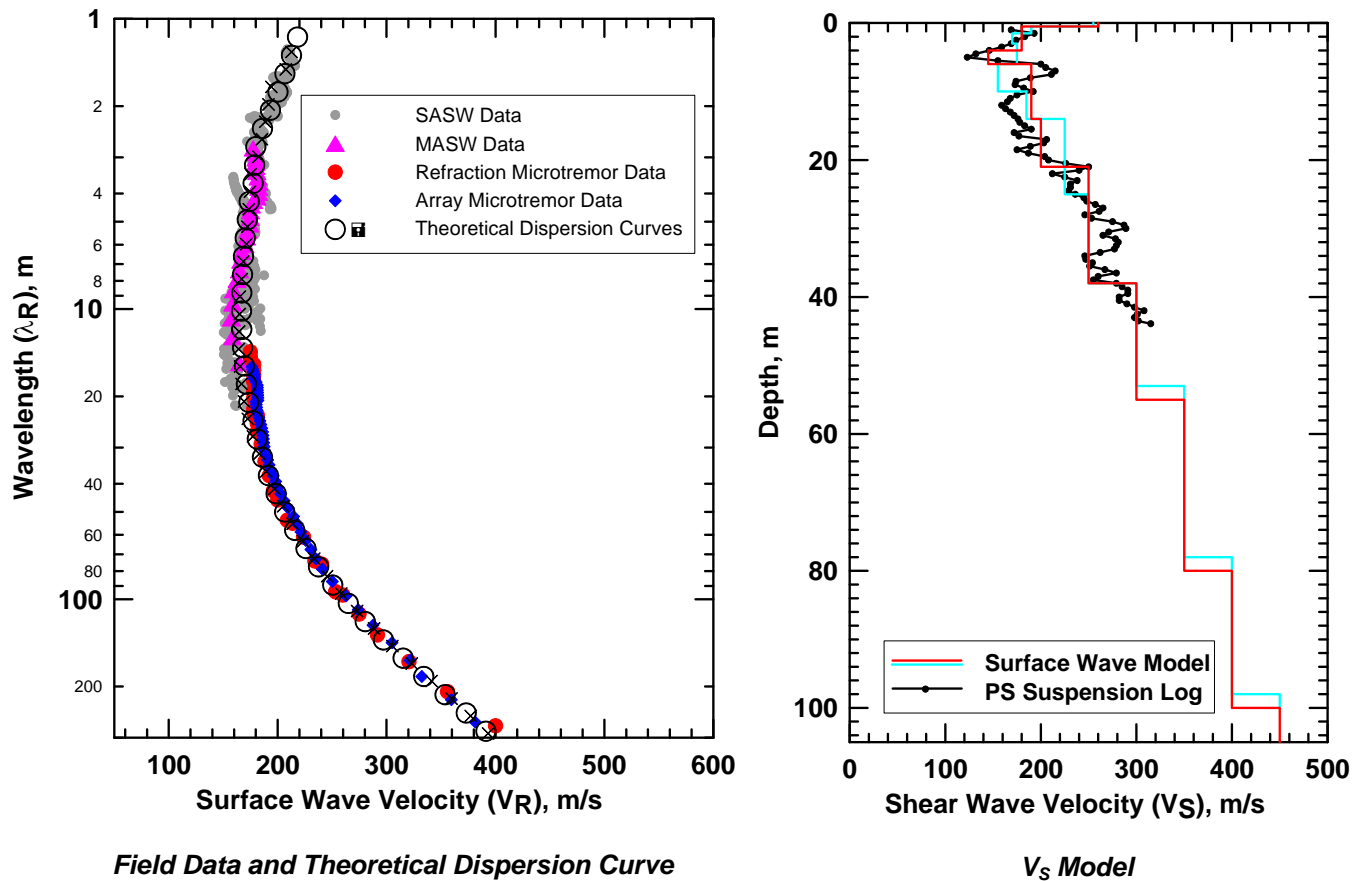
The figures below show the surface wave dispersion curves and alternative shear wave velocity models for a site in Los Angeles, California. All of the previous figures illustrating SASW, MASW, array and refraction microtremor techniques were from this site. The dispersion curves from all four methods are shown on the left along with the theoretical dispersion curves for alternative S-wave velocity versus depth models on the right. Conditions at this site were very poor for active surface wave techniques because of the presence of very low velocity hydraulic fill. In fact, with active surface wave techniques it was only possible to image to a depth of about 12.5m with energy sources typically capable of imaging to 30m. There is excellent agreement in the dispersion curves generated from all of the methods over the overlapping wavelength ranges. The minor differences probably result from variable velocity of the hydraulic fill within the sampling volume of the specific methods. Two Vs versus depth models were generated to illustrate the difficulty modeling the highly variable, near surface velocity structure evident in the PS log. The two surface wave models yielded similar values for the average shear-wave velocity of the upper 30m (V_{s30}), 201 and 202 m/s, illustrating that V_{s30} is much more tightly constrained than the actual layer thicknesses and velocities in the models. V_{s30} estimated from the PS log (194 m/s) is within 4% of that estimated from the two surface wave models (201 and 202 m/s). The small differences in V_{s30} between the two methods may easily result from the different sampling regimes (borehole versus large area) rather than errors in either of the methods.

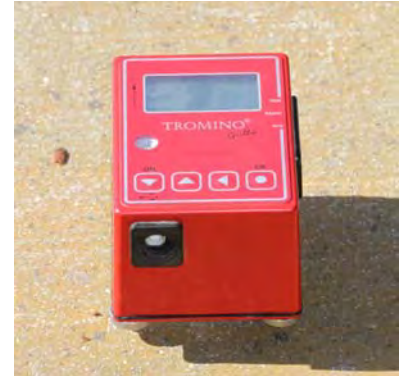
The HVSR method is a single station passive seismic method for estimating the fundamental site period (frequency), which is related to the thickness and average shear (S) wave velocity of the sediments overlying bedrock. It should be noted that the HVSR frequency peak is typically very close to, but not always identical to, the fundamental site frequency. Passive seismic techniques involve the recording of ambient noise emanating from ocean wave activity, atmospheric conditions, wind effects, traffic, industrial activity, construction activities, etc., and collectively are referred to as microseisms. Typically, microseisms with frequencies below 1 Hz have natural origins, whereas those with frequencies above 1 Hz are largely due to human activities. The HVSR technique is most often utilized as part of seismic microzonation studies of sedimentary basin, but is recently finding use in hydrogeologic studies to identify potential drill sites with bedrock at the greatest depth.

**Tromino ENGR used for HVSR
measurements in shallow basins**

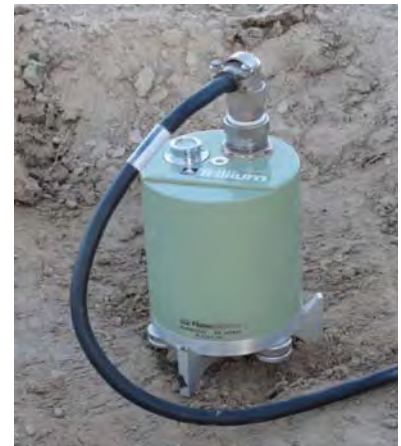
**Trillium Compact 120 second
seismometer used for HVSR
measurements in deep basins**

where f_0 is the site fundamental frequency, \bar{V}_s is the average shear-wave velocity of the soil column overlying bedrock at depth z . *This relationship* can be used to estimate the average shear wave velocity profile of the sediments when depth to bedrock is known or vice versa. As evident in this relationship, the fundamental site frequency is inversely proportional to bedrock depth; therefore, shallow bedrock will be associated with a high frequency peak and vice versa. If active and passive surface wave soundings are conducted in the deeper portion of sedimentary basins, it may be possible to develop an average S-wave velocity versus depth profile for the basin and use this along with the HVSR frequency peak to estimate bedrock depth. Alternatively, HVSR measurements can be made at locations with known depth to bedrock and a correlation between HVSR peak frequency and bedrock depth developed.
