# Suggested Practices for Avian Protection On Power Lines: The State of the Art in 2006

PIER FINAL PROJECT REPORT CEC-500-2006-022

Avian  
Power  
Line  
Interaction  
Committee

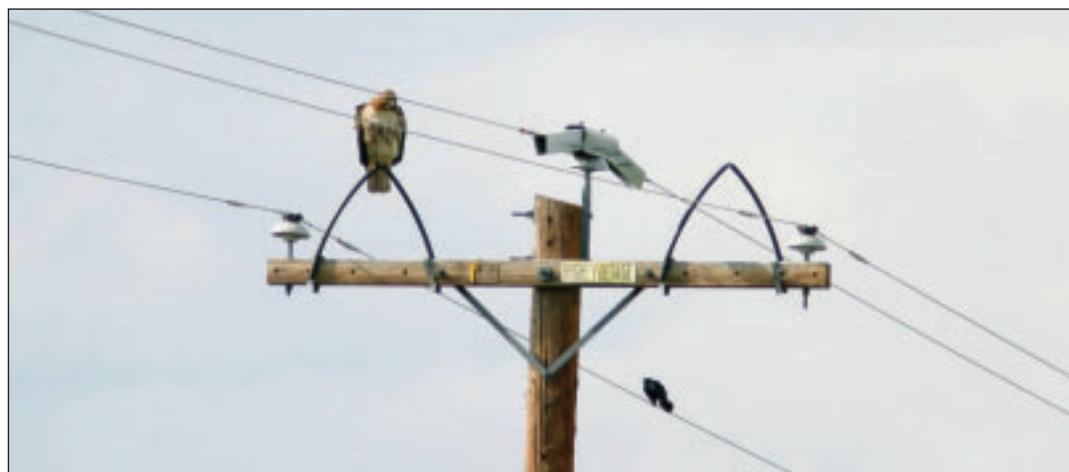
**FIGURE 2.5:** Perch discouragers have been installed on utility poles to prevent raptors or corvids from preying upon sensitive species. However, this is not recommended, as perch discouragers are intended to manage where birds perch, not to entirely prevent perching.

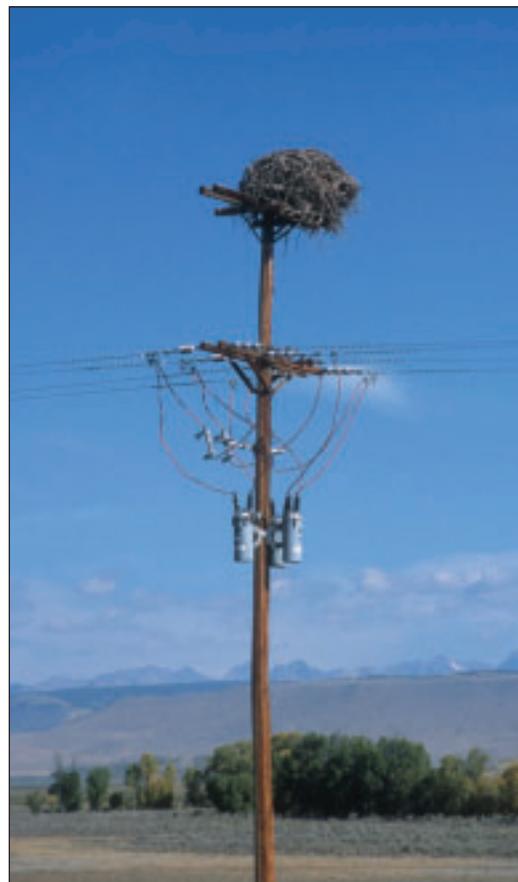
**FIGURE 6.16: Osprey nest in Wyoming atop double dead-end pole. Nesting material that may drop onto the conductors or equipment poses fire, outage, and equipment damage risks.**
