MITIGATED NEGATIVE DECLARATION

Project Title:	Raiser Helen M Tr & Helen M Raiser Tr
File Number:	PLN100396
Owner:	Raiser Helen M Tr & Helen M Raiser Tr
Project Location:	30650 Aurora Del Mar, Carmel
Primary APN:	234-341-001-000
Project Planner:	R. Craig Smith
Permit Type:	Combined Development Permit
Project Description:	Conversion of Emergency Permit to a Combined Development Permit consisting of a Coastal Administrative Permit and Design Approval for construction of 350 lineal feet Hilfiker wall, subterranean drainage system and stream bed restoration; Coastal Development Permit for development within 100 feet of environmentally sensitive habitat (ESHA); Coastal Development Permit for development within 50 feet of a coastal bluff; Coastal Development Permit for development within 750 feet of a known archaeological resource; and a Coastal Development Permit for development on slopes exceeding 30%.

NOTICE OF INTENT TO ADOPT A MITIGATED NEGATIVE DECLARATION MONTEREY COUNTY ZONING ADMINISTRATOR

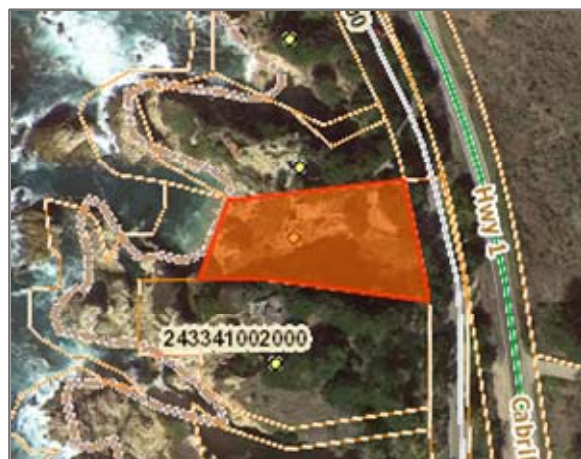
Figure 2 Aerial View

In October 2009, stormwater runoff concentrated within the arroyo leading to the failure of the northern creekbank slope and slope failure undermined the retaining wall elements below the Otter House. Under 2009 conditions, stormwater from both residential sites on either bank was discharged from the rooftops and other impervious areas associated with these residential developments, along with Aurora del Mar, and Highway 1, directly into the drainage channel. Stormwater runoff also originated from and the upper reaches of the arroyo east of Highway 1. The cumulative runoff created flooding situations that exceed the capacity of the arroyo and caused the erosion and ultimate failure of the northern banks of the arroyo below the Otter House. The eroded arroyo sidewall exposed the dwelling's shallow conventional foundation and pylons supporting the residence. The residence was thus "red tagged" by the Monterey County Building Division, which prohibited people from entering the structure because of structural instability and imminent safety concerns for human occupation. On February 10, 2010, an emergency permit (PLN100094) was issued by RMA to allow the owner to mitigate the emergency situation. The permit allowed construction of a Hilfiker wire retaining wall system of approximately 135 lineal feet with a maximum height of approximately 30-feet, and importation of backfill soil materials to repair and stabilize the foundation on the south side of the existing residence. Soils were also imported to restore the arroyo bottom to its approximate historical elevation. **Figure 1** (Regional Location) shows the location of the project site along the Big Sur coast, and **Figure 2** (Aerial View) identifies the project site (in orange).

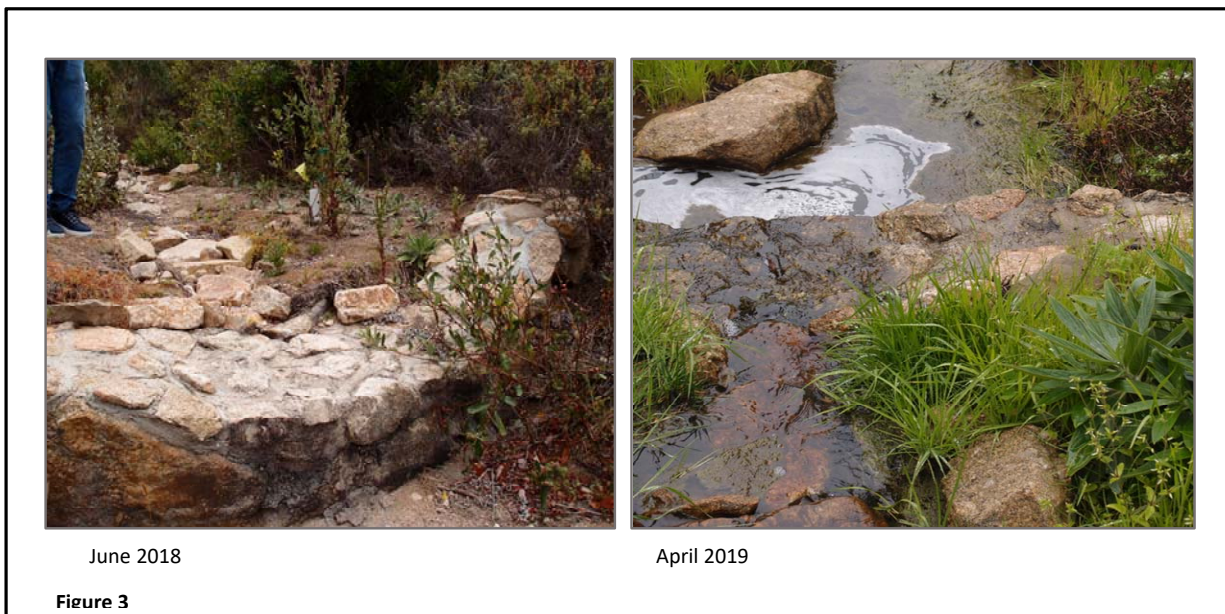
Figure 3

The County of Monterey is requiring Coastal Development Permits as a follow-up to the previously issued Emergency Coastal Development Permit for the project. The follow up permits constitute a Combined Development Permit (CDP) for: retaining wall construction, development on slopes in excess of 30 percent, drainage improvements, and development in an environmentally sensitive habitat area with archaeological sensitivity. As part of the CDP, the County, the California Coastal Commission (CCC), and the California Department of Fish and Wildlife (CDFW) required that dry-weather and stormwater flows up to the 2-year storm event are restored to the channel in order to maintain habitat and ephemeral stream function. The storm water inlet at the eastern reach of the arroyo is designed to allow surface flow during rain events. The weir tops within the arroyo are flush with the arroyo bottom so as not to impede surface flows. Refer to **Figure 3** below.
