Phase I Environmental Site Assessment

Escalante Meadows
Formerly a Portion of Guadalupe Ranch Acres

April 11, 2019

**Subject: Phase I Environmental Site Assessment
Escalante Meadows (Formerly a Portion of Guadalupe Ranch Acres)
Guadalupe, California**

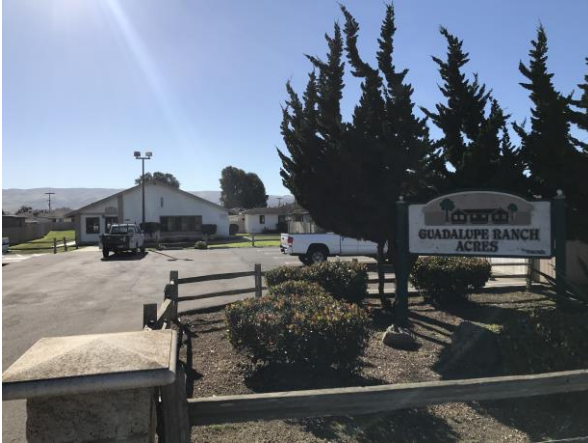
Photograph 1. View of the subject property (1050 Escalante St) and community center/office, facing southwest.

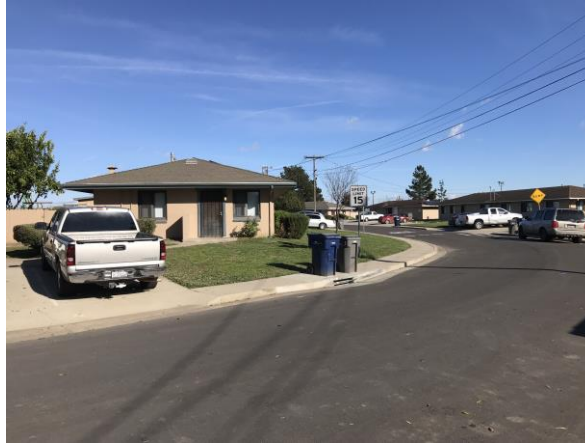
Photograph 2. View of residential duplex home along Escalante St. on the subject property.

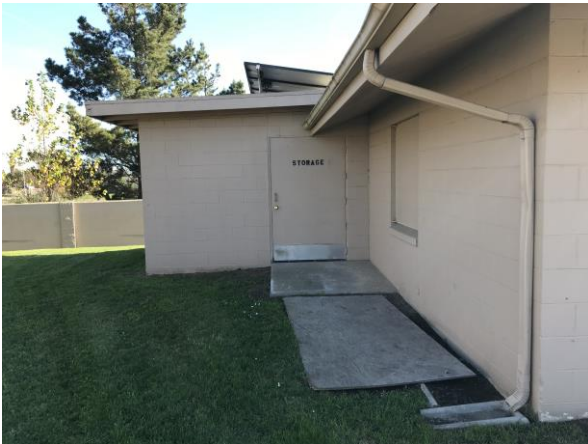
Photograph 4. View of the maintenance shop on the subject property, facing southwest.

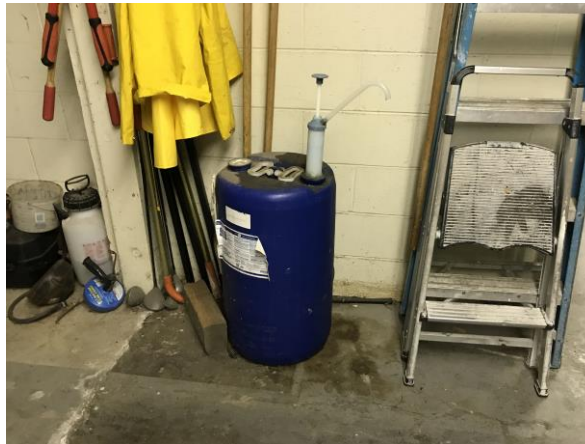
During the site reconnaissance, one 20-gallon drum (containing 999 Safety Solvent Degreaser) was observed on the subject property located in the maintenance shop. Rincon did not observe indications of releases from the drum on the subject property.

Photograph 5. View of 20-gallon drum containing 999 Safety Solvent Degreaser located in the maintenance shop area.

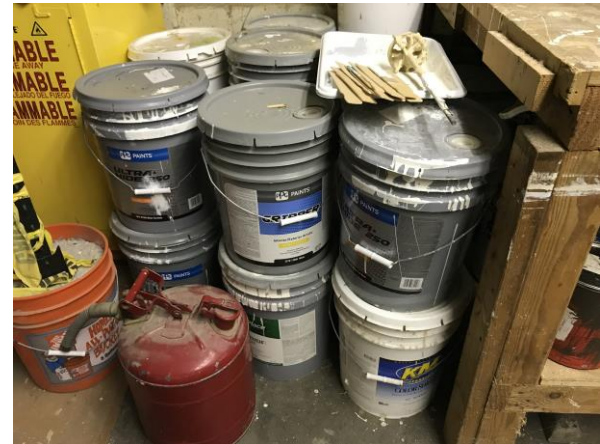
Photograph 6. View of paint buckets and portable fuel canister located in the maintenance shop area.

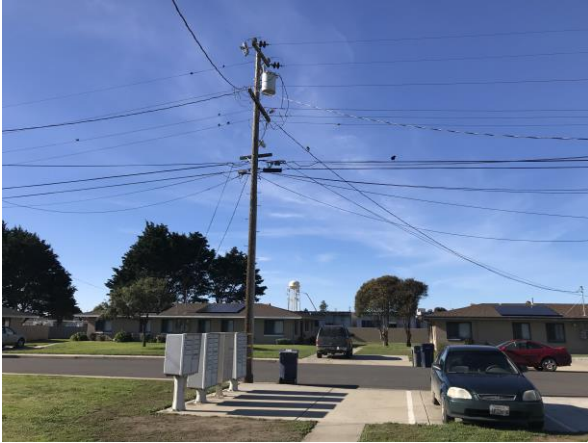
During the site reconnaissance, Rincon observed two PG&E pole-mounted transformers located along the western interior and eastern interior portion of Escalante St.

Photograph 7. View of pole-mounted transformer located along Escalante Street on the subject property, facing west.

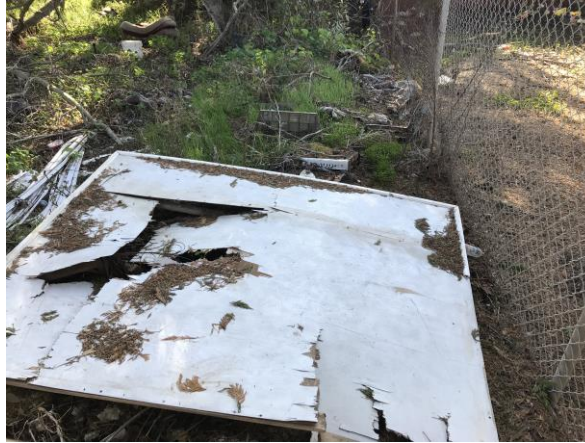
Solid Waste/Debris. During the site reconnaissance, miscellaneous solid waste debris were observed on the southwestern adjacent property of Mary Buren Elementary School and the wetlands.

Photograph 8. View of miscellaneous soil waste debris on the southwestern adjacent property of Mary Buren School and the wetlands.

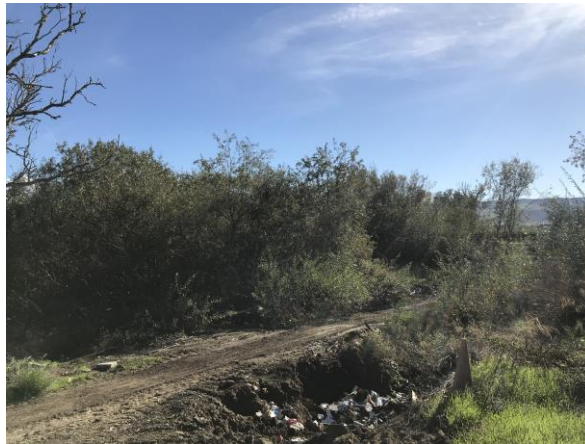
Wetlands. During the site reconnaissance, wetlands were observed south of the subject property and wetlands to the southwest of the subject property. The wetlands are listed on the US BROWNFIELDS database searched by EDR. Further information is described in the Additional Environmental Record Sources section of this report.

Photograph 11. View of the southern adjacent wetlands and vegetation, facing southeast.
