**REPORT OF GEOTECHNICAL INVESTIGATION  
SEWER GROUP 806 BRIDGE CROSSING PROJECT  
CITY OF SAN DIEGO**

AGE Project No. 185 GS-16-B

August 23, 2018  
(Revised October 23, 2018)

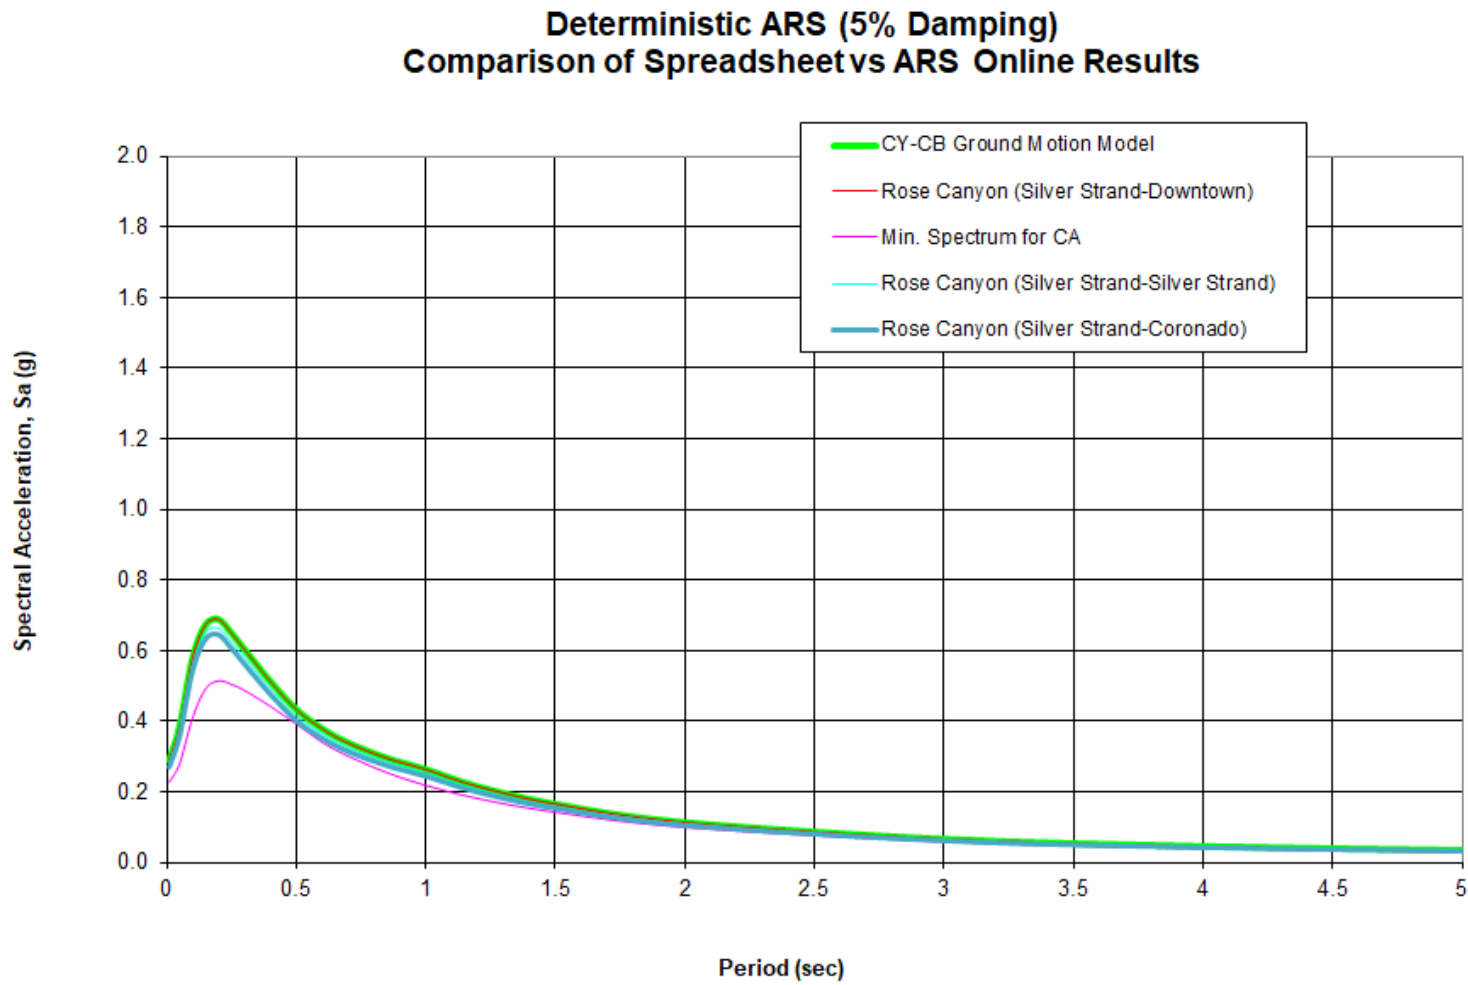
**FIGURE 3**

**DETERMINISTIC ARS**  
**SEWER GROUP 806 BRIDGE CROSSING PROJECT**

Based on the fault parameters, Maximum Magnitude (Mmax) earthquake for the site is equal to 6.8. Based on the subsurface conditions observed in the boring and test pit, a  $V_{s30}$  of 600 m/s was used in the development of the ARS curves (Site Class C). The deterministic and probabilistic ARS curves and curve coordinates that have been developed are shown on Figures 3 and 4. The design response spectrum which is shown on Figure 5 is the upper envelope of the spectral values of the deterministic response spectrum, probabilistic response spectrum and the minimum response spectrum for the state of California. A maximum peak ground acceleration (PGA) of 0.289 g is estimated for the bridge.

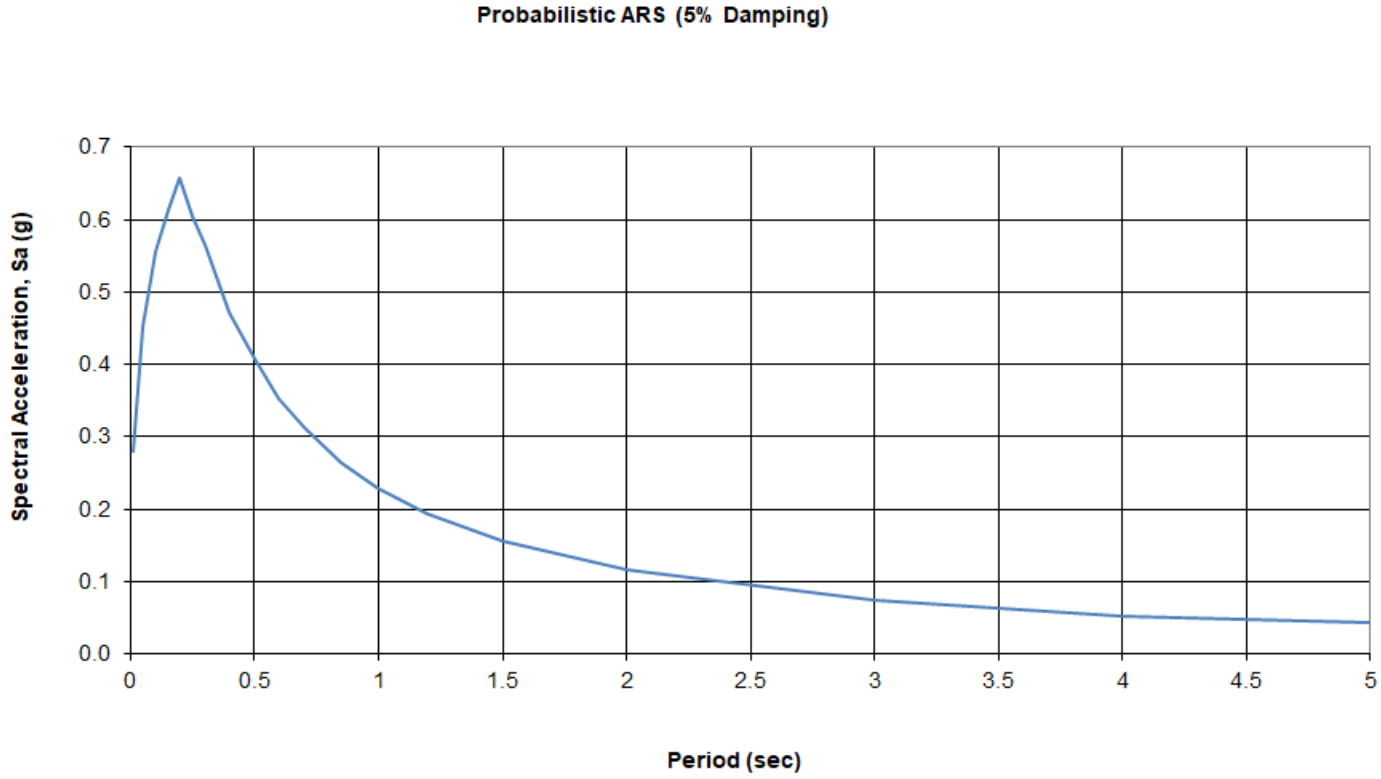
**FIGURE 4**

**PROBABILISTIC ARS/USGS DEAGGREGATION HAZARD DATA  
(5% EXCEEDANCE PROBABILITY IN 50 YEAR)  
SEWER GROUP 806 BRIDGE CROSSING PROJECT**

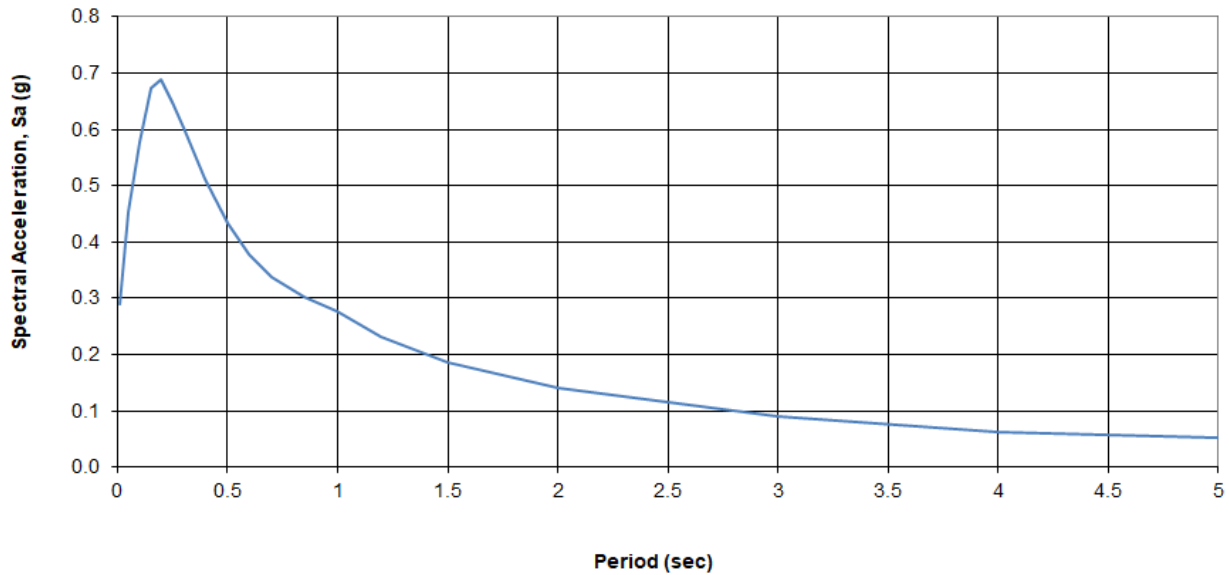
**FIGURE 5**

| T (sec) | Base Spectrum S(a) |
| 0.01 | 0.289 |

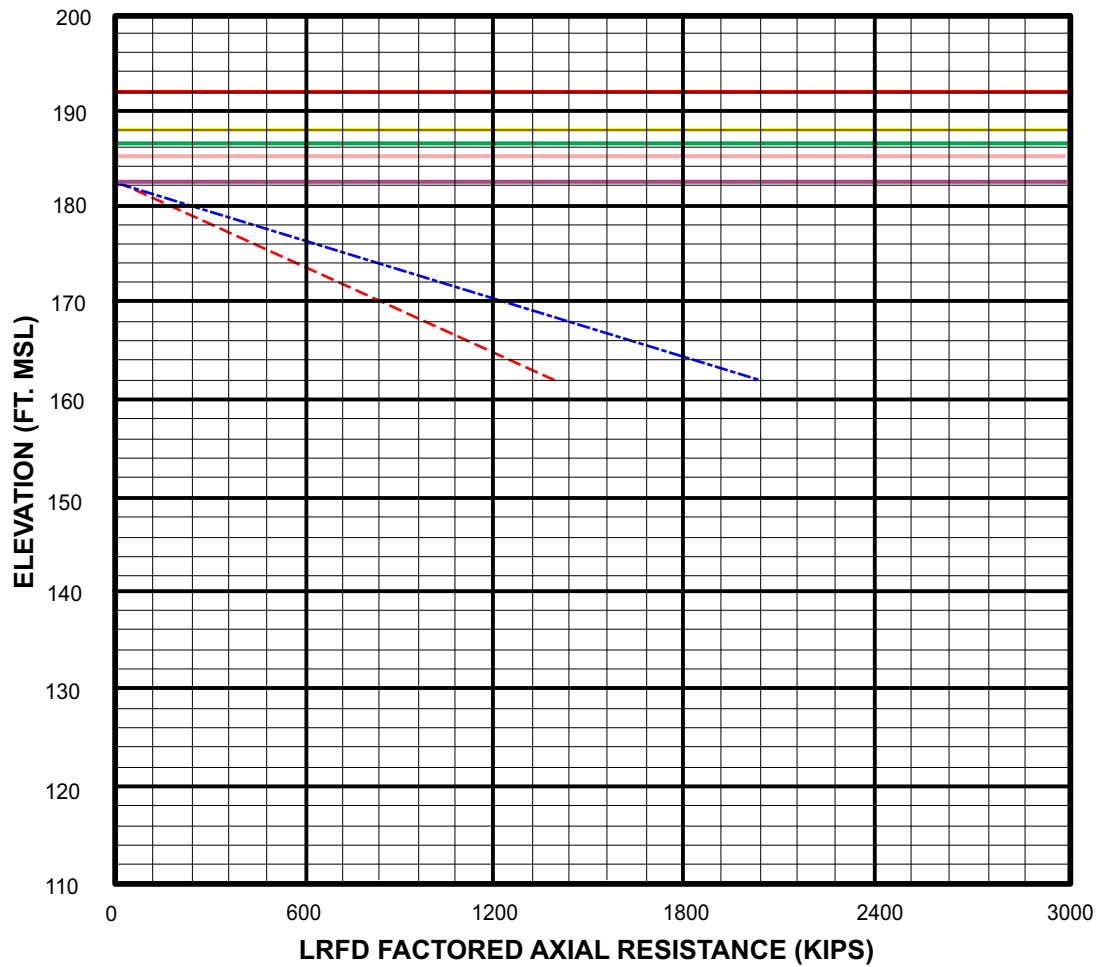
- Compressive Resistance Extreme Event Limit State I
- Compressive Resistance Strength Limit State
- Approximate Existing Grade Elevation
- Approximate Finish Grade Elevation (Abutment 1)
- Approximate Finish Grade Elevation (Abutment 2)
- Approximate Top of Rock
- Approximate Pile Cut-Off Elevation

Design soil input parameters for lateral pile capacity analyses using the software LPILE are presented in Tables 7 and 8 for use by the project structural engineer. The final design tip elevations should be determined based on the controlling value of axial and lateral demand. AGE recommends that the CIDH piles be embedded a minimum of 10 feet into the Stadium Conglomerate.

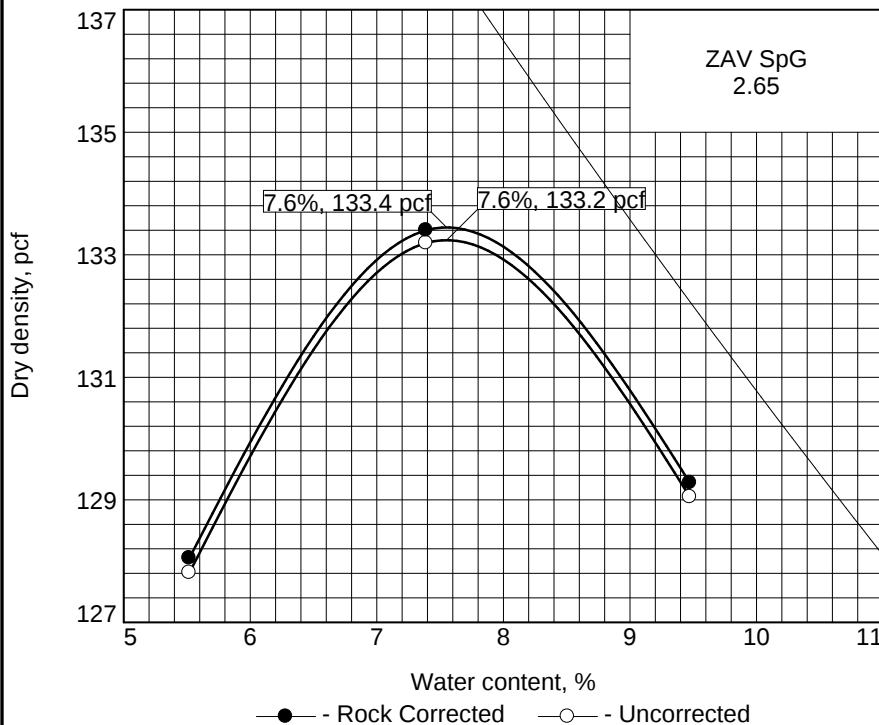
Curve No.

# COMPACTION TEST REPORT

ASTM D 1557-91 Procedure C Modified  
ASTM D4718-15 Oversize Corr. Applied to  
Each Test Point

Optimum moisture = 7.6 %

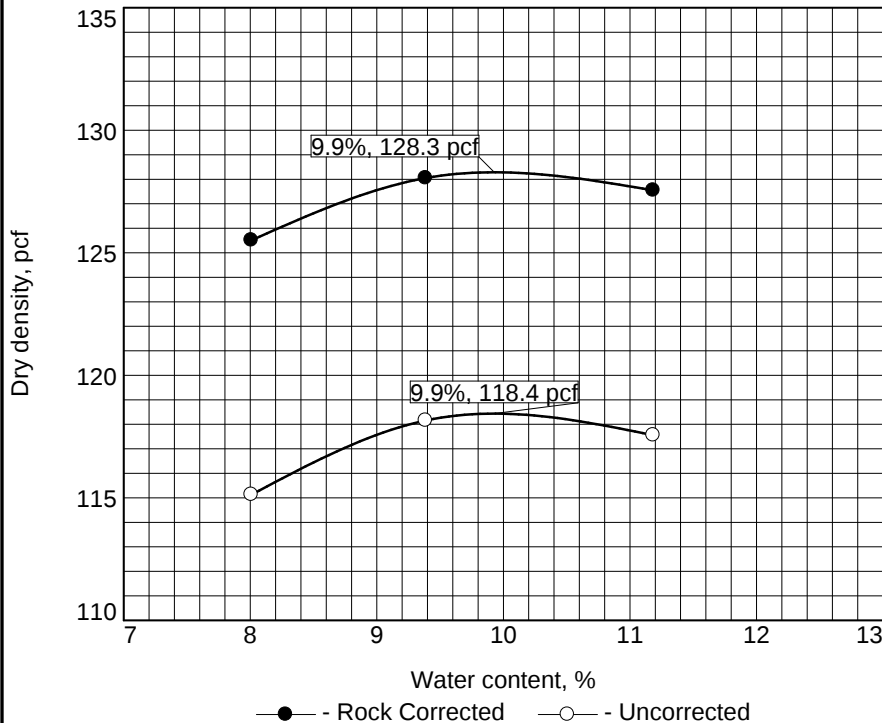
Curve No.

# COMPACTION TEST REPORT

ASTM D 1557-91 Procedure A Modified  
ASTM D4718-15 Oversize Corr. Applied to  
Each Test Point

Optimum moisture = 9.9 %

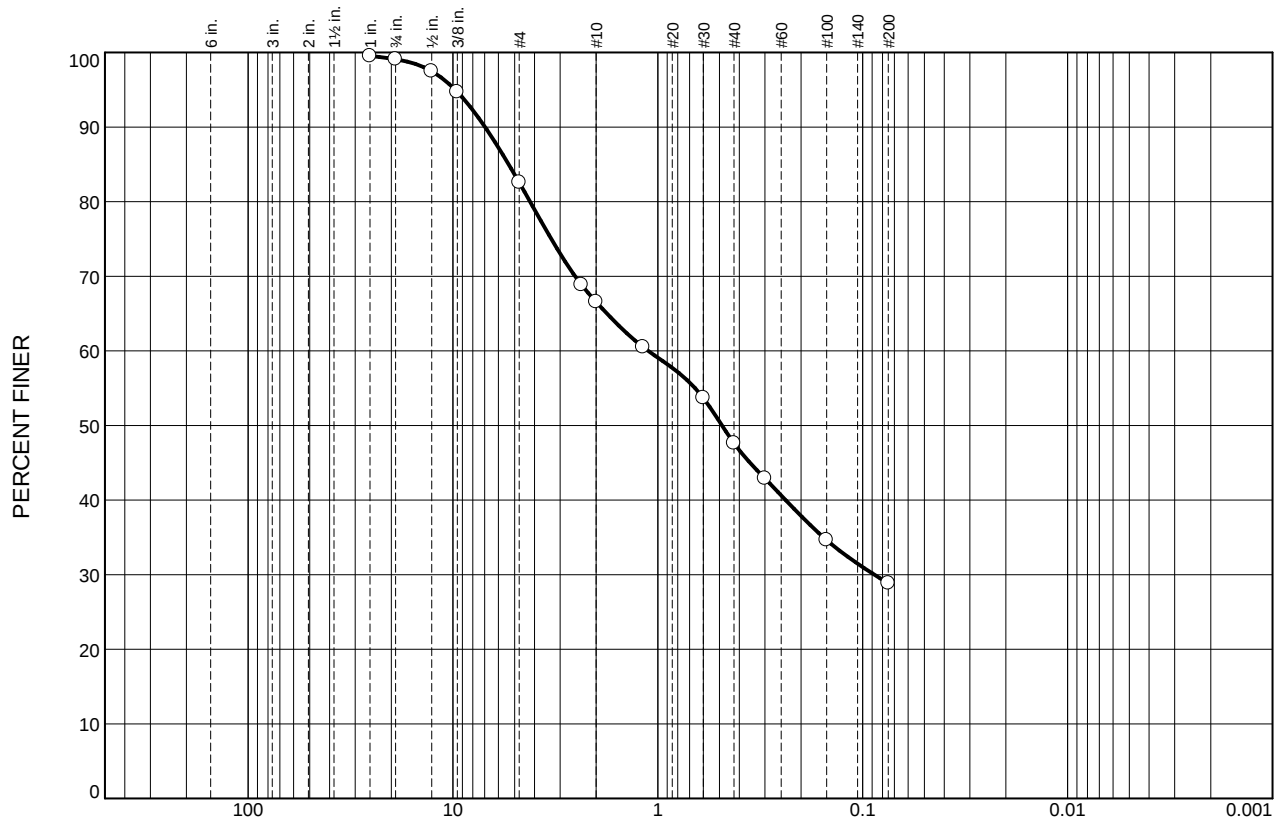
Figure B-2

# Particle Size Distribution Report

GRAIN SIZE - mm.

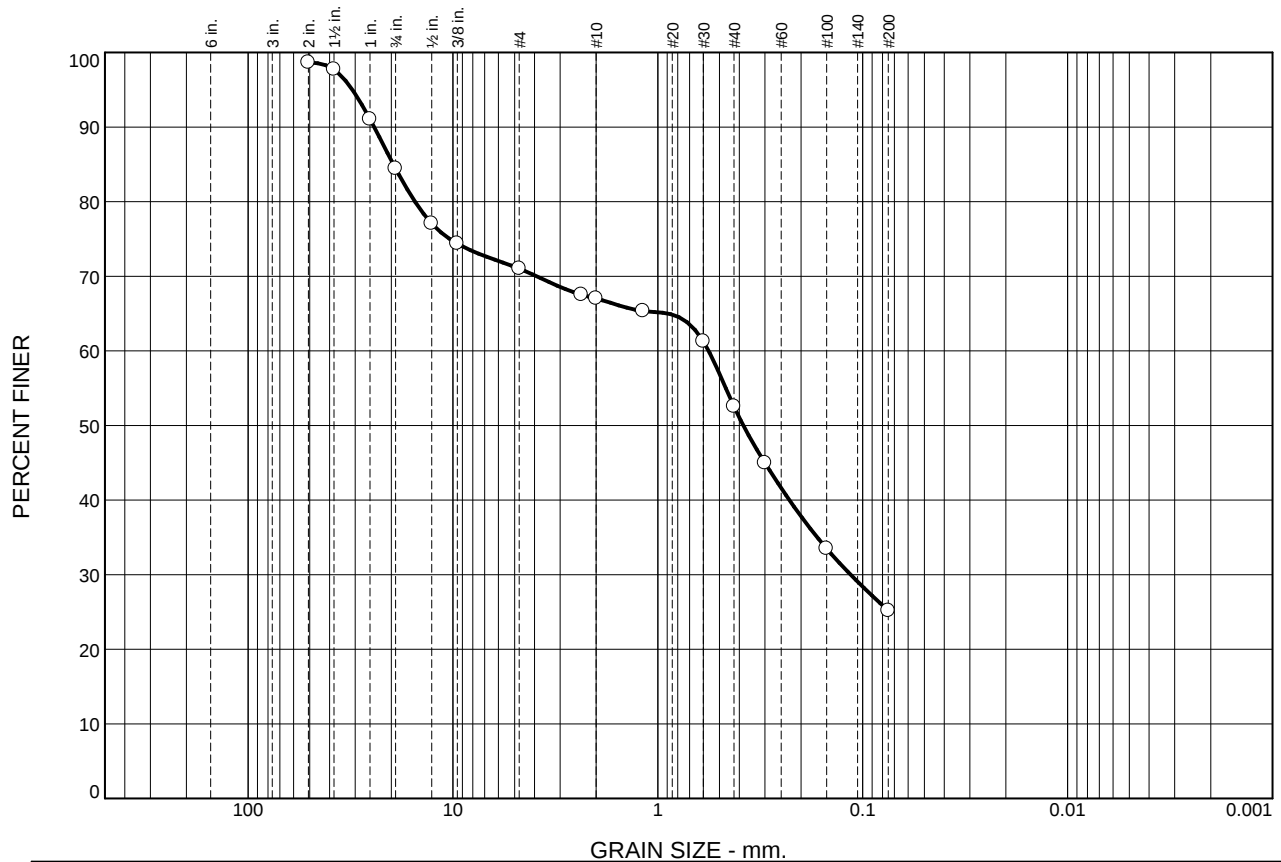
Figure B-4

# Particle Size Distribution Report

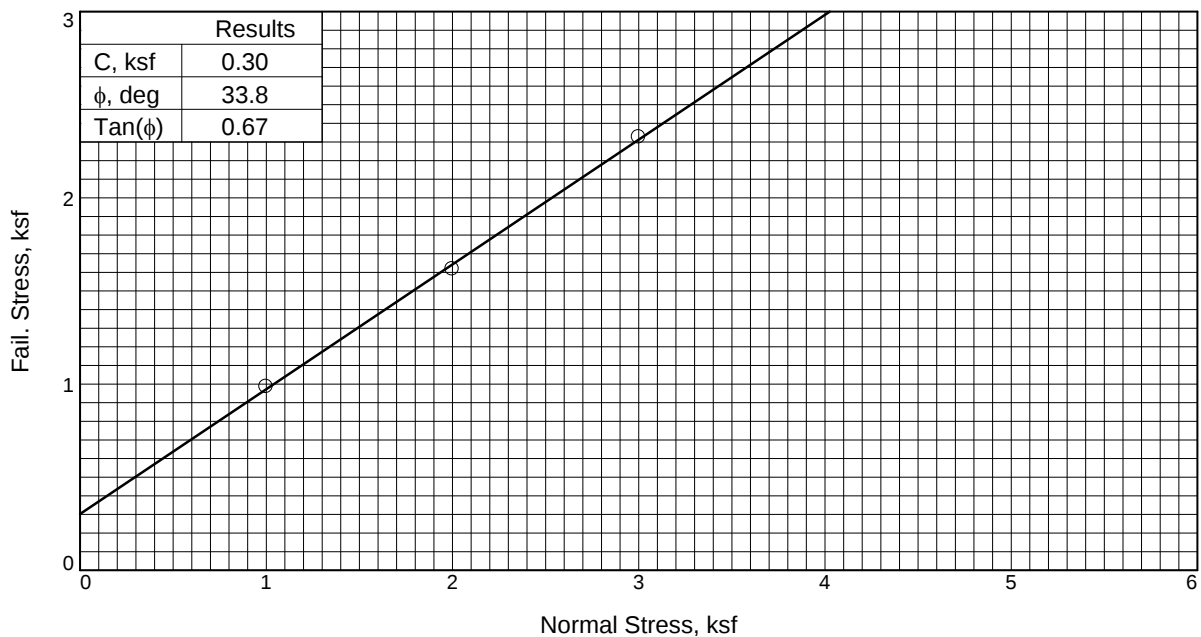
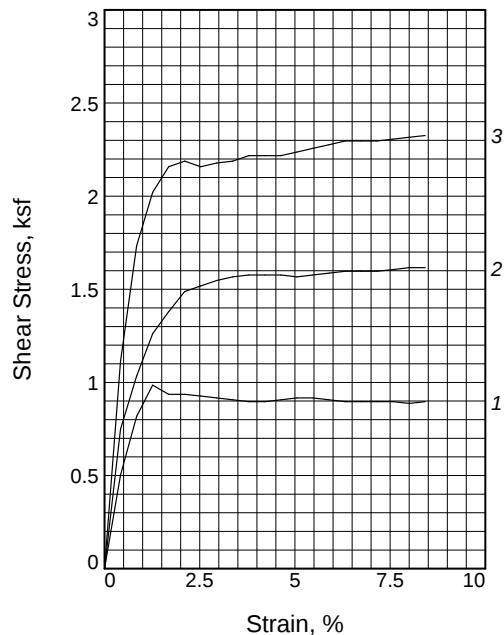
| Sample No. | 1 | 2 | 3 |
| Initial | Water Content, % | 10.3 | 9.7 |

- Determination of in-place moisture content (ASTM D2216). The final test results are presented on the boring and test pit logs;
- Determination of in-place dry density and moisture content (ASTM D2937) based on relatively undisturbed drive samples. The final test results are presented on the boring and test pit logs;
- Maximum density and optimum moisture content (ASTM D1557). The final test results are presented on Figures B-1 and B-2;
- Sieve analyses (ASTM D422), and the final test results are plotted as gradation curves on Figures B-3 and B-4;
- Direct shear test (ASTM D3080). The test results are presented on Figures B-5 and B-6.

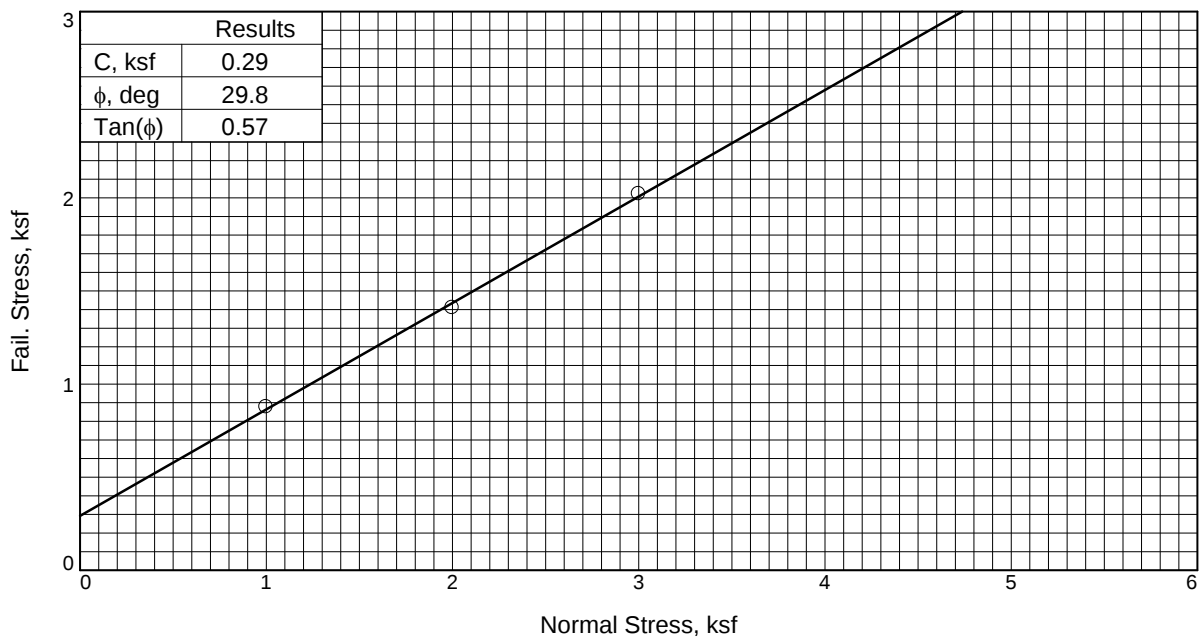
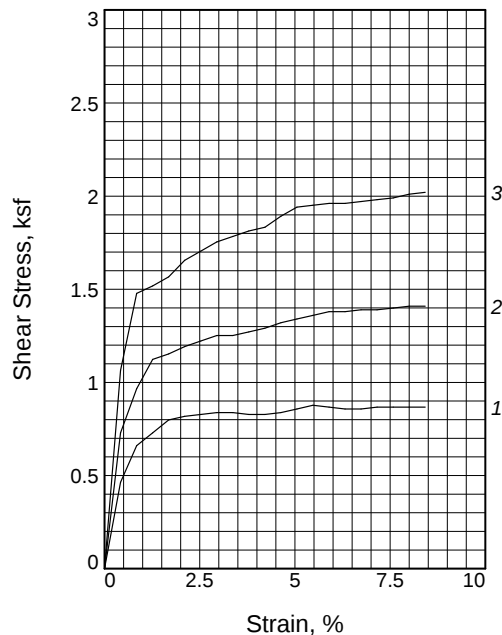
| Sample No. | | 1 | 2 | 3 |
| Initial | Water Content, % | 10.5 | 11.4 | 10.8 |
| Fail. Stress, ksf | | 0.88 | 1.41 | 2.02 |
