Preliminary Technical Report

Sierra Valley Preserve Public Water System

Sierra Valley Preserve
181 Austin Road
Beckwourth, CA 96122
Plumas County
APN: 025-220-025

July 6, 2020

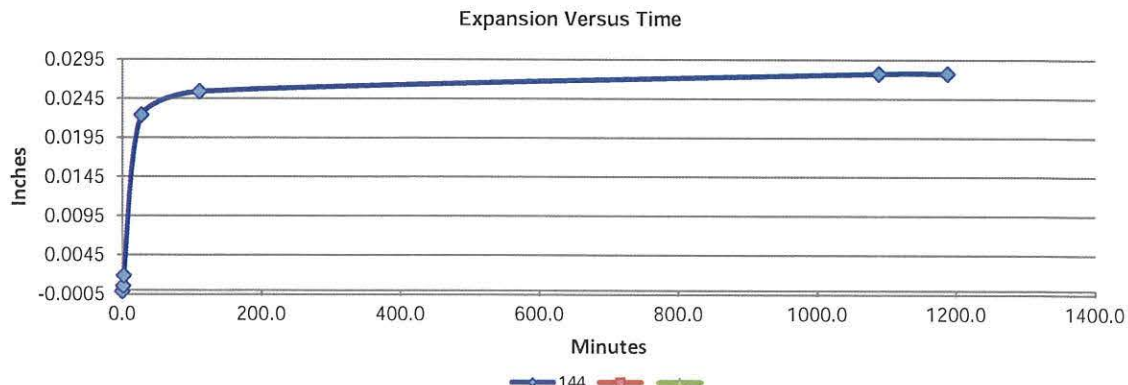
EXPANSION INDEX/SWELL
ASTM D4829

Expansion Index Number				Elapsed Time (m:s)	Change in Height (Inches)	Elapsed Time (m:s)	Change in Height (Inches)	Elapsed Time (m:s)	Change in Height (Inches)
Corrected to 50% Saturation				0.0	-0.0001				
Surcharge (psf)				1.0	0.0006				
Uncorrected				2.0	0.0019				
Test wt. 144				27.0	0.0224				
Test wt. 28				110.0	0.0254				
Test wt. 28				1089.0	0.0278				
				1188.0	0.0278

Expansion Index Values and Descriptions	
Expansion Index	Potential Expansion
0-20	Very Low
21-50	Low
51-90	Medium
91-130	High
Above 130	Very High

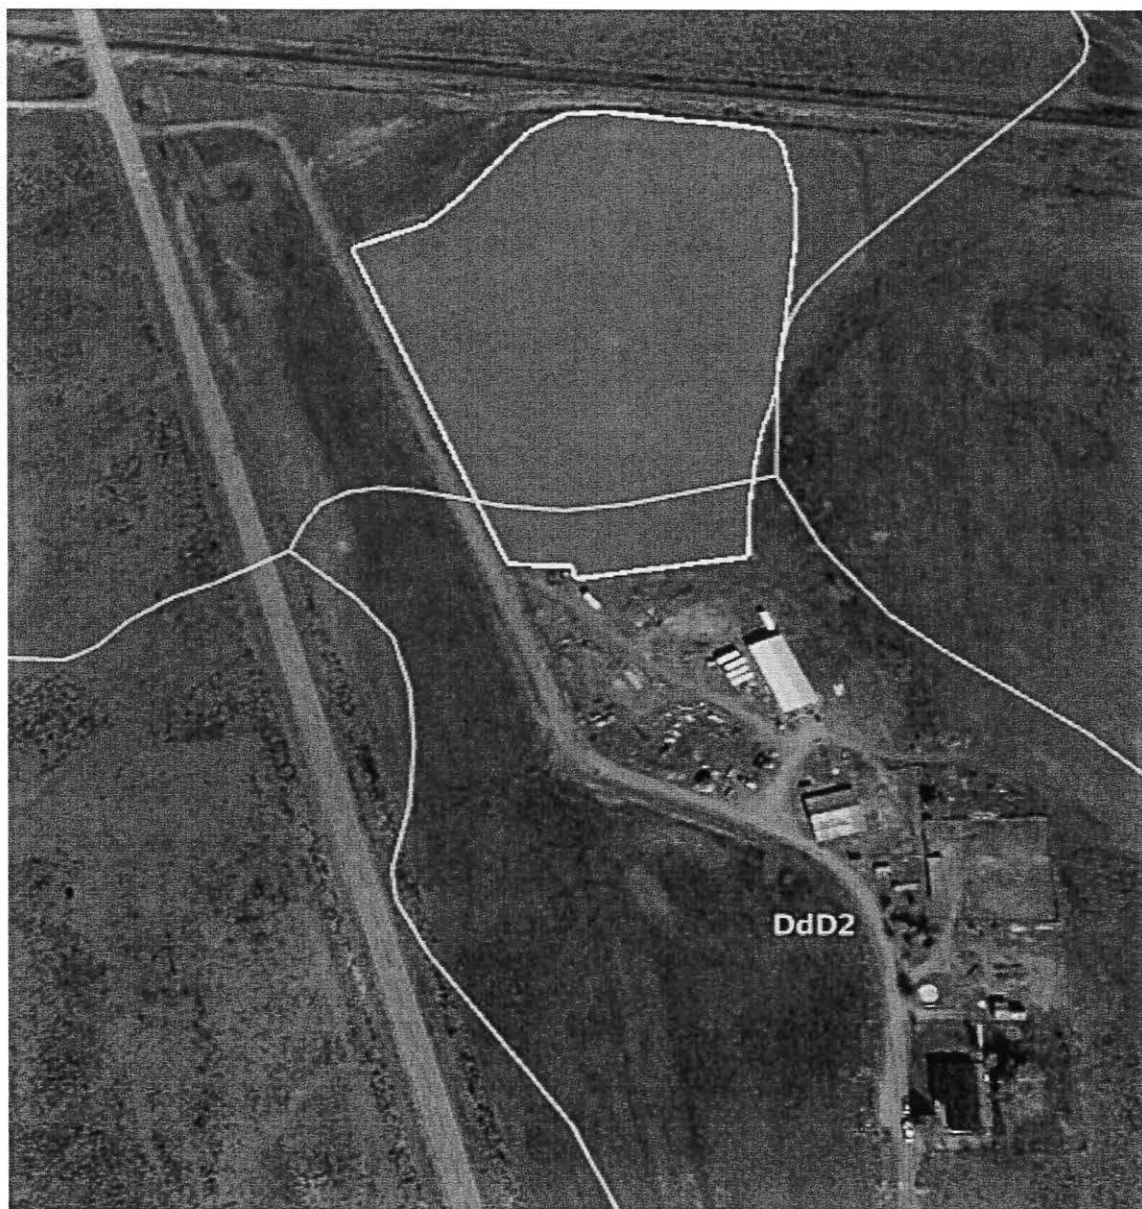
Figure 1. Area within which 4 recently-active American badger dens were observed on the Marshall Parcel (see turquoise polygon below).

Nesting/Denning by Special Status Species.—I observed nesting or recent denning by 3 special status species within proposed project areas (see **Table 1** below). I observed 4 recently-active (likely active in 2018) American badger dens/burrows on the northern portion of the Marshall Parcel (see **Figure 1** below). The American badger is a California Species of Special Concern. I observed nesting Brewer's Sparrows, a U.S. Fish and Wildlife Service Bird of Conservation Concern, within 100 meters of both proposed trails and the

Suitable habitat for Burrowing Owl occurs all along the proposed route of the Bluff Trail and within the American badger denning area (see **Figure 1**) on the Marshall Parcel. Burrowing Owl is a California Species of Special Concern. Suitable nesting and denning habitat for American badger and Burrowing Owl also occurs within the proposed Jenner Memorial site and all along the proposed Rebecca Trail extension.

Potential Impacts: Interpretive Center on Marshall Parcel.—In my professional opinion, construction of an Interpretive Center within the American badger burrowing/denning area shown in **Figure 1** has the potential to have moderate to significant negative impacts upon American badgers and their habitat on the SVP by

Avoidance and Mitigation of Potential Impacts: Interpretive Center on Marshall Parcel.—In order to avoid negative impacts to American badgers and badger habitat (as well as to suitable nesting habitat for Burrowing Owls), I recommend that the Interpretive Center be constructed in a location outside of the badger denning/burrowing area (see **Figure 1**). If the preferred location of the Interpretive Center is on or in the immediate vicinity of the badger denning/burrowing area, in order to mitigate potential negative impacts to badgers and burrowing owl habitat I recommend that:
