**FOR HONDA CREEK CULVERTS REPAIR AND CORROSION  
PREVENTION**

**VANDENBERG AIR FORCE BASE, CALIFORNIA**

**March 2021**

# Assessment of Potential Jurisdictional Waters for Honda Creek Culvert Repair at Vandenberg Air Force Base, California

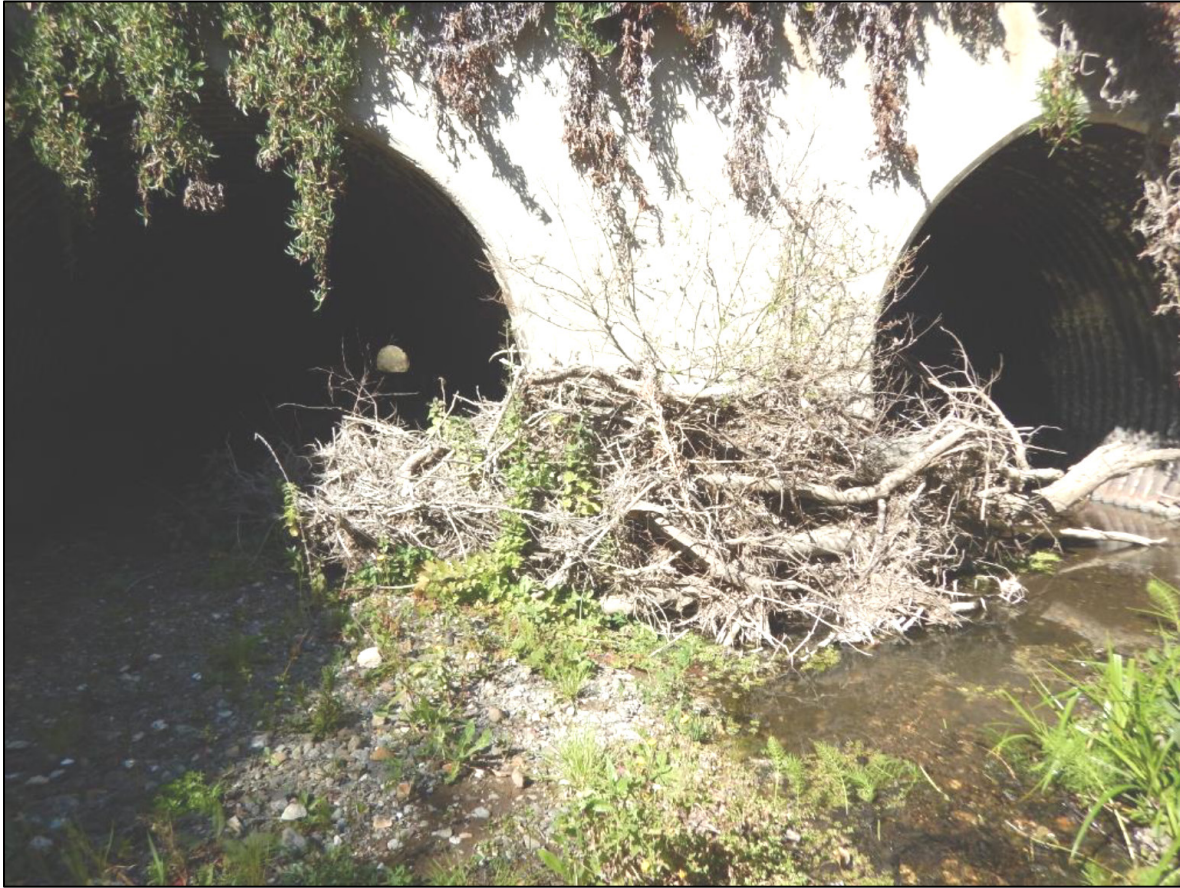
**Figure 1-3. Inlet End of the Honda Creek Culverts  
Showing Trapped Debris and Sediment**

The Proposed Action involves culvert repair and corrosion prevention at Honda Creek (Figure 2-1). The culverts have bituminous-coated corrugated metal pipes that are corroded and degraded, and collapse is a concern. The Air Force would install lining inside these metal pipes to prevent further corrosion and collapse. Smooth-walled, 11 ft (3.3 m) diameter high-density polyurethane liners would be grouted in place inside the existing culverts. The Proposed Action would eliminate Coast Road collapse risk. To install the lining, the Air Force would use existing roads and laydown areas and construct a temporary access route and temporary laydown areas (Figure 2-1).

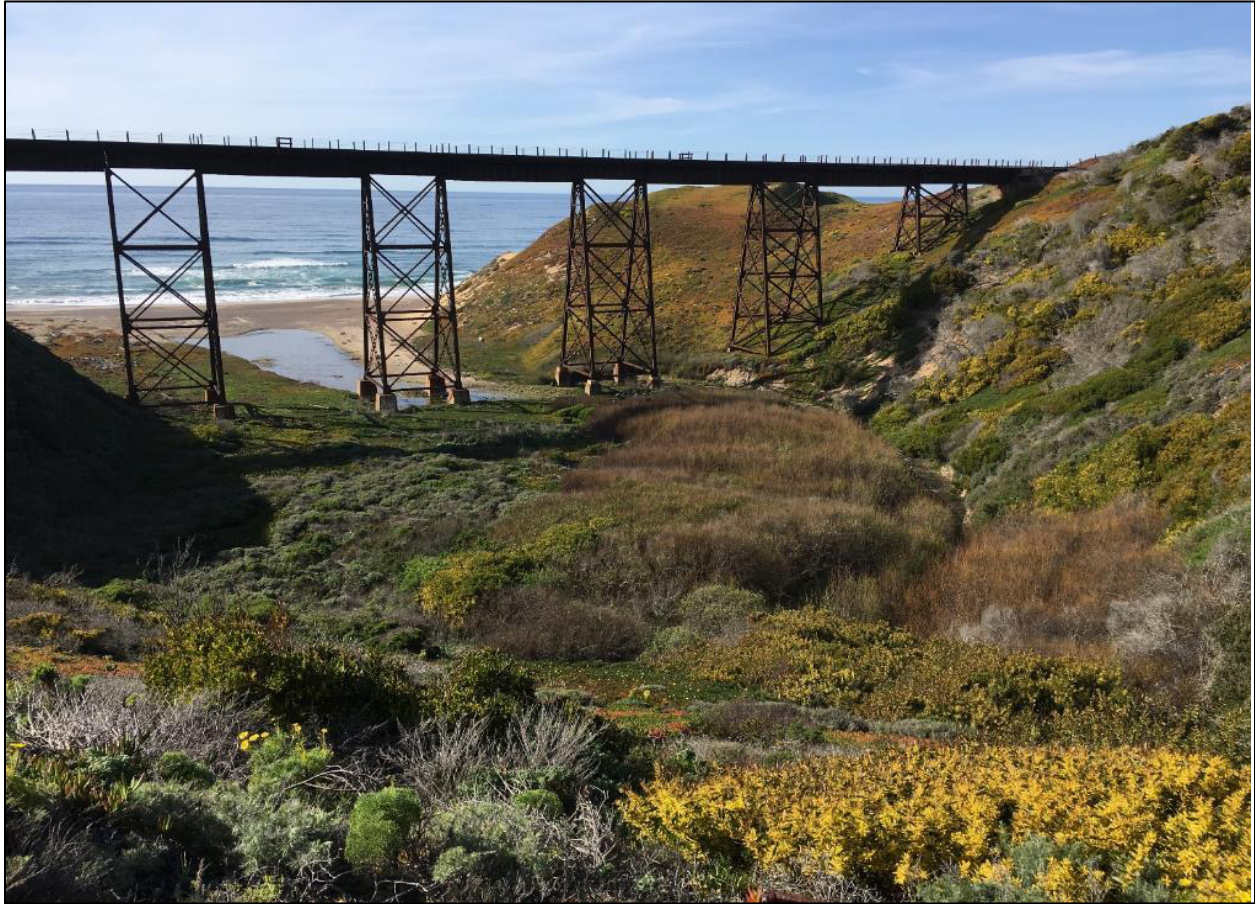
**Figure 2-2. Overview of the Mouth of Honda Creek and Honda Beach, Including the Railroad Bridge, Where a New Temporary Access Road Would Be Constructed**

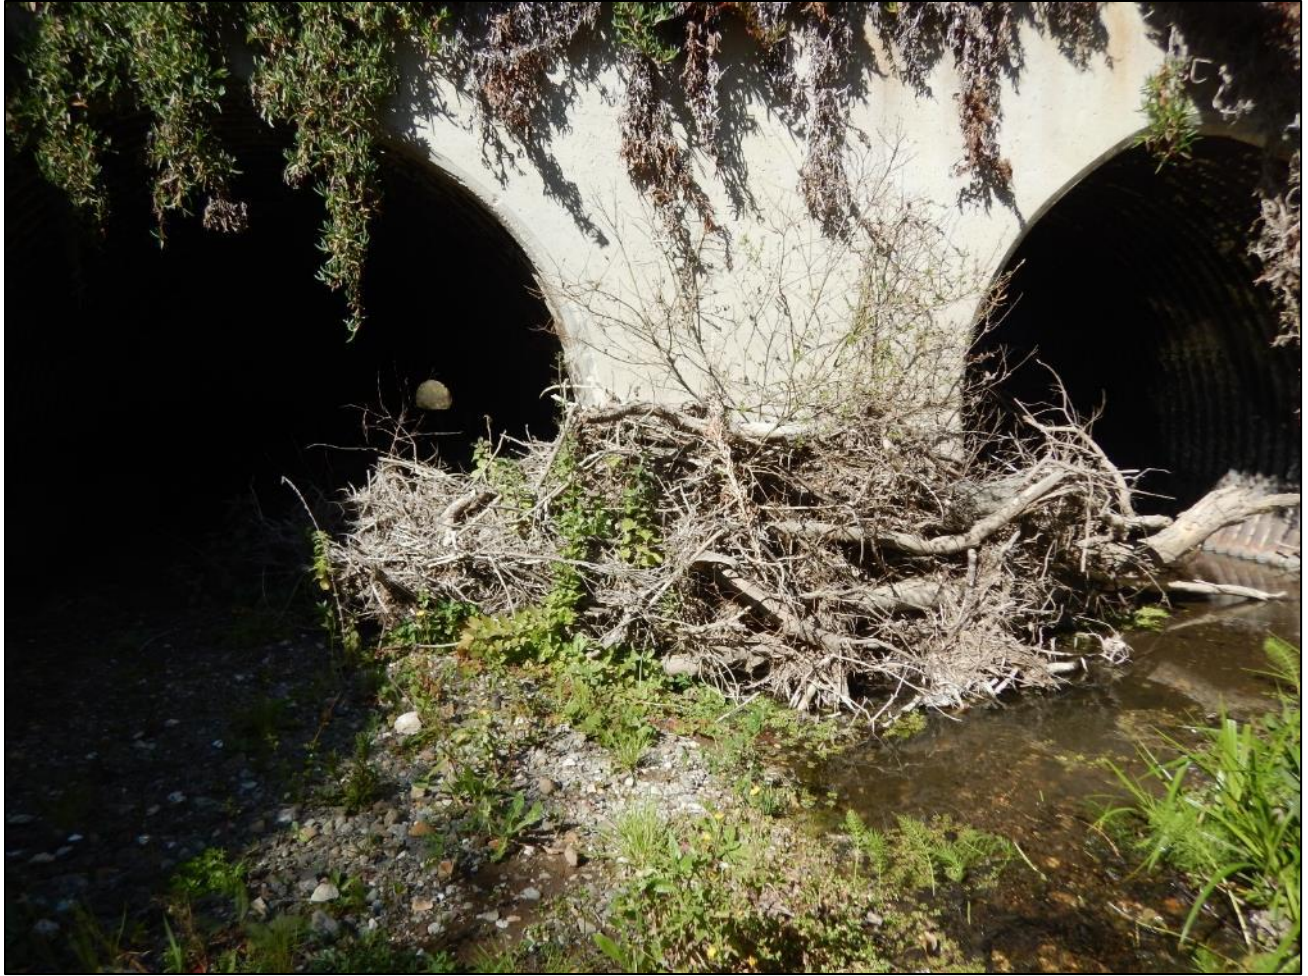
**Figure 2-3.** Inlet end of the Honda Creek culverts showing trapped debris and sediment.

Above and immediately below the culverts, Honda Creek is restricted to a narrow channel by its steep canyon sides. Just before the stream reaches the ocean, at approximately the 3-ft (0.9 m) contour line and approximately 300 ft (91.4 m) below the culverts' outflow, the canyon mouth broadens into a small estuary and beach. Coast Road crosses the stream channel at an elevation of 30 ft (9.1 m) on a constructed berm pierced by the culverts. Currently, the beach has built enough of a dune to contain a small area of tidally-influenced open water in the estuary which extends upstream under the railroad trestles to meet the freshwater coming down Honda Creek (Figure 2-4). This results in a complex system of tidally influenced and freshwater flow.

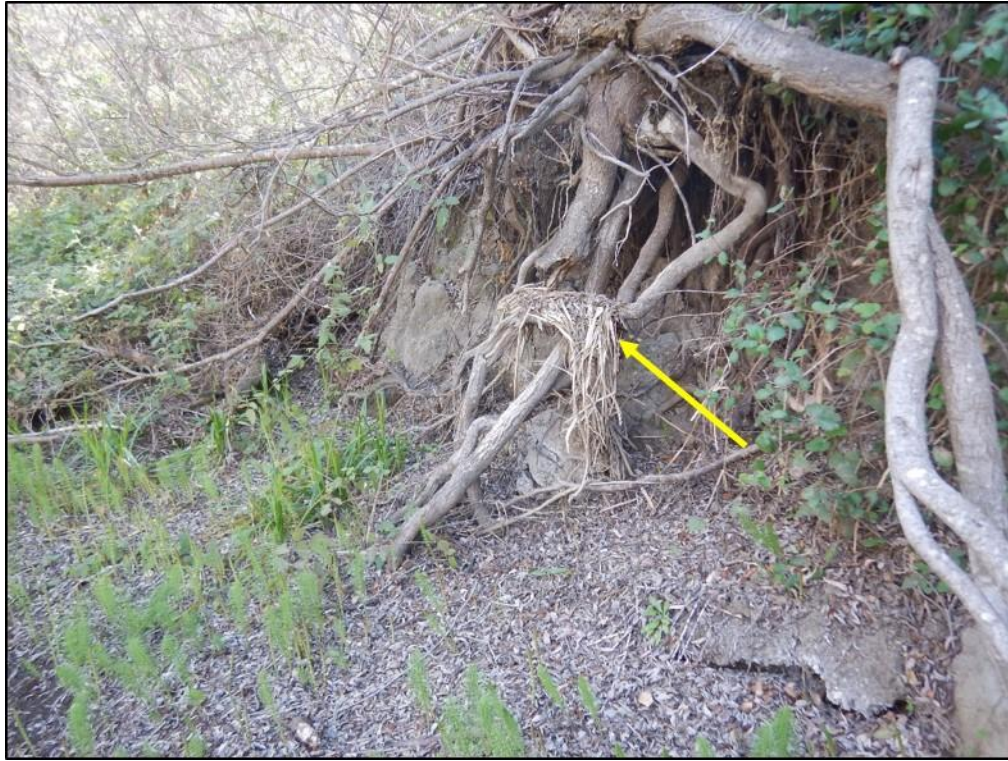
**Figure 5-5.** Entrained vegetation deposited during a high-water event, likely this winter. This is an indication of the OHWM.

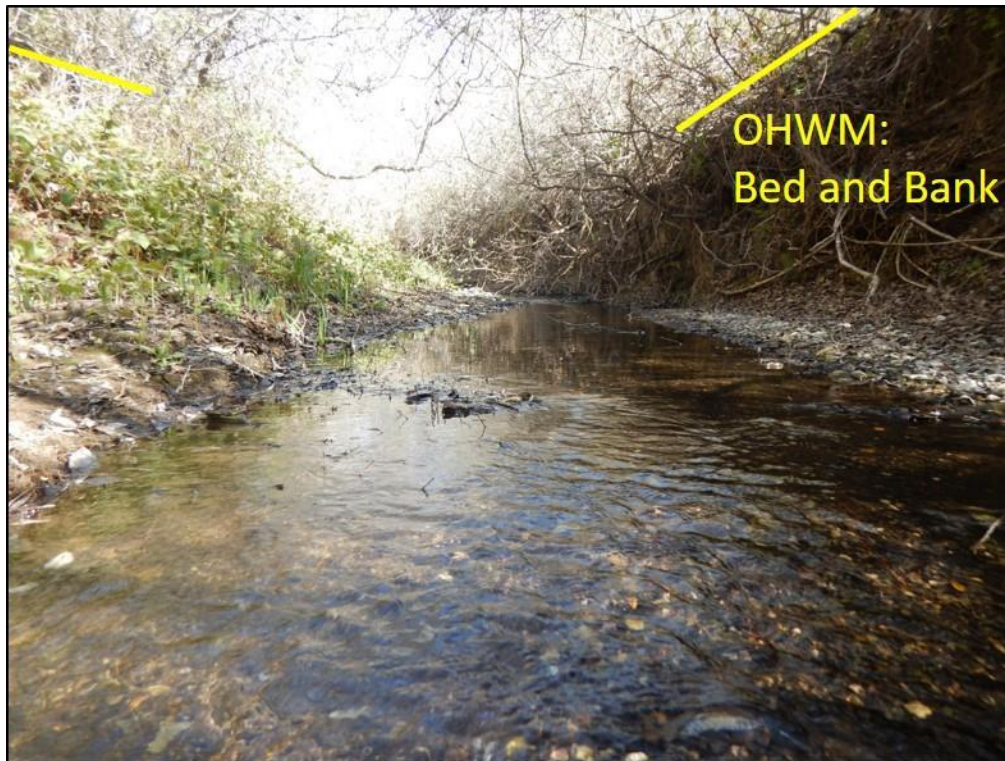
**Figure 5-6.** Bed and banks of Honda Creek upstream of the culvert intakes.
