### A.44 Chollas Creek – 54th Street (No. 5-04-280)

#### Summary of Recommended Maintenance

## Attachment A: Hydrology and Hydraulics Fact Sheets

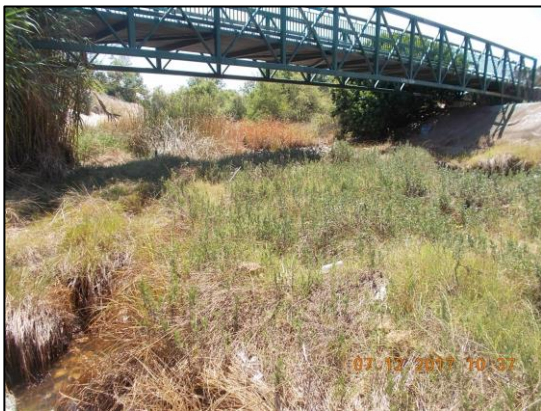
7. Alpha 1 (Reach 1): looking downstream under the pedestrian bridge located just east of I-5.

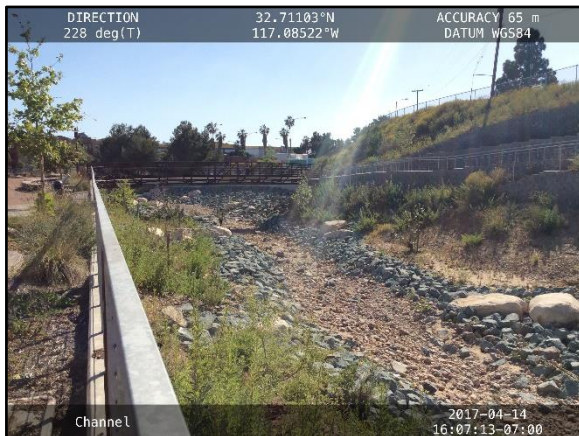
3. Euclid 1: Representative of earthen with cobble portion of channel.

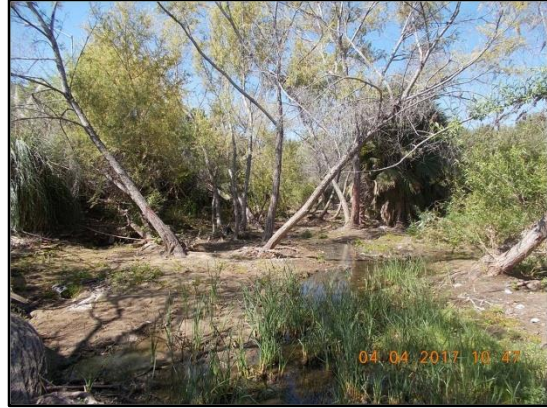
6. Imperial 1: Looking downstream at vegetation in channel.

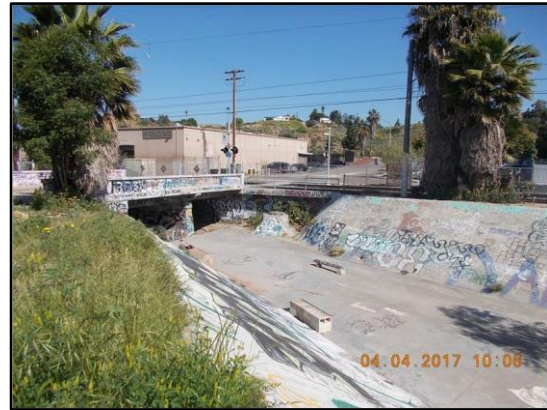
8. Imperial 1: looking downstream at transition to concrete channel at the 54<sup>th</sup> Street bridge.

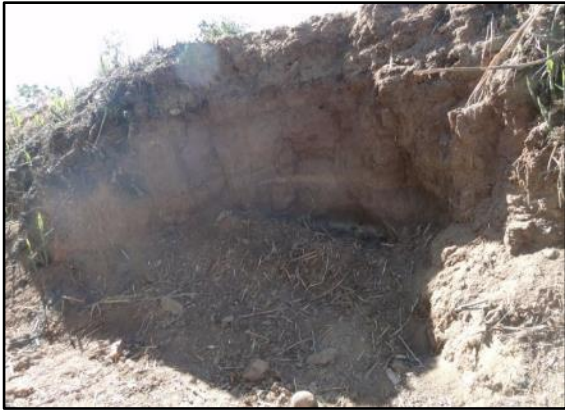
3. Lobrico 1, Reach 2: Erosion along right bank, at outlet of 48-inch RCP beneath Lisbon Street, looking southwest (November 2016).

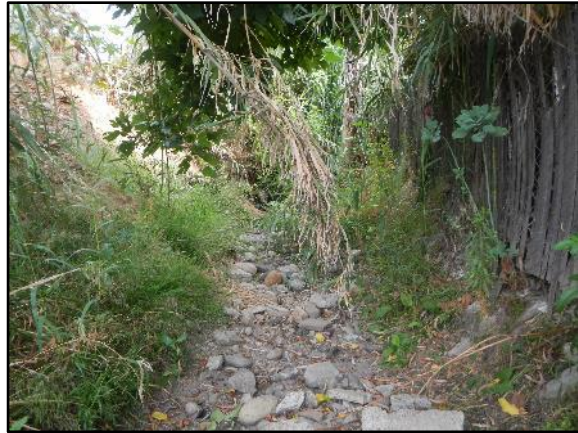
4. Lobrico 1, Reach 2: Typical section of downstream portion of Reach 2 with short left bank height, looking north (July 2019).

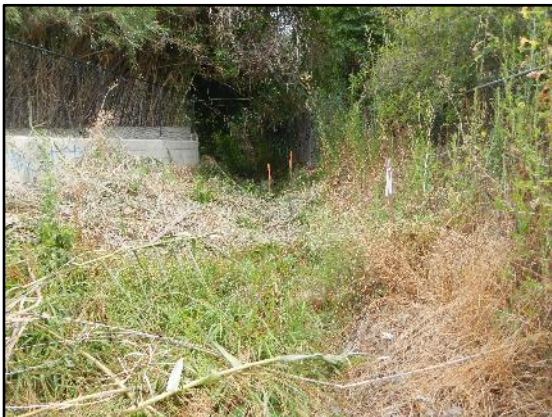
5. Lobrico 1, Reach 1: Dense vegetation present in channel and start of the 3-foot high private masonry wall along right bank, looking north (July 2019).

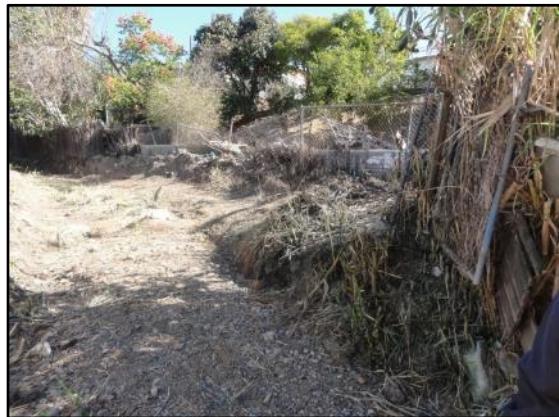
6. Lobrico 1, Reach 1: Middle portion of Lobrico 1 channel viewing the 3-foot high private wall along left bank, looking northeast (November 2016).

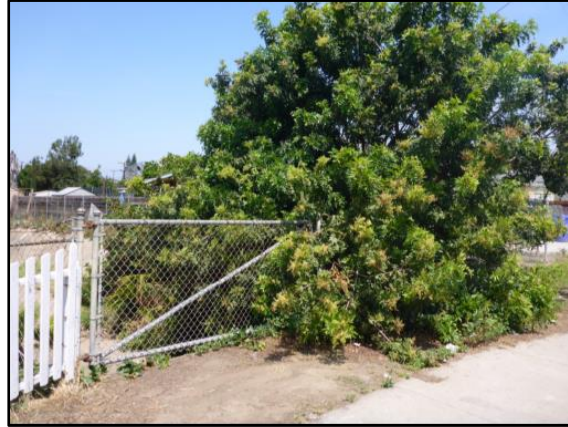
2. Cottonwood 2: Looking downstream from double 9-foot-wide by 5-foot-tall RCB culvert at 42nd Street; heavy vegetation and trees visible in segment.

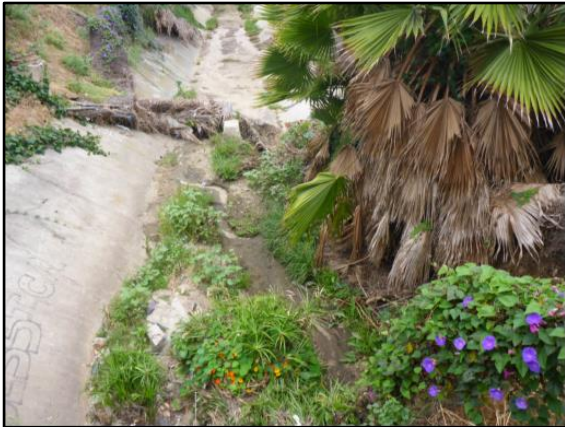
3. Cottonwood 2: Looking downstream at segment; vegetation and palm trees visible.

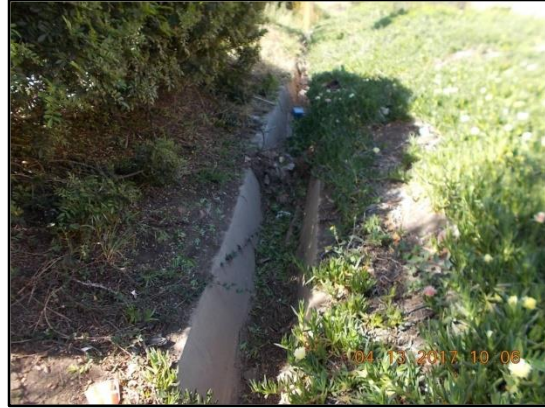
4. Outer 2: Looking downstream at debris/sediment and overhanging vegetation upstream of Outer 1 and Outer 2 junction.

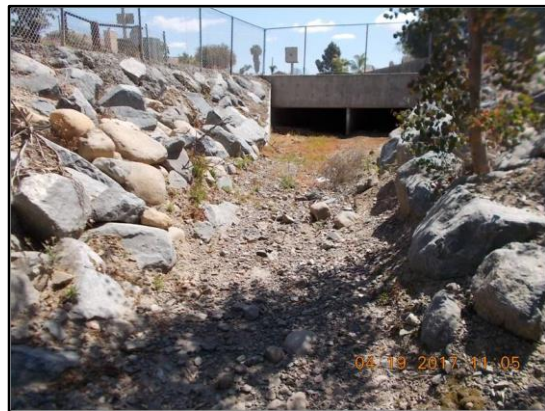
6. Tocayo 1: Looking upstream vegetation and outlet of double 10-foot by 4-foot RCB culvert.

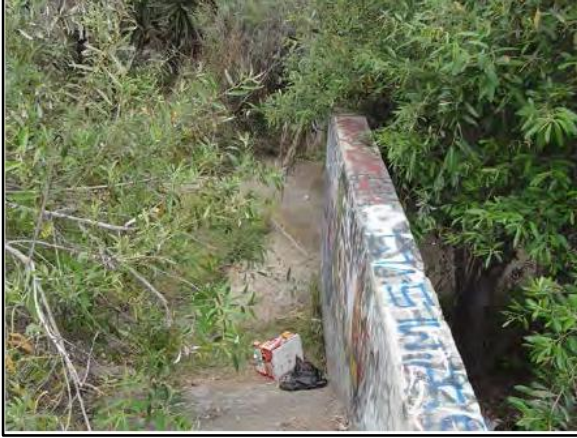
IHHA 4. Smythe 1, Map 2 (Reach 3): Upstream side of concrete check dam from northern bank.

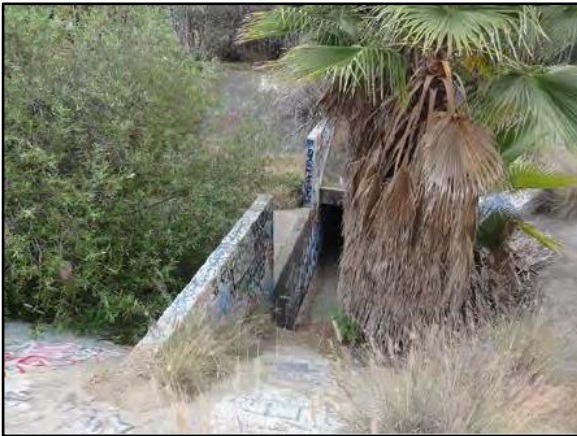
IHHA 6. Smythe 1, Map 2 (Reach 3): Downstream side of drop inlet structure.

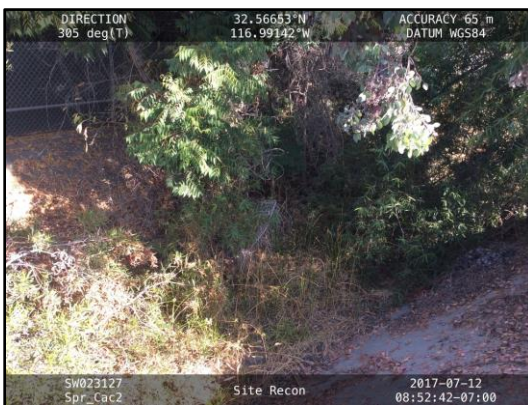
3. Cactus 1: Sediment/debris deposition and vegetation growth in basin.

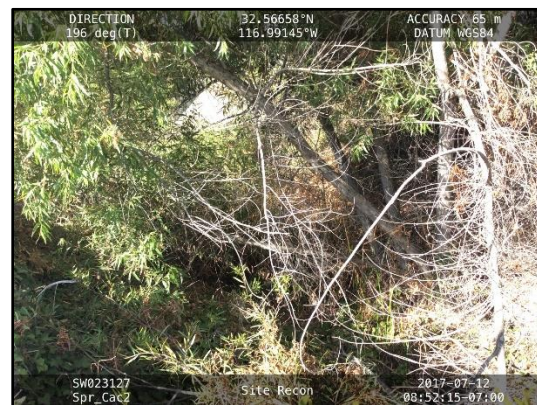
4. Cactus 1: Vegetation growth at outflow structure.

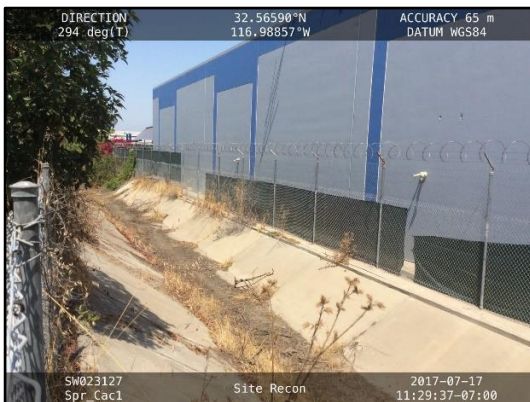
3. Cactus 2: Sediment deposition in basin.

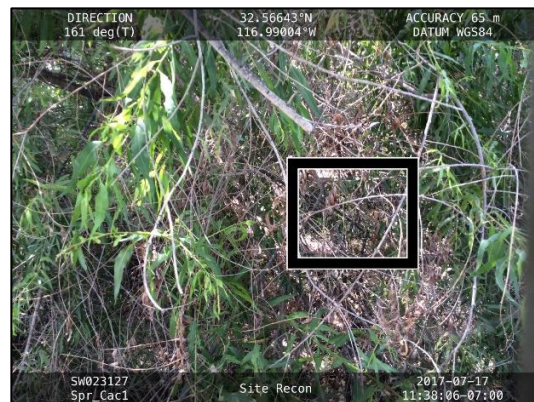
4. Cactus 2: Vegetation growth at outlet.

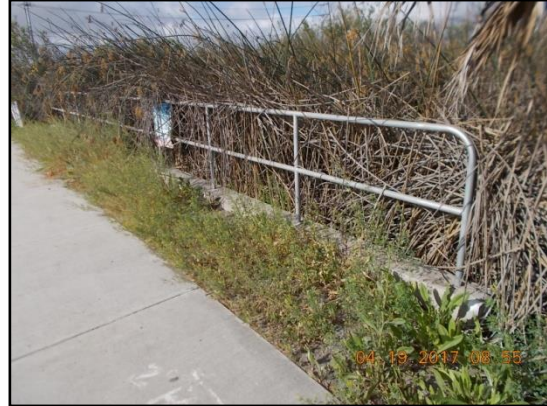
2. La Media 1: Looking downstream over headwall and three 24-inch-diameter RCP culvert outlet.

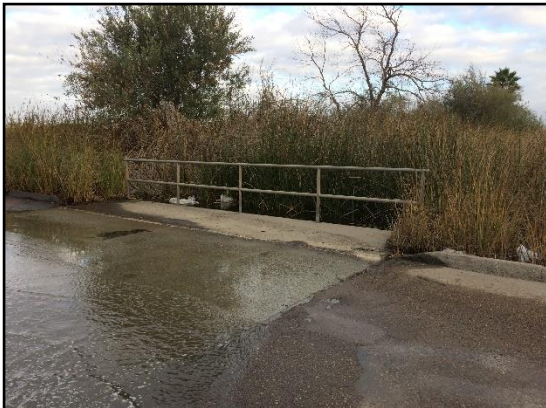
3. La Media 1: Looking upstream at conservation area from Airway Road.

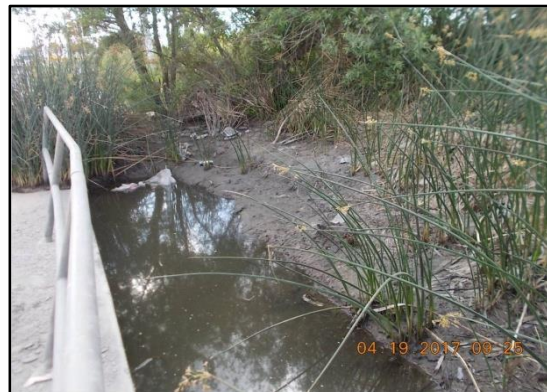
4. Downstream Domain of Analysis: Looking east at sediment and vegetation.
