PROTECTED TREE REPORT

1111 Sunset Blvd. Los Angeles, CA 90012

January 05, 2021

LISA SMITH, **THE TREE RESOURCE** REGISTERED CONSULTING ARBORIST #464 ISA BOARD CERTIFIED MASTER ARBORIST #WE3782 ISA TREE RISK ASSESSOR QUALIFIED - INSTRUCTOR MEMBER OF AMERICAN SOCIETY OF CONSULTING ARBORISTS P.O. BOX 49314, LOS ANGELES, CA 90049 **T** 310-663-2290 **E** lisa@thetreeresource.com

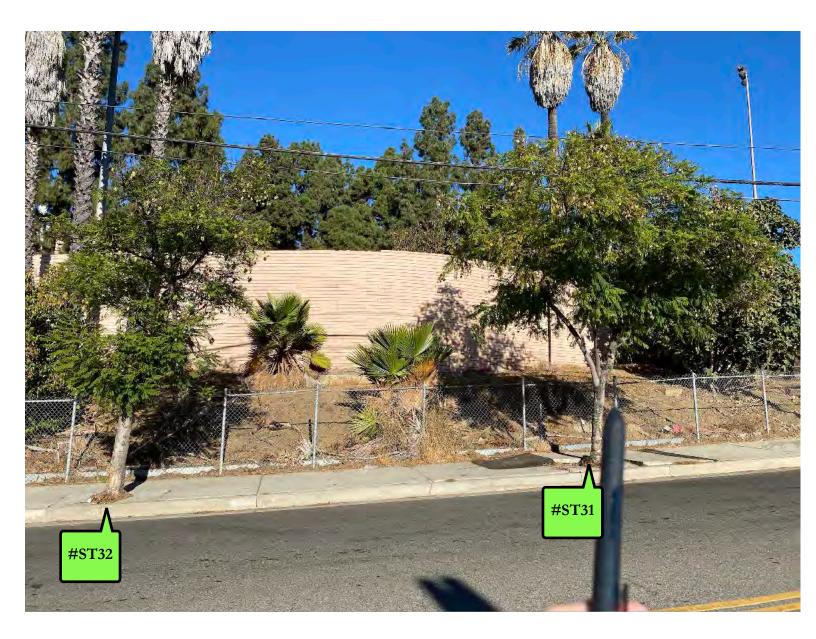
PHOTO 13 - Street Tree Jacaranda #32 (left) and #31 (right) to be retained and protected in place.

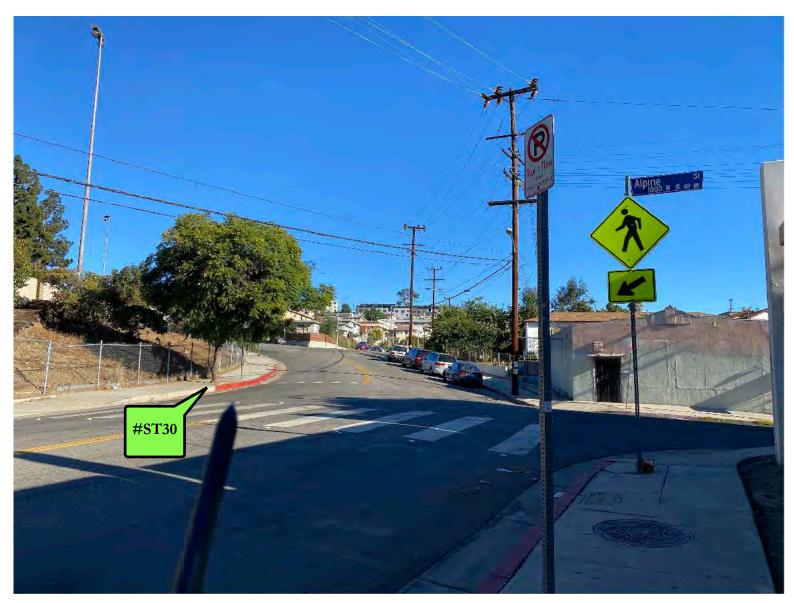
PHOTO 14 - Jacaranda Street Tree #30 - To be retained and protected in place.

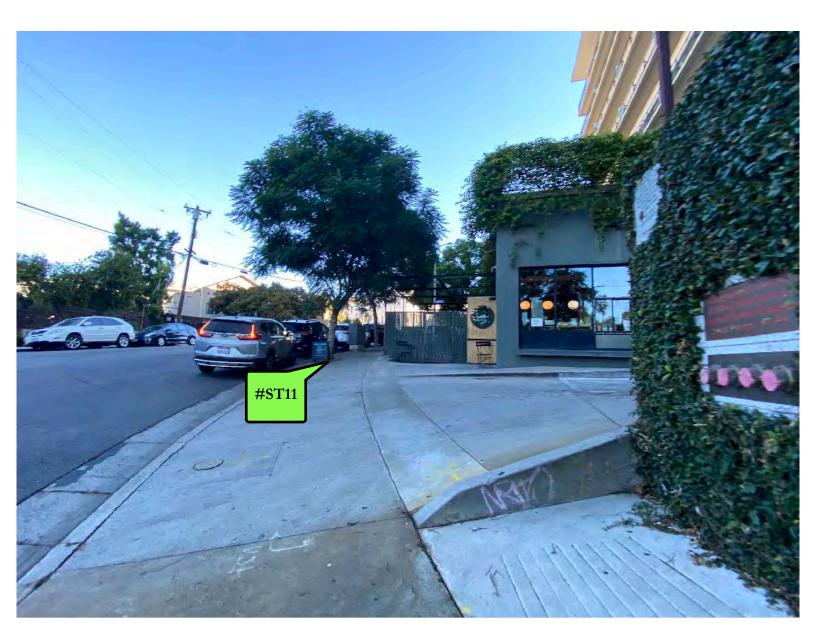
PHOTO 19- Street Tree Jacaranda #ST11 - To be retained and protected in place.

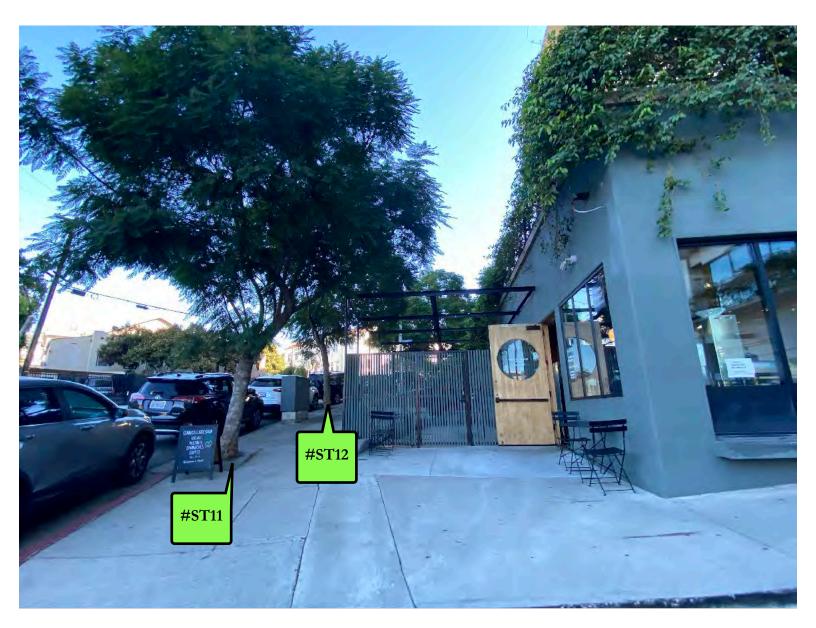
PHOTO 20 - Street Tree #ST11 and #ST12 - To be retained and protected in place.

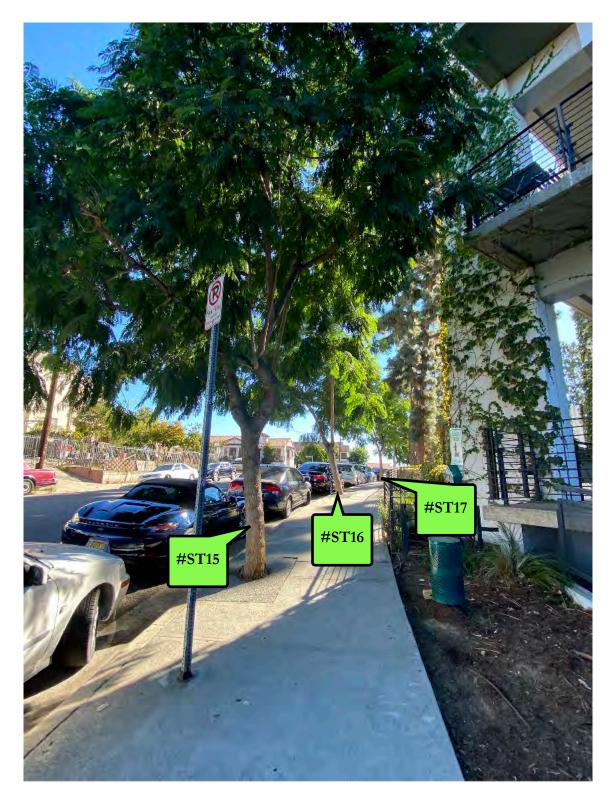
PHOTO 24 - Street Tree Jacarandas #ST15, #ST16 & #ST17 - to be retained and protected in place - Note ST15 is next to the NO Parking Sign on the left and the Doggy Clean up area to the right - for reference.

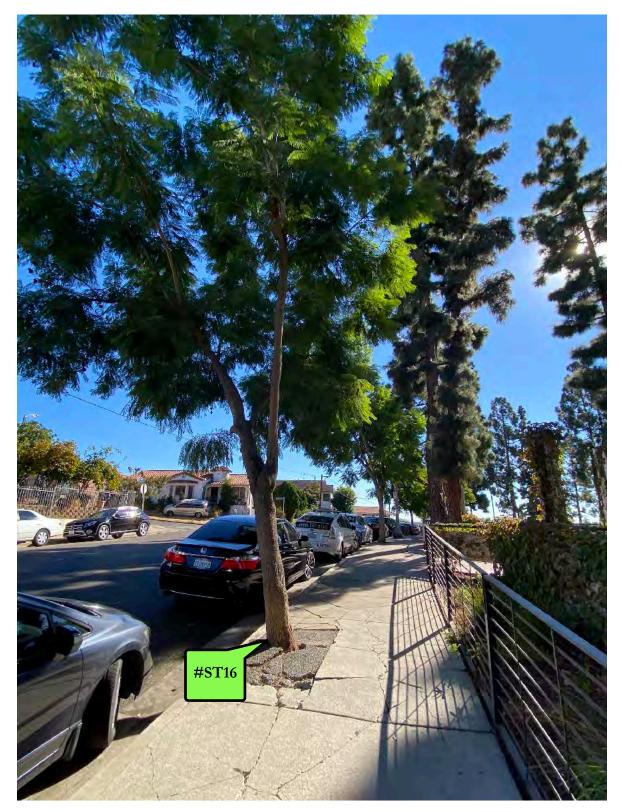
PHOTO 25 - Street Tree #ST16 - to be retained and protected in place

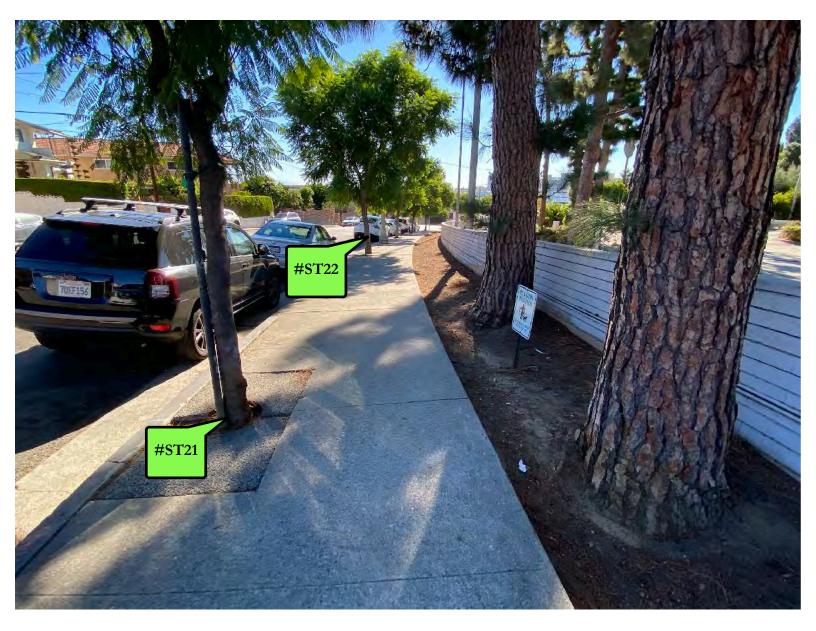
PHOTO 29 - Street Tree #ST21 (front with stake) and #ST22 (rear) - both to be retained and protected in place.

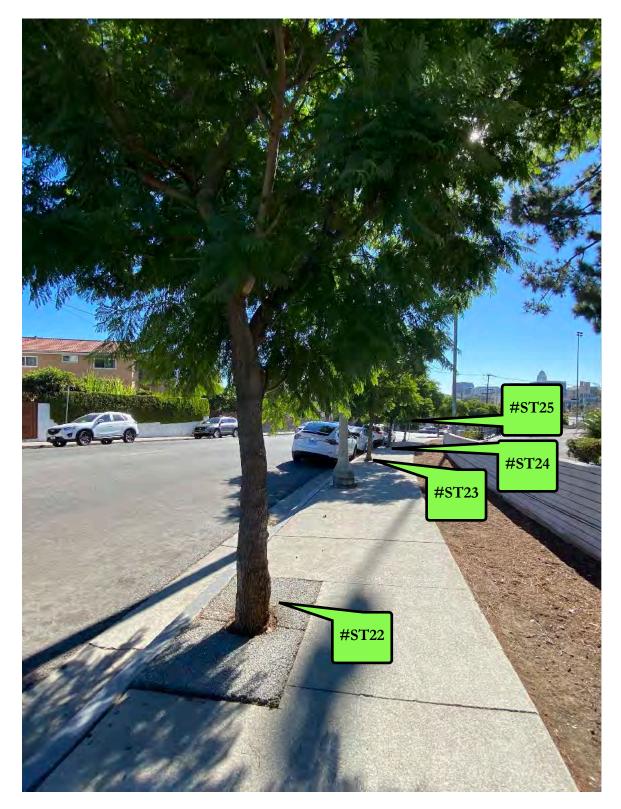
PHOTO 31 - Street Trees #ST22 (front) ST23, ST24 and ST25 - All to be retained and protected in place

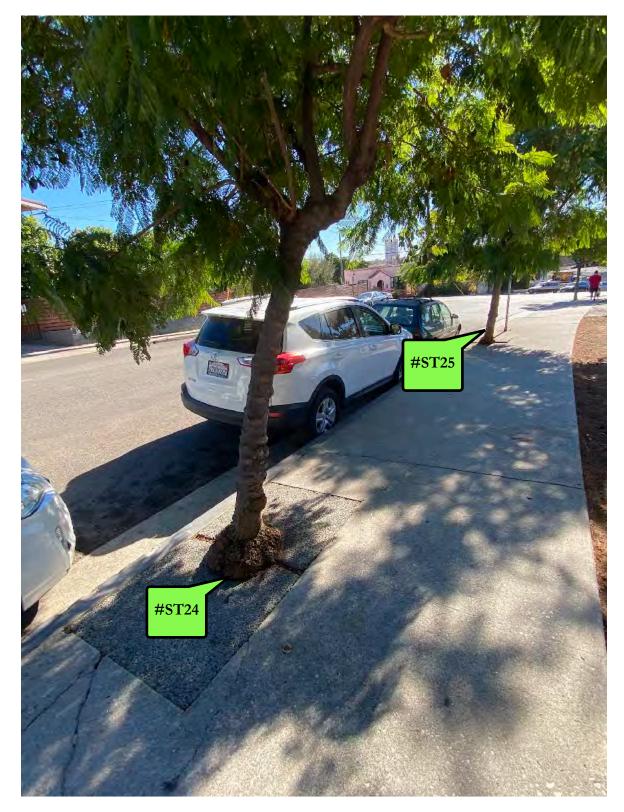
PHOTO 33 - Street Tree ST24 (front) and ST25 (back)

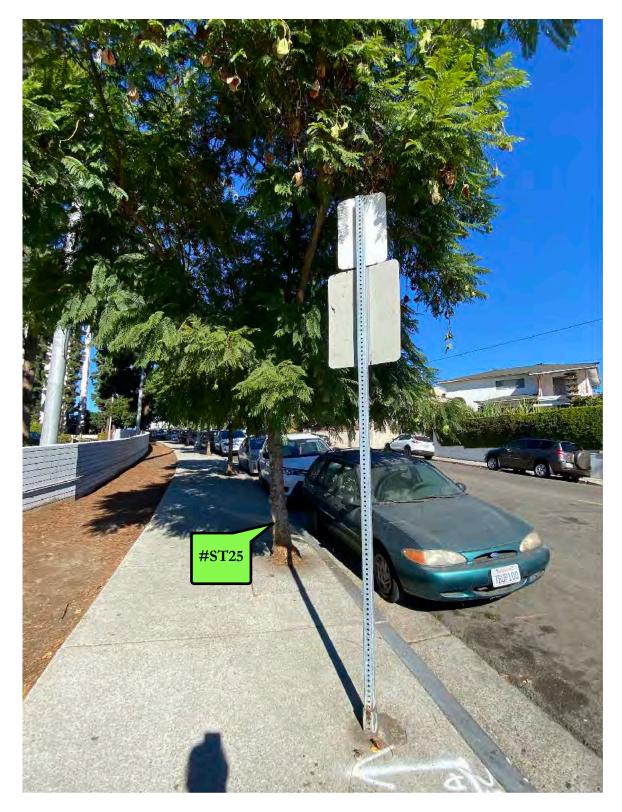
PHOTO 35 - Street Tree #ST25 - To be retained and protected in place.

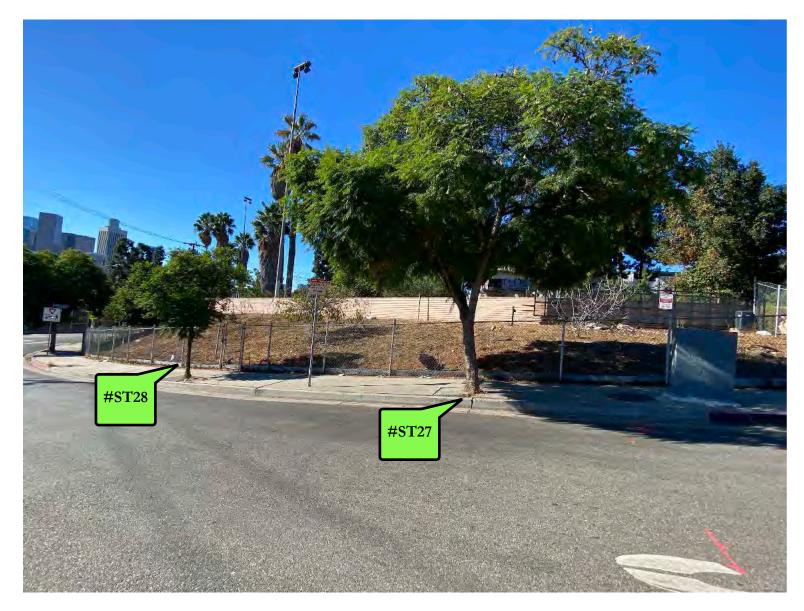
PHOTO 38 - Street Tree Jacarandas #ST27 (right) ST28 (left) to be retained and protected in place

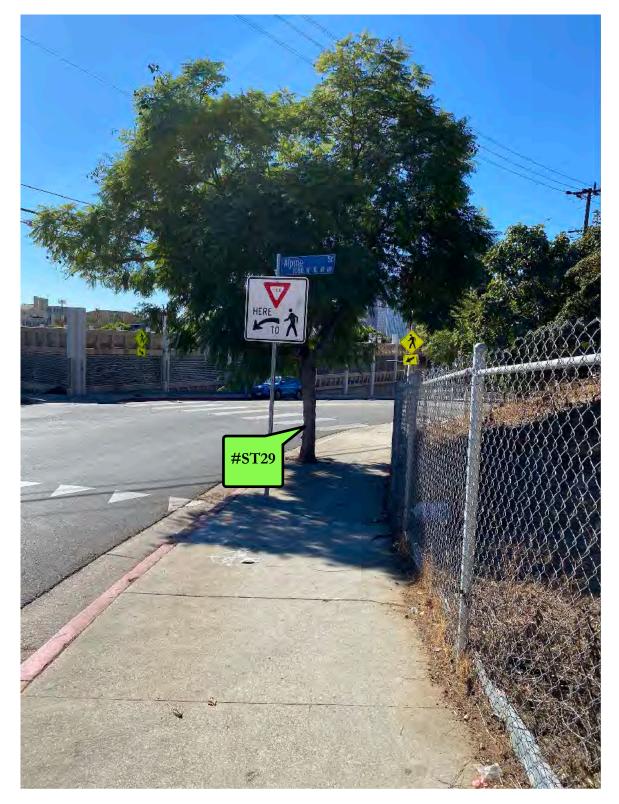
PHOTO 39 - Street Tree Jacaranda #ST29 - to be retained and protected in place.

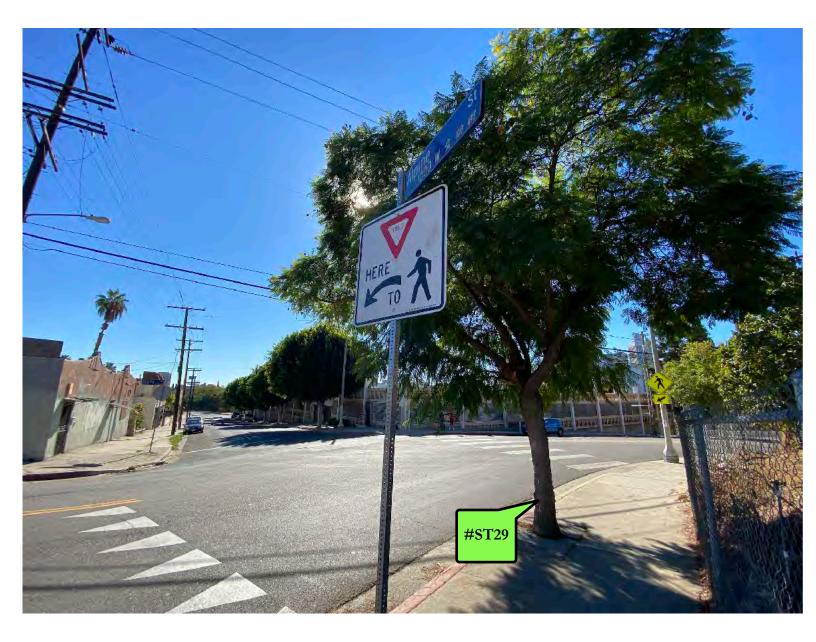
PHOTO 40 - Street Tree #ST29 -to be retained and protected in place.

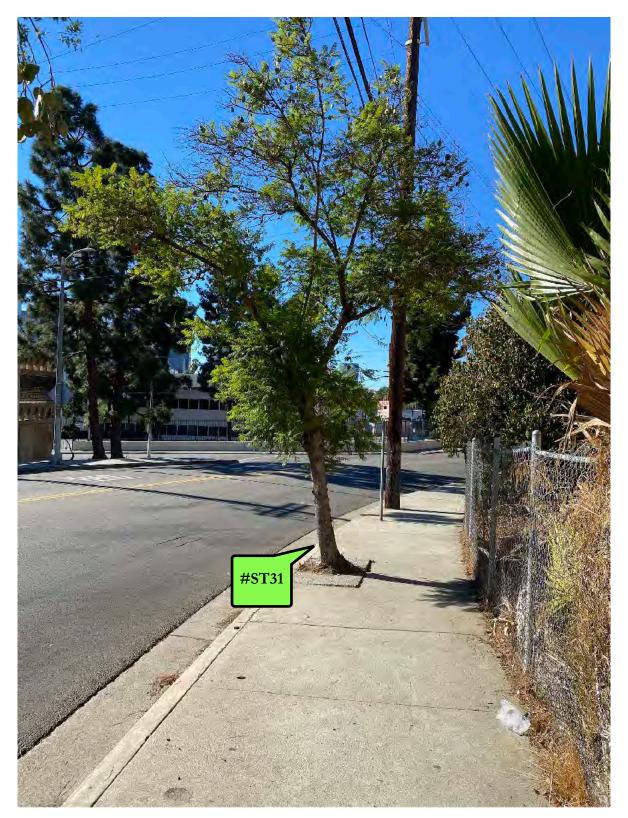
PHOTO 42 - Street Tree #ST31 - to be retained and protected in place.

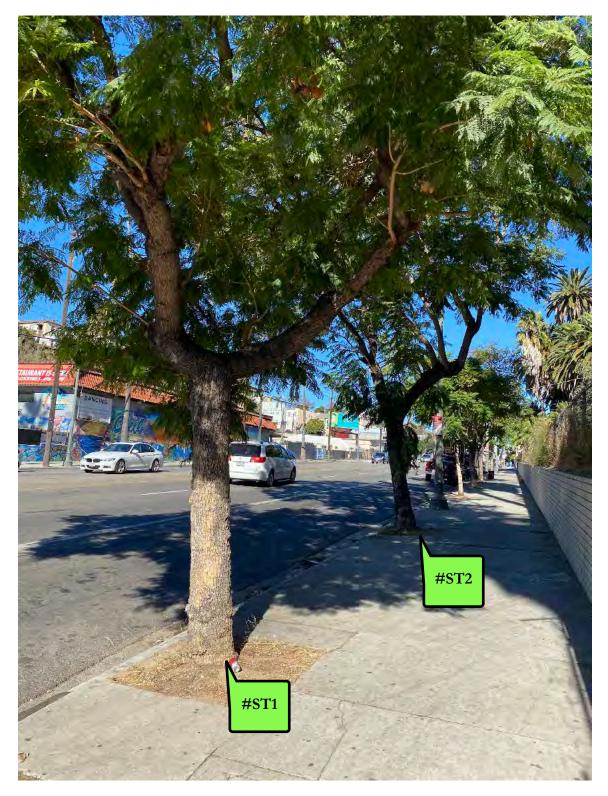
PHOTO 44 - Street Tree #ST1 (left) and #ST2 (right before street light post) - to be retained and protected in place.

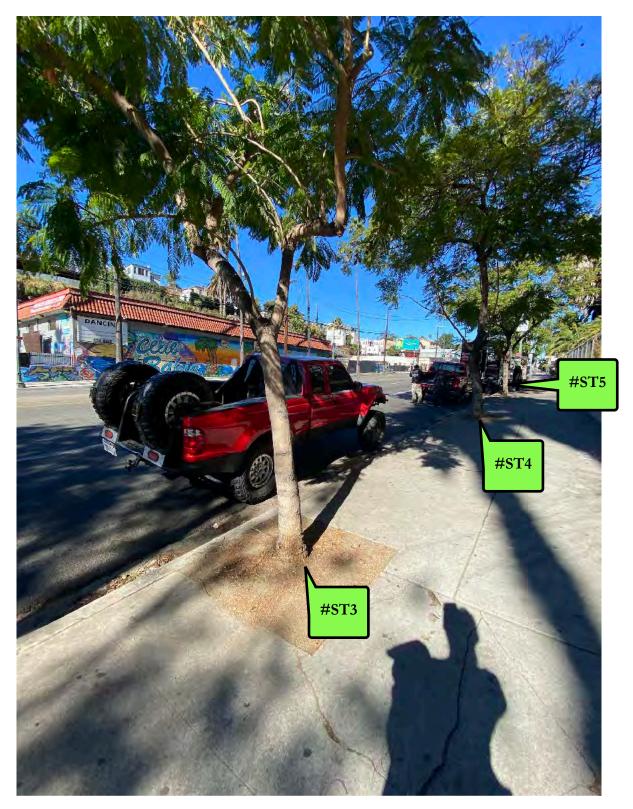
PHOTO 47 - Street Trees ST3 (next to red truck) ST4 (middle) and ST5 (back)
