# Appendix A

## **Design Specifications and Construction Considerations**

## Site-specific Repair Area Activities

2017 Storm Damage DWR Rehabilitation Program / 130028.39

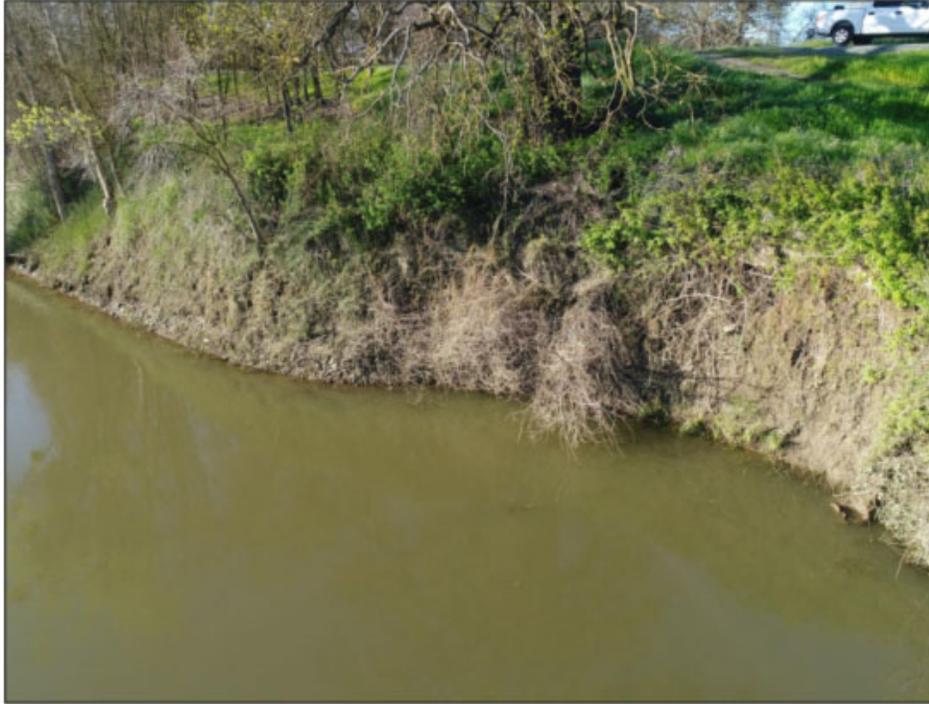
View looking southwest at vertical erosion in levee.

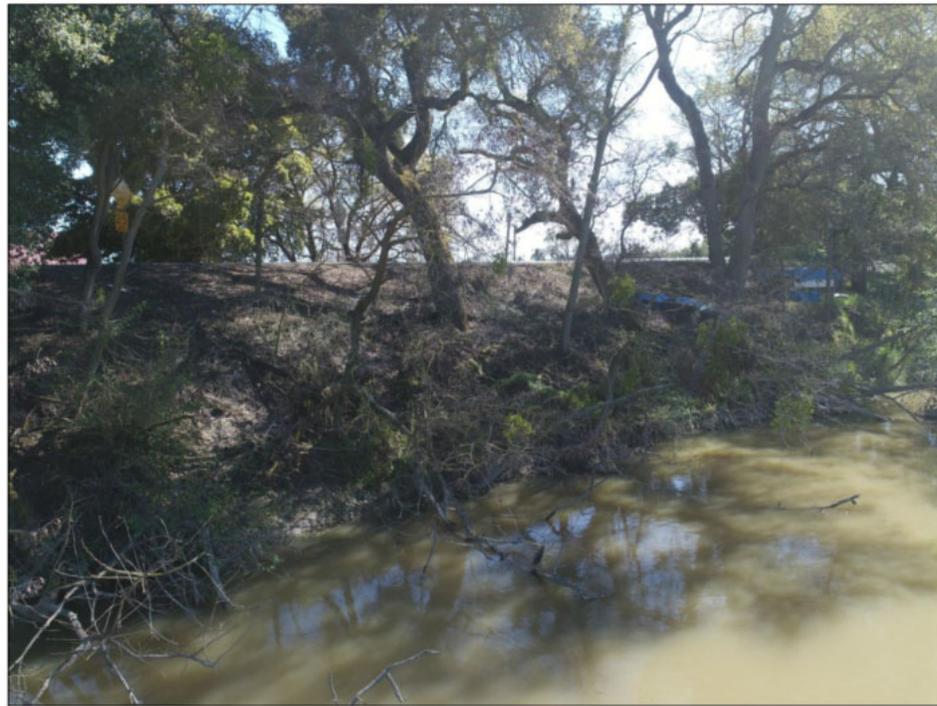
Aerial view looking southwest at erosion along waterside levee slope.

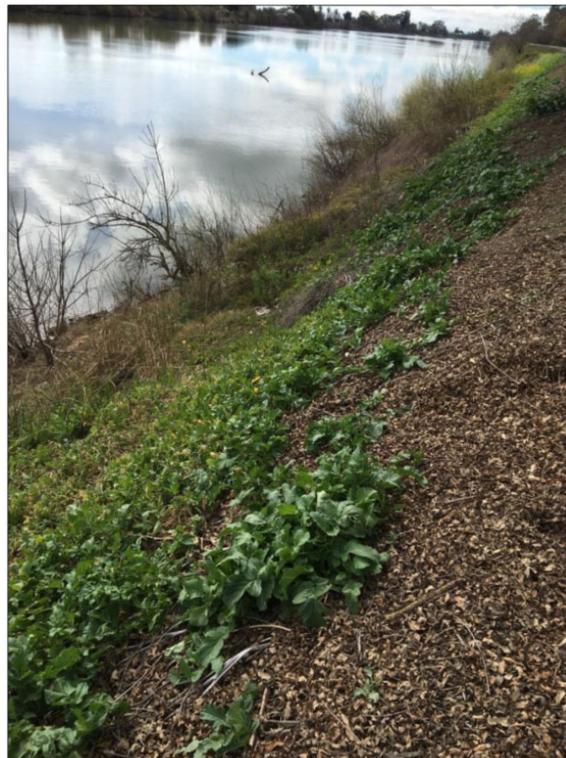
Vegetation along waterside of levee at erosion repair site.

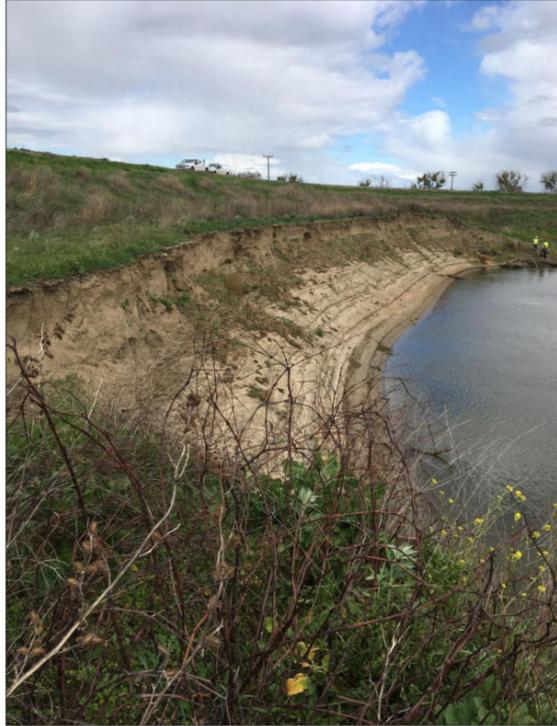
View looking from upstream at waterside levee bank erosion.

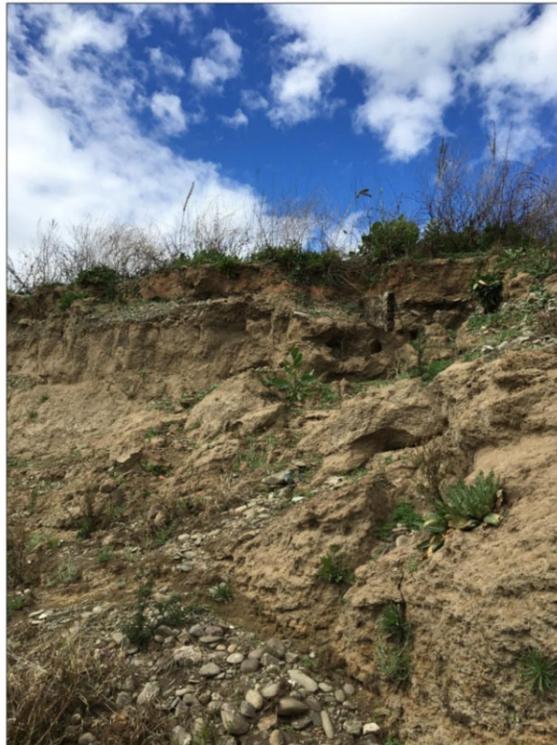
View of eroded bank with tension cracks.

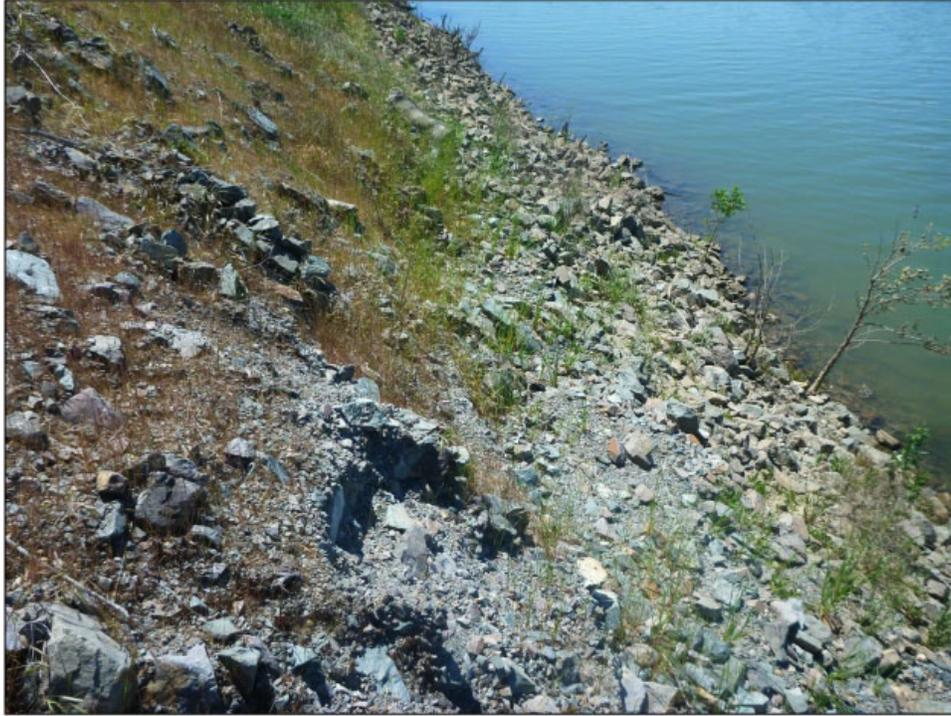
View of erosion along waterside levee which has fallen to the levee toe.

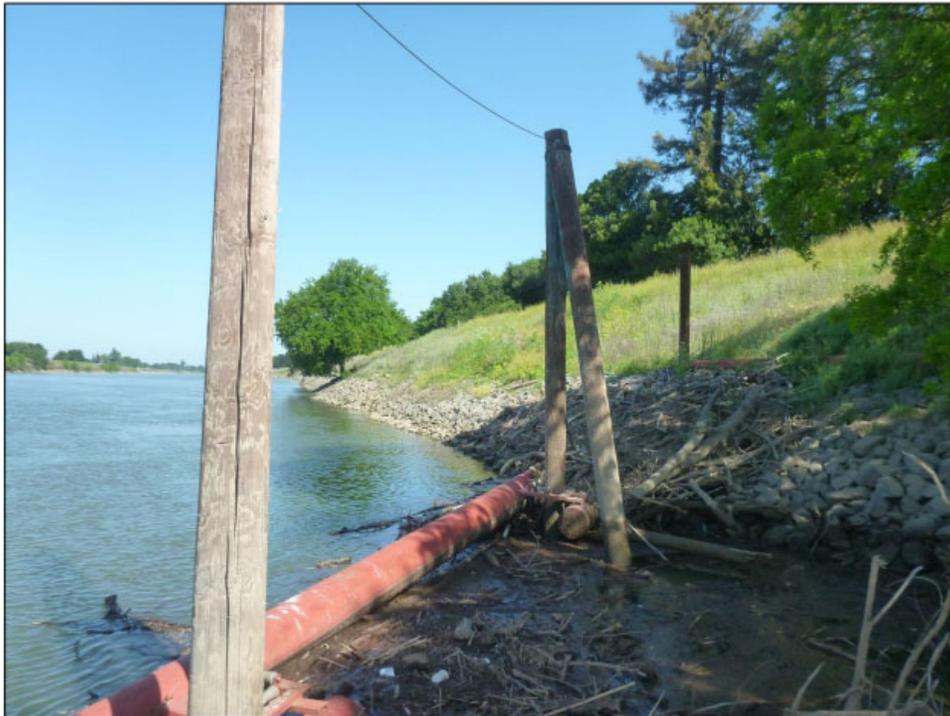
View of diversion structure at boat dock at southern end of erosion damage site.

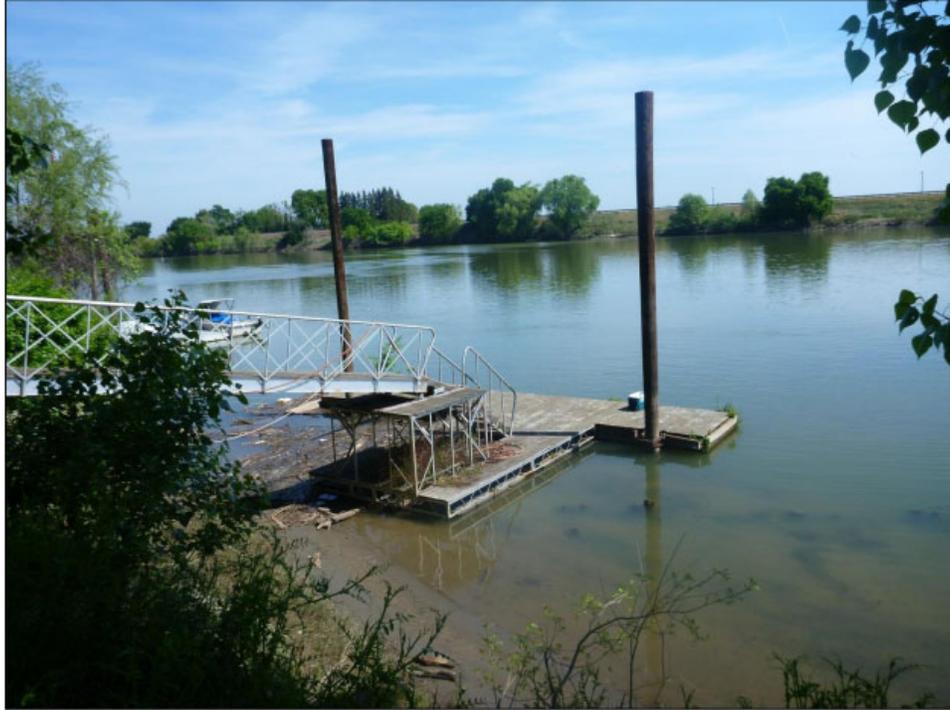
View of boat dock with erosion occurring behind boat dock.

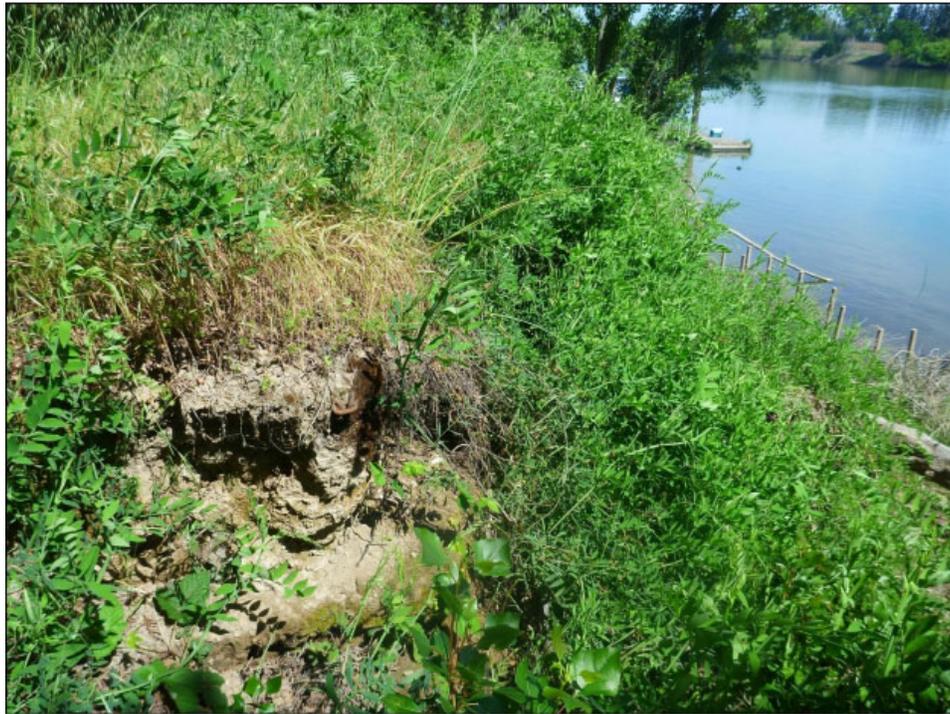
View of erosion along bank. Erosion control poles and boat dock visible in background.

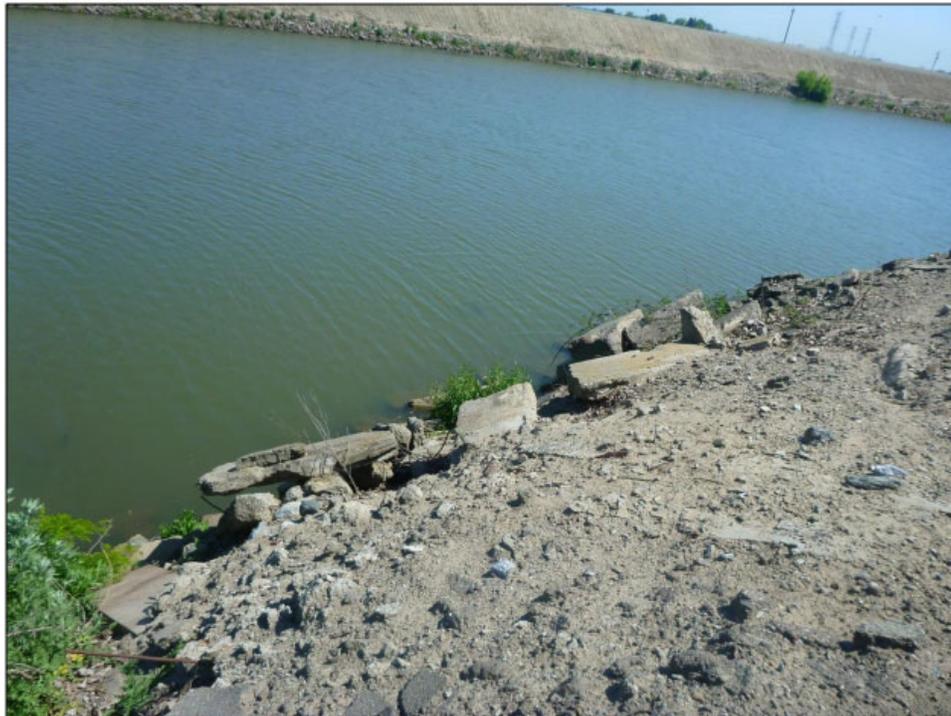
View of bank loss and construction debris

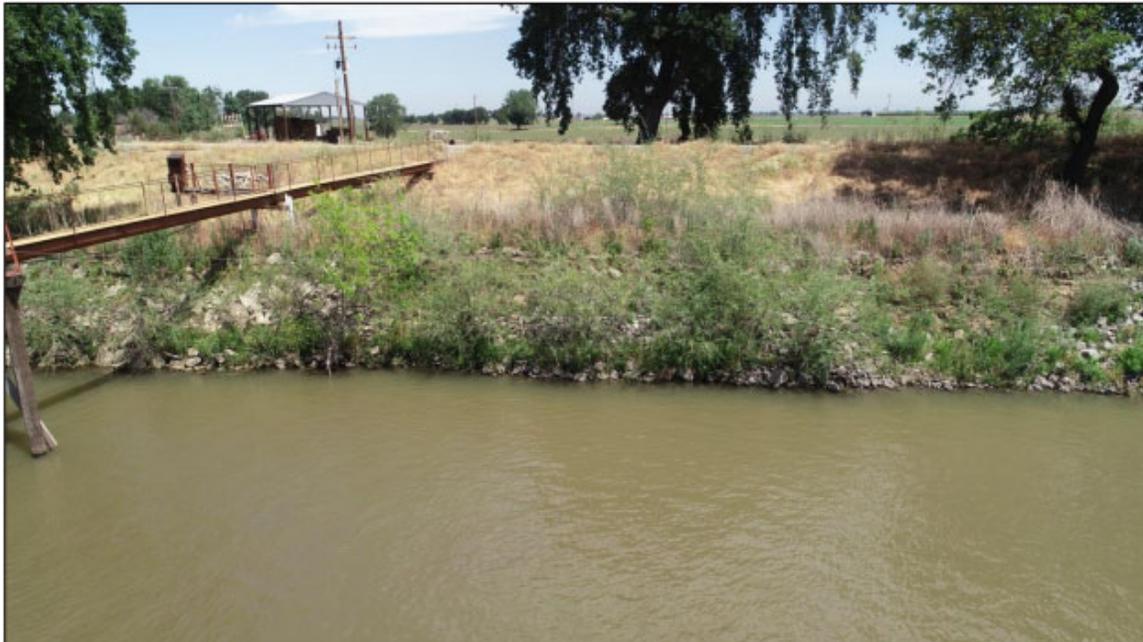
View of pipe through levee west of erosion repair site.

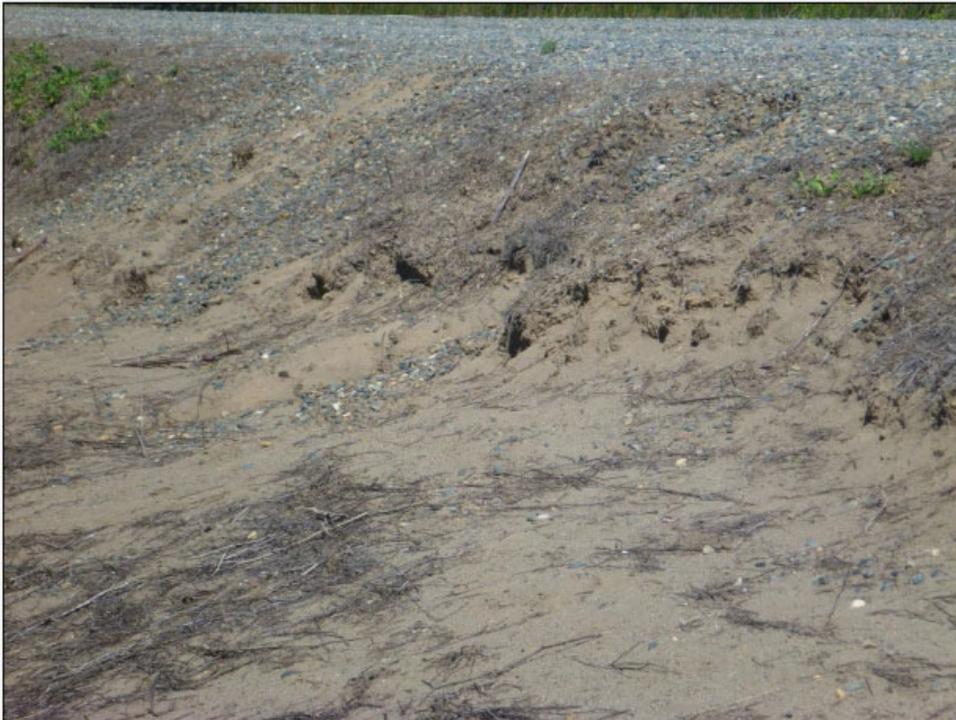
View of erosion and animal burrows along levee slope.
