PREPARED FOR City of Redwood City

April 2020

Project No. 047-60-19-23

WEST YOST ASSOCIATES

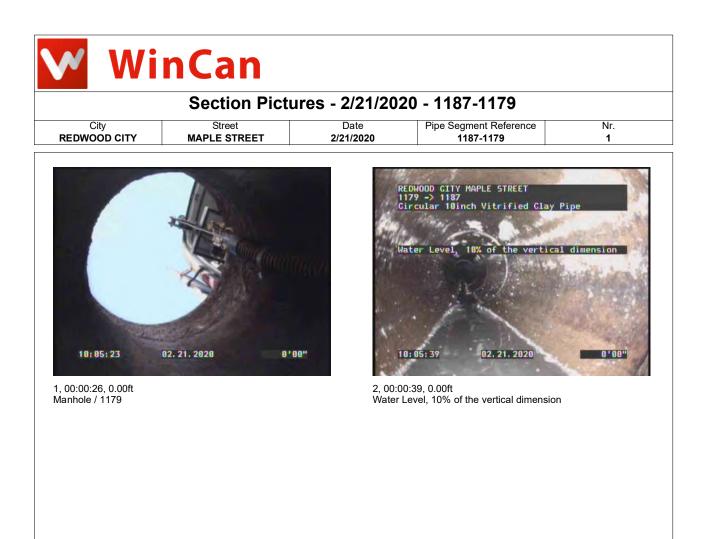
3, 00:00:43, 0.00ft Deposits Attached Grease, 5% of cross sectional area from 8 o'clock to 4 o'clock

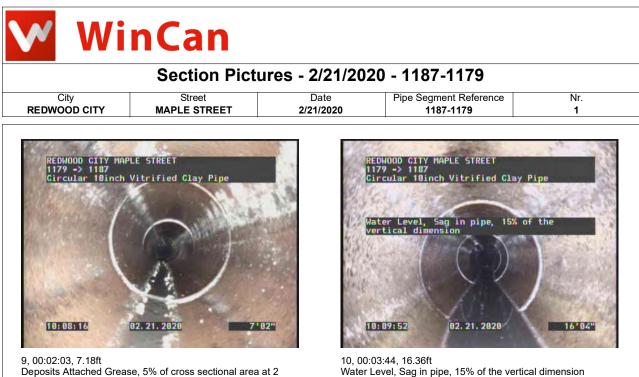
8, 00:02:03, 7.18ft Deposits Attached Grease, 5% of cross sectional area at 2 o'clock, Start

Deposits Attached Grease, 5% of cross sectional area at 2 o'clock, Start

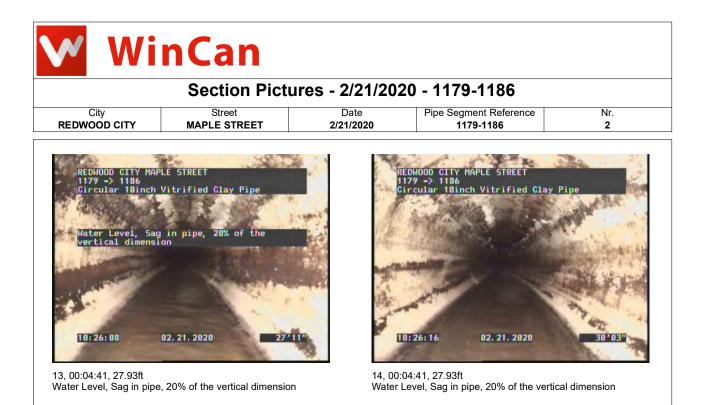
15, 00:05:49, 46.88ft Water Level, Sag in pipe, 25% of the vertical dimension

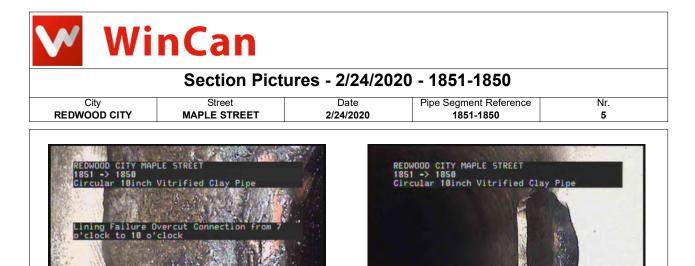
10, 00:04:42, 55.76ft

Lining Failure Overcut Connection from 7 o'clock to 10 o'clock

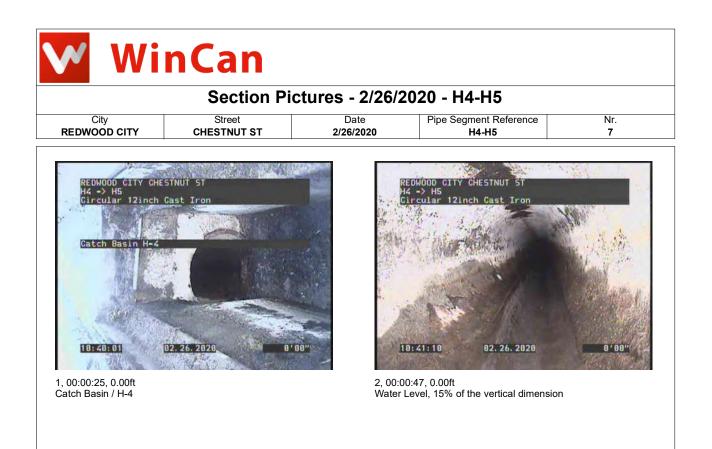
3, 00:01:06, 0.00ft Deposits Attached Encrustation, 5% of cross sectional area from 8 o'clock to 4 o'clock

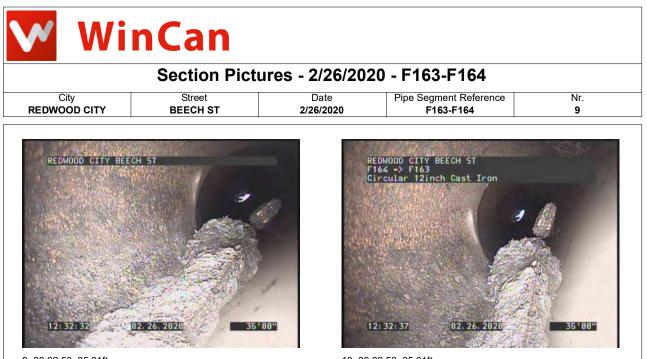
9, 00:02:53, 35.01ft Deposits Settled Fine, 10% of cross sectional area at 8 o'clock

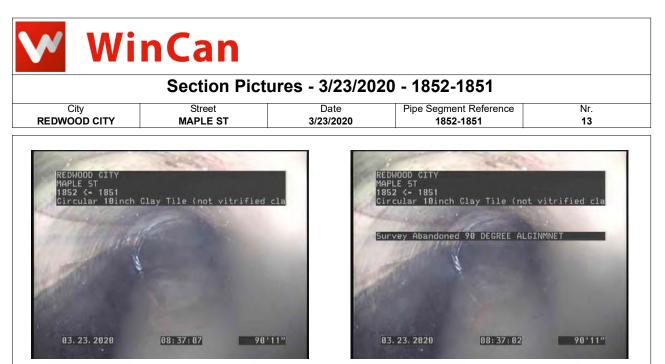
Deposits Attached Grease, 5% of cross sectional area from 11 o'clock to 1 o'clock, within 8 inch, Finish
