Nike Site Demolition Project

Alameda County, Annual

Project Information		Date:	07/23/2019 Tuesday	Project Number:	2062-163.00
Project Name:	Alameda County General Services Agency Nike Site Hazardous Materials Abatement and Demolition.				
Project Address:	2892 Fairmont Drive, San Leandro, Ca, Building B, Building C, Building D & the guard shed structure by the gate.				
Project Technician:	M.Massoud Navvab CAC # 98-2531 Lead # 8555	Project Manager:	Stephen Jackson (OAK)

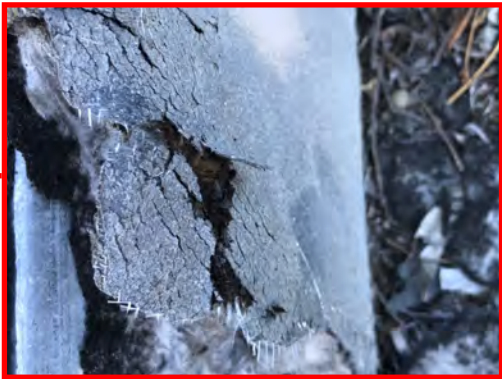
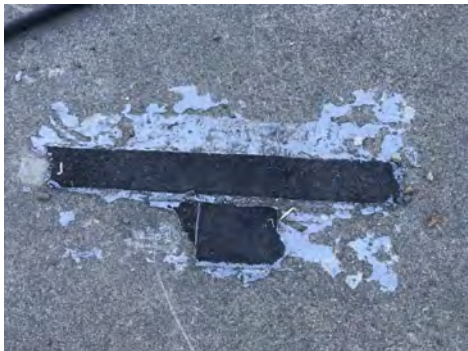
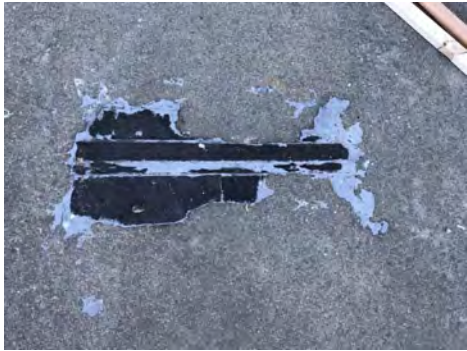
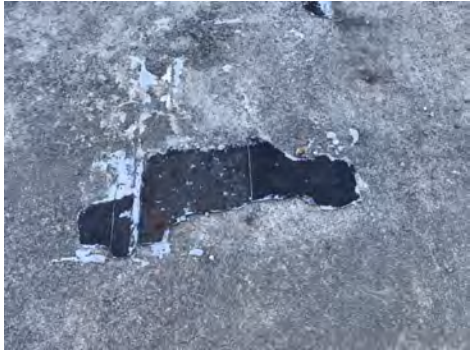
Remaining ACM Patching Compound on the Metal Duct & Concrete Flooring around the Bldg B Exterior.

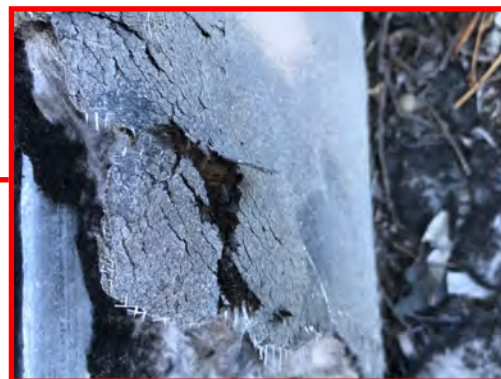
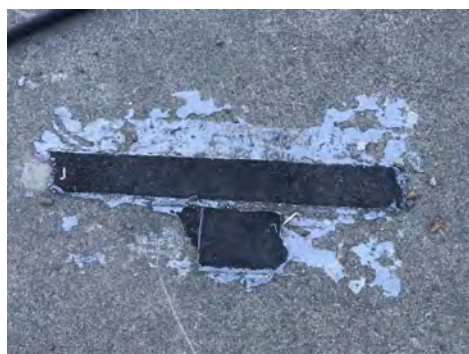
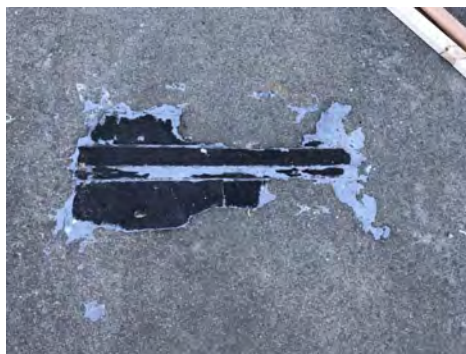
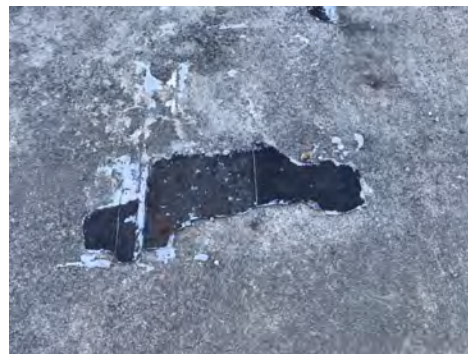
Building B, Exterior

Remaining ACM Patching Compound on the Metal Duct & Concrete Flooring around the Bldg B Exterior.

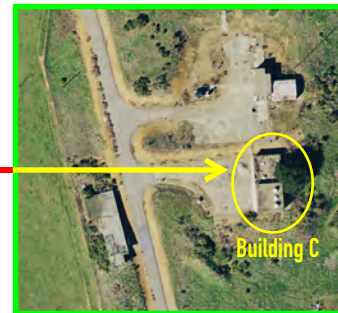
Building C, interior existing condition

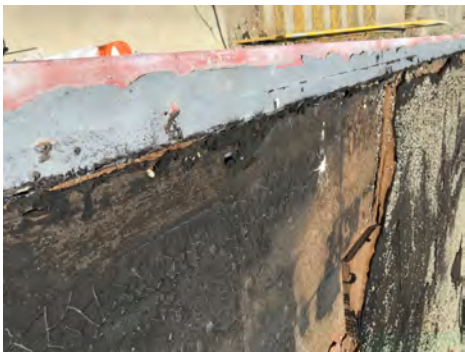
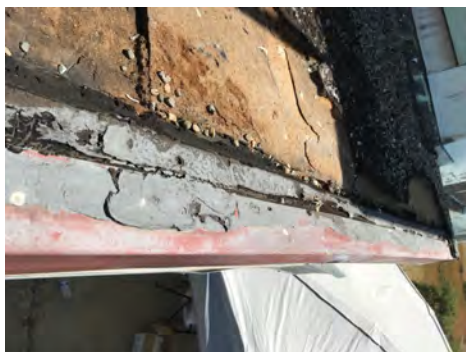
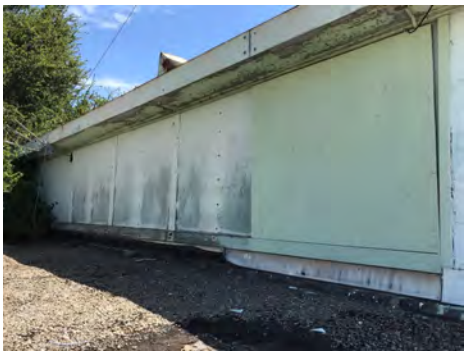
Building C Roof area with ACM Roof Patching Compound & ACM Transit Panels

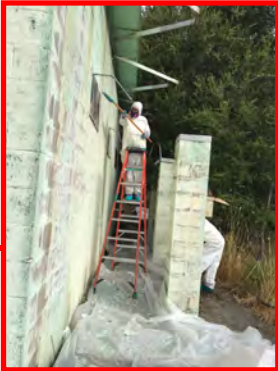
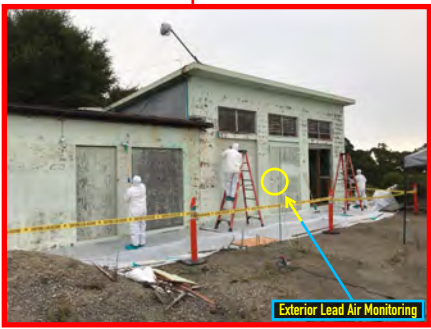
Building C, Exterior CMU Wall Loose & Peeling Lead Based Paint removal / Stabilization work activities

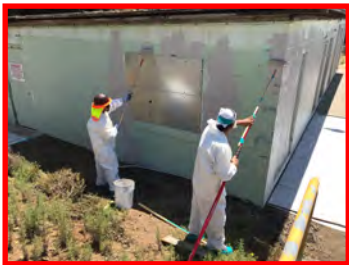
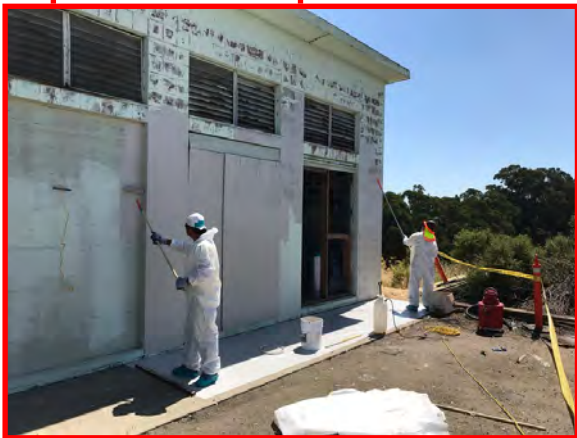
Exterior & Interior CMU walls Painting following Loose & Peeling Lead Based Paint removal & Stabilization in the Building C.

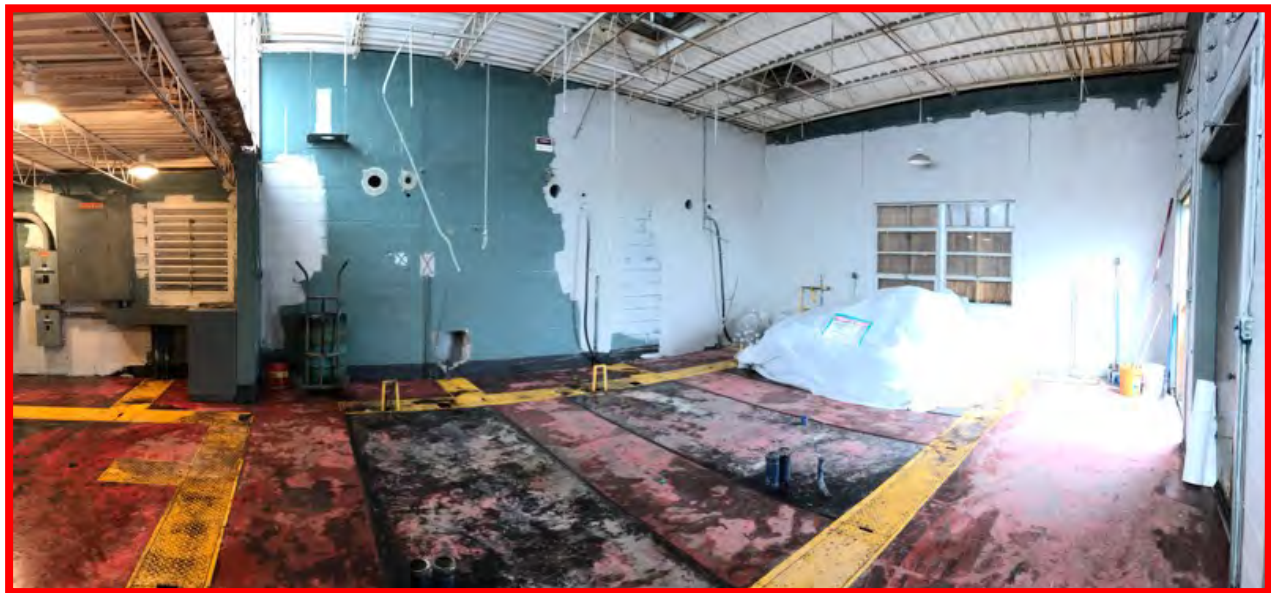
Building C, Interior space following the Completion of the final detail clean up

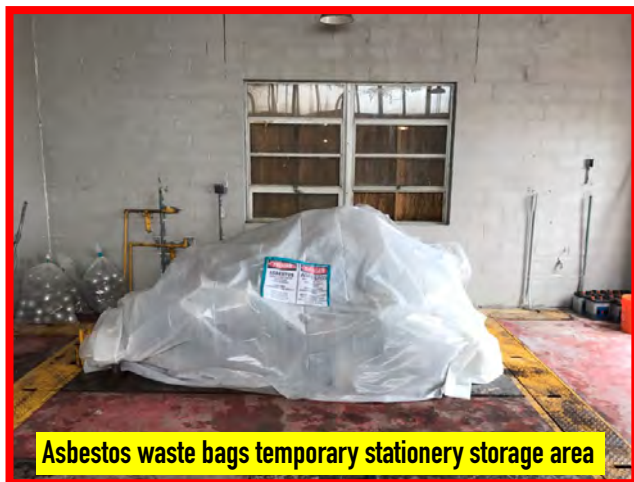
Asbestos waste bags temporary stationery storage area

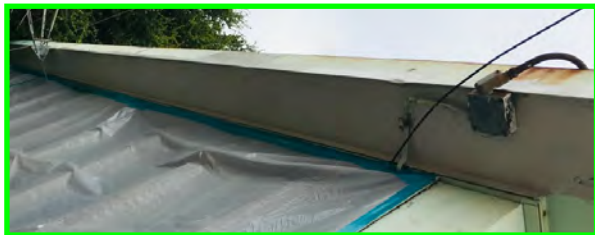
Exterior roof Eve Surface following Loose & Peeling Lead Based Paint removal & Stabilization in the Building C.

Exterior roof Eve Painting with primer following Loose & Peeling Lead Based Paint removal & Stabilization in the Building C.

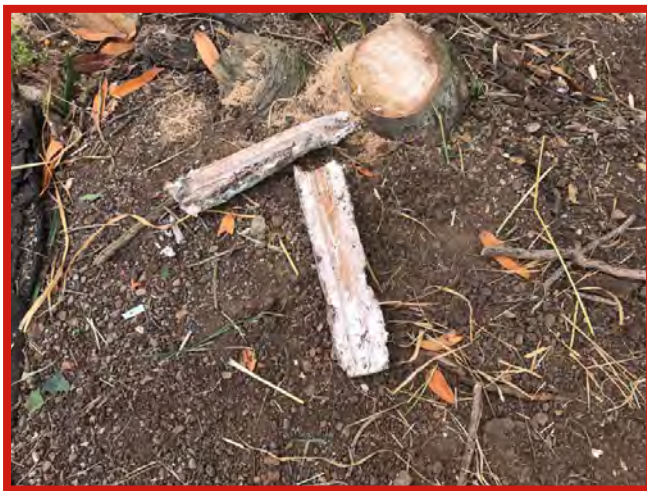
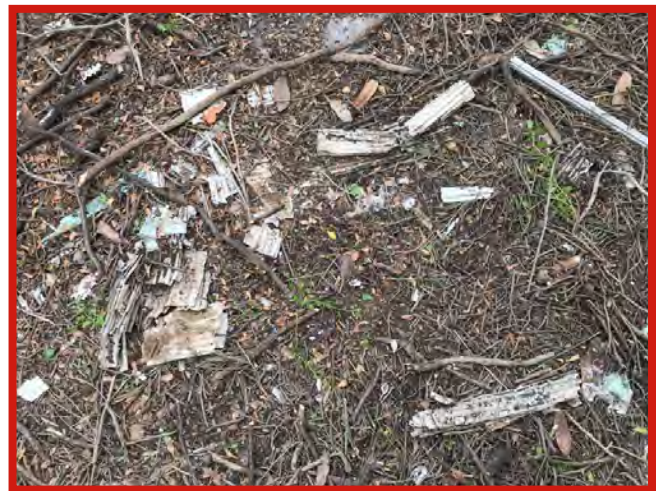
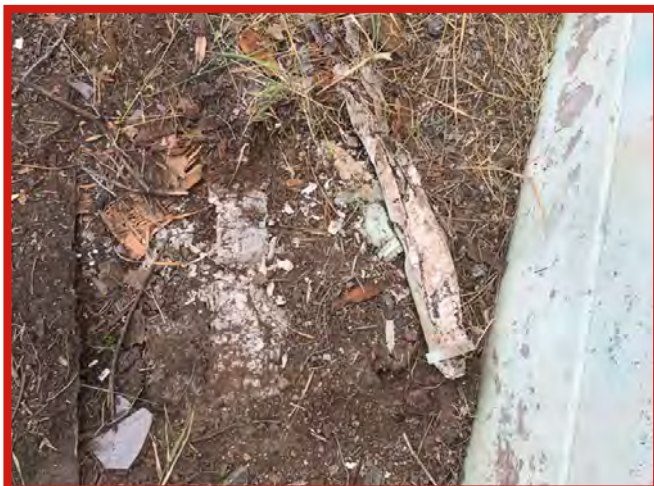
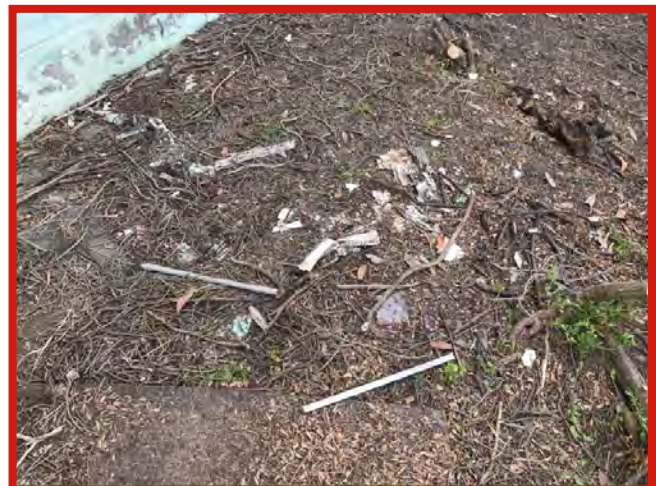
ACM TSI Pipe Insulation on the landscaping & Mixed with the dirt

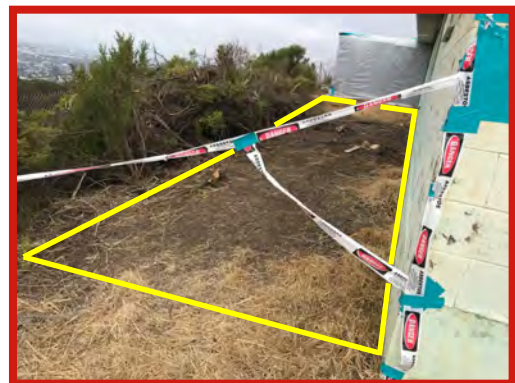
Approximate Location of
ACM TSI Pipe Insulation Debris Contamination area

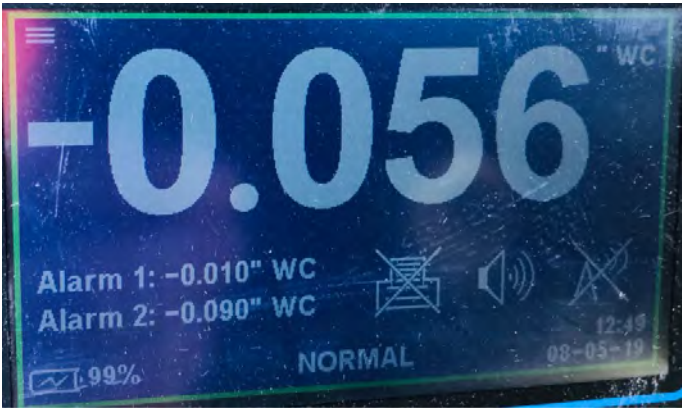
Building D, the decontamination unit & the negative air pressure

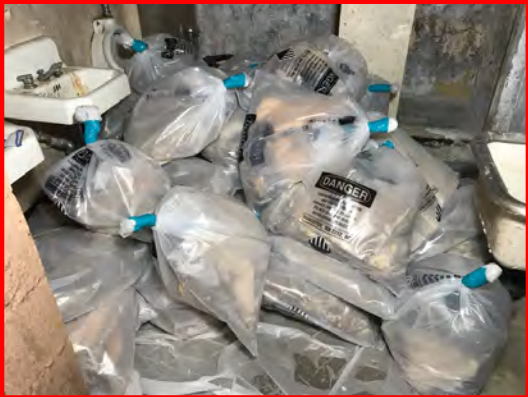
Asbestos bags are stored in restrooms area

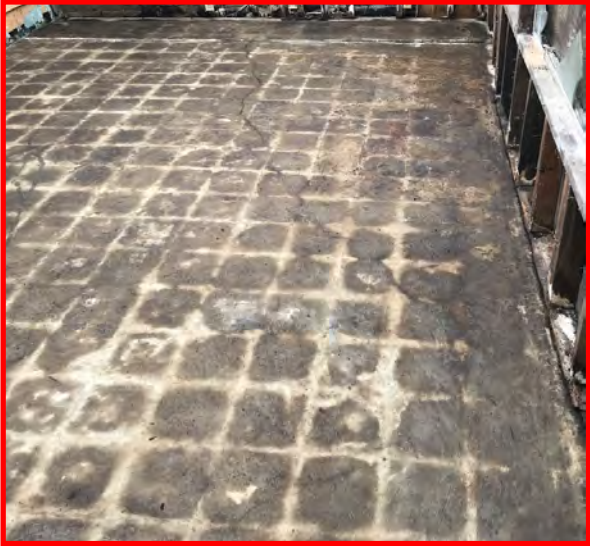
**Building D
Regulated area**

Completion of the ACM 9"x9" Floor tiles & ACM Black Adhesive removal & Final detail clean up

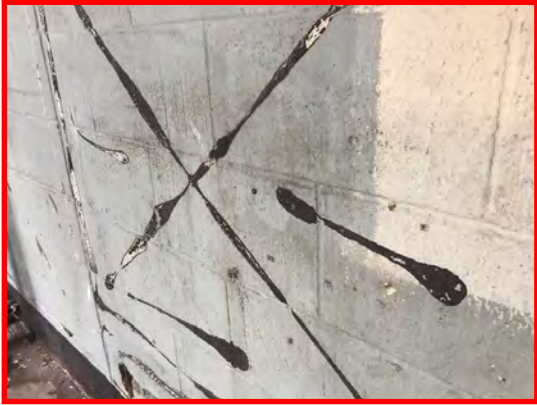
ACM Black Adhesive on CMU Wall

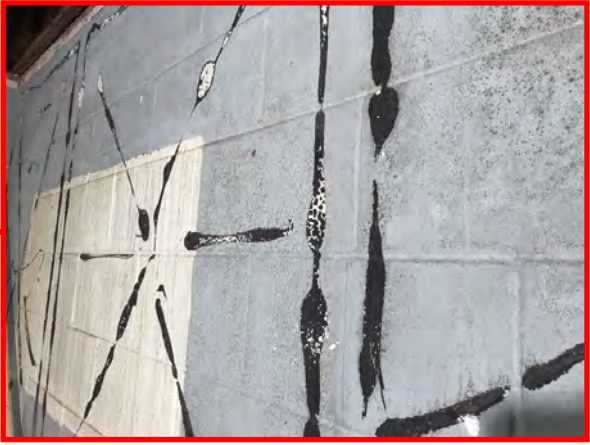
ACM Black Adhesive on CMU Wall

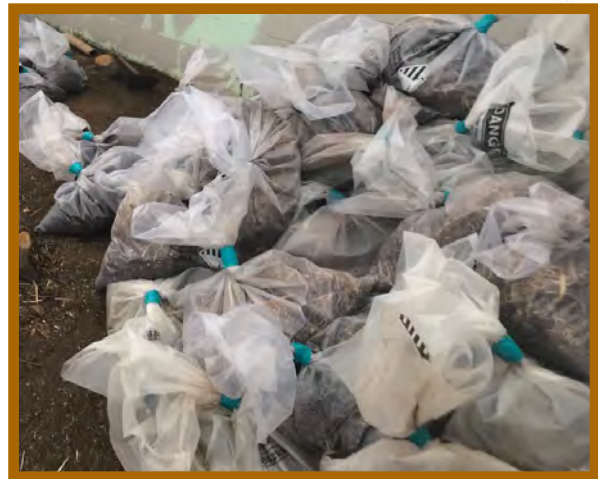
Contaminated Soil are bagged in Waste plastic asbestos bags

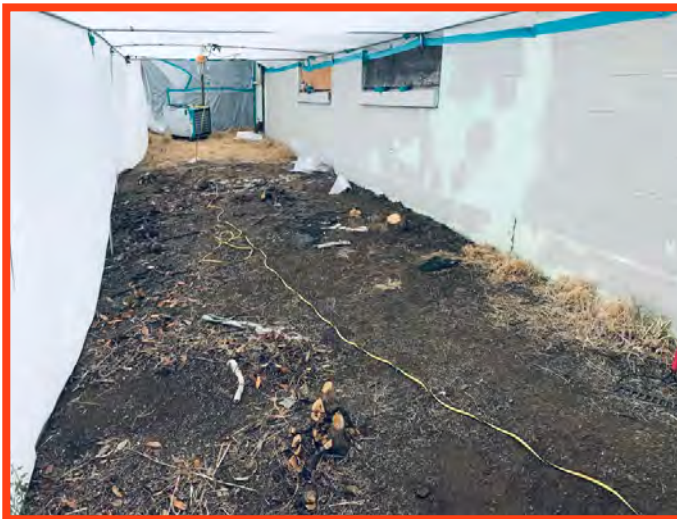
Inside the Containment on Monday 08/19/19

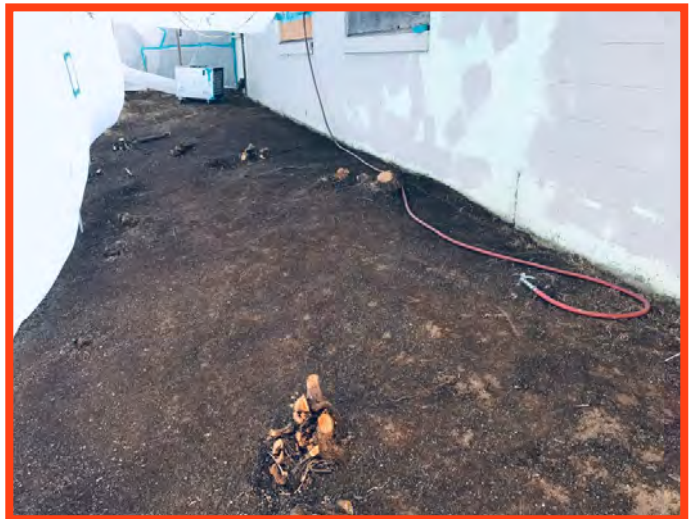
After Contaminated Soil with ACM TSI Pipe Insulation debris clean up

Inside the Containment on Wednesday 08/21/19
